The Impact of Cracks on Photovoltaic Power Performance

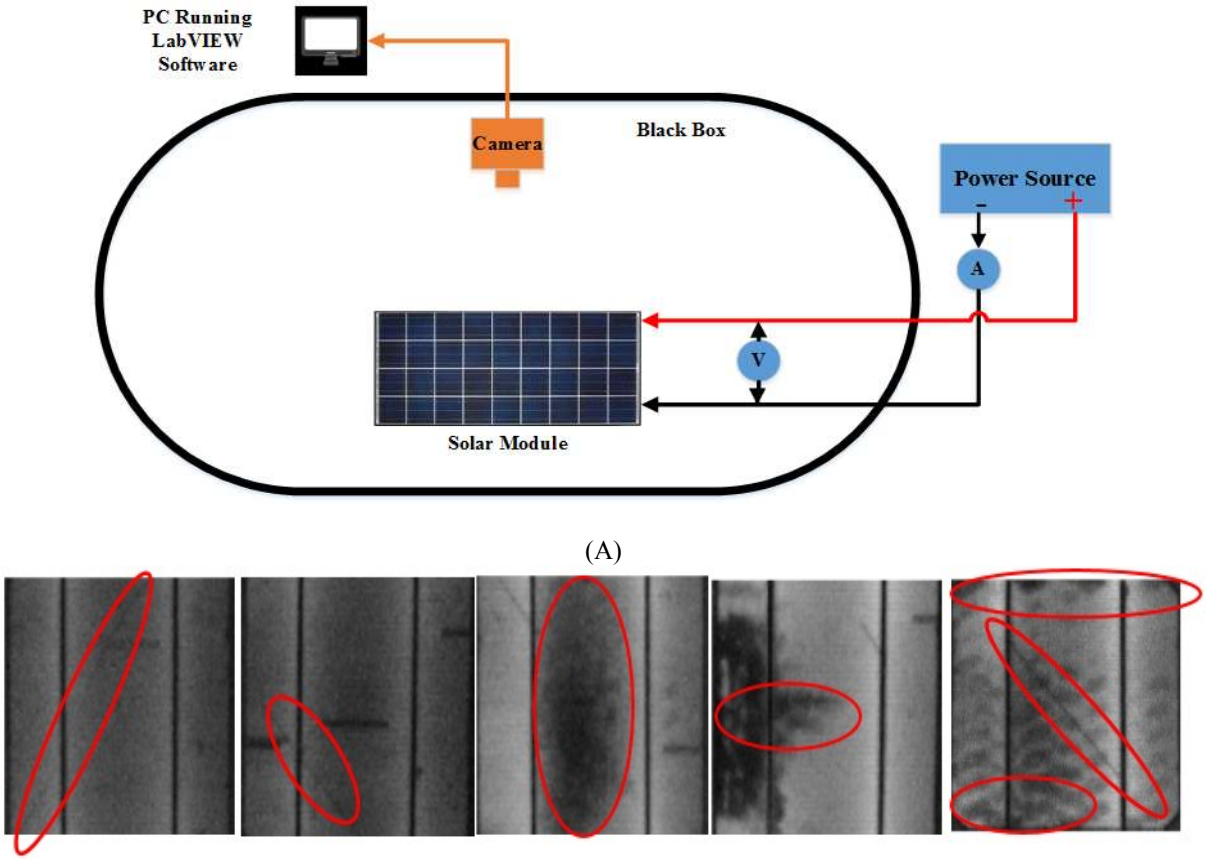
A. Diagonal crack ($+45^0$)
B. Diagonal crack (-45^0)
C. Parallel to busbars crack
D. Perpendicular to busbars crack
E. Multiple directions crack

Fig. 2. El Experimental Setup and Examined Crack Types. (A) Electroluminescence experimental setup; (B) Diagonal Crack ($+45^0$); (C) Diagonal Crack (-45^0); (D) Parallel to Busbars Crack; (E) Perpendicular to Busbars Crack; (F) Multiple Directions Crack

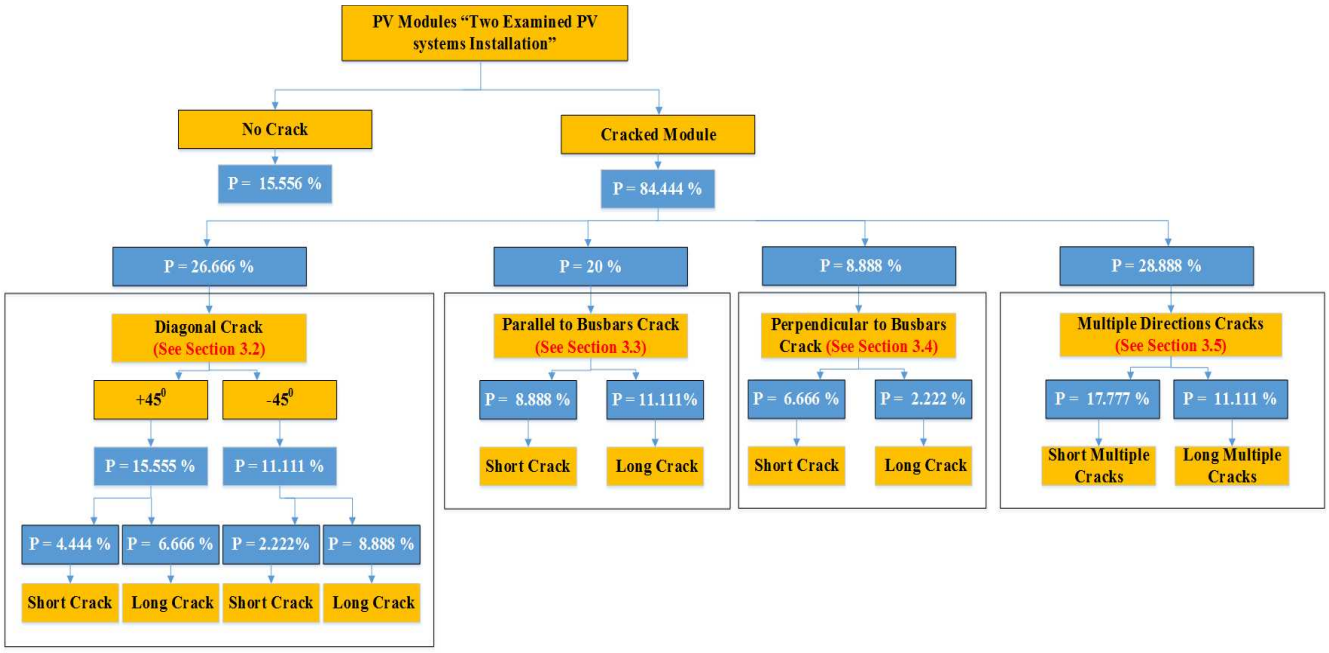
Broken cells are sorted according to the type of crack they show and the classification already presented in Fig. 2. The probability for a cell to be cracked and the crack-type distribution are presented in Fig .4. Only 15.556% of the total PV modules have no cracks. However, 84.444% of the PV modules contains at least one type of the crack: diagonal (26.666%), parallel to busbars (20%), perpendicular to busbars (8.888%) or multiple directions crack (28.888%).

Fig. 4. Crack Types Probability Distribution among Both Examined PV Systems (45 PV Modules)

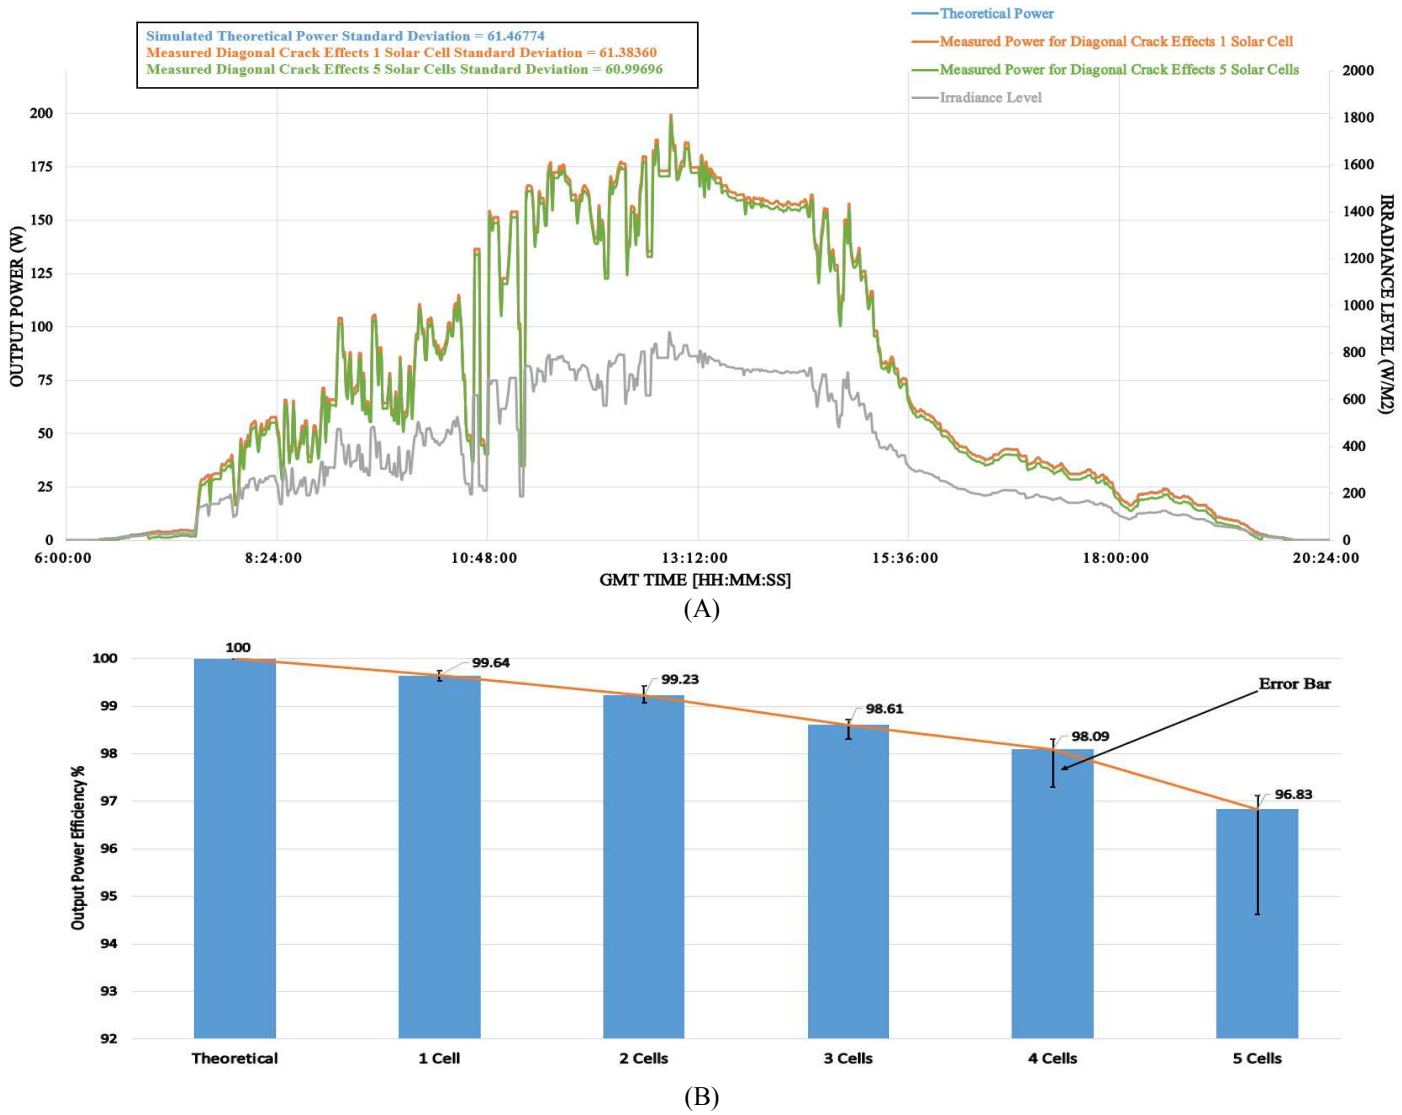
A real-time long-term measured data for a full day is carried out to estimate the output power performance for a diagonal crack which effects 1 and 5 solar cells are presented in Fig. 5(A). The theoretical simulated output power which is calculated using LabVIEW software has a standard deviation equals to 61.46 which is very close to the standard deviation for a diagonal crack which effects 1 solar cell (SD=61.38). However, a diagonal crack effects 5 solar cells has a huge reduction in the output power performance of the PV module where the standard deviation is equal to 60.99. Finally, the measured output power of the PV module matches the theoretical output power, therefore, the theoretical power in Fig. 5(A) cannot be seen, this results is also occurring in Fig. 6(A), Fig. 7(A) and Fig. 8(A).

Fig. 5(B) describes the output power efficiency for the examined diagonal cracks effects 1, 2, 3, 4 and 5 solar cells. Between 0.35 - 0.44% reduction of power estimated for a diagonal crack effects 1 solar cell. However, the estimated reduction of power for a diagonal crack effects 5 solar cells is between 2.97 - 5.37%. The output power efficiency can be estimated using (5).

Fig. 5. (A) Real-Time Long-Term Measured Data for a Diagonal Crack Effects 1 and 5 Solar Cells; (B) Output Power Efficiency for a Diagonal Cracks Which Effects 1, 2, 3, 4 and 5 PV Solar Cells

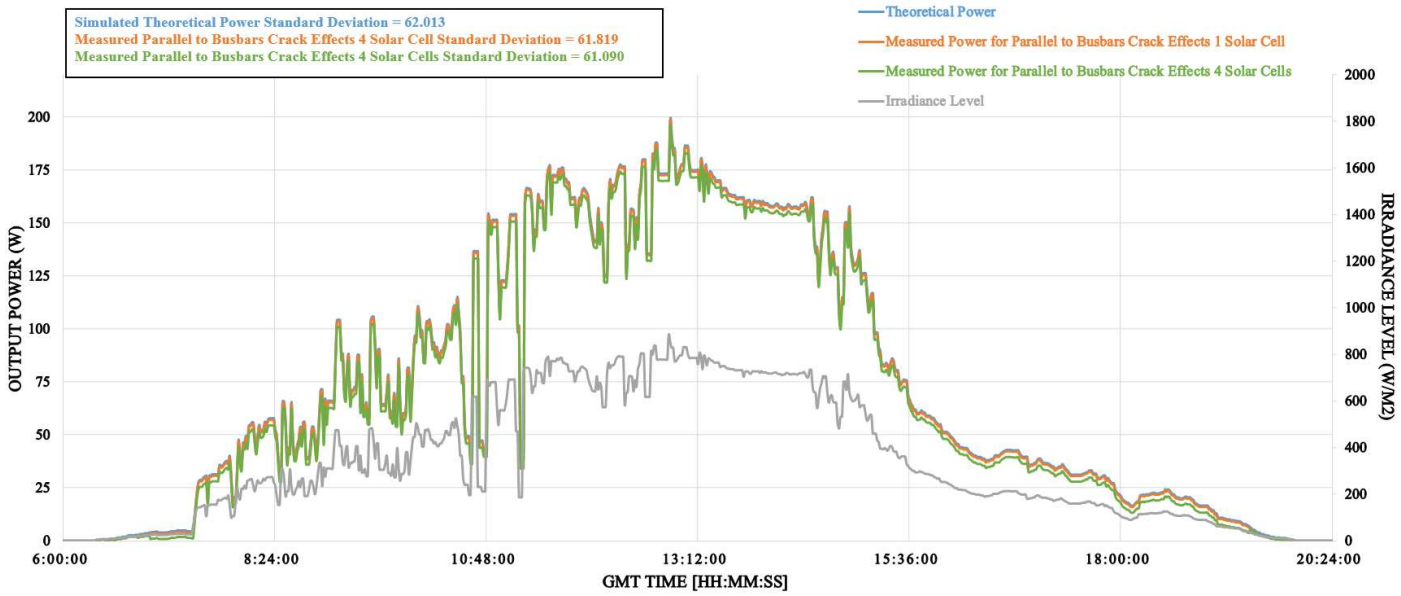
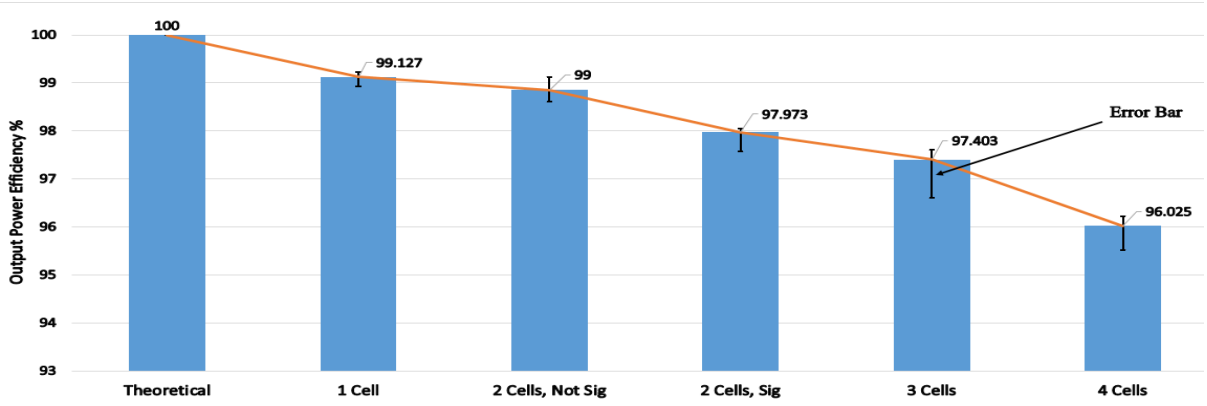
Fig. 6(A) presents real-time measured data for a parallel to busbars crack effects 1 and 4 solar cells. The standard deviation for the theoretical simulated power is 62.01 which is very close to the standard deviation for a parallel to busbars crack effects 1 solar cell (61.8). However, parallel to busbars crack effects 5 solar cells has a huge reduction in the output power performance of the PV module while the standard deviation is equal to 61.09.

Fig. 6(B) describes the output power efficiency for the examined parallel to busbars cracks effects 1, 2, 3 and 4 solar cells. The reduction of power estimated for a parallel to busbars crack effects 1 solar cell is between 0.75% - 0.97%. However, the estimated reduction of power for a parallel to busbars crack effects 3 and 4 solar cells is between 2.39% - 3.0% and 3.67% - 4.55% respectively.

Fig. 6. (A) Real-Time Long-Term Measured Data for a Parallel to Busbars Crack Which Effects 1 and 4 Solar Cells; (B) Output Power Efficiency for Parallel to Busbars Crack Which Effects 1, 2, 3 and 4 PV Solar Cells

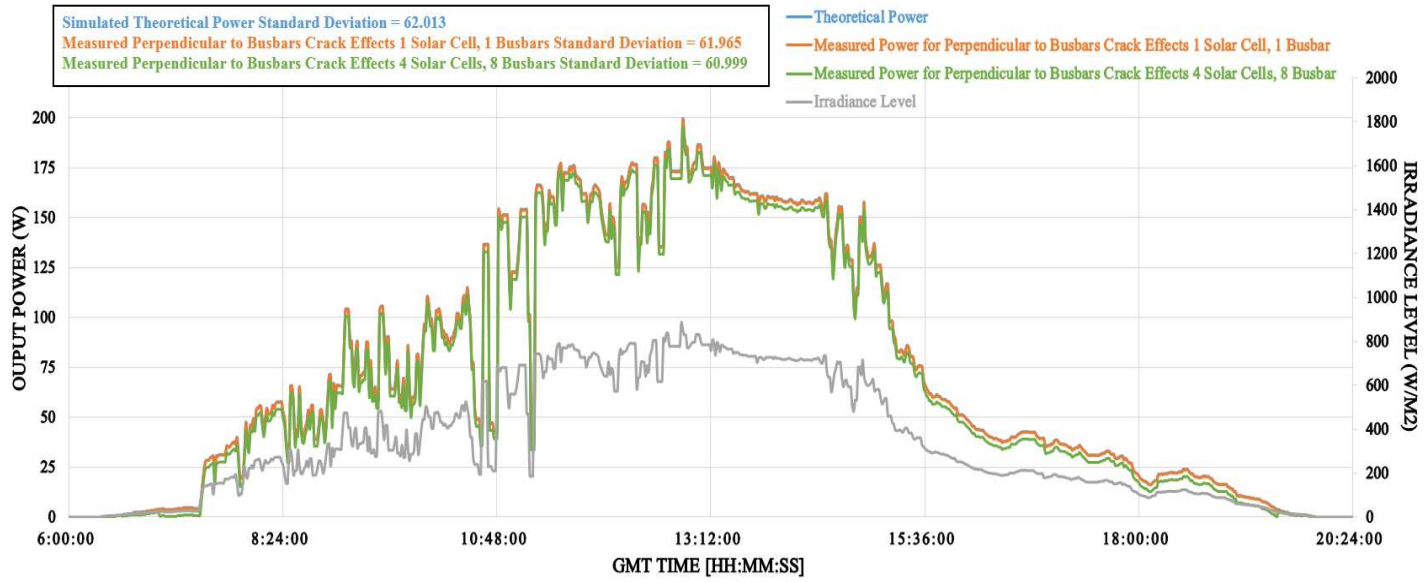
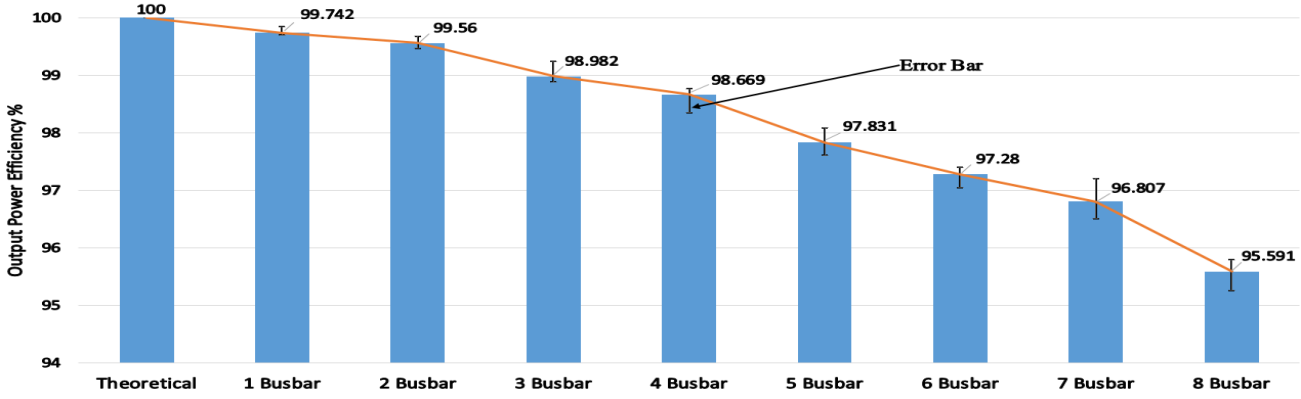
Table VI indicates that a perpendicular to busbars crack effects 1, 2 and 3 busbars statistically has no significant impact on the overall amount of power produced by a PV module. The measured results for a perpendicular to busbars cracks effects 1 and 4 solar cells can be seen in Fig. 7 (A), the difference between the theoretical standard deviation and a perpendicular to busbars cracks which effects 4 solar cells is equal to 1.014. Finally, Fig. 7(b) illustrates the output power efficiency measured for a perpendicular to busbars which effects 1, 2, 3 and 4 solar cells (1-8 Busbars), where the maximum power reduction is estimated for 8 busbars between 4.6 – 4.1%.

Fig. 7. (A) Real-Time Long-Term Measured Data for a Perpendicular to Busbars Crack Effects 1 and 4 Solar Cells; (B) Output Power Efficiency for a Perpendicular to Busbars Crack Which Effects 1, 2, 3 and 4 (1-8 busbars) PV Solar Cells

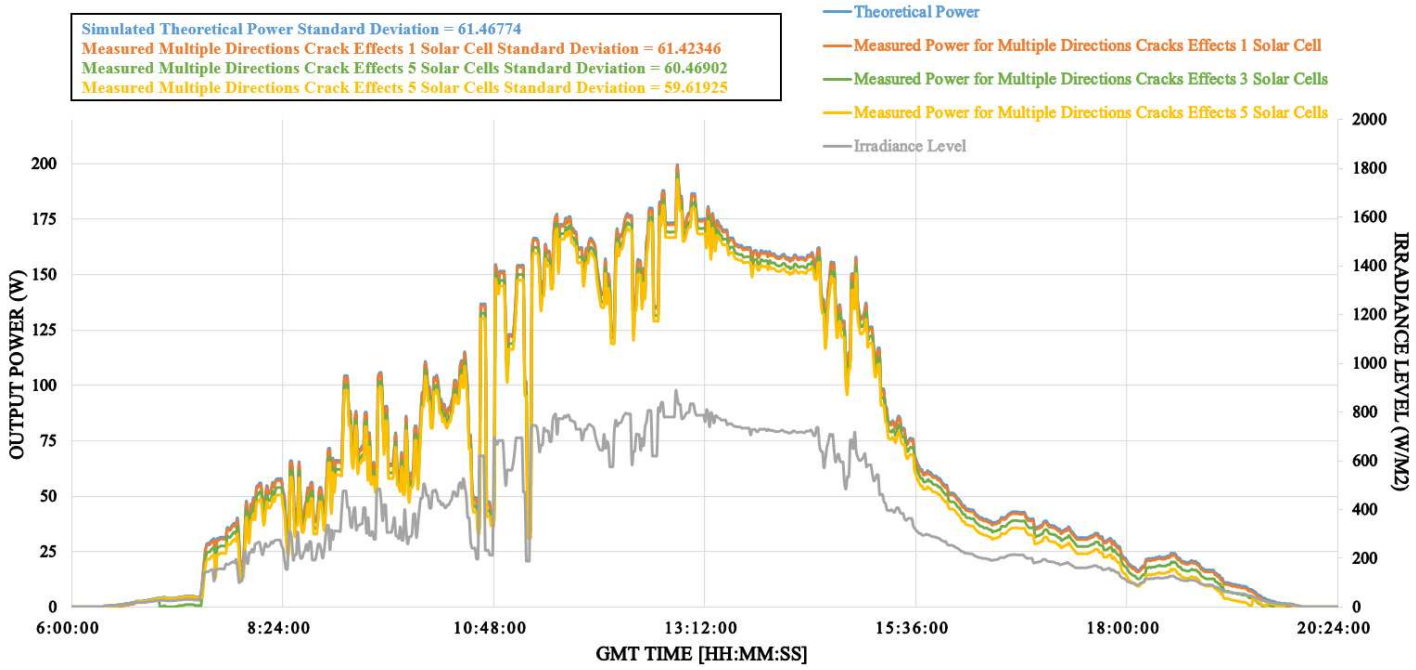
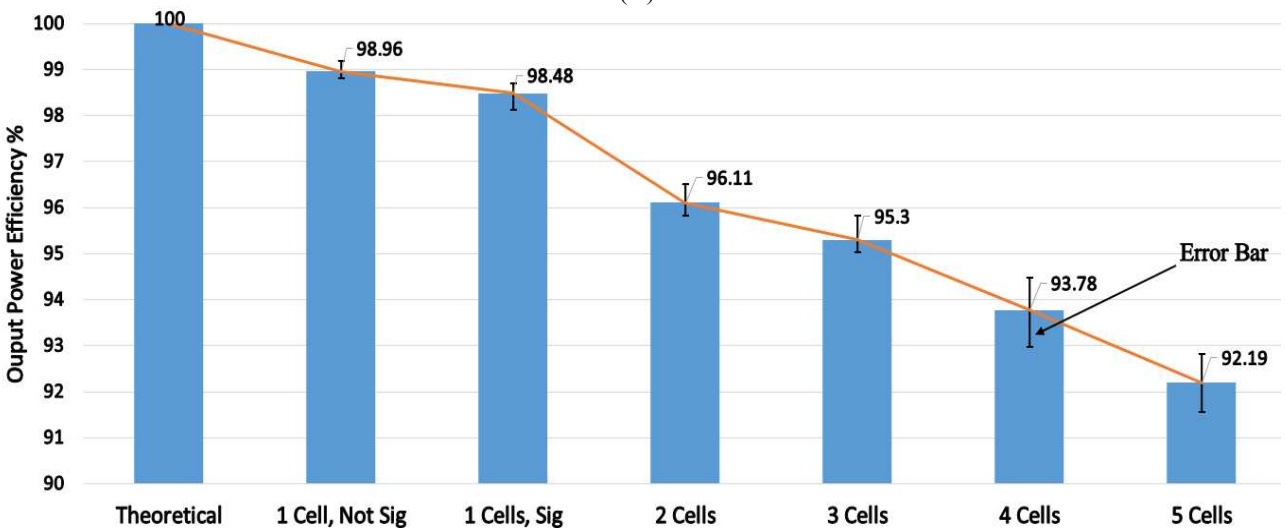
Multiple directions cracks have the highest degradation in the PV measured output power. Three different measured data are presented in Fig. 8(A). As illustrated in Fig. 8(B), multiple directions crack effects 5 solar cells reduce the power efficiency of the PV module up to 8.42%. However, the average reduction in the power for a multiple directions crack effects 1 solar cell with an approximate broken area less than 46.2 mm^2 is equal to 1.04%.

Fig. 8. (A) Real-Time Long-Term Measured Data for a Multiple Directions Crack Effects on 1, 3 and 5 Solar Cells; (B) Output Power Efficiency for a Multiple Directions Crack Which Effects 1,2,3,4 and 5 PV Solar Cells

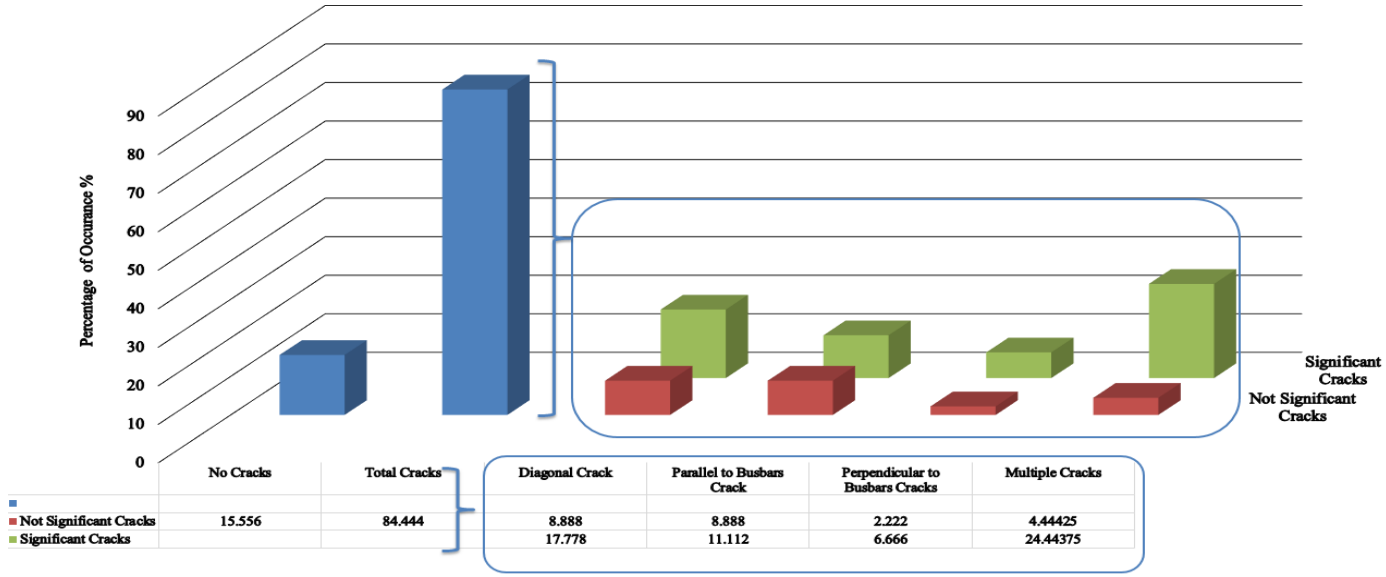
The observed modules have 38 PV modules with various crack-types. The probability of occurrence for each crack type can be seen in Fig. 4. Before considering the statistical approach, it is hypothetically true to say that 84.4% has a significant impact on the output power performance. However, the statistical approach has confirmed that this is incorrect, because only 60% has a significant impact on the output power performance for all examined PV modules.

Fig. 19. Percentage of Cracks in the Examined PV modules, overall significant Cracks equals to 60% out of 84.444%

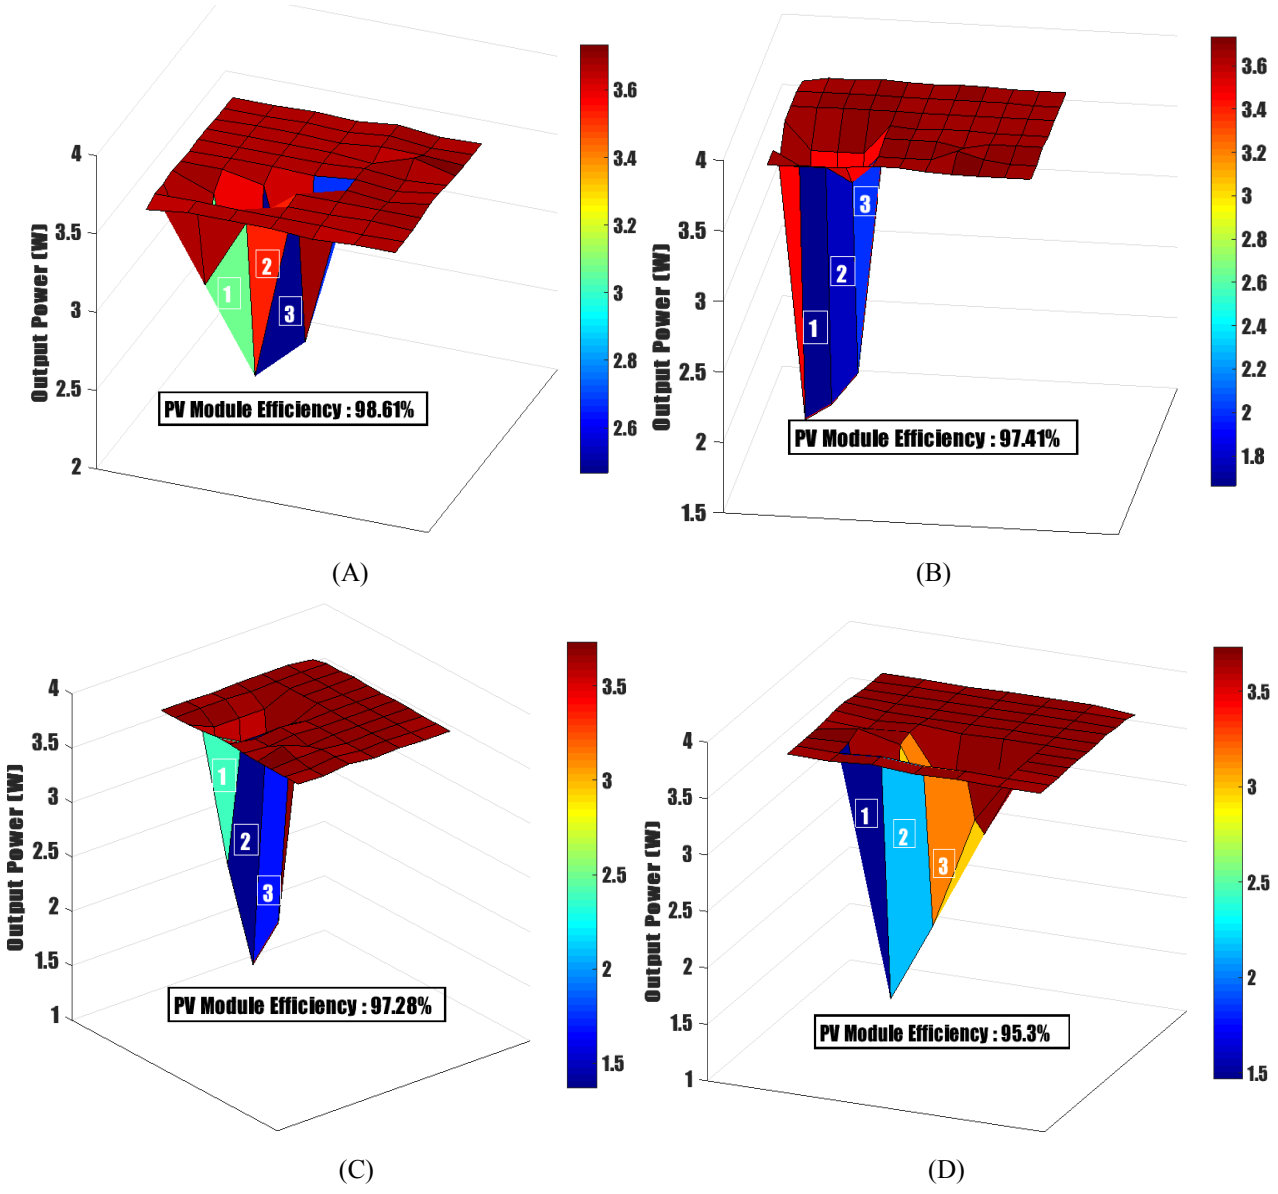
Fig. 10(A) shows a diagonal crack ($+45^0$) effects 3 solar cells. It is clear that the surface of three different solar cells are damaged (Noted as 1, 2 and 3). The degradation of the power for the solar cells is between 0.5 and 1 Watt. Overall PV module efficiency can be estimated by the MATLAB code which is equal to 98.61%, this result can be illustrated in Figs. 5(B) and 10(A).

Similarly, Fig 10(B) describes the surface shape of a parallel to busbars crack which effects 3 solar cells. The degradation of the power in the affected solar cells is between 2.5 and 2 Watt. The

overall power efficiency of the PV module is equal to 97.41% which is very similar to the value (97.4%) described earlier in Fig. 6(B).

The surface shape for a perpendicular to busbars crack effects 3 solar cells, 6 Busbars is illustrated in Fig. 10(C). However, Fig. 10(D) shows a cracked surface for a PV module that is affected by a multiple directions crack on 3 different solar cells. Moreover, a perpendicular crack effects a solar cell with 2 busbars has an estimated degradation of power equals to 1.5 Watt. Overall efficiency of the cracked surfaces is equal to 97.28% for a perpendicular to busbars crack which effects 3 solar cells (6 busbars), and 95.3% for a multiple directions crack which effects 3 solar cells.

Fig. 10. (A) Surface Shape for a Diagonal (+45^0) Crack Effects 3 Solar Cells; (B) Surface Shape for a Parallel to Busbars Crack Effects 3 Solar Cells (C) Surface Shape for a Perpendicular to Busbars Crack Effects 3 Solar Cells, 6 Busbars; (D) Surface Shape for a Multiple Directions Crack Effects 3 Solar Cells
