Micro Cracks Distribution and Power Degradation of Polycrystalline Solar Cells Wafer: Observations Constructed from the Analysis of 4000 Samples

Mahmoud Dhimish

University of Huddersfield, Co-Director of Photovoltaics Laboratory, Huddersfield HD1 3DH, United Kingdom

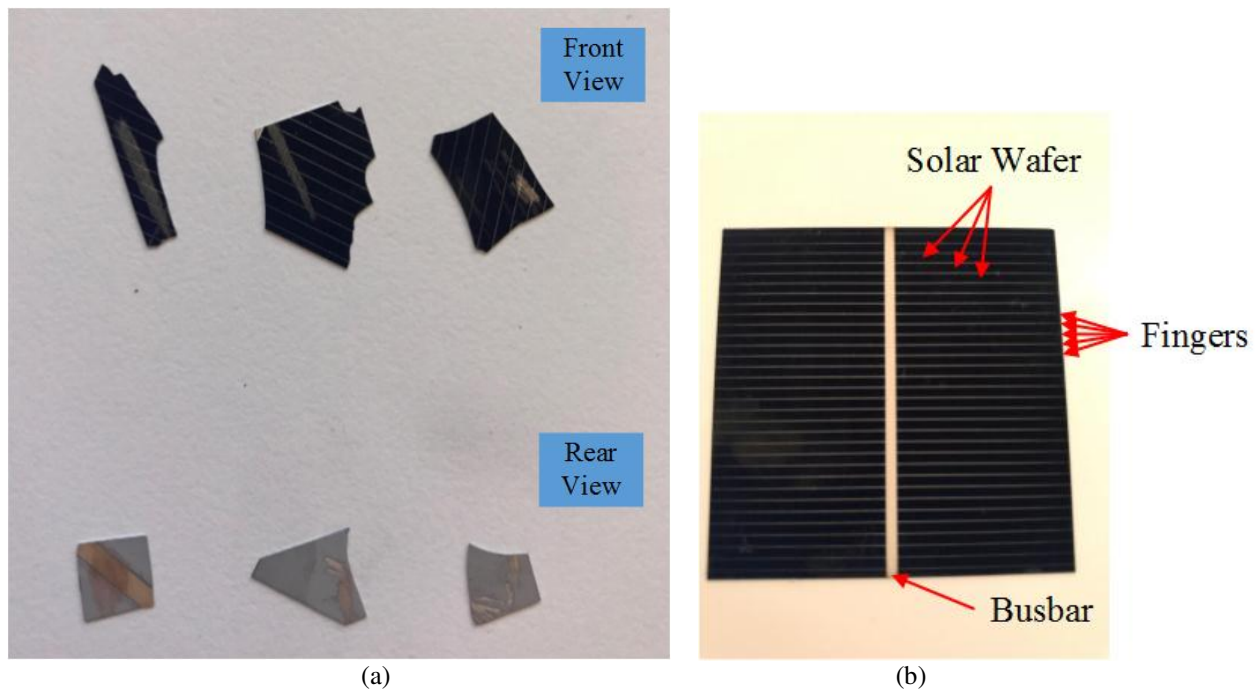
In this article, the examination of 4000 cracked solar cell have been examined; example of multiple samples are shown in Fig. 2(a); showing both front and rear view for diffident types of cracks. All tested samples are dismounted from actual PV modules operated in a field across the UK. The solar cells have been on actual operation for 5 to 13 years.

Fig. 2(b) shows the location of the fingers and the solar cell busbar. Solar cell fingers are the metallic rectangular–shape grid connecters which collect the generated current for devilry to the busbar. The busbar is constructed from copper, coated with silver to enhance the current conductivity (front side) as well as to lower oxidization (rear side).

Fig. 2. (a) Example of the front and rear view for multiple examined solar cell wafers, (b) Solar cell wafer, fingers and busbar

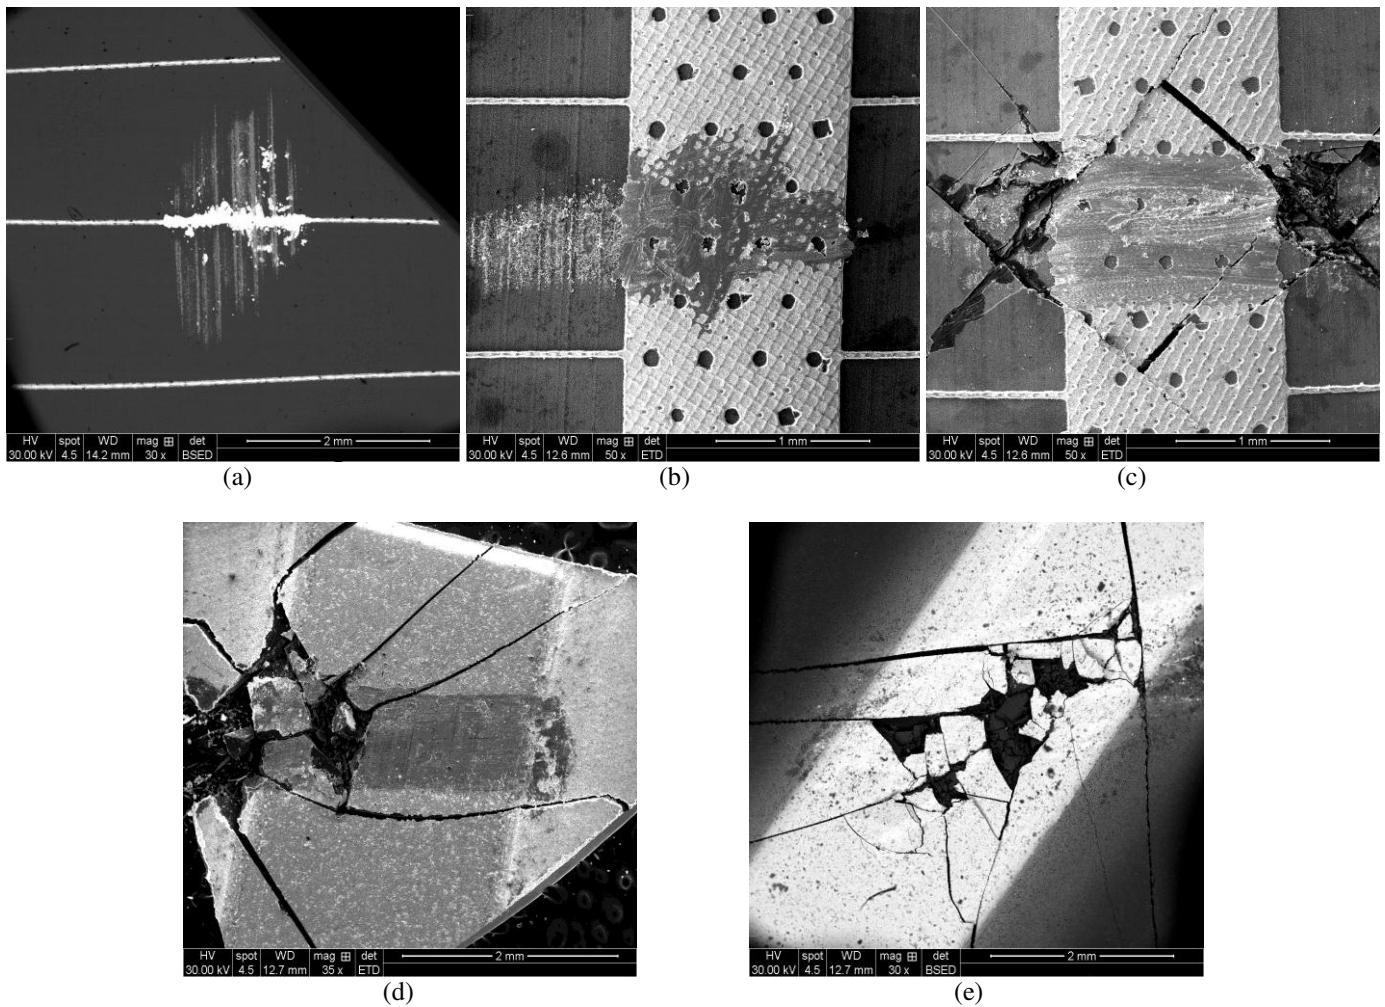
1) Wafer + Fingers (Fig. 3(a)): micro cracks affecting both wafer and the fingers of the solar cell.
2) Wafer + Busbar (Fig. 3(b)): existence of micro cracks on solar cell wafer and busbar, but not fingers.
3) Wafer + Fingers + Busbar (Fig. 3(c)): micro cracks affecting the wafer, fingers, and the busbars.

1) Micro cracks affecting rear surface of the solar cell, example shown in Fig. 3(d).
2) Micro cracks affecting both rear surface of the solar cell and the rear busbar, example shown in Fig. 3(e).

Fig. 3. Examples of the distribution for the micro cracks in different solar cell samples. (a) Micro cracks affecting solar cell wafer and fingers, (b) Micro cracks affecting solar cell wafer and busbars, (c) Micro cracks affecting solar cell wafer, fingers and busbar, (d) Micro cracks in the rear surface of the solar cell, (e) Micro cracks affecting rear surface of the solar cell as well as the rear busbar

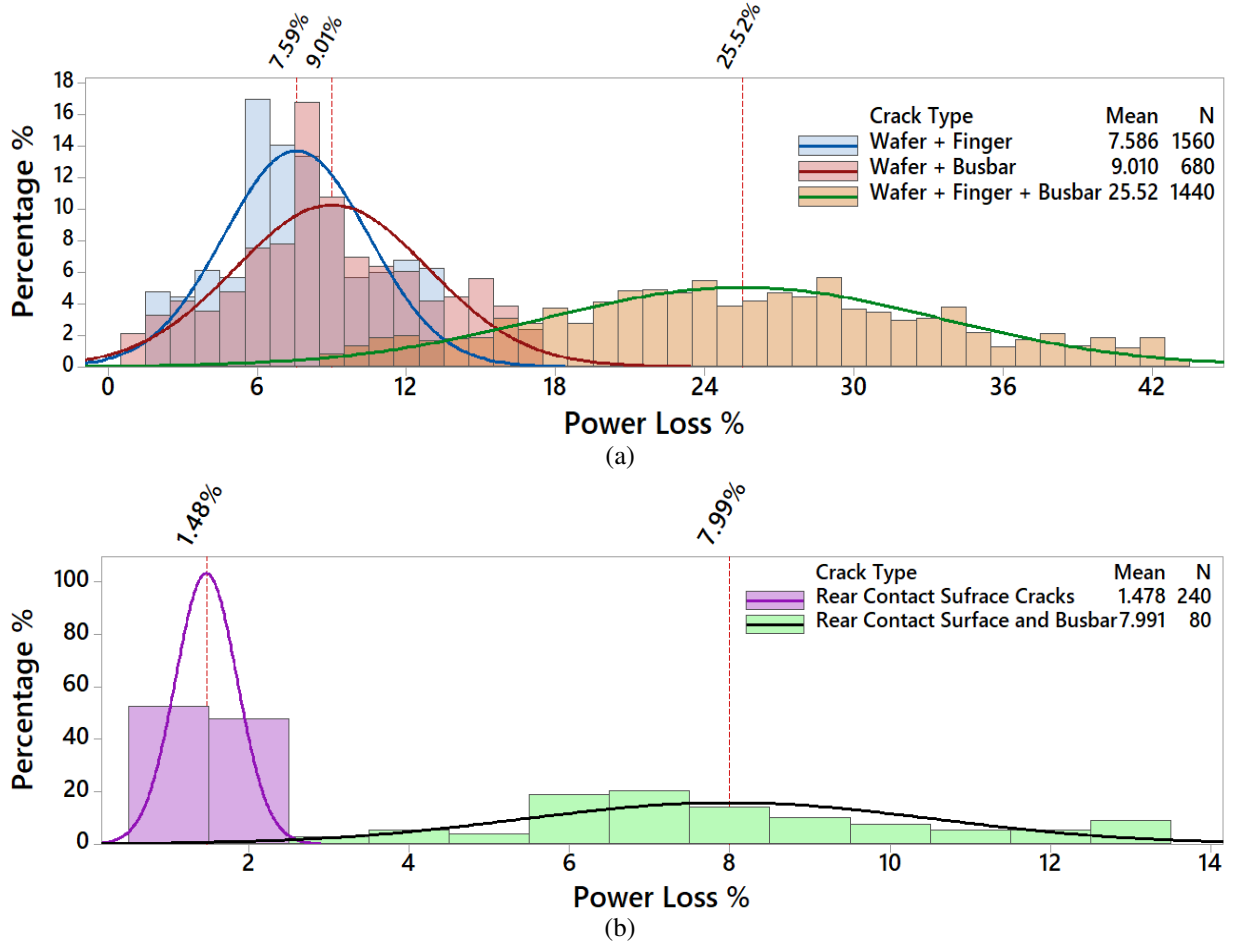
According to Fig. 4(a), the solar cell samples affected by cracks in the front contact have a power loss ranging from:

It is noticeable that front contact micro cracks have the most significant impact on the overall performance of the solar cells because these cracks affects the surface of the junction, ultimately limiting the amount of solar energy to be extracted by the cell. On the other hand, the output power loss for micro cracked rear surface is far less than the front contact, since it is much further away from the junction, whereas the rear busbar plays significant role in driving the solar cell current, therefore, cracks in rear and front busbar have a much higher output power loss.

Fig. 4. Power loss analysis of the cracked solar cell samples. (a) Front contact crack-types, (b) Rear contact crack-types

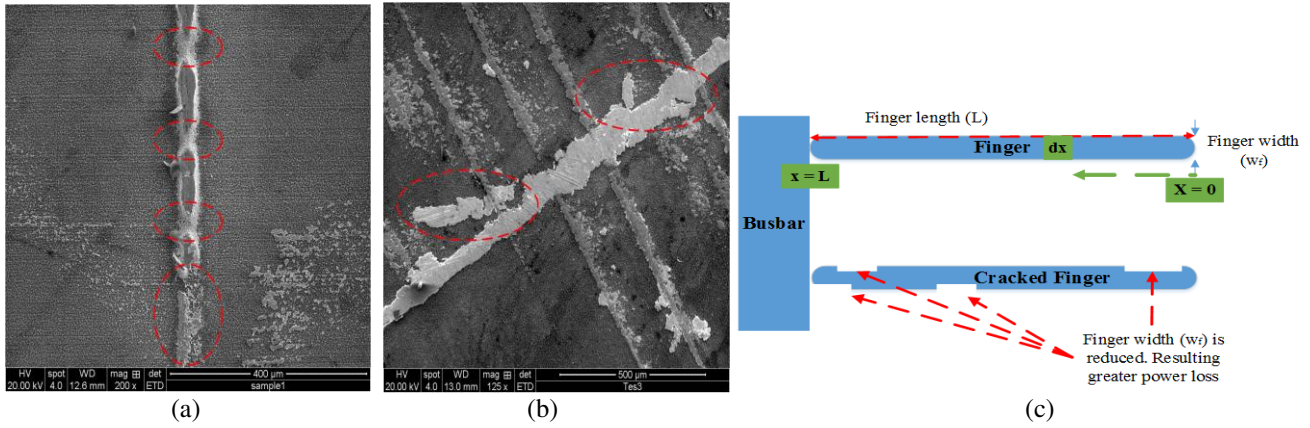
Due to the existence of micro cracks, it was observed that out of all examined samples, almost there are 1500 samples that has a breakdown/cracks in the solar cell fingers, resulting a less forward current generation of the solar cell. Two examples of the micro crack, damage and discontinuity in the solar cell fingers are shown in Figs. 5(a) and 5(b).

There is an increase in the output power loss due to the cracked/damaged fingers. In order to calculate the power loss in a single finger, the integration of the length for the finger starting from 0 to L (shown in Fig. 5(c)) gives the power loss as calculated by (2).

Fig. 5. (a) Cracked – non discontinuity in solar cell finger, sample 1, (b) Cracked – non discontinuity in solar cell finger, sample 2, (c) Illustration on the fingers main parameters, where the width of the cracked finger is reduced resulting a greater power loss

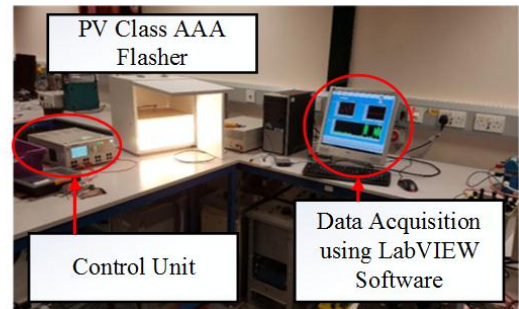
Fig. 6. (a) Cracked solar cell tested under STC, (b) PV Class AAA Flasher setup

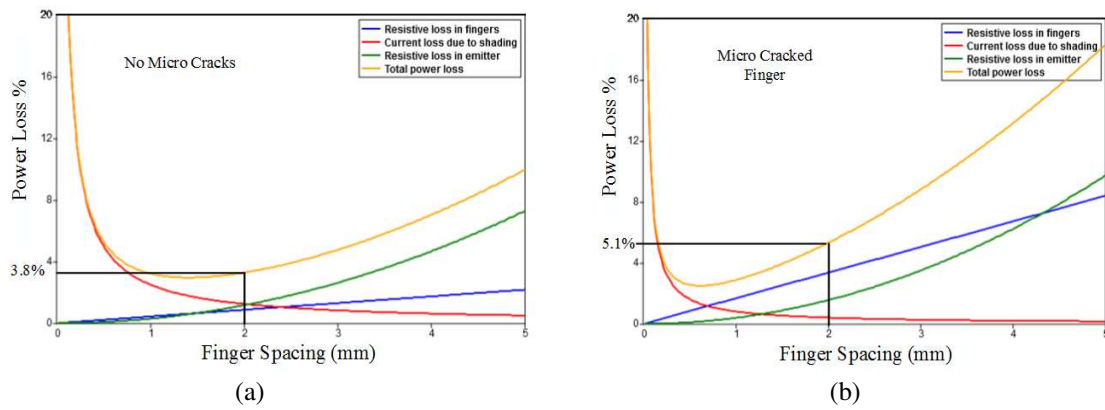
158   As shown in Figs. 7(a) and 7(b), the measured total power loss for the solar cell finger without the existence
159   of micro cracks is equal to 3.8%, while it is increased to 5.0% for the cracked finger sample. The main
160   reason in the increase of the power loss is due to the decrease in the finger width. Therefore, According to
161   (2), if the width of the finger w_f decrease, the finger power loss will increase. Furthermore, the cracks in
162   the solar cell fingers increase the heat-level of the affected solar cell, because the forward current will be
163   delivered though marginal size of metal (due to the reduction of the finger width size). Consequently, this
164   will create a hot-spot in the finger and will reduce the forward current delivered by the cracked cell. Fig.
165   6(a) shows a cracked solar cell sample tested under STC conditions, where two fingers are cracked.

Fig. 7. (a) Power loss estimation (~3.8%) for finger without existence of micro cracks, (b) Power loss estimation (~ 42%) for finger including micro cracks

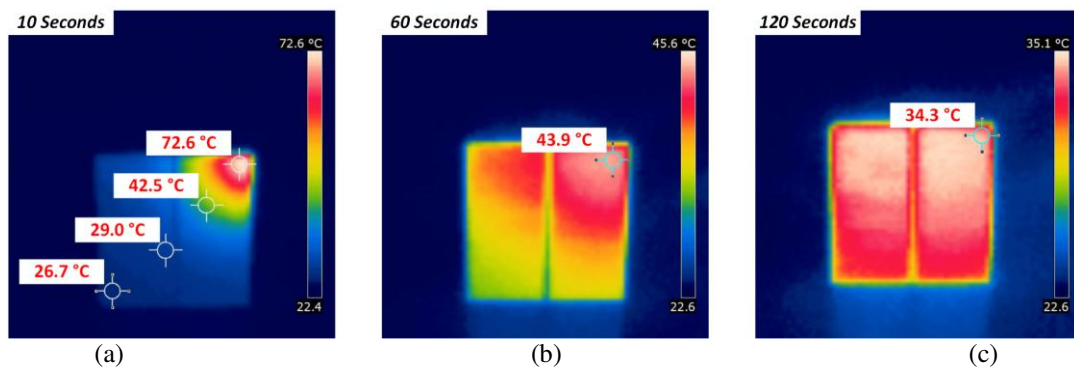
The output heat-map/thermal-image of the solar cell is shown in Fig. 8. By contrast with the results shown in Fig. 8(a), after ten seconds of evaluating the solar cell sample under STC, the temperature of the cracked area raised to 72.6 °C, whereas adjacent regions started to heat-up to a limit of 42.5 °C. Interestingly, due to the expansion of the heat over the whole solar cell, the heat of the cracked area started to decrease due to the flow of the heat over the full cell sample. In Fig. 8(b), thermal image of the solar cell sample is captured after 60 seconds, it is evident that the cracked area has a lower temperature of 43.9 °C, but more area of the solar cell is affected by a rise in the temperature. In addition, according to Fig. 8(c), after 120 seconds (the test sample was still under STC), the solar cell sample almost have an identical temperature level of 34.3 °C, compared to original temperature of 26.7 °C, therefore, the increase of the solar cell temperature due to the existence of the micro cracks is raised by 7.6 °C. It is worth noting that this temperature level remains same after 120 seconds. This result confirms that micro cracks in solar cells cause hot-spots, where the main heat source of the cell is spread from the original cracked area, and it heats up significantly due to the excitation of the electrons through a thinner width of the metal carrying the current either in the fingers or busbars, subsequently an increase in the solar cell temperature will be garneted, as well as an increase in the output power loss would highly be expected.

Fig. 8. Heat-Map distribution of the cracked solar cell shown in Fig. 6, operating under STC, images are captured using FLIR thermal camera. (a) After 10 seconds, (b) After 60 seconds, (c) After 120 seconds – this level of temperature remains steady

197 According to [25] it was observed that 78% of the reverse power is turned into heat at the hot-spot area.
198 The remaining fraction of the power was evenly distributed over the cell, accounting for the normal reverse
199 current, possible contact resistance and additional small shunts. Consequently, the distribution of the heat
200 over the cell is generated due to the reverse current flowing from the hot-spotted area throughout the cell
201 using the adjacent fingers and busbar, successively reducing the output generated power of the affected
202 solar cell. Similarly, authors in [26] presented a new method which provides simple and fast evaluation of
203 the hot-spotted solar cells. It was shown that the heat of the affected solar cell by possible hot-spots could
204 be distributed across the adjacent locations after a period of 60ms, where the main cause of the heat
205 distribution is due to the existence of non-cracked fingers and busbars.

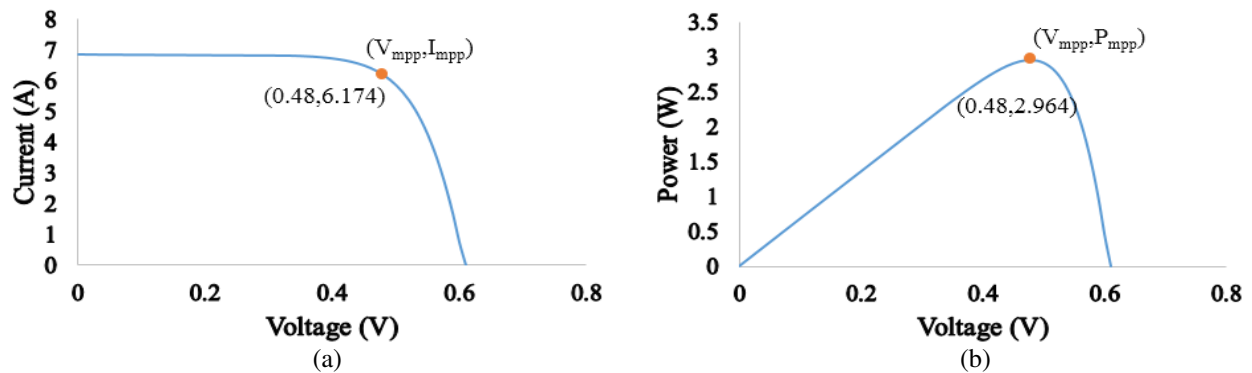
206 In order to determine the I-V and P-V curves of the solar cell sample under STC, an experiment has been
207 carried out using the class AAA LED flasher shown in Fig. 6(b). The obtained I-V and P-V curves are
208 presented in Fig. 9. Compared to the theoretical predictions (discussed earlier in Table 1), the solar cell
209 sample has almost equal V_{mpp} of 0.48V. However, there is drop in the I_{mpp} by 0.286A; I_{mpp} (theoretical:
210 6.46A) – I_{mpp} (cracked solar cell: 6.174A). Resulting an output power loss of 4.39%; calculated as follows:

211
$$Power\ Loss\ (\%) = \ 100 - \left(\frac{2.964\ (P_{Micro\ cracked\ solar\ cell})}{3.1\ (P_{Theoretical\ maximum\ power})} \times 100\right) = \ 4.39\%$$

Fig. 9 Obtained I-V & P-V curves of the cracked solar cell sample shown in Fig. 6(a) under STC

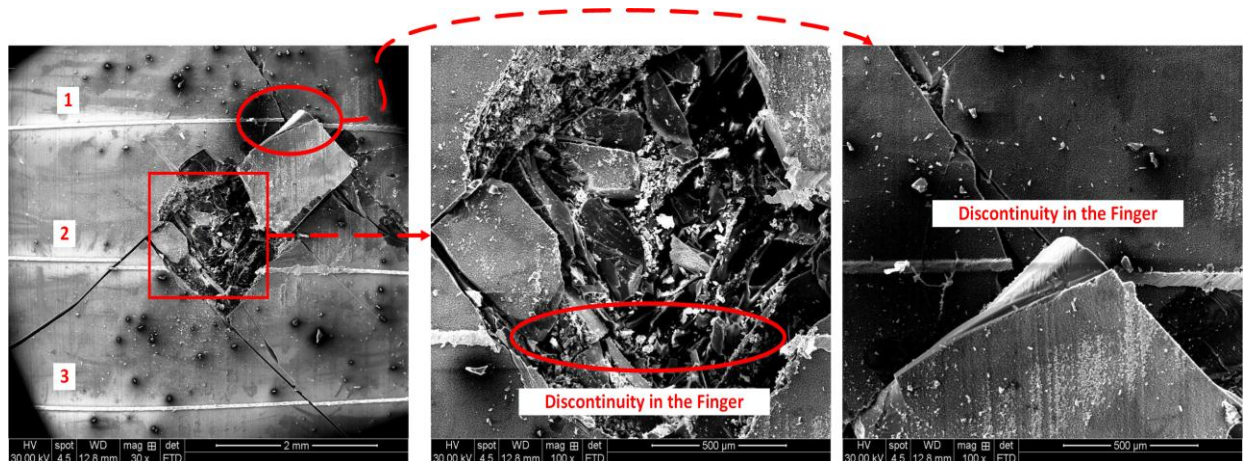
212 Another example of cracked fingers has been examined, the cracked cell is shown in Fig. 10. The cell is
213 affected by three cracked fingers, where it is evident that there is a discontinuity in the finger connections,
214 this would result an increase in the amount of heat generated by this particular case.

Fig. 10. Micro crack affecting three fingers – there is a discontinuity in the finger connection to the main busbar

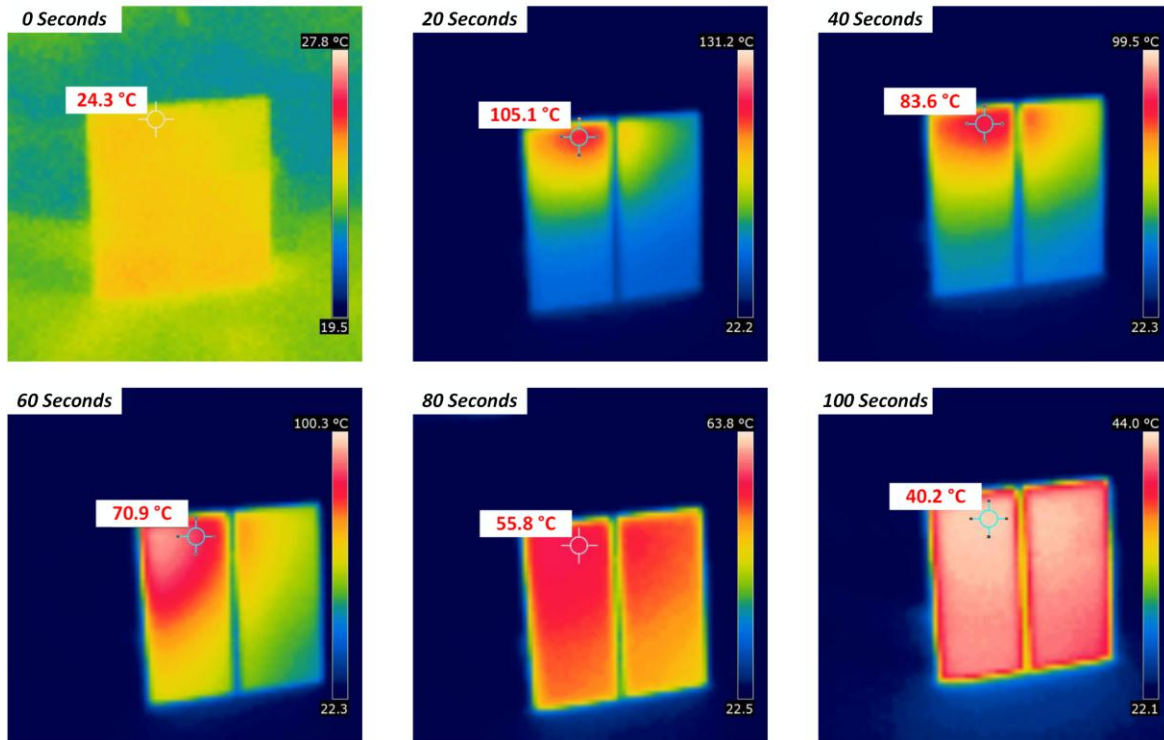
218 At zero seconds, the temperature of the cell is equal to 24.3 °C. The temperature of the cracked area raised
219 to 105.1 °C after 20 seconds of testing the cell under STC. Ultimately, the heat-level of the cracked would
220 decrease, due to the expansion of the heat over the cell, resulting a temperature levels of:

221   1) 83.6 °C (40 seconds)
222   2) 70.9 °C (60 seconds)
223   3) 55.8 °C (80 seconds)
224   4) 40.2 °C (100 seconds) - this level of temperature remains consistent

225 In contrast with the results of the heat-distribution, the solar cell had an increase in the temperature of about
226 15.9 °C; final temperature level 40.2 °C – original temperature level 24.3 °C. Therefore, this results
227 confirms that micro cracks in solar cells are one of the main cause of PV hot-spotting, as well as, the
228 increase in the size of cracked area, ultimately will increase the heat-level of the hot-spot in the affected
229 solar cell.

Fig. 11. Heat-Map distribution from 0 to 100 seconds of the cracked solar cell shown in Fig. 9; the solar cell is operated under STC

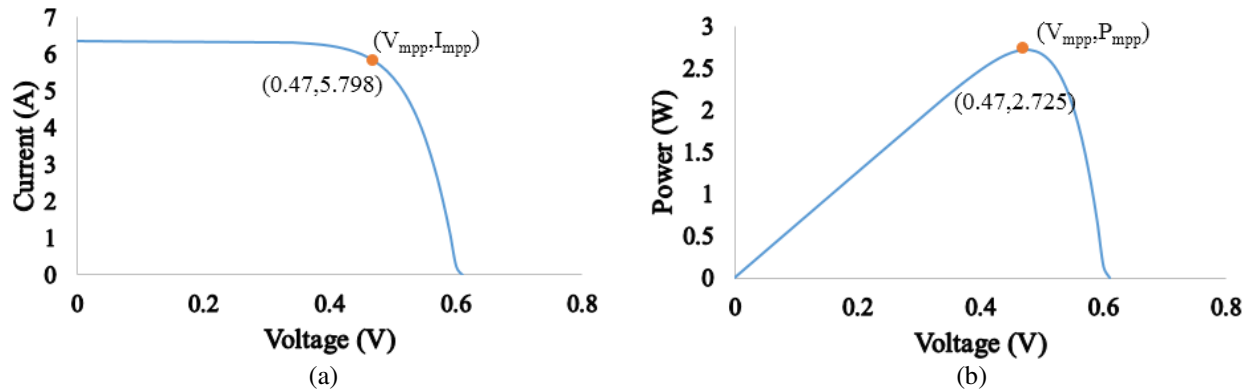
Fig. 12 Obtained I-V & P-V curves of the cracked solar cell sample shown in Fig. 10 under STC

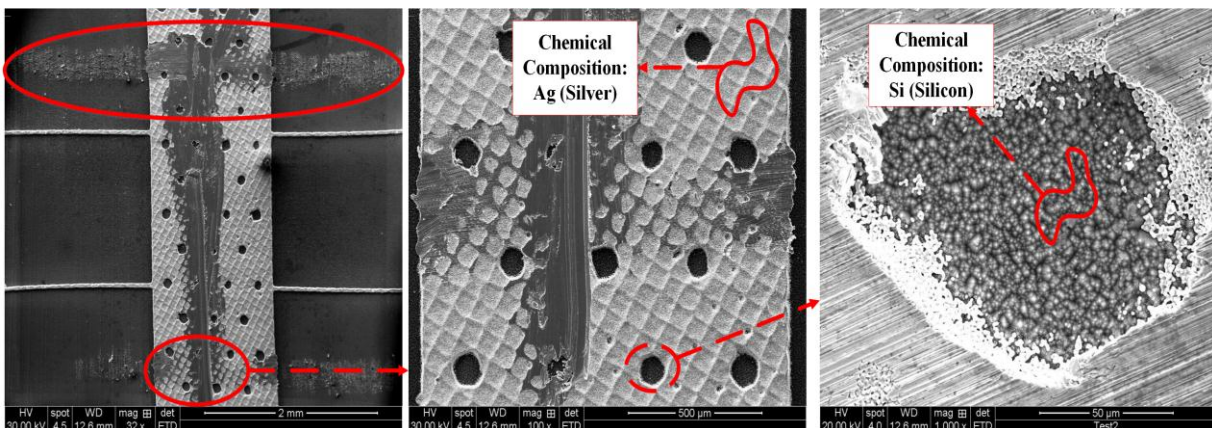
A sample showing a poor adjustment of the busbar metal is shown in Fig. 13. As noticed, there are a number of cracks in the solar wafer, while the busbar contains multiple cracks. The silicon (Si) chemical composition is present instead of original chemical composition of the silver (Ag). This poor busbar structure leads to a second breakdown in the solar cell sample, ultimately causing hot-spot.

Fig. 13. Micro cracks and soldering mismatch in a solar cell busbar

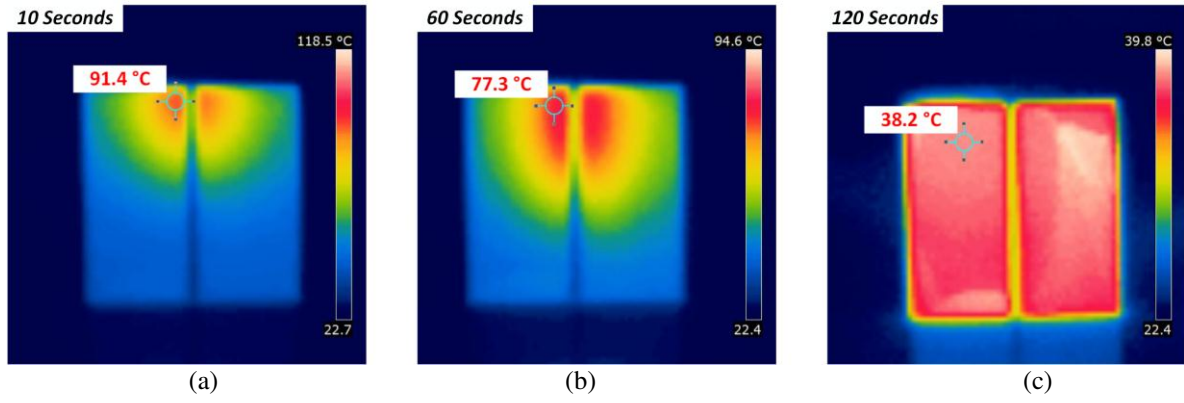
The solar cell shown in Fig. 13 has been examined under STC (experimental setup similar to Fig 6). The solar cell has a micro crack as well as poor soldiering in the busbar. It is expected after 10 seconds the heat would increase significantly in the cracked area, and as shown in Fig. 14(a), the temperature of the cracked area increased to abnormal level of 91.4 °C. After 60 seconds, the heat started to expand over the entire solar cell, where the busbar and the cracked area has a temperature of 77.3 °C, as presented in Fig. 14 (b).

Fig. 14. Heat-Map distribution of the cracked solar cell shown in Fig. 8. (a) After 10 seconds of operating the solar cell under STC, (b) After 60 seconds, (c) After 120 seconds – this level of temperature remains consistent

250 According to Fig. 14(c), the heat is spread all over the solar cell sample, the temperature is equal to 38.2
251 °C; this temperature level stays consistent after 120 seconds. Therefore, this experiment proves that cracks
252 in solar cell busbars have a significant impact on the solar cell heat level, ultimately initiating hot-spots.

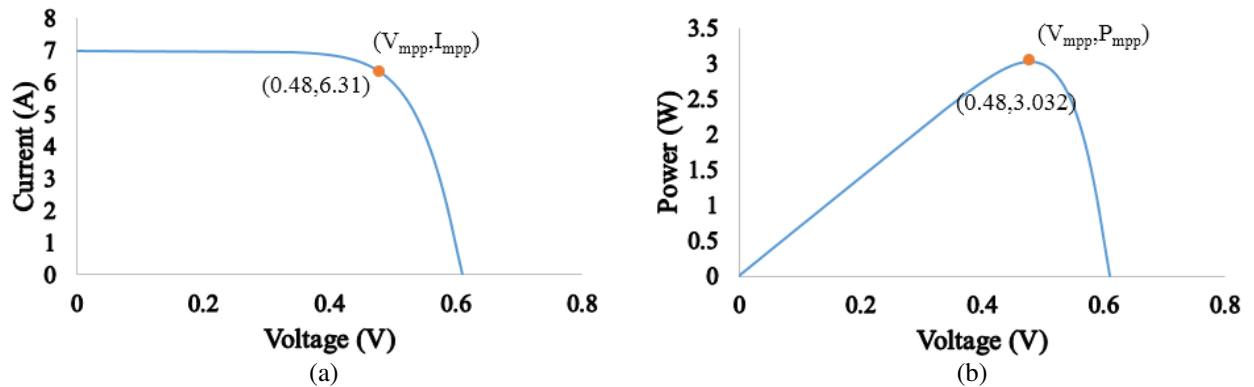
253 I-V and P-V curves for the solar cell sample have been measured under STC, results are presented in Fig.
254 15. The measured V_{mpp} of 0.48V is identical with the theoretical predictions (presented earlier in Table 1).
255 However, there is a drop in the maximum output current of 0.15A; I_{mpp} (theoretical: 6.46A) – I_{mpp} (cracked
256 solar cell: 6.31A). Resulting a loss in the output power equals to 2.19%; calculated as follows:

257
$$Power\ Loss\ (\%) = \ 100 - \left(\frac{3.032\ (P_{Micro\ cracked\ solar\ cell})}{3.1\ (P_{Theoretical\ maximum\ power})} \times 100 \right) = \ 2.19\%$$

Fig. 15 Obtained I-V & P-V curves of the cracked solar cell sample shown in Fig. 13 under STC

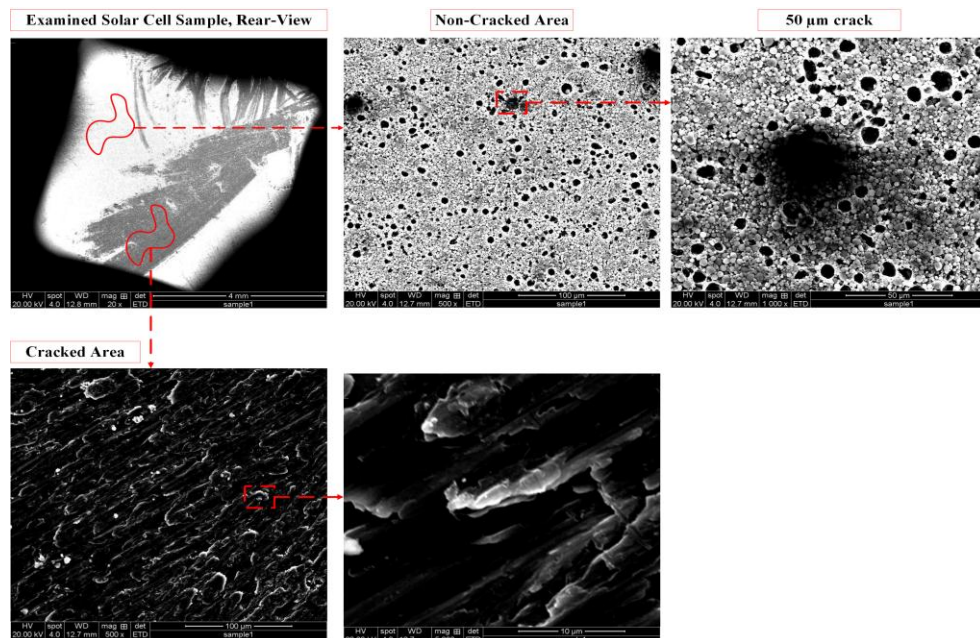
266 As shown in Fig. 16, the non-cracked area has multiple micro cracks of 50 µm width; nevertheless, it does
267 not have a noteworthy loss to the solar cell rear contact. However, the actual size of cracked rear area varies
268 from 4mm to 300 µm. This damage in the rear contact of solar cell resulting a limited open circuit voltage
269 (V_{oc}), subsequently will reduce the efficiency of the cell. In light of what was observed during the
270 experiments, hot-spotting phenomena has no correlation with the presence of micro cracks in solar cells

Fig. 16. Micro cracks affecting rear contact of a solar cell

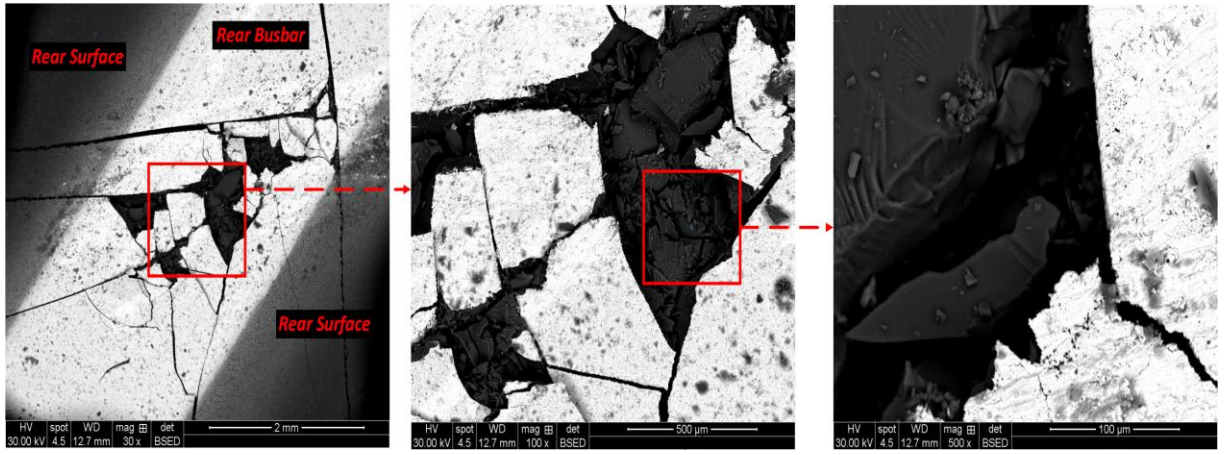
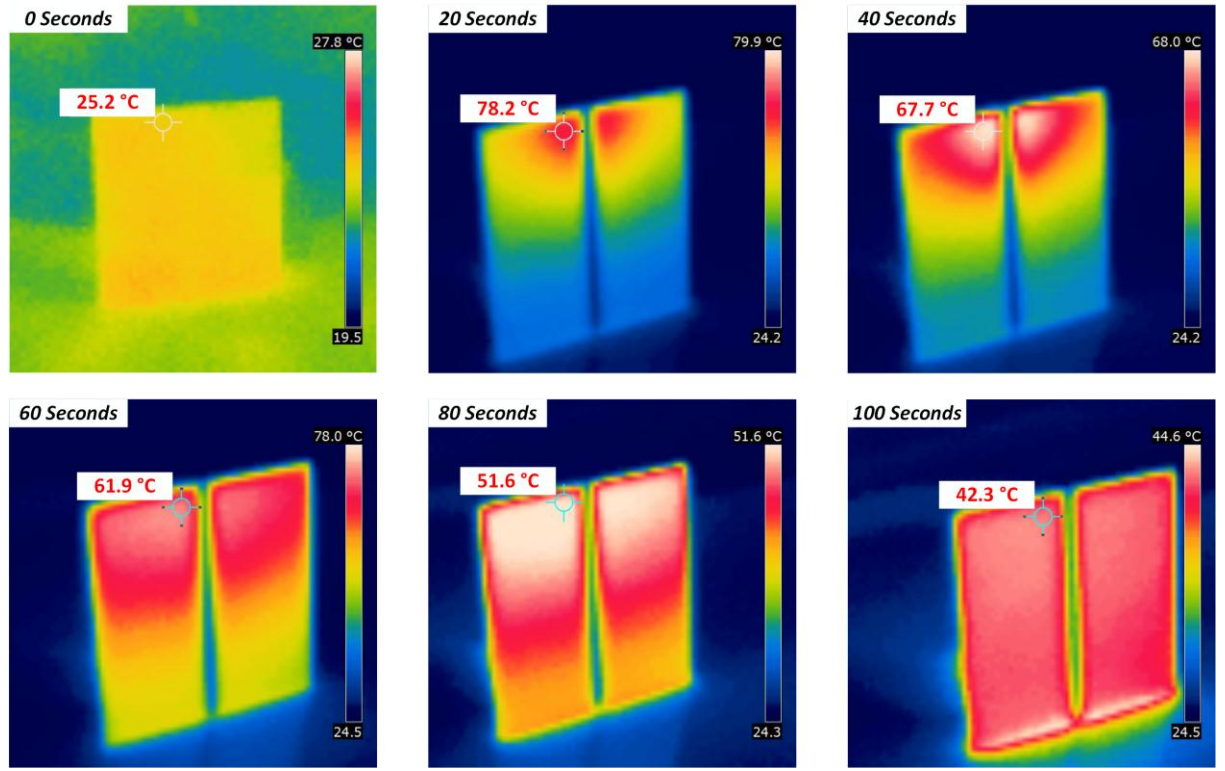
272 Likewise, Fig. 17(a) shows a rear contact image for a solar cell samples affected by micro cracks in the
273 surface and busbar. The solar cell was tested under STC, while the temperature of the cell has been captured
274 and reported in Fig. 17(b); image is taken from 0 seconds to 100 seconds.

275 At zero seconds, the temperature of the cell is equal to 25.2 °C. The temperature of the cracked area raised
276 to 78.2 °C after 20 seconds. Eventually, the heat-level of the cracked area will decrease, due to the expansion
277 of the heat over the cell and would result a temperature levels of 67.7 °C (40 seconds); 61.9 °C (60 seconds);
278 51.6 °C (80 seconds); and 42.3 °C (100 seconds), this level of temperature remains consistent. In light with
279 the results of the heat-distribution, the solar cell had an increase in its temperature of 17.1 °C; final
280 temperature level 42.3 °C – original temperature level 25.2 °C. Therefore, this result shows the impact of
281 micro cracks on the rear contract temperature, while it was evident that there is an abnormal increase in the
282 cell temperature while performing at STC.

Fig. 17. Micro cracks affecting rear contact surface and busbar of a solar cell. (a) Crack affected rear surface and busbar; images magnification of 2mm, 500µm and 100µm, (b) Heat-Map distribution from 0 to 100 while the solar cell is illuminated under STC

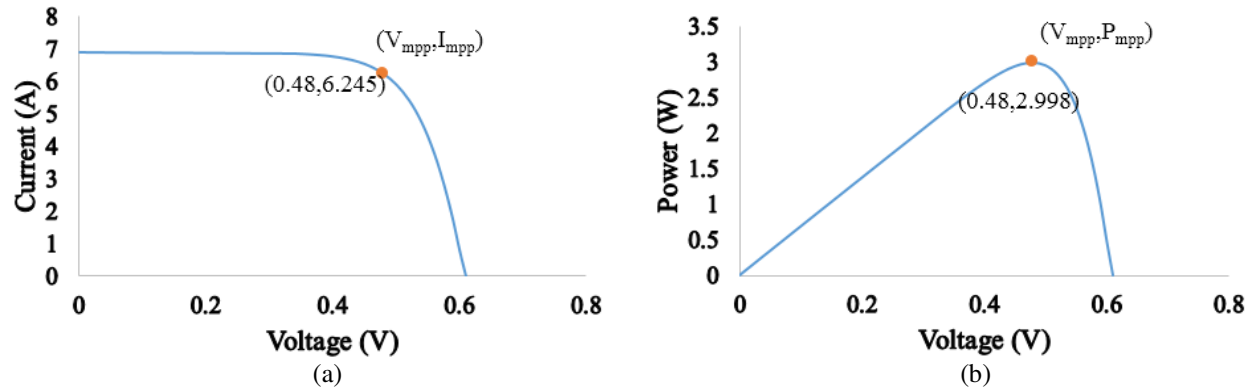
I-V and P-V curves for the solar cell sample have been measured under STC, results are presented in Fig. 18. The measured V_{mpp} of 0.48V is identical with the theoretical predictions (presented earlier in Table 1). However, there is a drop in the maximum output current of 0.215A; I_{mpp} (theoretical: 6.46A) – I_{mpp} (cracked solar cell: 6.245A). Resulting a loss in the output power equals to 3.29%; calculated as follows:

$$Power\ Loss\ (\%) = 100 - \left(\frac{2.998\ (P_{Micro\ cracked\ solar\ cell})}{3.1\ (P_{Theoretical\ maximum\ power})} \times 100 \right) = 3.29\%$$

Fig. 18 Obtained I-V & P-V curves of the cracked solar cell sample shown in Fig. 17(a) under STC
