Published paper

Full-scale shaking table tests on a substandard RC building repaired and strengthened with Post-Tensioned Metal Straps

(Short Version: Shake table tests on PTMS-strengthened RC frames)

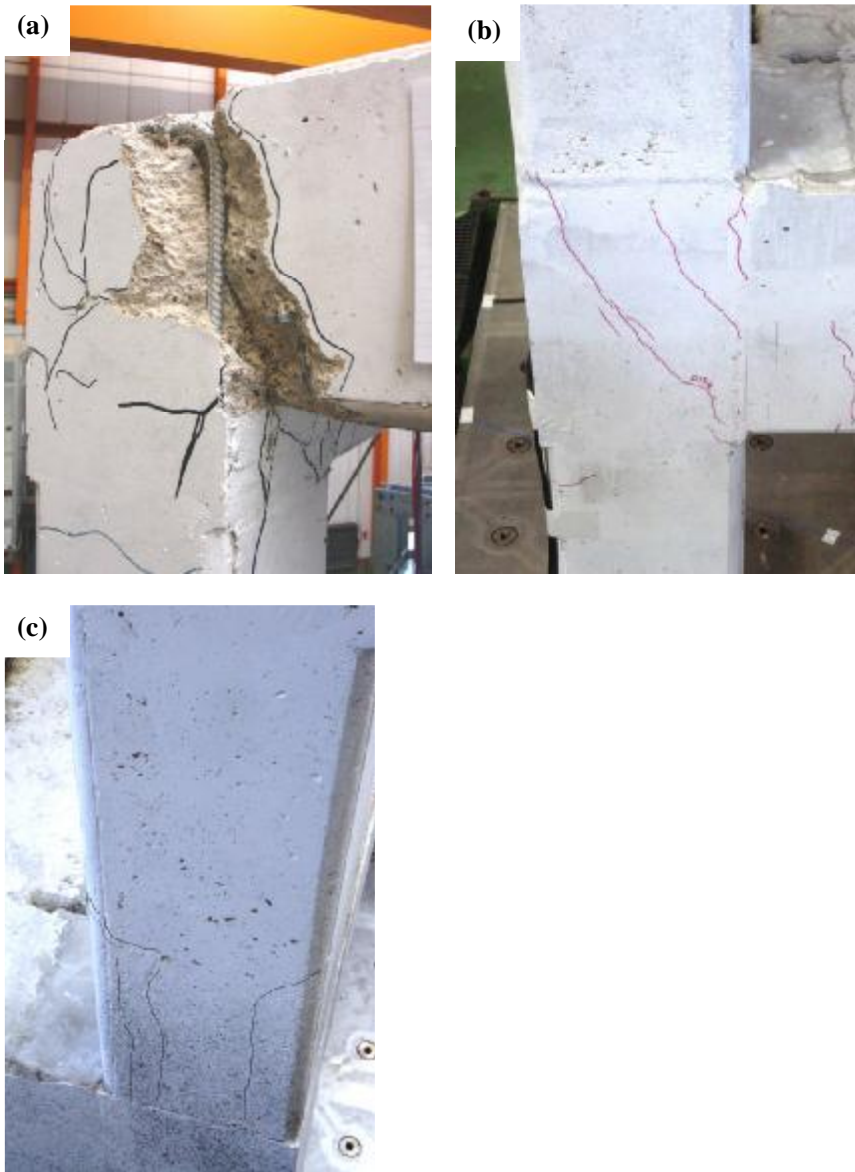
The first two shake table tests (PGA=0.025 and 0.05g) did not produce significant damage to the bare building. The first cracks appeared at the beam-column joints during the test at a PGA level of 0.10g. At PGA=0.15g, some of the 2nd floor joints experienced severe cracking and concrete spalling. The damage observed in joint J2A-2 suggested that a local failure occurred within this joint during this test. This was confirmed by removing the spalled concrete after the test as shown in Fig. 7(a). The beam reinforcement may have also pulled out from the joint due to the excessive crack widths (>10 mm). However, only narrow diagonal cracks formed at the 1st floor joints at this PGA level (see Fig. 7(b)). This indicates that whilst the 2nd floor joints experienced significant local damage due to the lack of stirrups and inadequate reinforcement detailing, the capacity of the 1st floor joints was not fully developed. Concrete cover splitting also occurred along the spliced longitudinal reinforcement of column C2A-2 (Fig. 7(c)). Horizontal cracks appeared in all 2nd floor columns at the location of the internal steel stirrups. The experiments were halted after the second test at PGA=0.15g to avoid irreparable local damage in the 2nd floor joints and a possible collapse of the 2nd floor.

1) The capacity of the substandard bare building was limited by the premature local failure of the beam-column joints at the 2nd floor. Following various levels of seismic excitation, the joints and columns at the 1st floor experienced limited damage. The damage produced during the shaking table tests in the X direction (Phase 1) reduced the initial stiffness of the bare building by 70%. The tests were halted at a PGA level of 0.15g to avoid excessive damage and a possible collapse of the 2nd floor.

Fig. 7. Damage in beam-column joints and columns after Phase 1: (a) J2A-2Y, (b) J1A-1X, (c) concrete splitting along lapped flexural reinforcement of C2A-2X

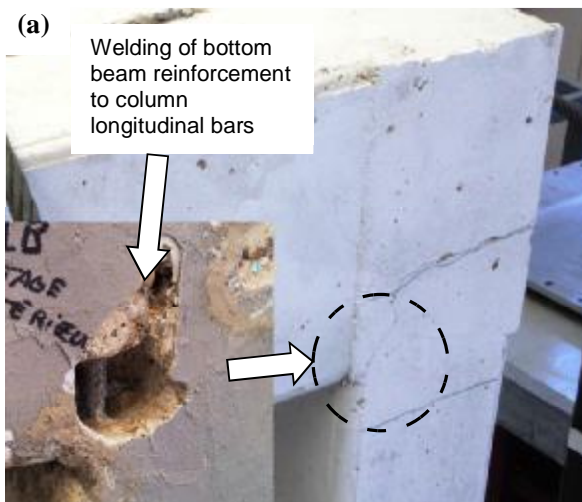
Fig. 9. Repairs after Phase 1: (a) welding of external beam bars to column bars, (b) mortar repair at J2B-2 and injection ports for crack injection, (c) crack injection in progress

b) Replacing damaged and spalled concrete with high-strength repair mortar (Fig. 9(b)), and

c) Injecting cracks with epoxy resin (Fig. 9(c)).

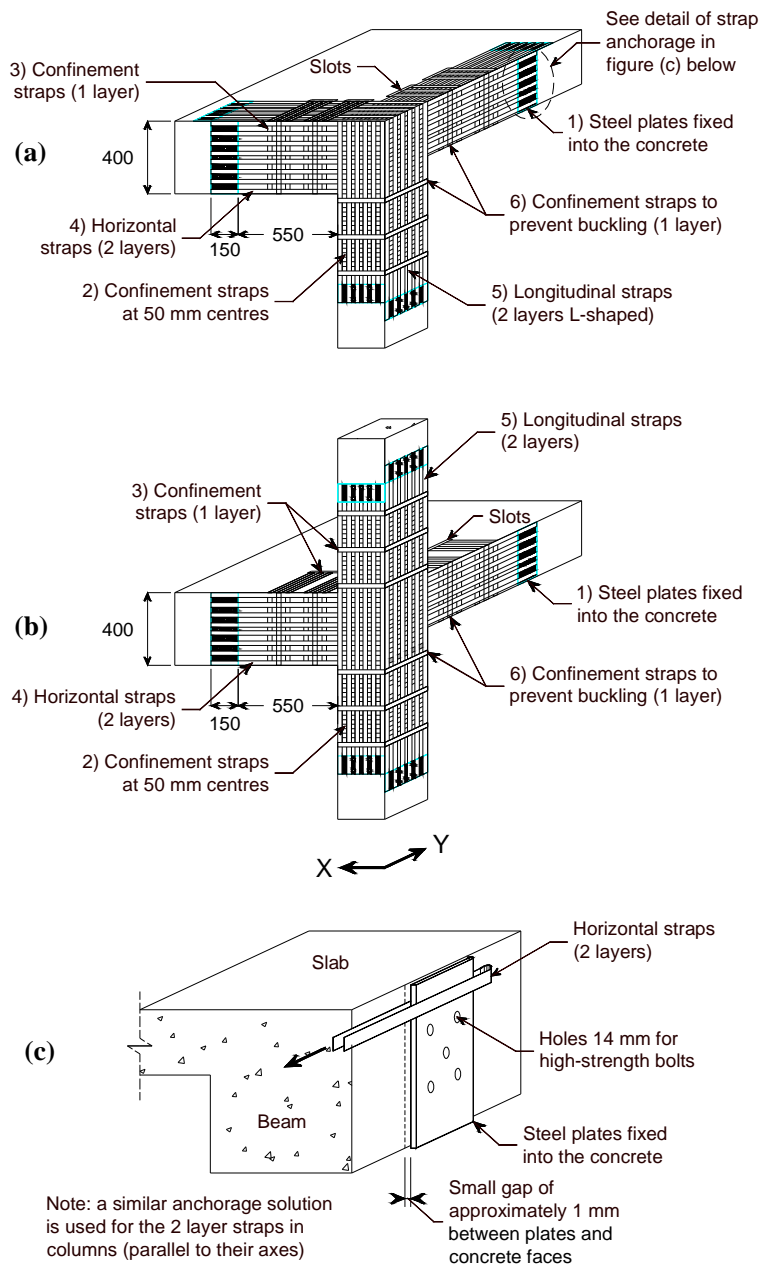
Fig. 10. Sequence of PTMS strengthening in joints: (a) 2nd floor, (b) 1st floor, and (c) gap between steel plates and concrete faces to secure the 2 layer metal straps

All columns and joints were strengthened locally using PTMS to increase their capacity. The metal straps were installed progressively, as described below and shown in Figs. 10 and 11.

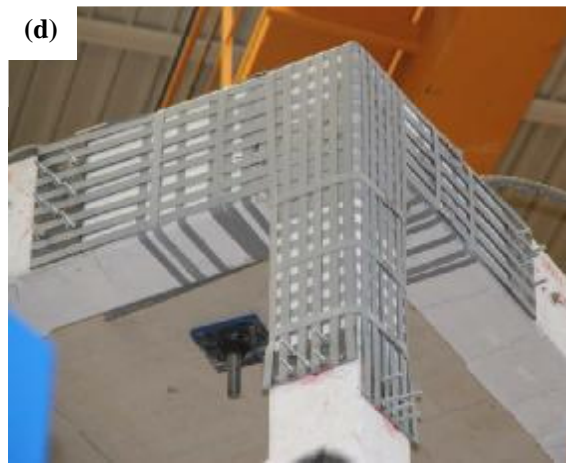
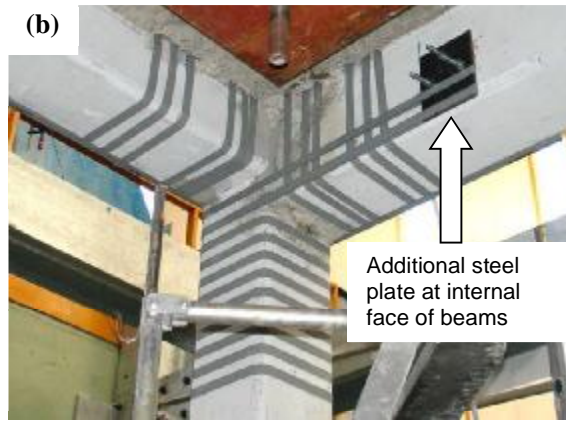
Fig. 11. PTMS strengthening of beam-column joints: (a) fixing of steel plates, (b) additional anchorage plate at interior face of beams, (c) final view of 1st floor joints, (d) final view of 2nd floor joints.

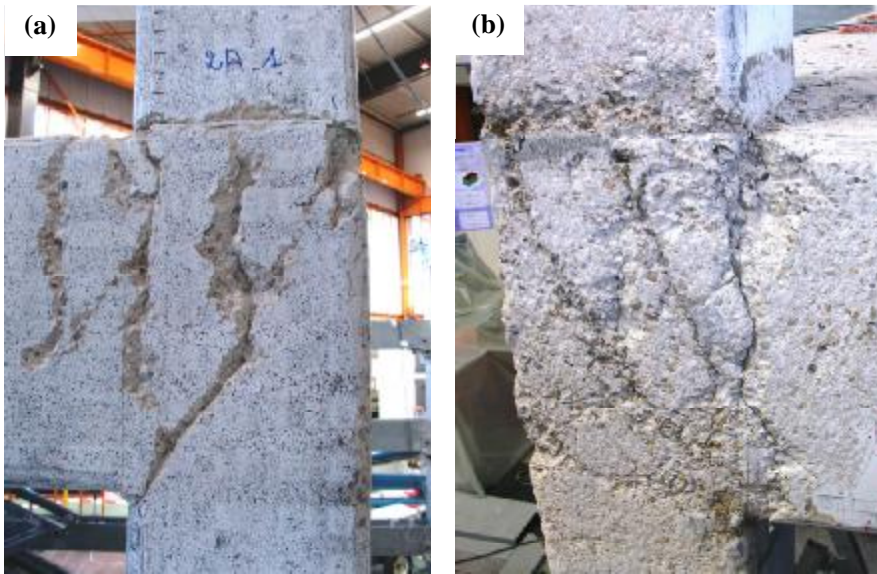
Fig. 12. Damage in beam-column joints after removal of PTMS in Phase 3: (a) J2A-1X, and (b) J1A-1X

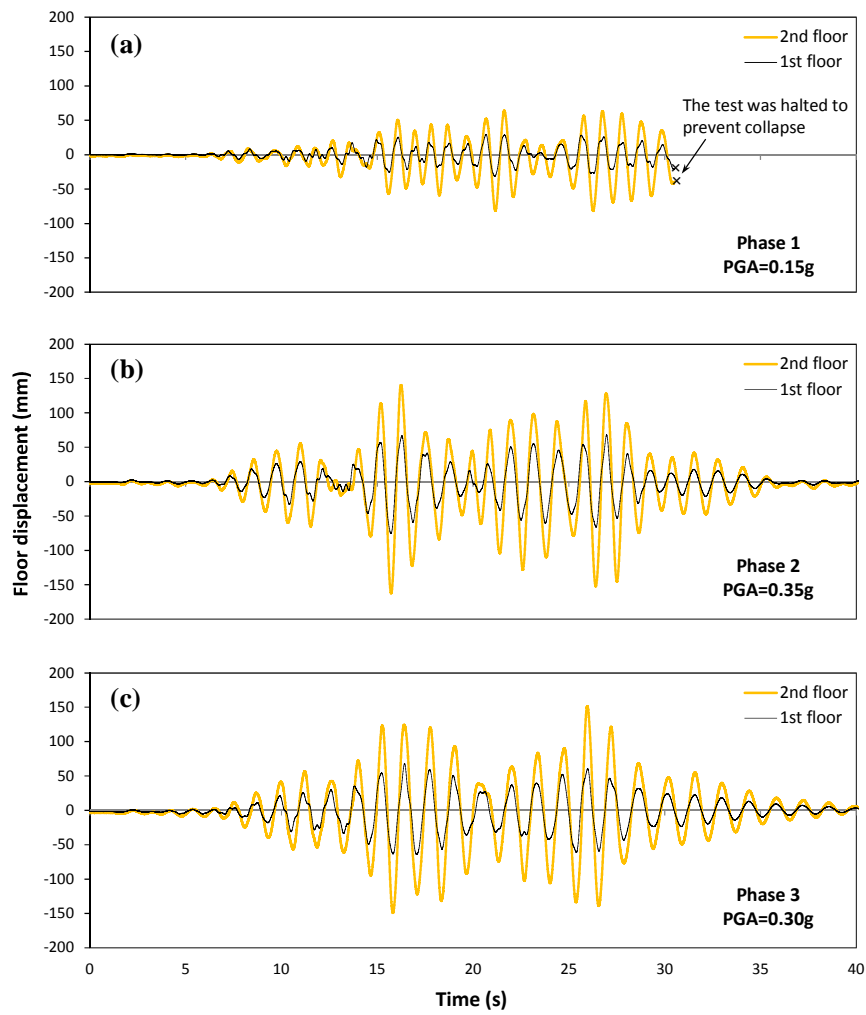
Fig. 14 shows displacement time-history of the 1st and 2nd floors for the last test performed in each testing Phase. It is shown that the 2nd floor exhibited higher lateral displacement (up to 160%) compared to the 1st floor in all three tests. Fig. 14 shows that residual displacements at the end of Phases 2 and 3 were very small (approximately 2-3 mm), which confirms the effectiveness of the PTMS intervention at controlling damage and maintaining the building stability. The test in Phase 1 was halted after approximately 32 s (see Fig. 14 (a)) to prevent the possible collapse of the 2nd floor, and therefore, residual displacements were not measured. In general, readings from the equidistant

Fig. 14. Displacement time-histories of 1st and 2nd floors, last test of Phases 1 to 3
