Initiation of sub-surface micro-cracks and white etching areas from debonding at non-metallic inclusions in wind turbine gearbox bearing

H.A. Al-Tameemi, H. Long, R.S. Dwyer-Joyce

Department of Mechanical Engineering, The University of Sheffield, Sheffield, S1 3JD, UK

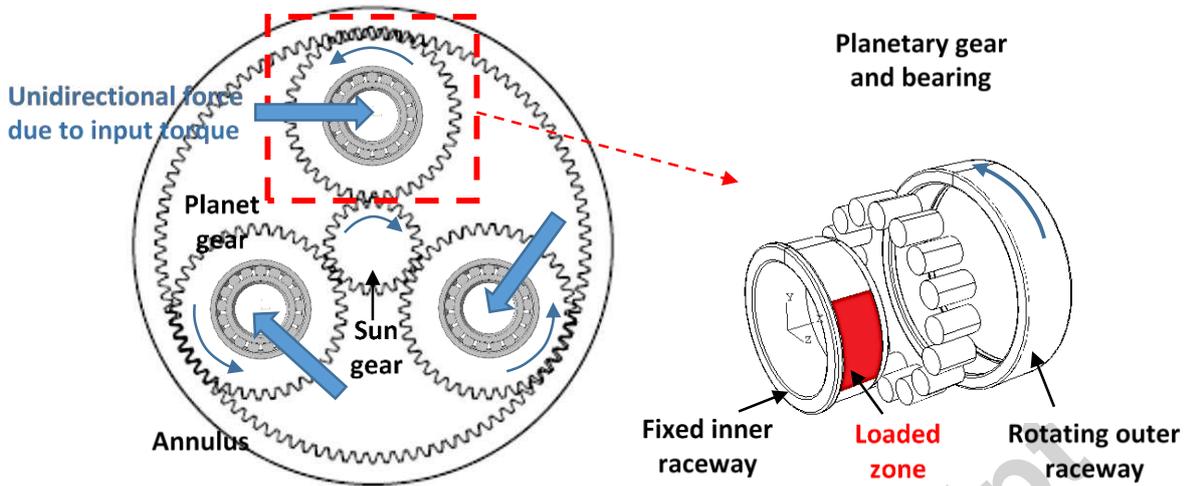
operation. The visual inspection showed extreme surface damage on the inner raceway compared to the outer raceway. The damaged area was in the loaded-zone where a unidirectional load was applied in the planetary bearing, as shown in Figure 1.

Fig 1: Illustration of WT planetary gear stage showing the unidirectional load and the loaded zone on the inner raceway of the planetary bearings

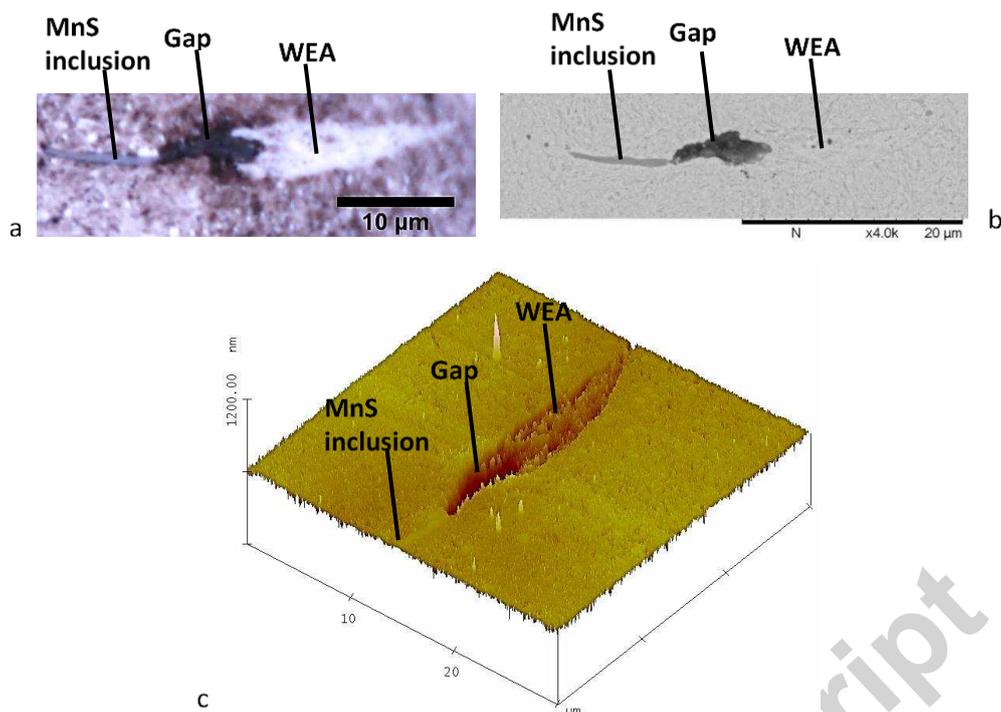
To obtain detailed mapping images of some of the butterflies, Atomic Force Microscopy (AFM) was used to provide measurements of the topography of the surface of the WEA at the nano-scale. In addition, AFM was utilized to clearly show the separation of the debonded MnS inclusions from the steel matrix. The images obtained helped in characterising the gaps attached to the MnS inclusions and the WEAs. The AFM revealed more details on the deformations in the WEA as shown in Figure 3 that could not be revealed by the optical microscope or the SEM, which are limited by two dimensional images.

Fig 3: Illustration of the difference between images of the same feature taken by different microscopic techniques (a) optical microscopic (b) SEM (c) AFM

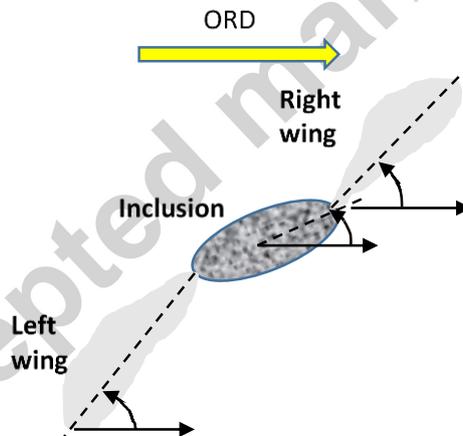
Fig 5: Definition of the angles of inclusion and butterfly right and left wings

The characteristics of each catalogued inclusion included: length, width, inclination angle and depth from the surface. The measurements were made according to the definition given in Figure 5. The first observation was that inclusions initiated damage were bigger in size, length and width than that the inclusions not initiated damage. In Figure 14, the characterization of micro-cracks initiated by inclusion and butterflies are presented separately in order to investigate the characteristics of the inclusions that initiated them. In Figure 14 (b), the definitions of right and left wings relative to the ORD are shown in Figure 5 which are also applied to the left and right cracks in Figure 14 (a). The common observations from the length of micro-cracks and butterfly wings initiated from inclusions were: a) They
