Fatigue Failure of Polyethylene Electrofusion Joints Subject to Contamination

Pedrom Tayefi, Stephen. B. M. Beck, Rachel A. Tomlinson

Department of Mechanical Engineering, University of Sheffield, Mappin St, Sheffield, S1 3JD, UK

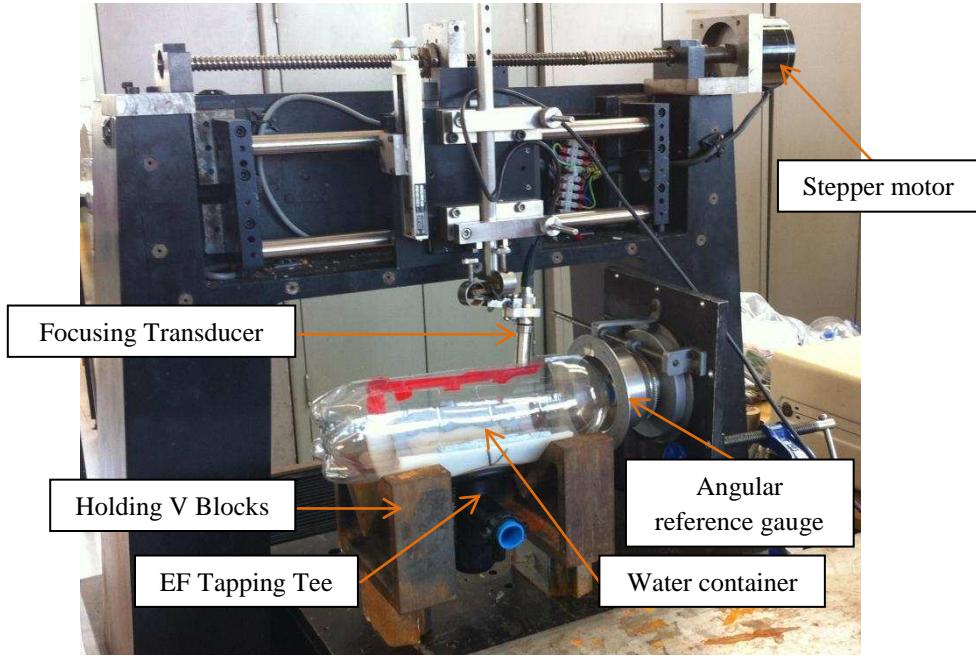
Fig. 5 Ultrasound focussing transducer arrangement

A rig was designed and built to observe the leak paths of failed joints. The rig consisted of an ultrasonic focussing lens attached to a stepper motor stage (**Fig. 5**). The stepper motor stage allowed for line scans to be performed. Joints that have been tested to failure in the fatigue programme (**Fig. 2**) were cut in half using a bandsaw, along the centre line of the pipe. This left the internal bore and the underside of the tapping tee exposed so that the ultrasonic transducer could focus on the internal bore of the pipe. Furthermore, the focussing lens transmitted pulses perpendicular to the internal bore of the PE pipe and fitting assembly.
