Bryant, MG, Buente, D, Oladokun, A et al. (2017) Surface and subsurface changes as a result of tribocorrosion at the stem-neck interface of bi-modular prosthesis. *Biotribology*, 10. pp. 1-16. ISSN: 2352-5738

Surface and subsurface changes as a result of tribocorrosion at the stem-neck interface of bi-modular prosthesis

M.G. Bryant, D. Buente, A. Oladokun, M. Ward, G. Huber, M. Morlock, A. Neville

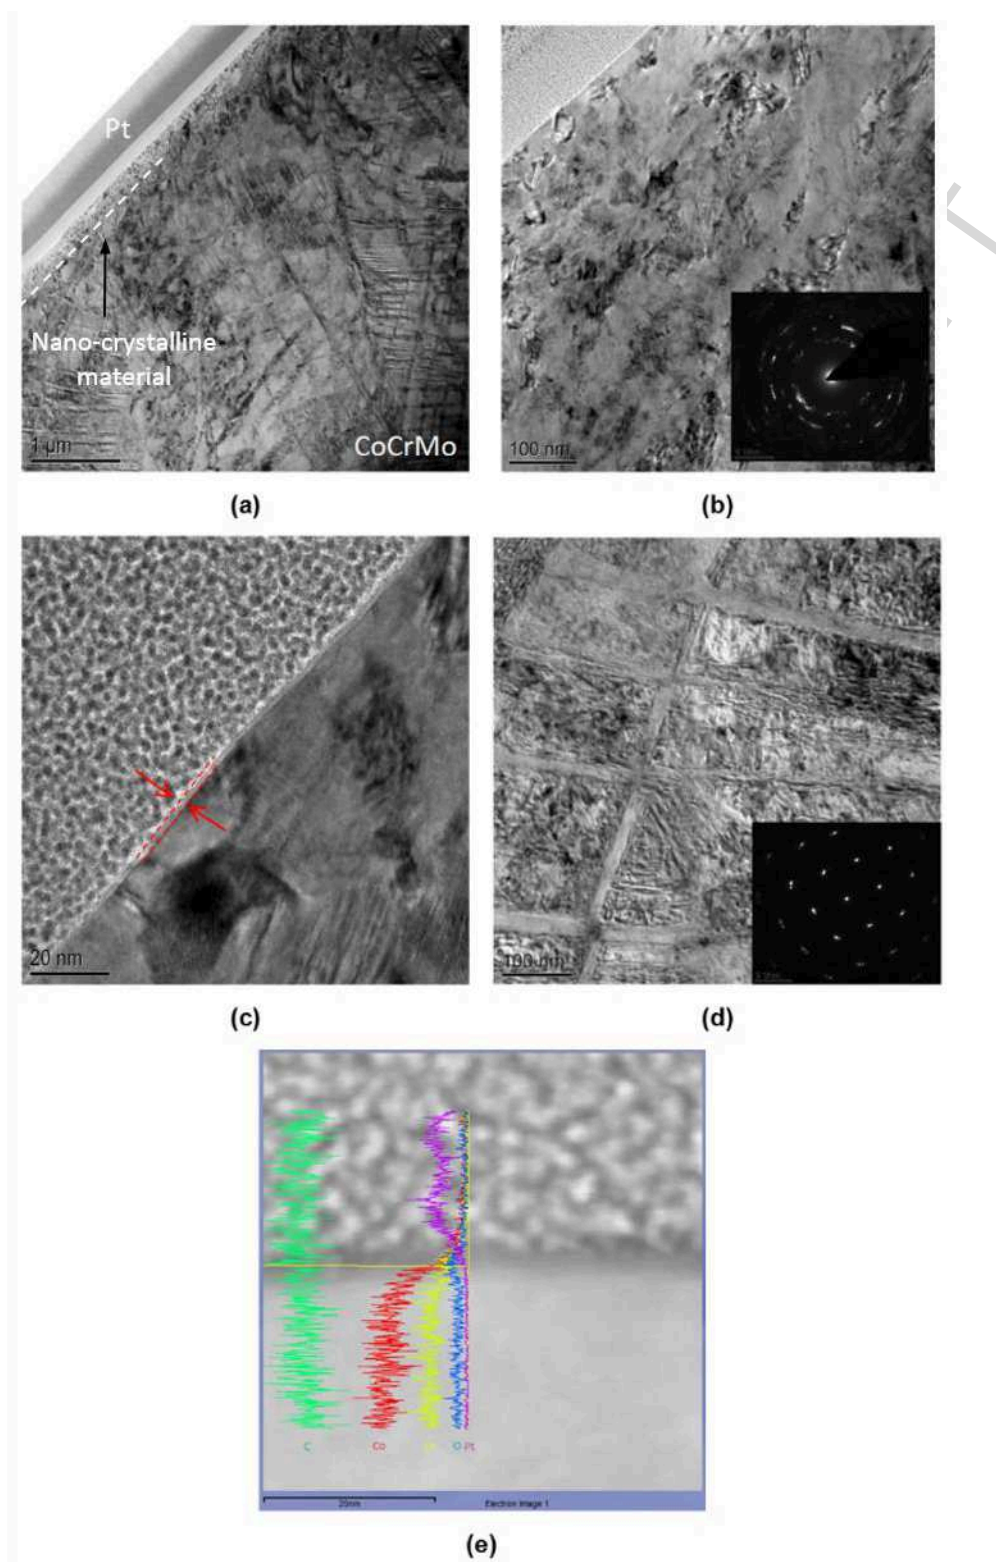
Figure 5 shows bright field images and electron diffraction data for the CoCrMo section prepared from the unworn, undamaged area of the implant (Figure 2, area 1). Figure 5a shows the top 5 μm of the CoCrMo alloy surface. It can be seen that within the top 250 nm of the surface, a nano-crystalline region exists. This is typified by the ringed diffraction pattern inset in Figure 5b. This was

Figure 5 – Reference CoCrMo alloy of the trunnion component of a) overview of the subsurface b) nano-crystalline uppermost surface ($\approx 500\text{nm}$) c) Pt-CoCrMo interface and d) crystalline subsurface ($\approx 2\text{-}3\mu\text{m}$). Evidence of a Cr and O rich interfacial layer (highlighted between red dashed lines) could be observed (Region 1, Figure 2). This was supported by EDX line analysis (e) where the green spectra = Carbon, red = Cobalt, yellow = Cr, blue = O and purple = Pt.

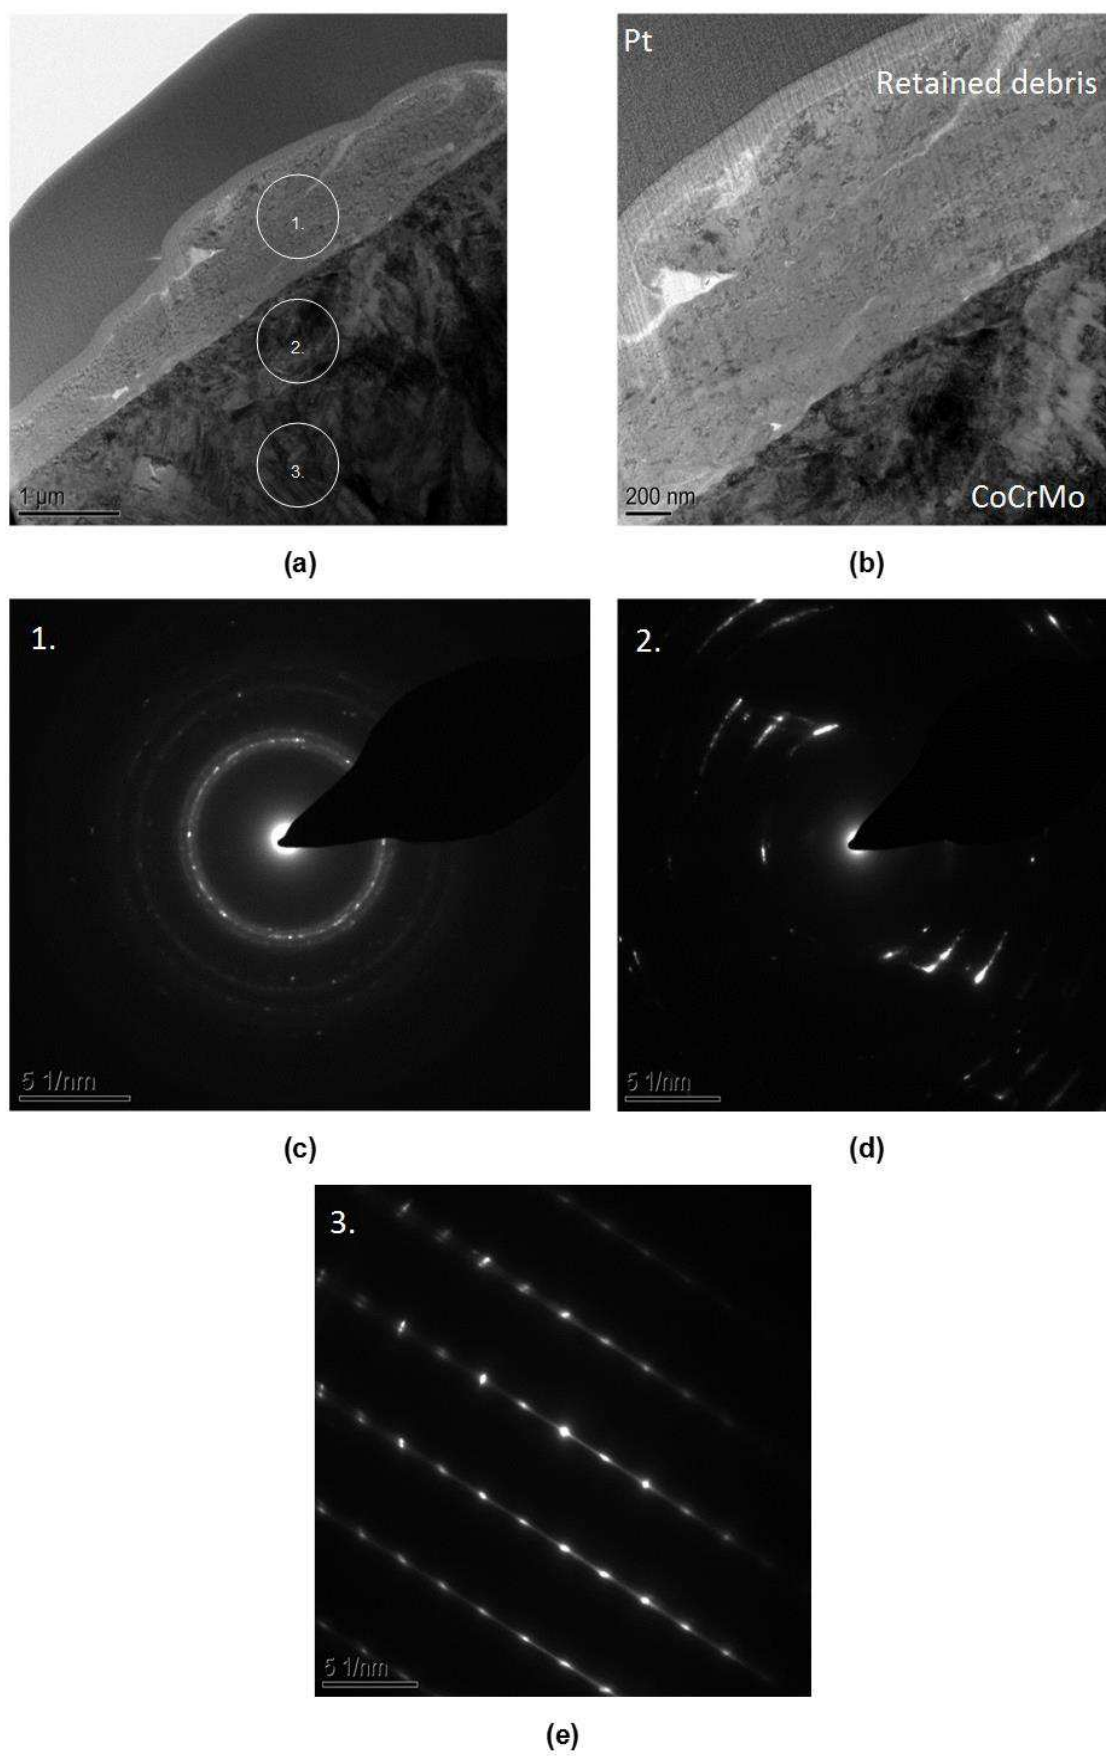
Figure 7

Figure 7- Electron microscope and images of a) debris and subsurface morphology on the patch area b) magnified image of the debris-CoCrMo interface c-e) electron diffraction patterns from regions of interest (Region 2, Figure 2).

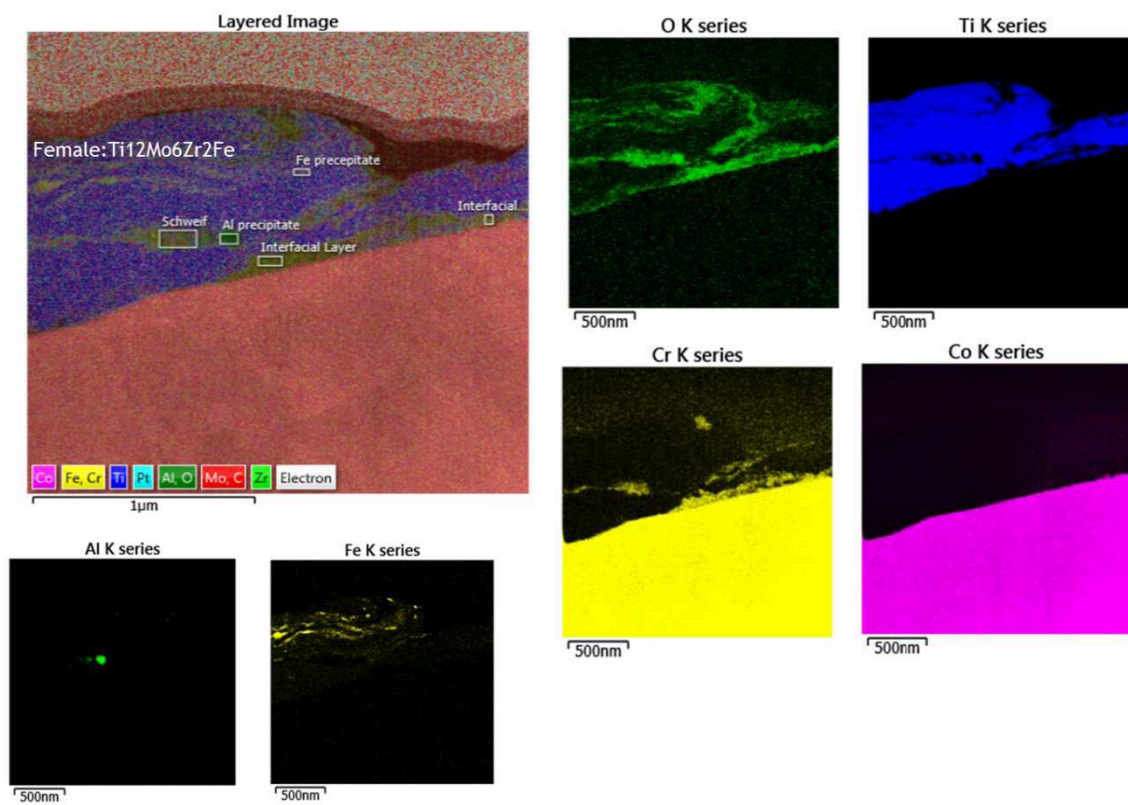
Figure 8 – EDX analysis of debris isolated on the patch area.

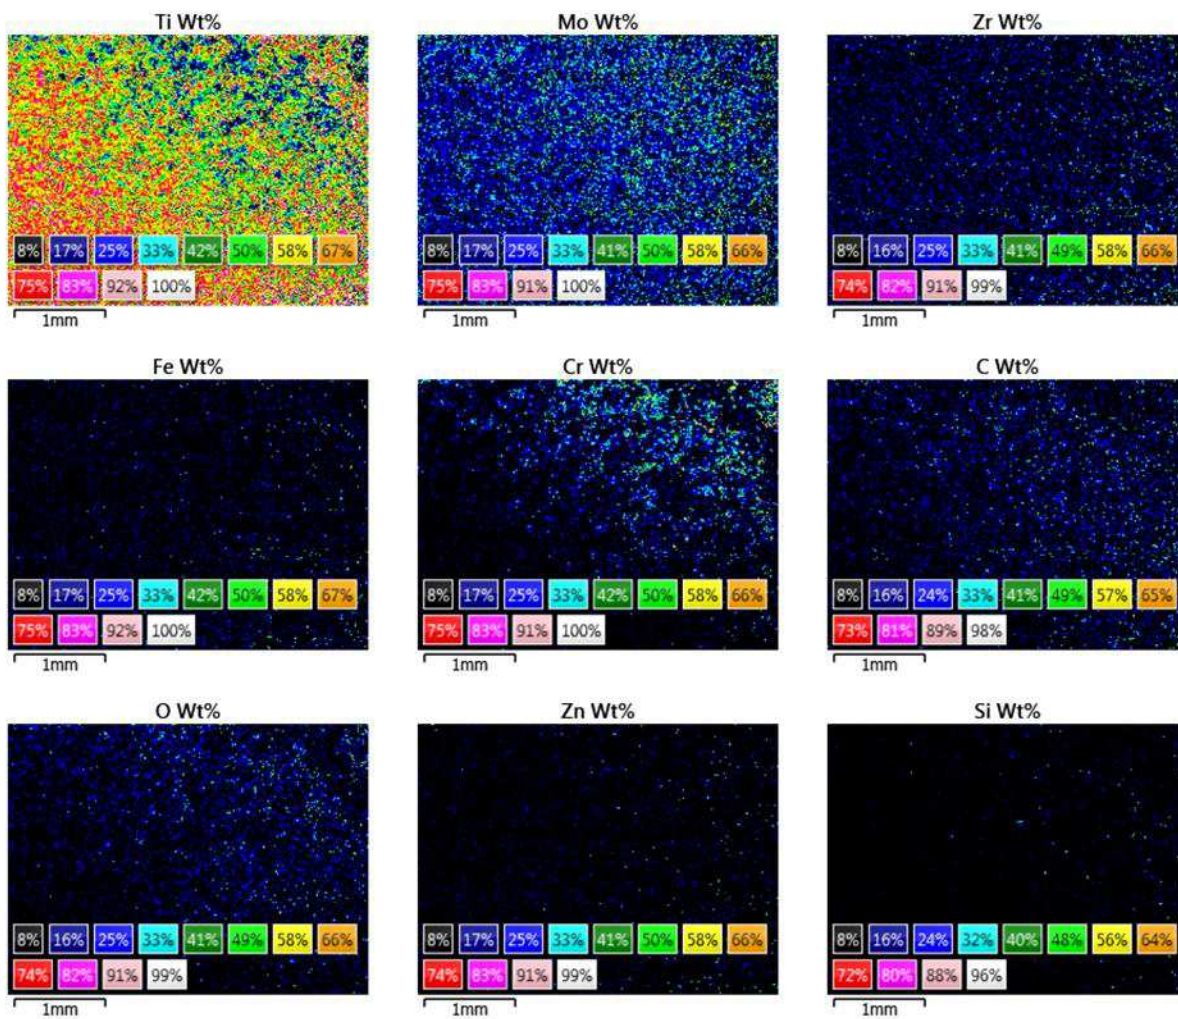
Figure 12 – EDX mapping for Figure 11b at 20 kV.

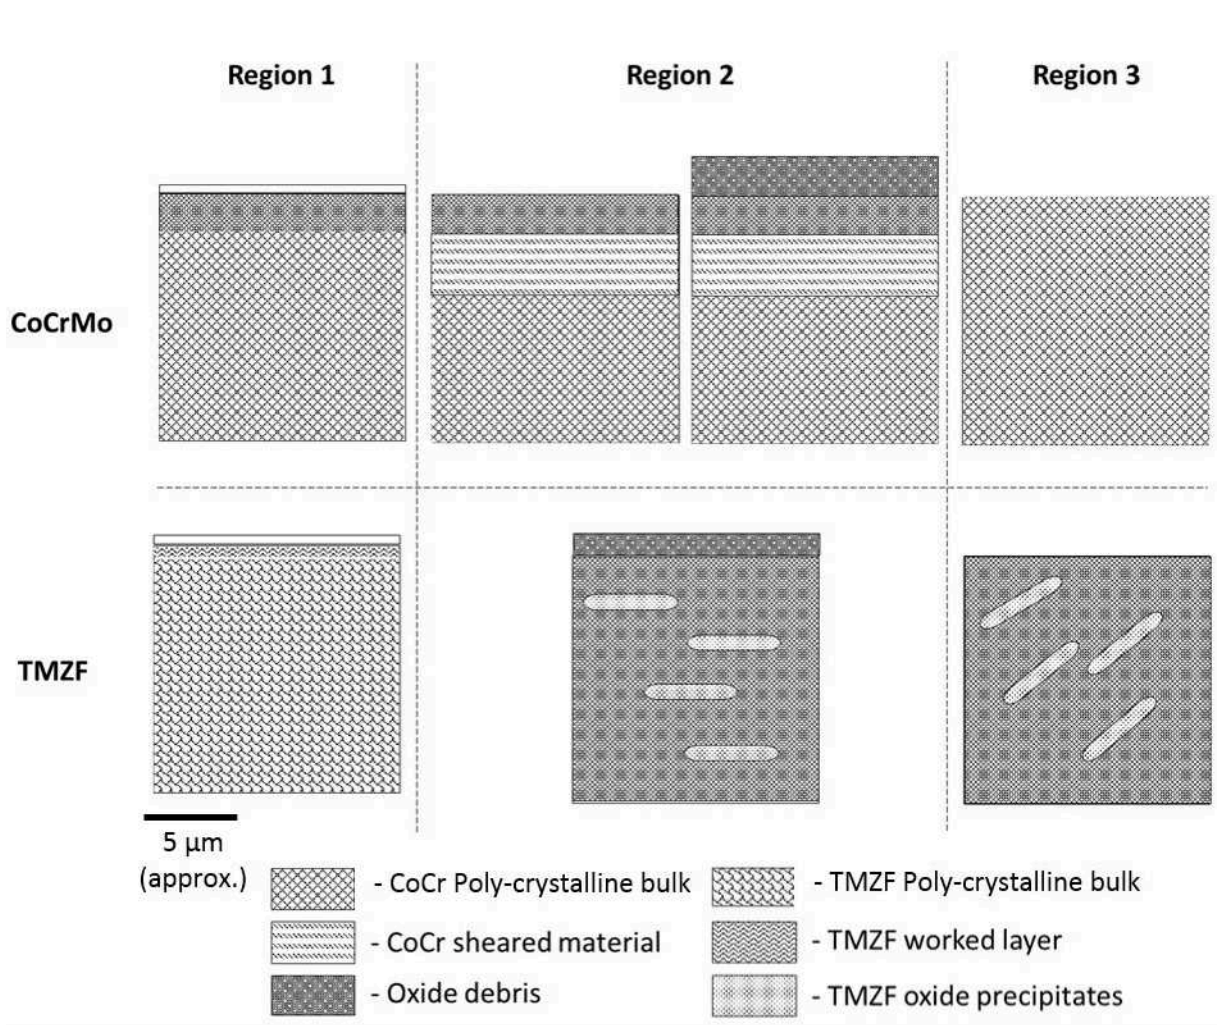
Figure 20 – illustration of the subsurface morphology for CoCrMo taper and TMZF trunnion in each of the regions analysed.
