Buente, D, Bryant, M orcid.org/0000-0003-4442-5169, Ward, M et al. (3 more authors) (2017) The taper corrosion pattern observed for one bi-modular stem design is related to geometry-determined taper mechanics. *Medical Engineering & Physics*, 46. pp. 79-88. ISSN 1350-4533

1 **The Taper Corrosion Pattern Observed for One Bi-Modular Stem Design**
2 **is Related to Geometry-Determined Taper Mechanics**

23 Bi-modular primary hip stems exhibit high revision rates owing to corrosion at the
24 stem-neck taper, and are associated with local adverse tissue reactions. The aim of
25 this study was to relate the wear patterns observed for one bi-modular design to its
26 design-specific stem-neck taper geometry.

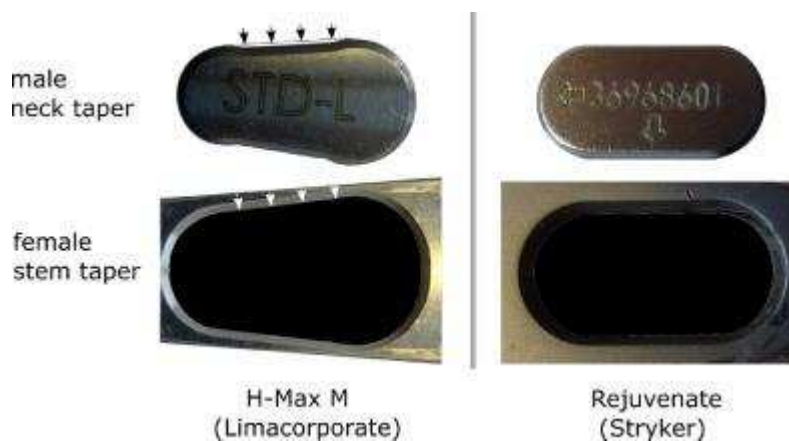
31 The determined geometry of the taper junction revealed design-related engagement
32 at its opening (angle mismatch), concentrated at the medial and lateral apexes (axes
33 mismatch). A patch of retained topography on the proximal medial neck-piece taper
34 apex was observed, surrounded by regions of high wear. On the patch, a deposit
35 from the opposing female stem taper —containing Ti, Mo, Zr, and O—was observed .

223 **Taper wear:** The infinite focus microscopy from the medial apices of the male tapers
224 revealed a high-gradient wear pattern at the proximal taper opening (Figure 1).
225 Surrounded by worn areas, characteristic patches with preserved original texture

561 *Figure 1: In vivo orientation of wear pattern for a male non-circular neck taper, 26*
 562 *months in situ. Surface deviations from the estimated pristine geometry*
 563 *are color-coded from green (no deviation) to red (wear). Wear in highly*
 564 *loaded regions exhibited a characteristic pattern, developing around the*
 565 *confined patches at the apex of the conical sections (most prominent*
 566 *medially at the proximal taper end (arrow), but and also diagonally*
 567 *across on the lateral apex).*
