Microscopic investigation of subsurface initiated damage of wind turbine gearbox bearings

Jasim H AL-Bedhany and Hui Long*

Department of Mechanical Engineering, The University of Sheffield, Sheffield, UK.

Abstract. Wind turbine gearbox bearings experience premature failures by White Structure Flaking (WSF), often occurs much earlier than their designed life of 20 to 25 years. This results in increased operational and maintenance costs due to unplanned maintenance and early replacement. The main causes and damage initiation mechanism of this premature failure are not fully understood; despite extensive research and investigation in recent years. In this paper, two planetary bearings from a failed gearbox of a multi-megawatt wind turbine are destructively investigated to characterize the subsurface microstructural damage and to understand damage initiation mechanism leading to surface WSF. The results show that the non-metallic inclusions are not the only initiator of subsurface damage. The microcracks are also initiated in the subsurface to form macrocracks which then propagate or connect to other macrocracks to reach the rolling contact surface causing WSF. The characterization

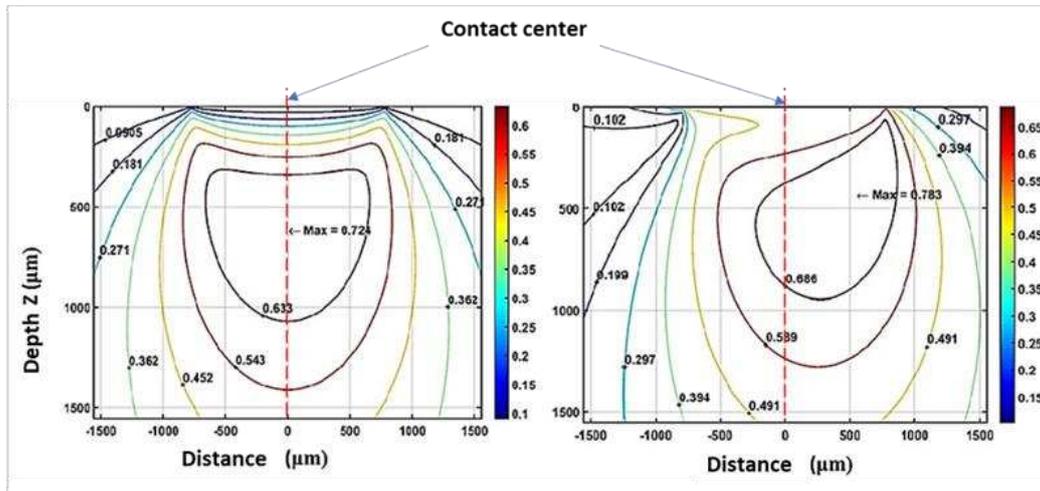
Subsurface stress distributions beneath the contact surface are calculated using Hertzian contact theory by applying compression and traction loading according to the designed stress level specified by the international standards[20][21]. [figure 2](#) shows the distributions of the maximum shear stress when under compression only and under combined compression and traction respectively. Increasing the compressive loading moves the maximum shear stress zone further away from the contact surface. Introducing surface traction into compression moves the maximum shear stress zone closer towards

the contact surface. The maximum shear stress zone will be compared with the locations where various forms of damage are found in the following sections.

Figure 2. Distributions of maximum shear stress (in GPa), (left) under compression loading 1.8 GPa and (right) under combined compression loading 1.8 GPa and 0.2% traction.
