Tayefi, P., Beck, S.B.M. and Tomlinson, R.A. orcid.org/0000-0003-2786-2439 (2019) The fatigue performance of electrofusion tapping tees subject to contamination. *International Journal of Pressure Vessels and Piping*, 171. pp. 271-277. ISSN 0308-0161

**THE FATIGUE PERFORMANCE OF ELECTROFUSION TAPPING TEES
SUBJECT TO CONTAMINATION**

P. Tayefi, S.B.M Beck, R.A. Tomlinson

Department of Mechanical Engineering, University of Sheffield

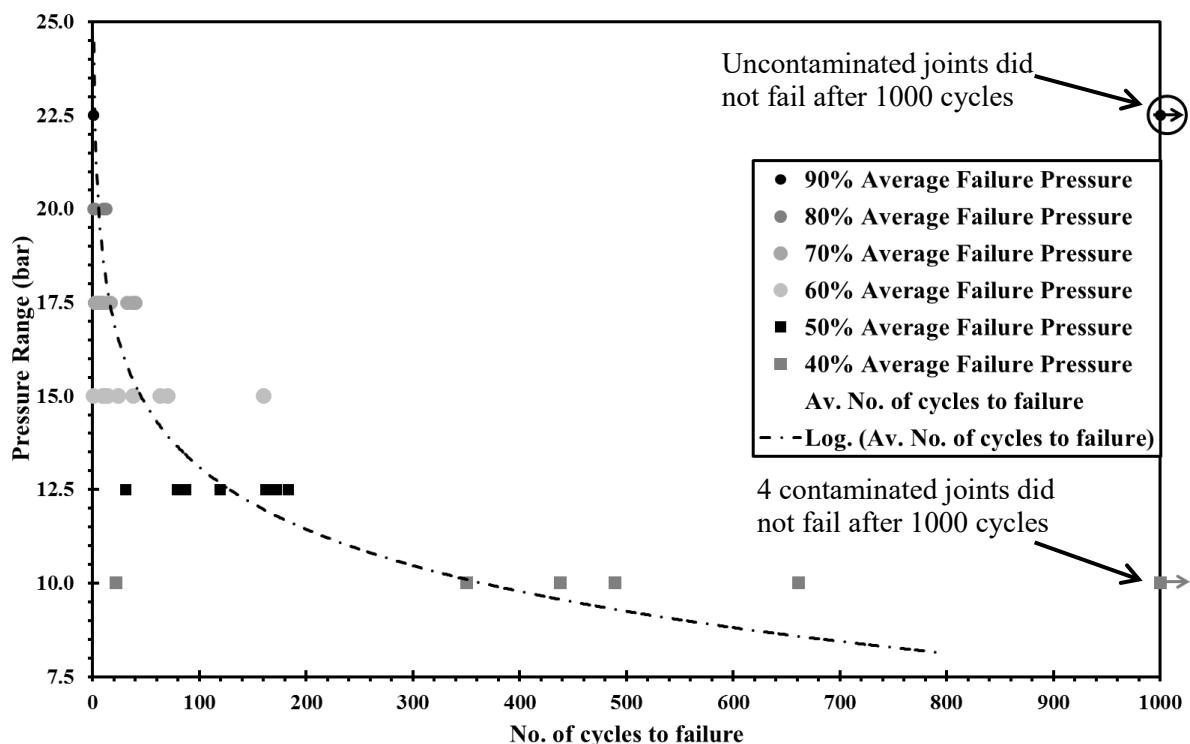
Figure 3.1 - Pressure Range vs. Number of cycles to failure for the dynamic (fatigue) loading test (where; $P_{MEAN} = 12.5 \text{ bar}$)

It is important to note that the fatigue test was stopped if a specimen did not fail after 1000 cycles as this testing programme is classed as low cycle fatigue. A minimum of eight tests were conducted for each pressure range with the exception of the 90% $P_{MAT,MAX}$ pressure range where three specimens failed to reach one cycle. In contrast, the two tests on “perfect”, uncontaminated joints which were conducted at this highest pressure range (circled in Figure 3.1), did not fail after being subject to 1000 cycles. In the 40% $P_{MAT,MAX}$ pressure range, five tests were successful, in that they failed within 1000 cycles, however, four tests did not fail (i.e. exceeded 1000 cycles). These are highlighted in Figure 3.1

It can be observed that as the pressure range decreases, the distribution of failure increases. This becomes evident in the 10 bar range whereby one specimen failed below 50 cycles and some did not fail after 1000 cycles. It can be argued that this low pressure range pushes the boundary of the short term fatigue life of the product. Based on the indicative logarithmic line plotted against the mean number of cycles to failure (Figure 3.1), it can be said that if the pressure range were to be dropped further, there is a likelihood that most specimens would successfully reach 1000 cycles without failure. Hence there is an argument that for low pressure ranges (<10 bar) there may be a fatigue limit in this testing regime.

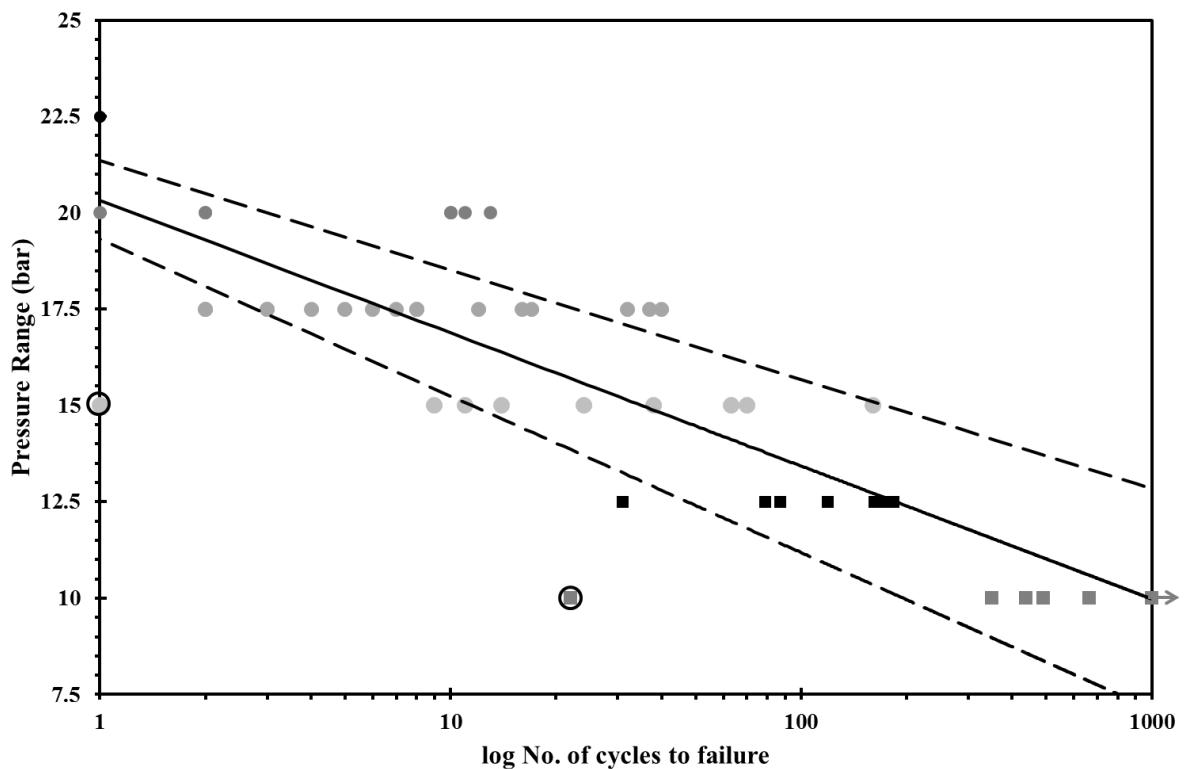
Figure 3.2 Pressure Range vs. Log Number of cycles to failure

Using the experimental data in Figure 3.1, a regression analysis was performed and the 95% confidence limits obtained. Figure 3.2 indicates the average number of cycles to failure with the 95% confidence limits on pressure range Vs. Log number of cycles to failure. The limits clearly show two results that lie well below the lower boundary at 15 and 10 bar pressure range as highlighted in Figure 3.2.

With regards to the two anomaly results that sit well below the 95% confidence limits (circled in Figure 3.2), there were no obvious reason why these failed prematurely. It can therefore be assumed that there may have been a variation in the specimen preparation procedure.
