Damage characterisation of white etching cracks in a black oxide coated wind turbine gearbox bearing

H.A. Al-Tameemi, H. Long, R.S. Dwyer-Joyce

This study presents a damage investigation of a failed BO coated planetary bearing retrieved from the gearbox of a multi-megawatt wind turbine. The investigation consisted of a metallurgical damage examination and BO layer characterisation. The examination focused on characterising the initiation of both surface damage and sub-surface damage associated with non-metallic inclusions. In order to characterise the subsurface microstructural defects associated with non-metallic inclusions, steel cleanliness of the BO bearing was examined. To evaluate the mechanical properties of BO coating layer, hardness, modulus of elasticity and thickness of the BO layer in damaged and undamaged raceway surface regions were measured by using Nano-indentation technique. Various forms of microstructural damage were observed in the BO coated bearing, which were compared with the microstructural damage observed in the uncoated bearings investigated in our previous published studies [13][14][38].

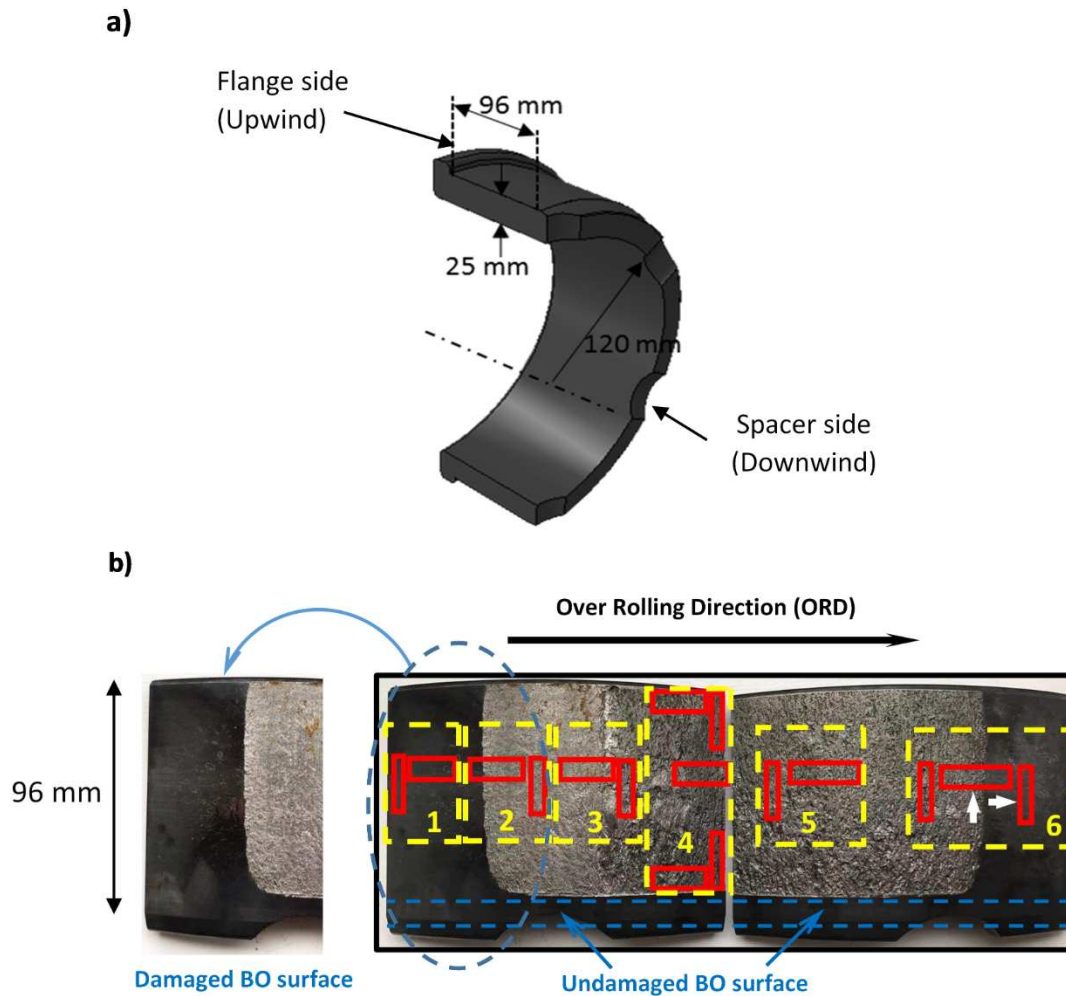
The examined inner raceway of the BO coated bearing had severe surface damage in the loaded zone, with a band covered the entire width of the raceway, except the edges under the cage, and extended to 220mm in length along the raceway circumference, as shown in Figure 1. Along this band, the BO coating had been completely removed. Outside the severe damaged region of the loaded zone, in the vicinities close to the entrance and the exit sides of the loaded zone of the raceway, the visual examination revealed that the BO layer was slightly removed. Various sized indents, which could be produced by debris carried from the severe damaged region, were seen over almost the entire raceway circumference outside the loaded zone. However, the indents had a higher density and greater size (more than 3mm in maximum dimension) at the exit side of the loaded zone when compared with those at the entrance side to the loaded zone.

Figure 1: (a) Dimensions of the examined BO bearing (b) Sectioning of the inner raceway: locations of samples (shown as red blocks) – 8 for observation in the axial direction and 8 for observation in the circumferential direction (shown by white arrows), covering 6 regions (shown by yellow boxes).

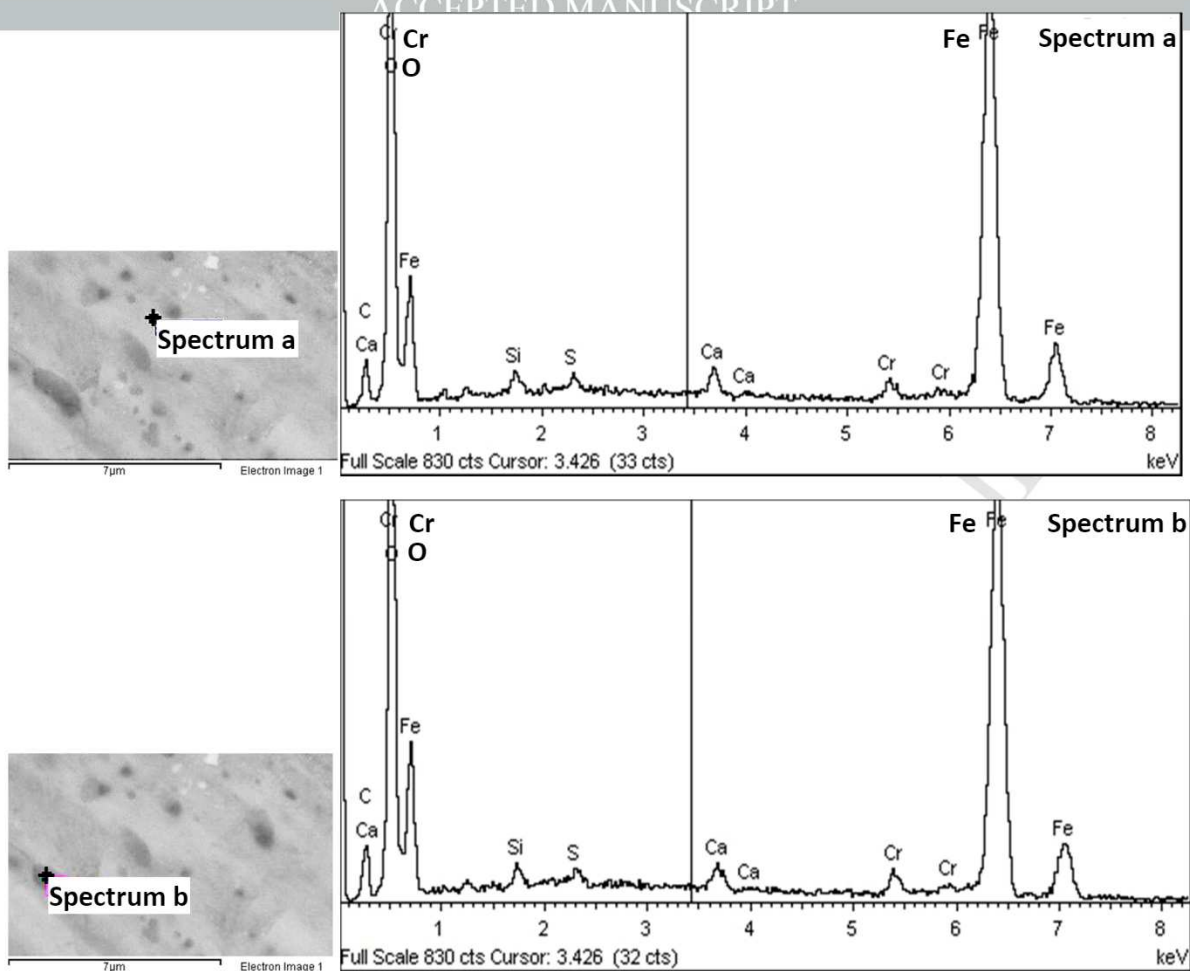
Figure 2: EDXA of the undamaged region of BO layer at the side of the raceway

EDXA was also used to view the chemical composition of the BO layer, as shown in Figure 2. The analysis was conducted on the undamaged region of the BO layer at the side of the raceway, as shown in Figure 1. Because the X-ray can penetrate the very thin BO layer, Figure 2 shows mainly peaks of iron oxide and other chemical elements existed in the bearing steel such as Cr and Si. Dark spots appear in the SEM images of this layer, which have a similar spectrum of chemical elements as the rest of the BO layer, by comparing the two spectrum diagrams in Figure 2. Accordingly, these dark spots indicate the porosity of the oxide.

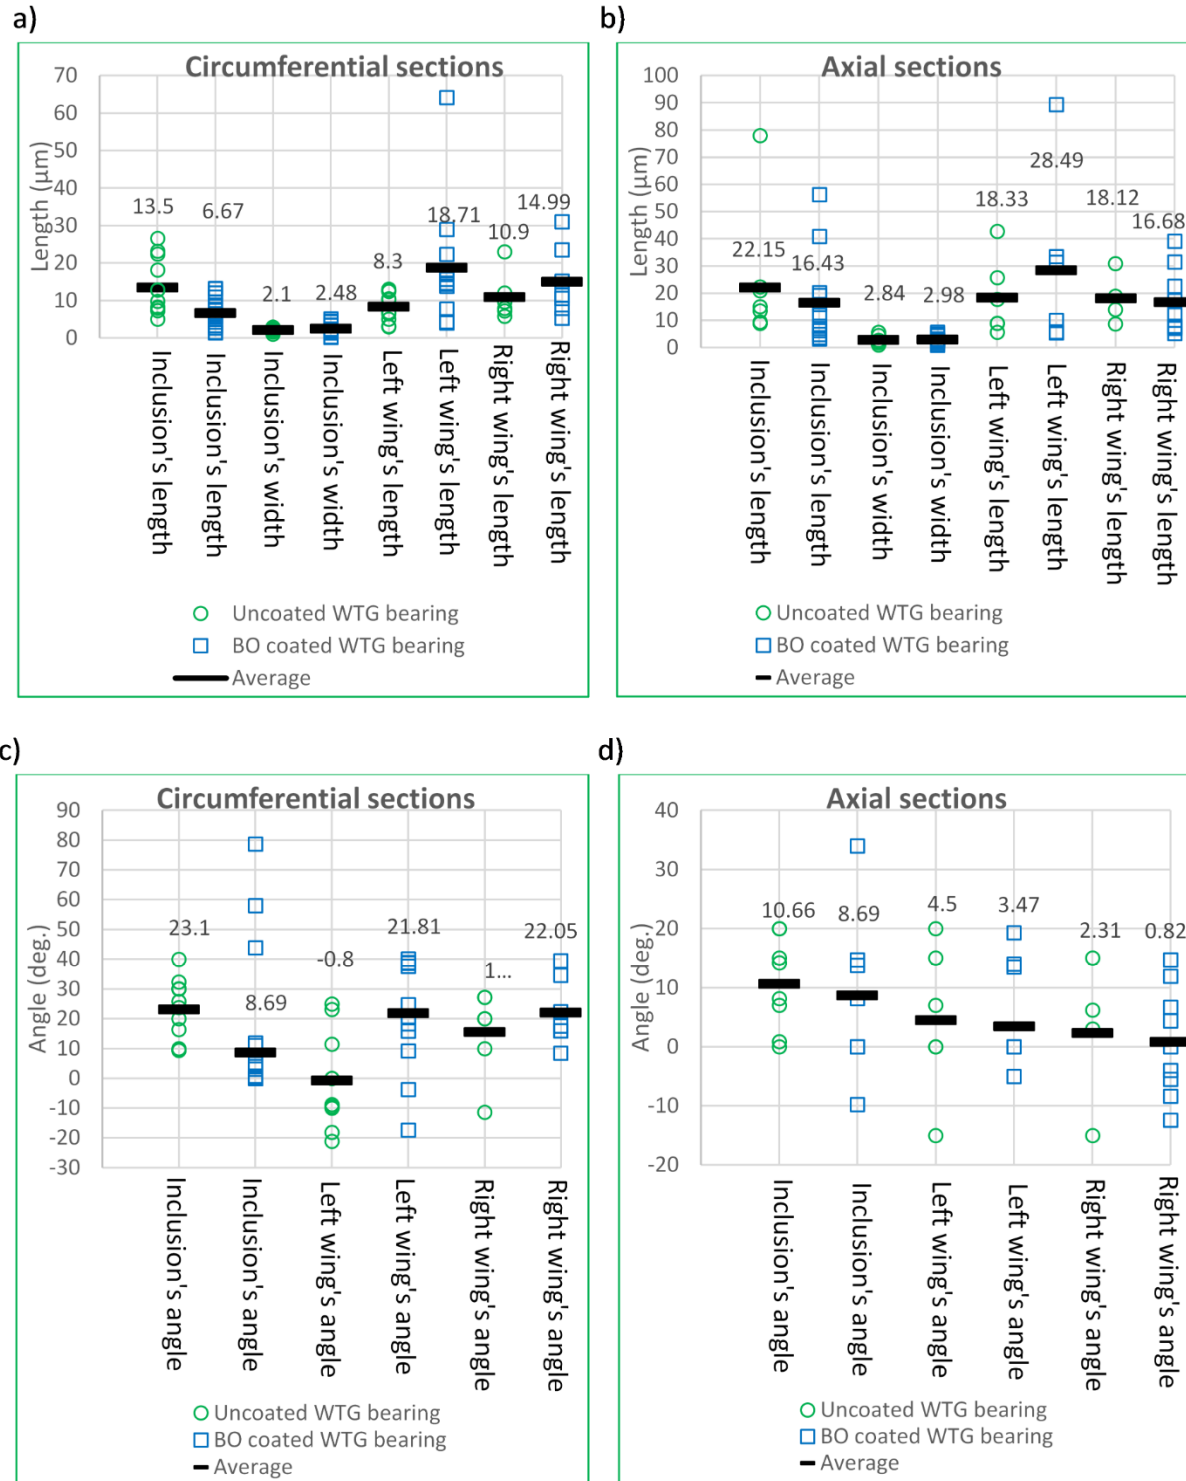
In this bearing, the inclusions associated with butterfly wings were mostly Type D inclusions (65% of all inclusions observed). The total number of butterflies with single and double wings observed in the circumferentially and axially sectioned samples was 28. The characteristics of the butterflies and their initiating inclusions are shown in Figure 5, which are compared with that observed in the uncoated WTG bearings in one of our previously published studies [14]. Despite being different in sizes between the two bearings, the characteristics of the observed butterflies in both bearings showed

bearing in both circumferential and axial sections despite the BO bearing has shorter average lengths of inclusions. In addition to the inclusion size, the inclination of the inclusions is different in both bearings as shown in Figure 5(c). The variation in the size and inclination of inclusions could be due to the different sizes of bearings and different inclusion types where Type D was the dominating damage initiating inclusion type in the BO coated bearing. This inclusion type has different aspect ratios when comparing to that of Type A inclusions (MnS) in the uncoated bearings of our previous study [14]. The difference in the size of butterfly wings could be due to the different number of cycles and loading levels experienced by each bearing. Figures 5(c) and (d) show that in both bearings the inclination angles of the butterfly wings are less than the angle of the maximum shear stress, 45° , indicating the effect of surface traction on the formation of the observed butterflies in both bearings, as depicted in Figure 6. This provided an evidence indicating that the BO coating had not prevented the formation of the butterfly cracking initiated at inclusions despite its intention was to reduce hydrogen absorption and prevent bearing subsurface initiated embrittlement leading to cracks/WECs.

Figure 5: Characteristics of the observed butterfly wings and their initiating inclusions in the BO coated bearing and the previously examined uncoated bearing [14] (the number above each characteristic refers to the average value): (a) length of inclusions and butterflies wings in circumferential sections; (b) length of inclusions and butterflies wings in axial sections; (c) inclination angle of inclusions and butterflies wings in circumferential sections; (d) inclination angle of inclusions and butterflies wings in axial sections

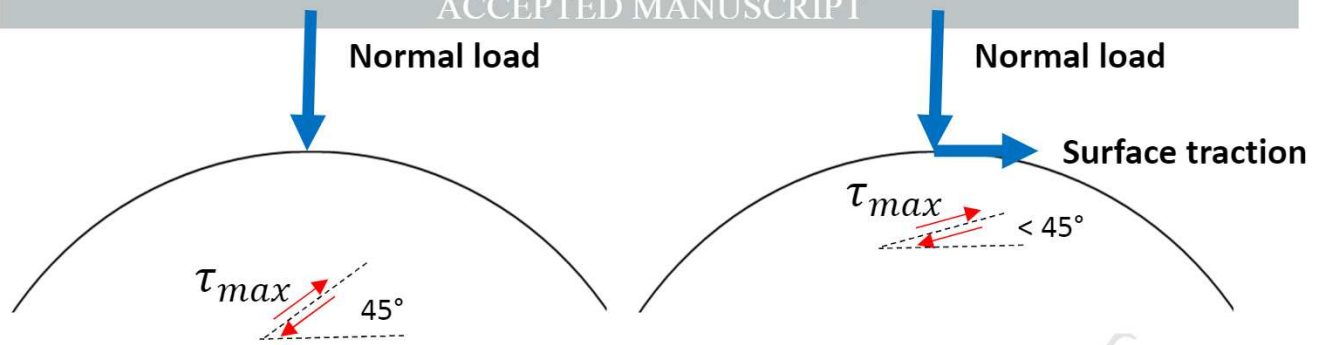
Figure 6: Illustration of the effect of surface traction on the inclination of maximum shear stress and thus butterfly wings angles and damage location in subsurface

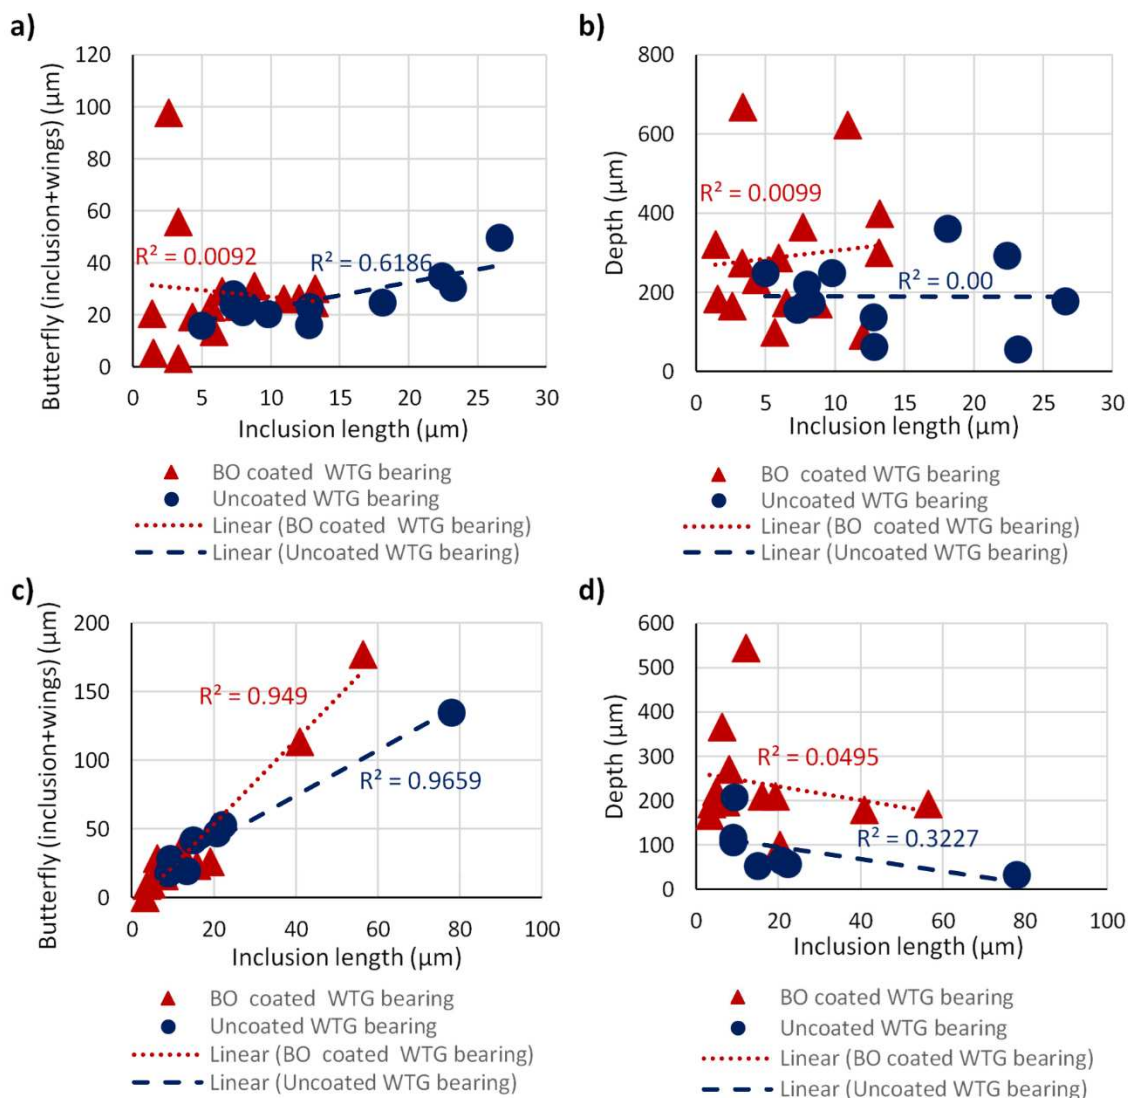
Figure 9: Inclusion length vs. total butterfly length and Inclusion length vs. depth of inclusions: (a) and (b) butterflies in circumferentially sectioned samples (c) and (d) butterflies in axially sectioned samples.

Figure 9 shows the relations between total butterfly length (inclusion length + butterfly wing length) and inclusion length in circumferentially and axially sectioned samples from the BO coated bearing investigated in this study and the uncoated bearing investigated in the previous study [14]. Figure 9(a) shows that the relation between the butterfly length and inclusion length in the BO coated bearing circumferentially sectioned samples is not similar to that in the uncoated bearing. The difference of the dominant inclusion types, thus different inclusion aspect ratios, in each bearing can

conclusion can be supported by the results shown in Figure 9(c) where a very clear relation exists between butterfly length and inclusion length in the axially sectioned samples since the inclusion lengths in the axially sectioned samples are much greater than that in circumferentially sectioned samples. Although Figures 9(b) and (d) show similar trends for the relation between inclusion length and butterfly depth in both coated and uncoated bearings, these relations are not strong. In addition, no assertive conclusions could be made about the effect of inclusion depth on the total length of butterfly. These observations and analysis from Figure 9 show similar trends of the effect of inclusions on butterfly formations for both the BO coated bearing and previously investigated uncoated bearing [14]. This indicates that the BO coating layer was ineffective in alleviating the effect of non-metallic inclusions on the subsurface initiated damage of micro-cracks and butterflies.

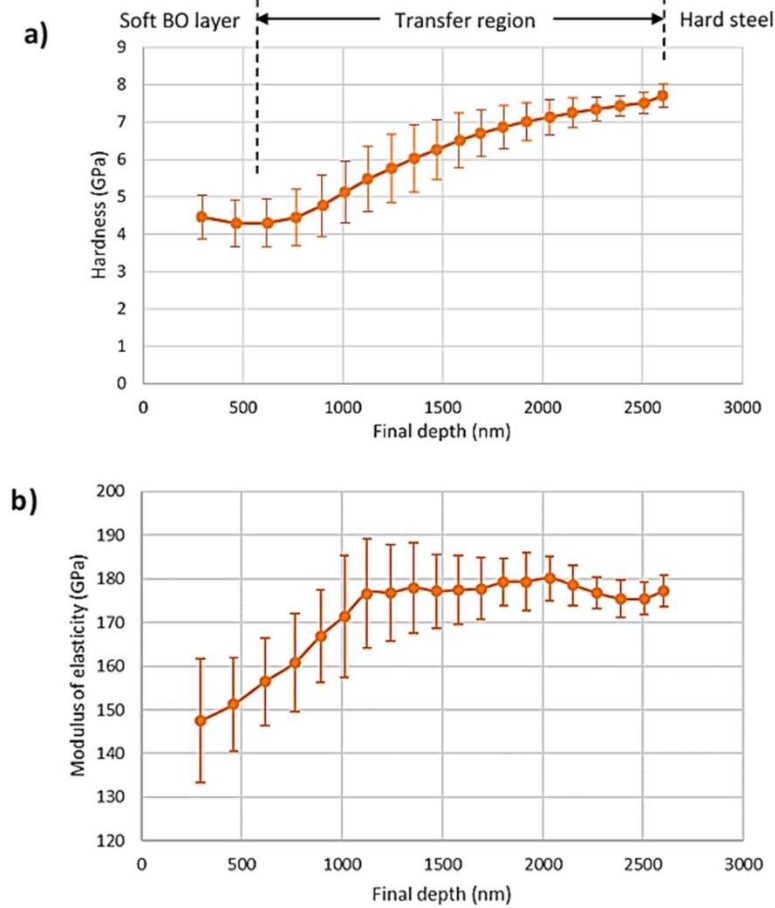
Figure 14(a) shows that the end of the BO coating layer is around 2.2 μm in depth from the surface where the hardness of the bearing steel is reached. This thickness is very close to the 2 μm reported by a bearing manufacturer [29]. Previous study reported by Evans et al. [33] investigated the effect of BO coating on the performance of bearing steel during bearing fatigue test as discussed in Section 1. The BO coating was prepared according to the DIN 50938 standard for black oxidation. The preparation process included cleaning the steel components with alkaline solutions followed by immersing the components in a boiling aqueous alkaline bath at ($< 150\text{ }^\circ\text{C}$) for a certain time. The components were then rinsed to remove the residual of the oxidation solution and to coat the steel components with rust preventing oil [33]. In their study the BO layer was prepared using single-bath, double-bath, and extended single-bath to achieve different thickness of the BO layer. The mechanical properties for the double-bath BO layer were examined using Continues Stiffness Measurement (CSM) Nano-indentation. Although the thickness of the double-bath BO layer in their study was estimated to be around 2 μm , their study reported the modulus of elasticity (E) and hardness (H) at the depth range of 200-300 nm only and the result obtained was a single value without measuring the variation across the depth. The single measurement could not obtain the properties across the entire thickness as seen in Figures 13 and 14, showing the gradual increase of the BO hardness and modulus of elasticity. It can be seen that the BO layer has different E and H values at different depths. Table 2 shows the average values of H and E of the BO layer at different depths. This table also included the values of E and H for the double-bath BO layer reported in [33]. It can be seen that the mechanical properties for the double-bath BO layer at 200-300 nm depth are fairly close to those found from the BO layer on the investigated bearing for the first 400 nm. The E and H values within this range of depth are considerably lower than those for the bearing steel; however, at further depths, the properties of the BO layer increase significantly. This can also be seen in Figures 13(b) and (c) where the E and H values of the remaining thin layer of the damaged BO layer, after the wear-out during service, are very close to the high values of E and H of the bearing steel. Accordingly, the

Figure 14: Undamaged BO layer: (a) Nano-indentation hardness; (b) Modulus of elasticity; measured using Hysitron TI Premier (\pm one standard deviations).
