Bal, İE, Dais, D orcid.org/0000-0002-0533-5171, Smyrou, E et al. (1 more author) (2021) Monitoring of a Historical Masonry Structure in Case of Induced Seismicity. *International Journal of Architectural Heritage*, 15 (1). pp. 187-204. ISSN 1558-3058

Monitoring of a Historical Masonry Structure in Case of Induced Seismicity

Ihsan Engin Bal^{*1}, Dimitris Dais^{1,2}, Eleni Smyrou¹, Vasilis Sarhosis²

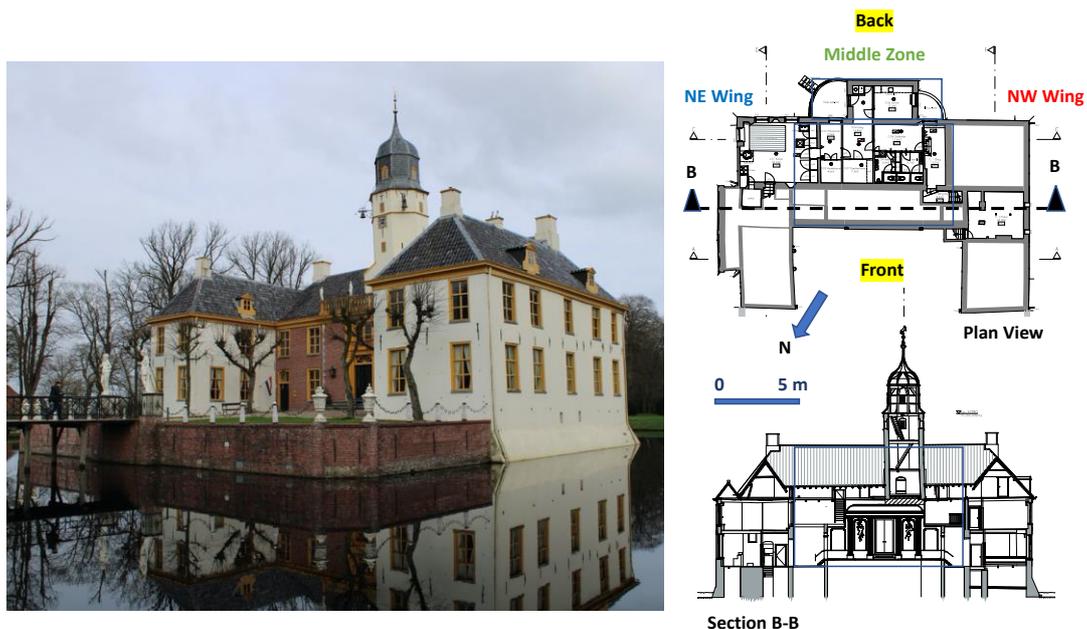
Figure 1. Photograph of Fraeylemaborg (looking from West towards East), plan view and section.

The timber elements of the floors are poorly connected to each other and thus a diaphragmatic action is not ensured. Numerous steel anchors exist at various locations of the structure (Figure 1) in order to connect the floors to the peripheral walls. The structural elements of the roof are timber beams transferring the loads to the peripheral walls.

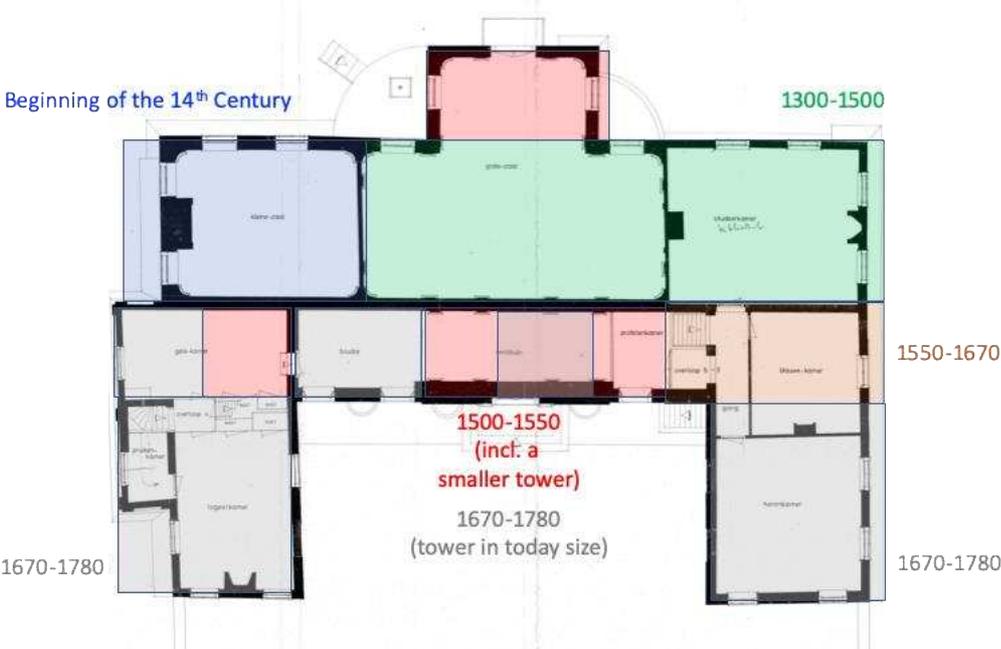
Figure 2. Construction phases of the building.

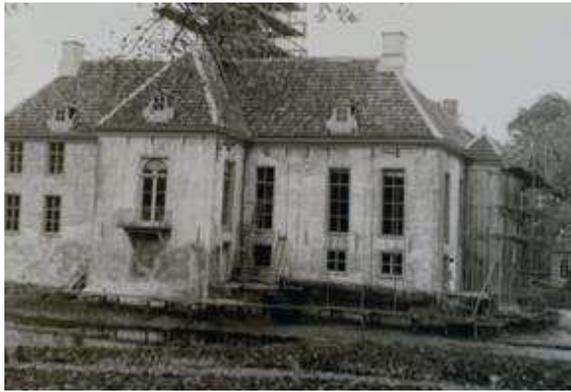
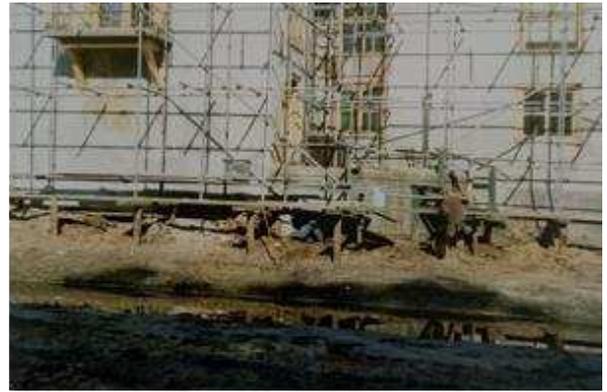
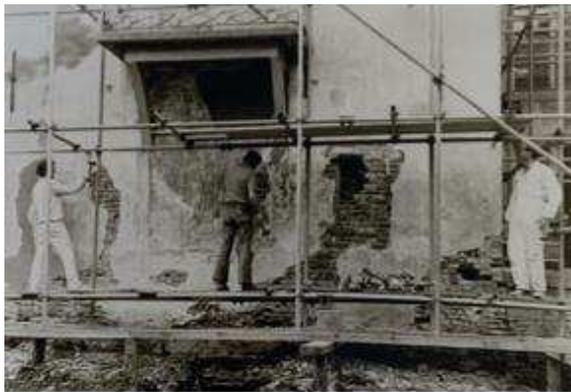
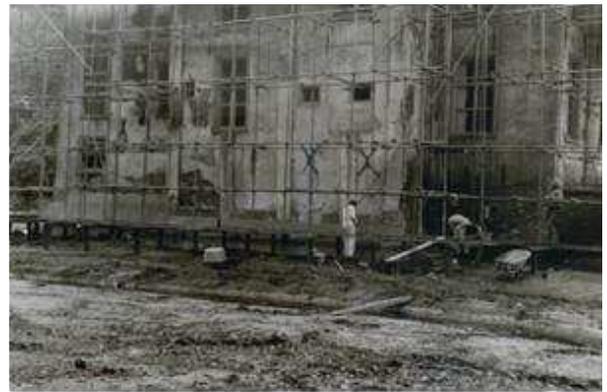
Figure 4. Photos from the restoration Works in 1973, a) a general view from the building under restoration, b) works at foundations along the perimeter, c) mason works on the brick walls, and d) works on the walls and the foundations.

The structure went through a serious renovation in 1973, including structural interventions in the retaining walls outside as well as in the floors and connection details inside the building. There is no written report from that period, but photographs of a personal archive have been used to identify the nature of the structural interventions. As shown in Figure 4, bricks from damaged masonry walls were removed and replaced, however the cause of these damages are unknown. The foundations at the perimeter of the building are also made of brick masonry. They were repaired by using new bricks. A reinforced concrete floor was added above the main entrance, right below the tower. Steel profiles were added at the base of the tower to stabilize it. Finally, all masonry retaining walls were repaired, missing parts were added, and new steel anchors were placed behind the walls.

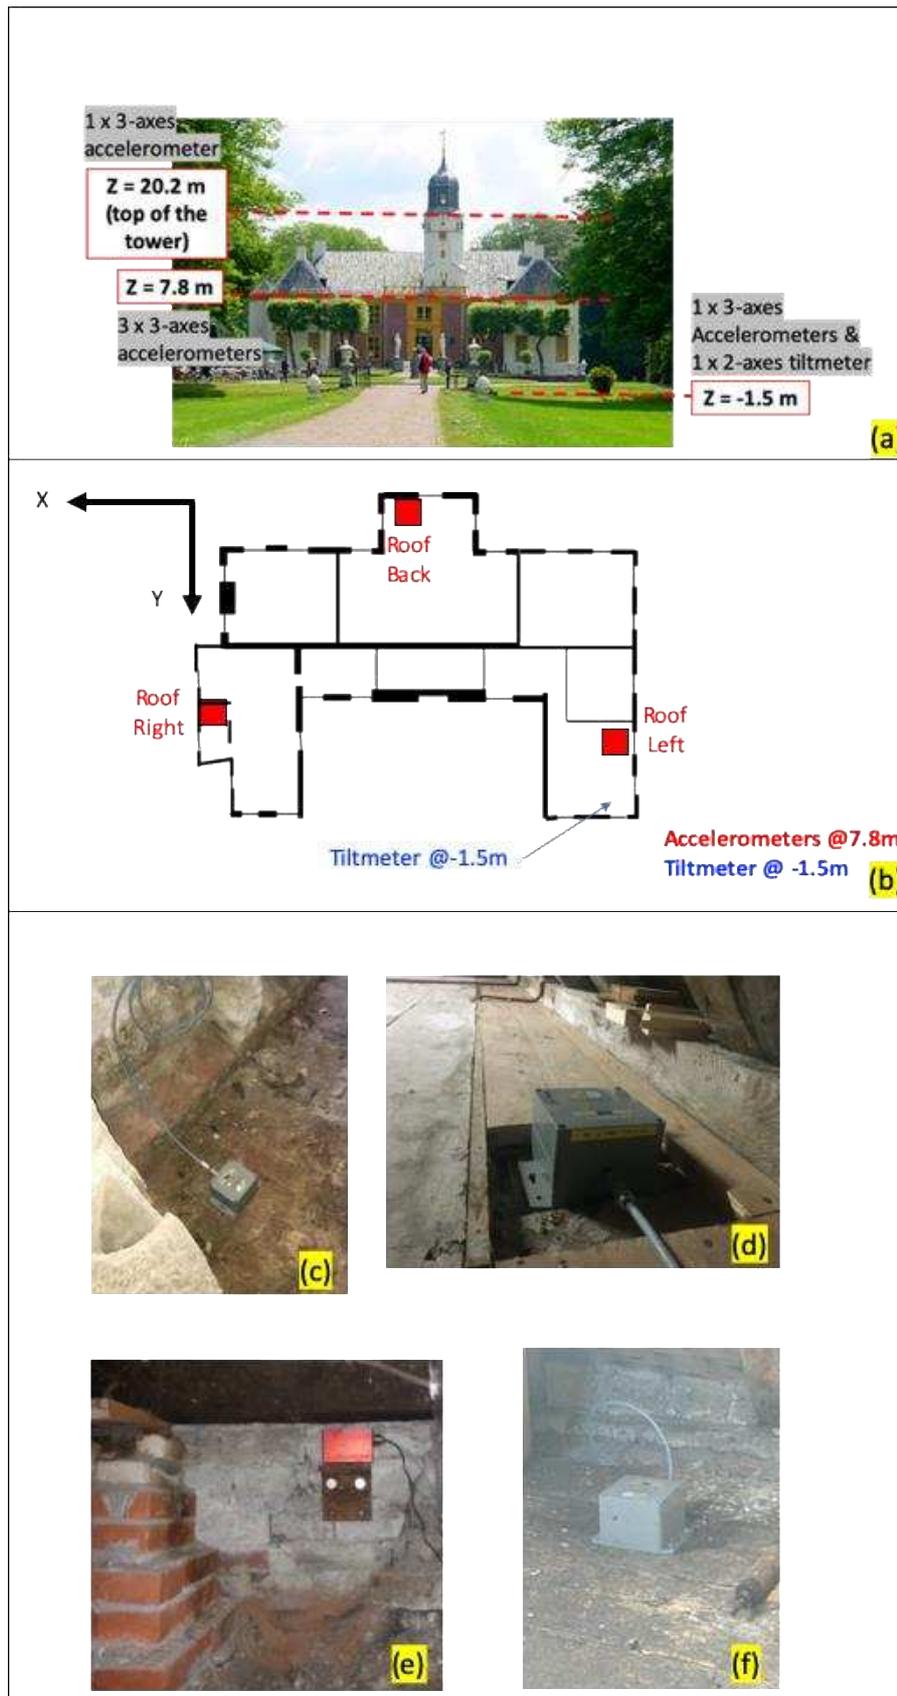
The distribution and mounting of accelerometers and the tiltmeter can be seen in Figure 6. The accelerometers used in the seismic SHM system are force-balance type with ultra-low noise levels of 130 ng/Hz^{0.5}. The bandwidth of the sensors is 0.1-120Hz, with a range of +/-2 g. More information can be found in the technical sheets of the producer (1). The analogue sensors are connected to a 16-channel digitizer. The data are collected into a computer on site and continuously mirrored in a network mapped hard-drive on a virtual machine. Some example data from a recent ML 3.2 earthquake in May 2019 (Bal and Smyrou 2019a) and the accelerometer and tiltmeter data from 2018 August (Bal and Smyrou 2019b) are digitally available.

Figure 6. a) elevation of the sensor locations, b) sign convention for the accelerometers and the tiltmeter sensor, c) accelerometer at the basement, d) accelerometer on top of the bearing walls at 7.8m elevation, e) tiltmeter at the basement, and f) accelerometer on the tower floor.
