This is a repository copy of *Characterisation of the surface topography, tomography and chemistry of fretting corrosion product found on retrieved polished femoral stems*.

Bryant, M orcid.org/0000-0003-4442-5169, Ward, M, Farrar, R et al. (4 more authors) (2014) Characterisation of the surface topography, tomography and chemistry of fretting corrosion product found on retrieved polished femoral stems. *Journal of the Mechanical Behavior of Biomedical Materials*, 32. pp. 321-334. ISSN 1751-6161

**CHARACTERISATION OF THE SURFACE TOPOGRAPHY, TOMOGRAPHY AND
CHEMISTRY OF FRETTING CORROSION PRODUCT FOUND ON RETRIEVED
POLISHED FEMORAL STEMS**

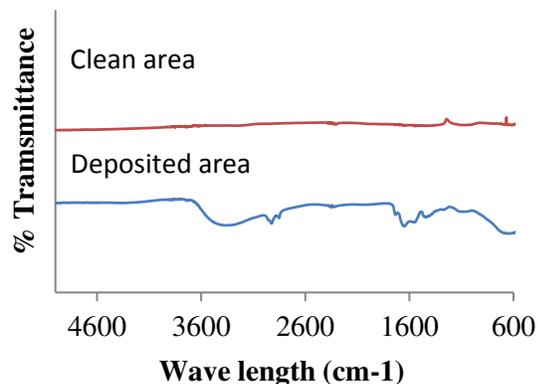
FT-IR was utilised in order to determine the chemical structure and bonds present on the surface of the retrieved samples. FT-IR analysis was again conducted on the deposited layer and clean areas of retrievals. Figure 14 demonstrates the FT-IR spectra obtained from the retrieved cohort. FT-IR demonstrated that no chemical bonds were present on the surface of the clean metallic area. FT-IR analysis on the deposited areas demonstrated characteristics of human serum albumin suggesting that no unfolding or denaturing of the proteins had occurred on the surface, although the film seemed to be mechanically mixed with Cr_2O_3 debris.

Figure 14- (a) FT-IR analysis of clean and deposited areas with (b) associated peak locations and structures seen on clean and deposited areas.
