# **Characterisation of white etching crack damage in wind turbine gearbox bearings**

**T. Bruce, E. Rounding, H. Long\*, R. S. Dwyer-Joyce**

**Leonardo Centre for Tribology, Department of Mechanical Engineering, The University of Sheffield, United Kingdom**

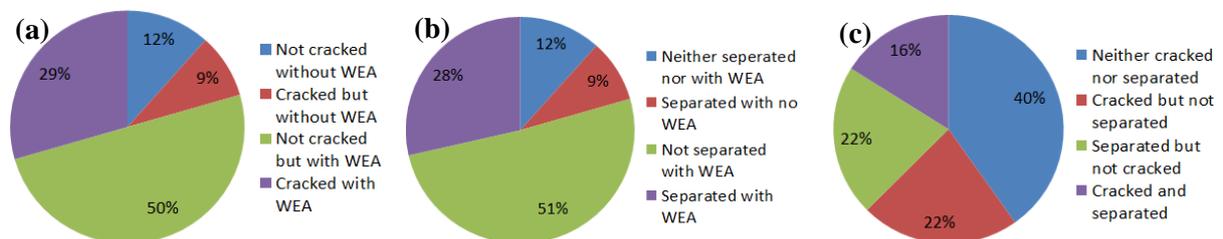
Figure 11 shows the relationship between three types or stages of damage at MnS inclusions; internal cracking, separation from the bulk material and WEAs linked to the inclusions. Figure 11a shows that 29% of damaged inclusions were both internally cracked and WEA initiating, while, 50% had initiated WEAs without being internally cracked. This result clearly demonstrates that an inclusion does not necessarily need to be internally cracked in order to initiate a WEA. Similar percentages in Figure 11b show that separation from the bulk material has a similar link to the probability of the inclusion interacting with a WEA, with 28% of separated inclusions being linked to WEAs, and 51% of non-separated being linked. This shows that an inclusion that does not separate from the steel matrix is more likely to initiate a WEA than one that does, perhaps because some stress is relieved by the separation. Figure 11c appears to show no strong prevalence of damage occurring at inclusions that are internally cracked or that are separated from the bulk material, or those that are both cracked and separated.

Figure 11: Relationship between damage types (a) internal cracking and WEA formation (b) separation from bulk material and WEA formation (c) internal cracking and separation from bulk material

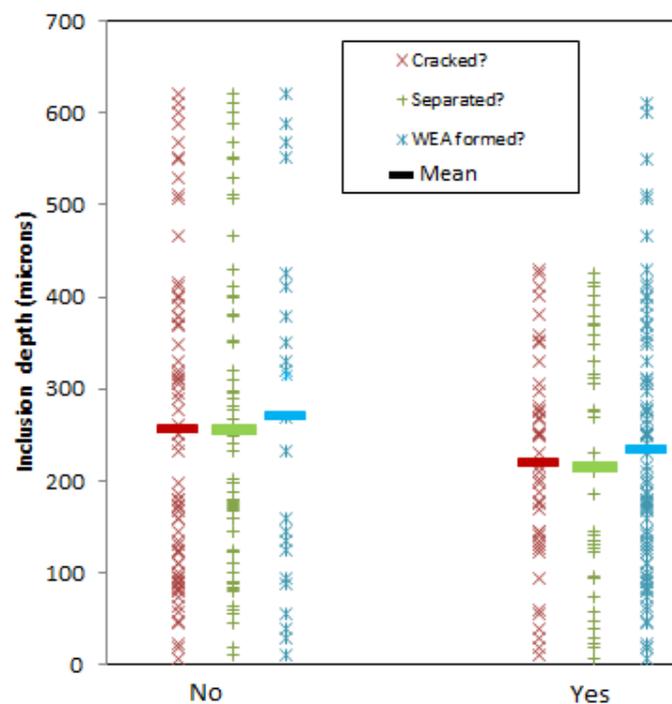
No trends were found when comparing the angle and the size of inclusions with their depth from the raceway surface, thus it is clear that inclusion distribution is random in the sample bearings and that the effects of over-rolling have little influence on the size and orientation of the inclusions. In addition, WEAs were found on many of the deepest damaged inclusions, to a depth of approximately 600 microns from the raceway surface. It was interesting, however, that no internally cracked or separated inclusions were found deeper than 430 microns. In fact the average depths for inclusions that were internally cracked and for those that had separated from the surrounded bulk material were just 3 microns different (219.5 microns and 216.2 microns respectively). This suggests that inclusion cracking and inclusion separation may be affected by similar initiation mechanisms. These results are outlined in Figure 12.

Figure 12: Variation of inclusion damage with depth

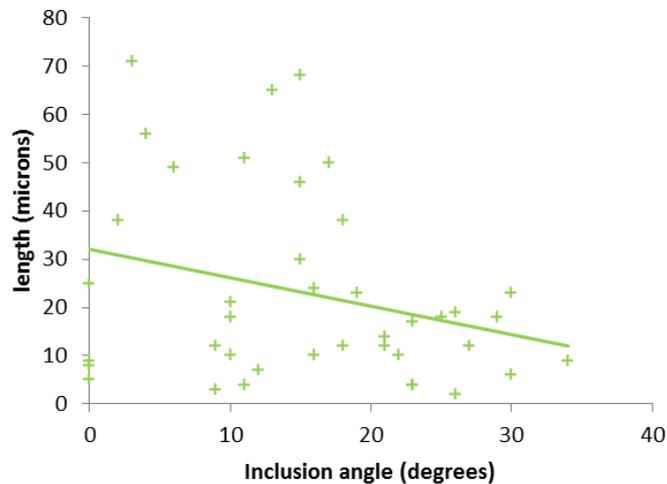
No trends were found when properties were compared to inclusion orientation in the circumferential sectioned samples. However Figure 13 shows that the length of cracks propagating in the axial direction was generally greater in “flatter” axially sectioned inclusions. That is to say that it appears that the closer the inclusion’s major axis is to being parallel with the bearing raceway surface, the longer the initiated propagated crack is likely to be. This finding suggests that an inclusion is more likely to act as a damage initiator in the axial direction if it is closer to being parallel with the bearing

raceway surface. Figure 13, shows the magnitude of the angle of the inclusion from parallel, that is, the direction of the angle from parallel is not considered.

Figure 13: Relationship between inclusion angle magnitude from horizontal and propagated crack length

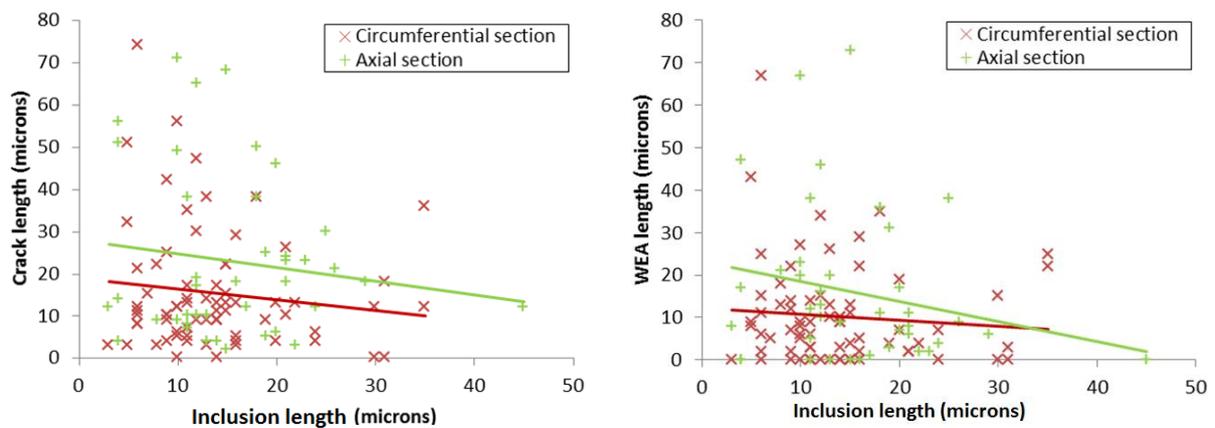
Damage was present on inclusions of all sizes between 3- 45 microns, but trends were found, between the lengths of cracks propagating into the bulk material, connected to inclusions and that of the inclusion interacting WEAs. As shown in Figure 14a, crack length tended to be longer at smaller inclusions for both axially and circumferentially sectioned samples. This is not unexpected as coarser inclusion sizes, in general, have a larger local stress-concentration factor [28]. Similarly, Figure 14b shows that interacting WEAs were generally longer at smaller inclusions for both sample types. The results also show that cracks and WEAs tended to be longer in axially sectioned inclusions than circumferentially, that is, that both forms of damage were more pronounced in the inclusions that were sectioned along their major axis. There was no trend found between inclusion length and the likelihood of internal cracking.

Figure 14: Variation of inclusion damage with inclusion width (a) initiated crack length (b) attached WEA length
