Zeng, P, Rainforth, WM and Stewart, TD (2017) Characterisation of the wear mechanisms in retrieved alumina-on-alumina total hip replacements. *Wear*, 376–37 (Part A). pp. 212-222. ISSN 0043-1648

# Characterisation of the wear mechanisms in retrieved alumina-on-alumina total hip replacements

P Zeng<sup>1</sup>, W M Rainforth<sup>1</sup> and T D Stewart<sup>2</sup> 1. Department of Materials Science and Engineering, University of Sheffield, Sheffield S1 3JD, UK 2. School of Mechanical Engineering, University of Leeds, Leeds LS2 9JT, UK

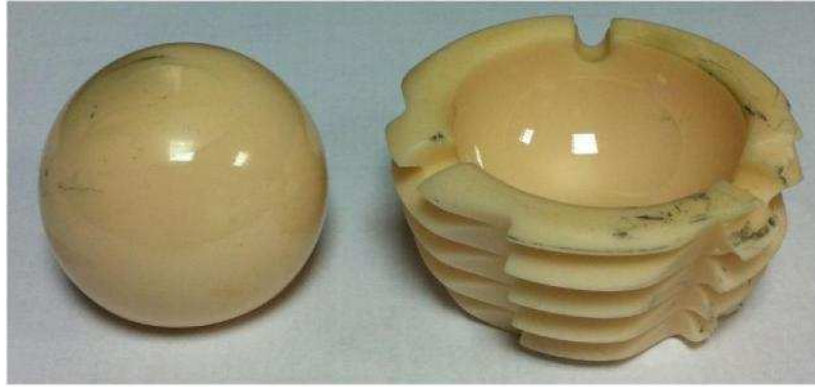
7 pairs of retrieved alumina-on-alumina THRs were investigated and the details of each pair are given in Table 1. An example of the retrieved in vivo alumina femoral head and acetabular cup are shown in Fig.1. The alumina ceramics used for operations were Biolox<sup>®</sup> alumina ceramic material with a mean grain size of 3.2  $\mu\text{m}$  and a density of 3.95  $\text{g}/\text{cm}^3$ .

**Fig.1 A pair of retrieved in vivo alumina femoral head and acetabular cup.**
