Assessment and Retrofitting of an Existing Steel Structure subjected to Wind-Induced Failure Analysis

C. Maraveas^{1,2*} and K.D. Tsavdaridis³

¹C. MARAVEAS & ASSOCIATES P.C. - Consulting Engineers, Greece

The "Dimitrios Vikelas" athletic centre in Ermoupolis of Syros (Greece) is selected and it consists of two buildings. Building B has a steel superstructure that was constructed approximately 35 years ago. It was initially used as a boat shelter and no design calculations were available, possibly constructed as a pre-engineered structure. It contains steel columns with varying cross-section heights. The spans are bridged via trusses and I-beams. Significant geometrical inconsistencies are noted among the existing steel connections and failures have been resulted due to buckling in several beams and bracings during the service life of the athletic centre. The current study presents an investigation performed in order to diagnose structural problems and propose strengthening and intervention measures.

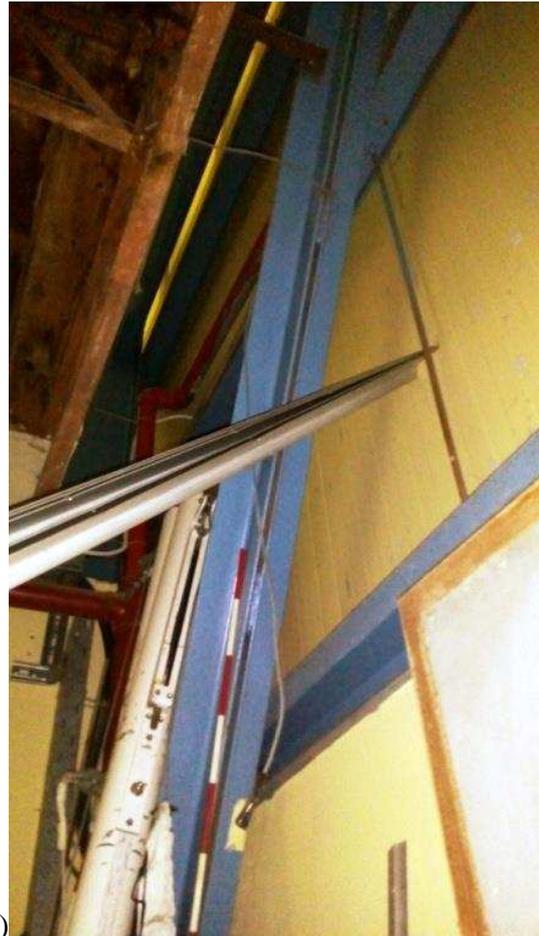
a) Extended buckling deformation of the corroded Λ -type vertical bracings to the south (Fig. 4a) as well as of the connecting beams between the IPE360 columns at +8.70 m (Fig. 5).

a) b)
Fig. 4. Vertical Λ -type bracing on the southern section of the building: a) the corroded portion with major second-order deformation and b) the undamaged portion.

An interesting clue appears to significantly affect the structural response with regard to excessive second-order deformation of the south-west lower bracing [member no. 10114 presented in Fig. 4(a)]. The stiffness and vertical load capacity of the damaged member are obtained from FE buckling analyses using Abaqus [20]. The results are presented in section 2.3.2.

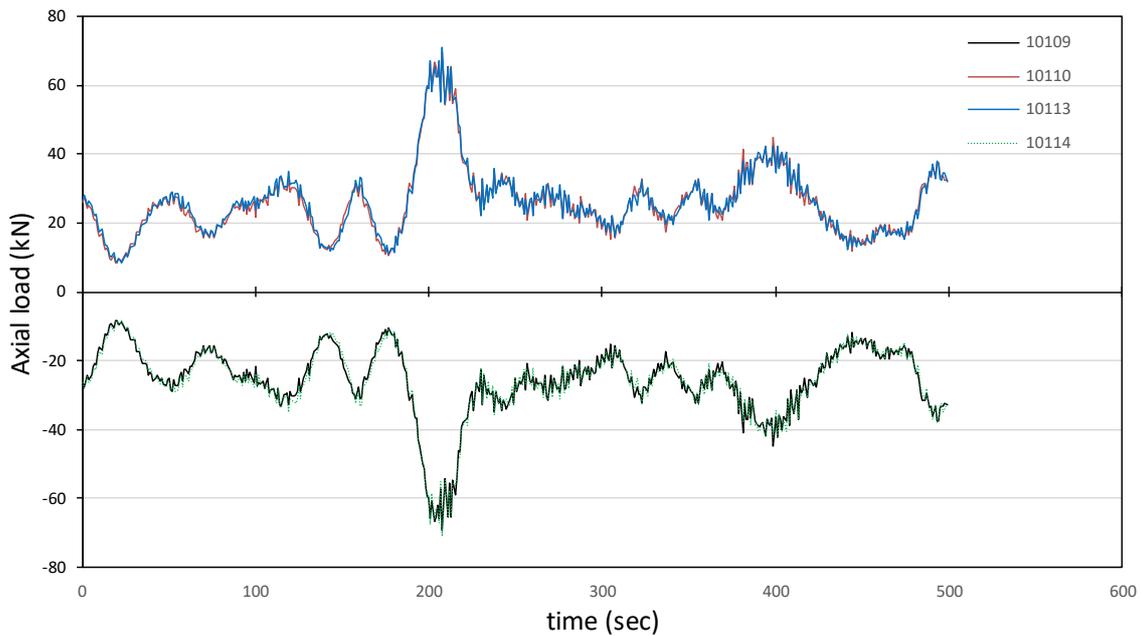
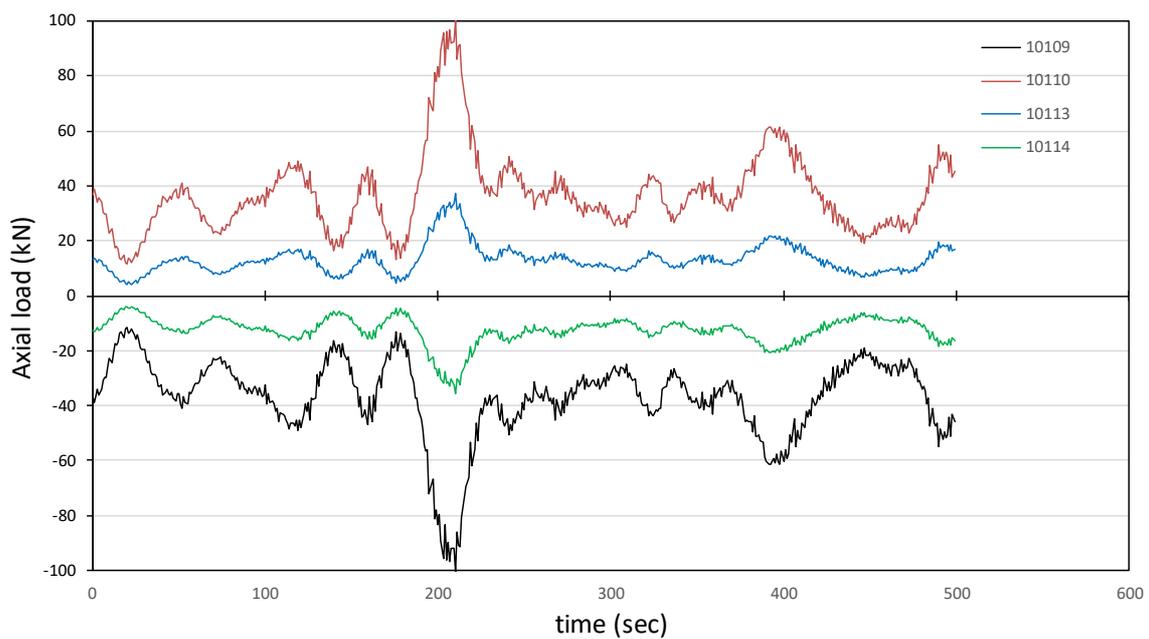
The results of the time-history dynamic analyses for the selected beam elements in terms of axial force are presented in Figs. 12(b) and 12(c). Figure 12(a) shows the axial forces developed on element 10114 (failed element) during the time history analyses performed for the 10 different wind spectras. The two figures (12(b) and 12(c)) respectively address conditions that exclude and include geometrical imperfection from the buckled L-section. The latter case can be referred to as the "imperfect" one. A thickness reduction of 1.0 mm due to corrosion is also included in this case. One can clearly observe relief of the damaged and tensile (member no. 10113) members. In contrast, the east pair of bracings displays additional axial force, which reveals a more unfavourable design status (member nos. 10109, 10110). The axial forces are differentiated by approximately $\pm 45\%$.

Fig. 12. Axial load histories for Λ -type vertical bracings with a) axial force developed on element 10114 for 10 different wind spectras and b) perfect structure axial loads of bracing elements 10109, 10110, 10113 and 10114 for the most unfavourable time history and c) imperfect structure axial loads of bracing elements 10109, 10110, 10113 and 10114 for the most unfavourable time history.

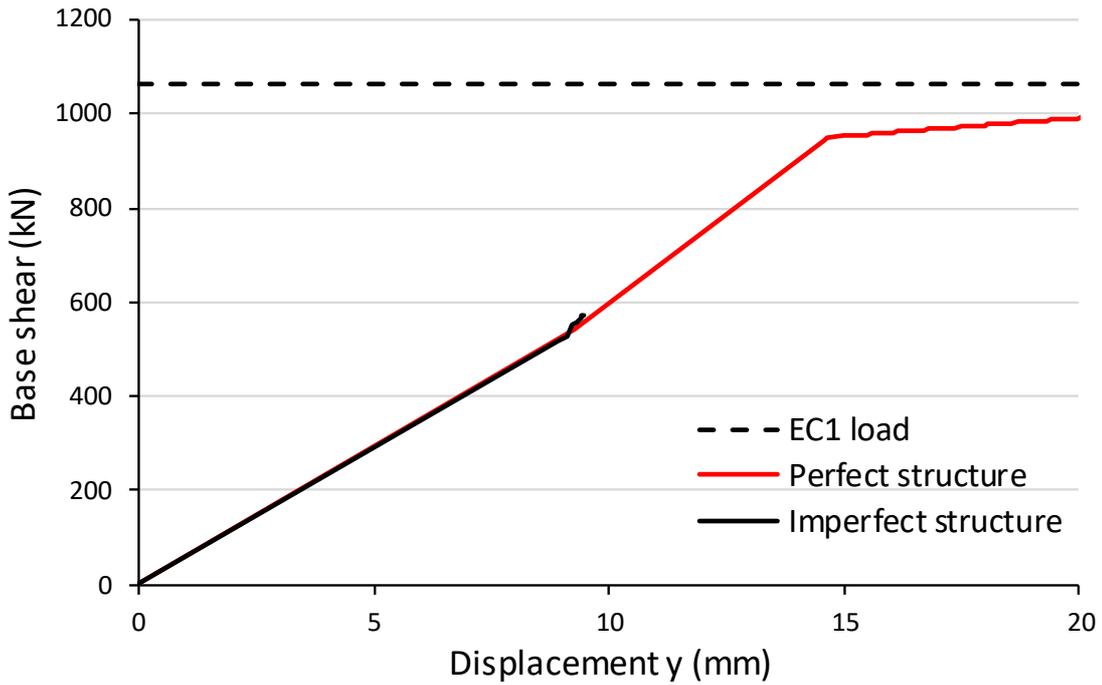
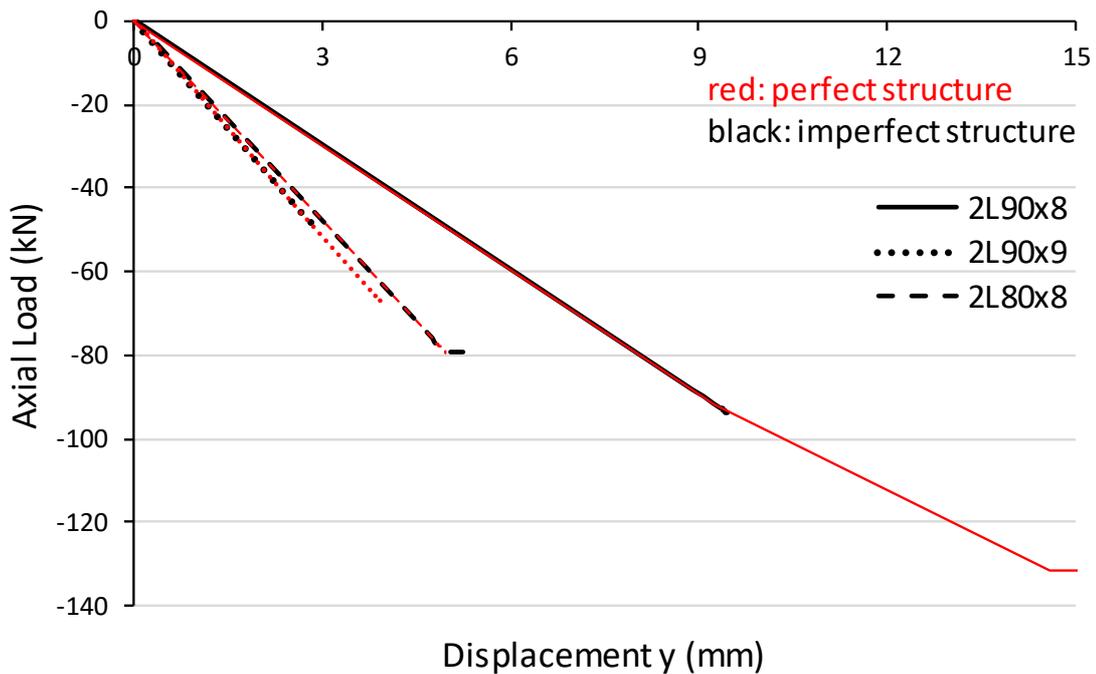
The vertical load capacity curves are shown in Fig. 15(a) capture the total response of the structure, while the dashed line defines the minimum requirement that the structure should have met. After considering imperfections, i.e., excessive deformation of the damaged bracing, the bearing capacity is only 58% of the perfect sample. Nevertheless, the latter vertical load capacity does not satisfy the Eurocode requirement in terms of the total base shear force. Furthermore, the axial load-displacement curves of the major vertical bracings are compared in Fig. 15(b), while the selected imperfection is neglected during pushover analysis. The double equal angle cross-sections L90x8, L80x8, and L90x9 correspond to the existing bracings of the north, south, and Section 1-1 views, respectively.

Fig. 15. Comparison of the a) vertical load capacity curves and b) axial load-displacement paths of vertical bracings within perfect and imperfect structures.

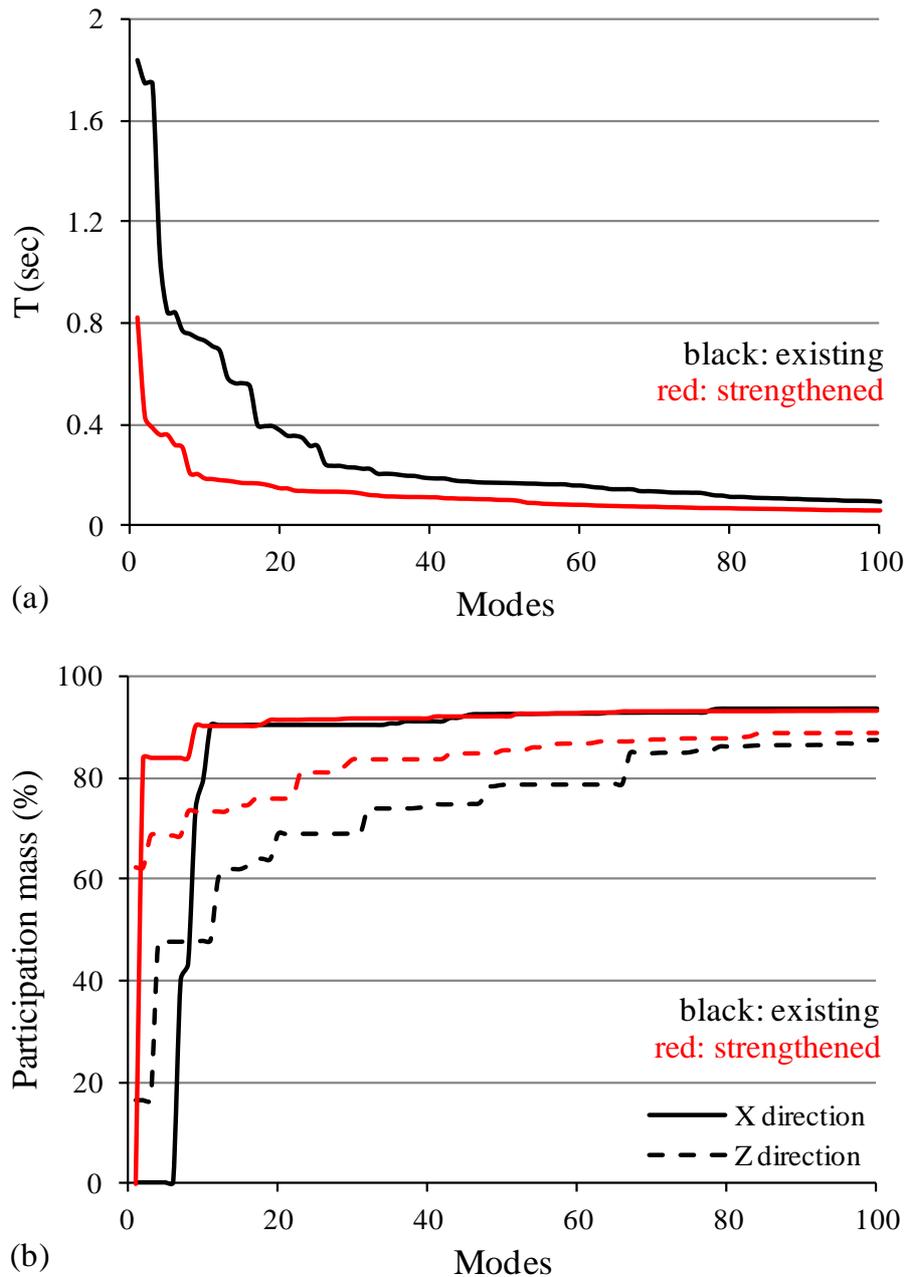
Fig. 19. Comparison of the dynamic characteristics of the existing (black) and strengthened (red) structure (solid and dashed lines for the X- and Z-directions respectively).

Modal analyses [23] have been performed to compare the existing and strengthened structures. The results are shown in Fig. 19 demonstrate clear improvement to the dynamic characteristics of the structure. In particular, mass participation is increased to 62% and 84% in the long and transverse directions (along Z- and X-axis, respectively), compared to 31% in the unstiffened structure. The corresponding periods decrease from 1.07 s to 0.82 s and from 0.74 s to 0.43 s along Z- and X- directions, respectively, after the proposed retrofit. The aforementioned mode shapes for the long and transverse directions are compared in Figs.

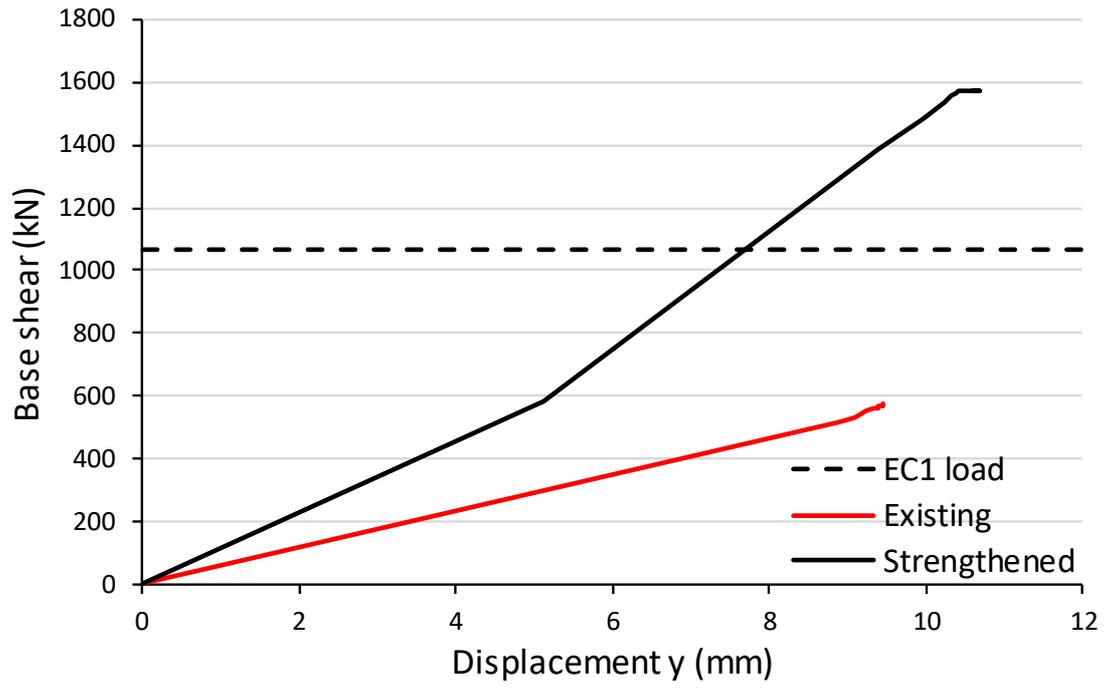
For the sake of completeness, the vertical load capacity curve of the proposed modified structure was established and compared to that of the existing structure. The procedure presented in Section 2.3.1, is repeated in Sofistik using the enhanced properties of the new and strengthened members. Fig. 21 depicts the new curve that indicates a total base shear force enlargement from 571 kN to 1571 kN.

Fig. 21. Comparison of the vertical load capacity curves of the existing and strengthened structures.

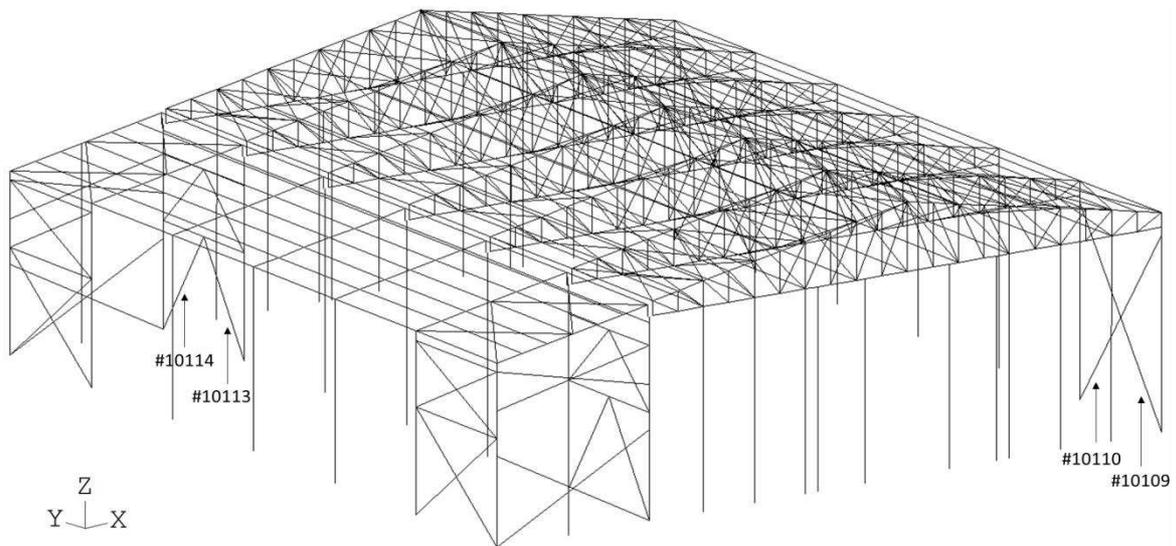
Furthermore, Fig. 22 shows the axial force histories of bracing elements for the 10 different wind histories. In order to ensure that the analysis parameters are providing safe results, a sensitivity analysis for the coherence factor was performed and showed that the used coherence factor was appropriate (Fig. 23).

Fig. 22. (a) Strengthened structure numerical model with a number of bracing elements analysed, (b) axial force history of element 10109 for 10 wind time history analyses, (c) same for element 10110 (d) same for element 10114 and (e) for element 10113.
