Sharma, AK, Kumar, A and Sarhosis, V (2021) Evaluating the Seismic Performance of Domestic and Historical Masonry Structures in Himachal Pradesh Region of India. In: Kolathayar, S and Chian, SC, (eds.) Lecture Notes in Civil Engineering. Virtual Conference on Disaster Risk Reduction (VCDRR 2021), 15-20 Mar 2021, Online. Springer, pp. 477-490. ISBN: 978-981-16-4616-4. ISSN: 2366-2557. EISSN: 2366-2565.

Forensic investigations on earthquake damaged domestic and historical masonry structures in Himachal Pradesh region of India

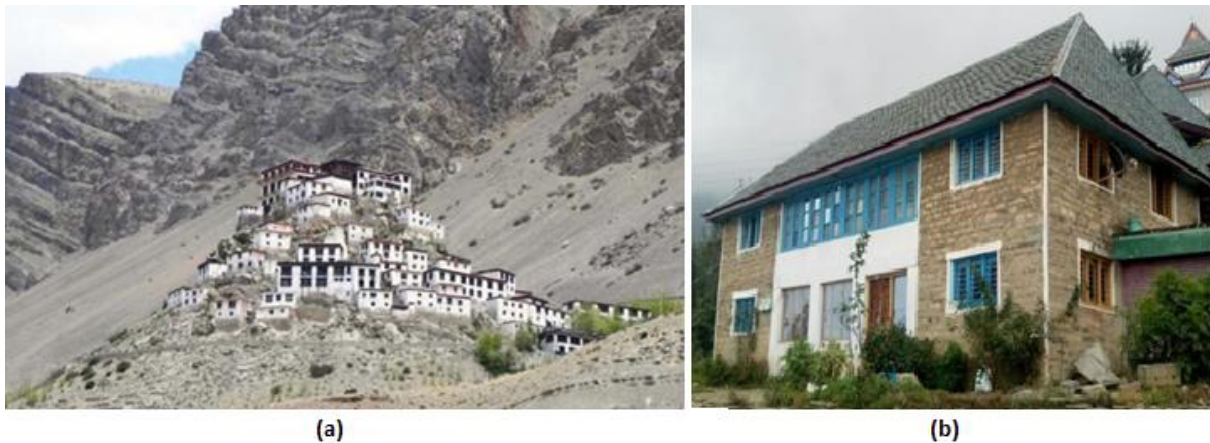
Fig 1: **a** Kii monastery in village Kii in Lahaul and Spiti district of Himachal Pradesh (Sood et al. 2012), **b** typical stone masonry house with sloping roof in Himachal Pradesh
