Observations from the March 2021 Thessaly Earthquakes: an earthquake engineering perspective for masonry structures

Abstract

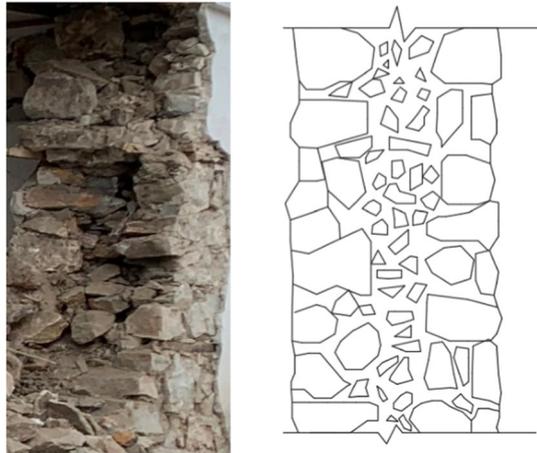
Lack of maintenance contributed in many cases to increase in the seismic vulnerability of the existing masonry buildings in the region. Other reasons for the development of such out-of-plane failures are the absence of horizontal binding elements and inadequate connections at wall intersections, see Fig. 14. These uncoursed walls have two exterior vertical layers (called wythes) of large stones, filled in between with loose stone rubble and mud mortar. Although someone could consider such stone masonry buildings robust due to their large wall thickness, in effect this is not the case. Such buildings are one of the most deficient building systems from an earthquake-resistance point of view. The excessive wall thickness and the absence of connection between the two wythes of the wall, as well as the use of round stones instead of regular shaped ones

Fig. 14 Typical uncoursed random rubble stone masonry walls found in buildings in Thessaly region **a** view of the inner part of the thick wall; **b** cross-section of the wall (average thickness of walls is 0.5 m)

could split the wall into two vertical layers. Often outward bulging of the vertical wall layer was encountered.
