# Analysis of Early-Retrieved Dual-Mobility Polyethylene Liners for Total Hip Replacement

Mackenzie Smeeton <sup>1,\*</sup>

**Abstract:** Despite their emerging use, the in vivo behaviour of dual-mobility (DM) total hip replacements (THR) is not well understood. Therefore, the purpose of this study was to assess the articulating surfaces of 20 early-retrieved DM polyethylene liners (mean length of implantation  $20.0 \pm 18.8$  months) for damage to improve the current understanding of their in vivo functional mechanisms. The internal and external surfaces of each liner were visually and geometrically assessed, and the material composition of embedded debris particles were further characterized. Scratching and pitting were the most common modes of damage identified on either surface, and a high incidence of burnishing (50%) and embedded debris (65%) were observed on the internal and external surfaces, respectively. Embedded debris particles were commonly titanium- or iron-based, although other materials such as cobalt-chrome and tantalum were also identified. The geometric assessment demonstrated highly variable damage patterns across the liners, with the internal surfaces common

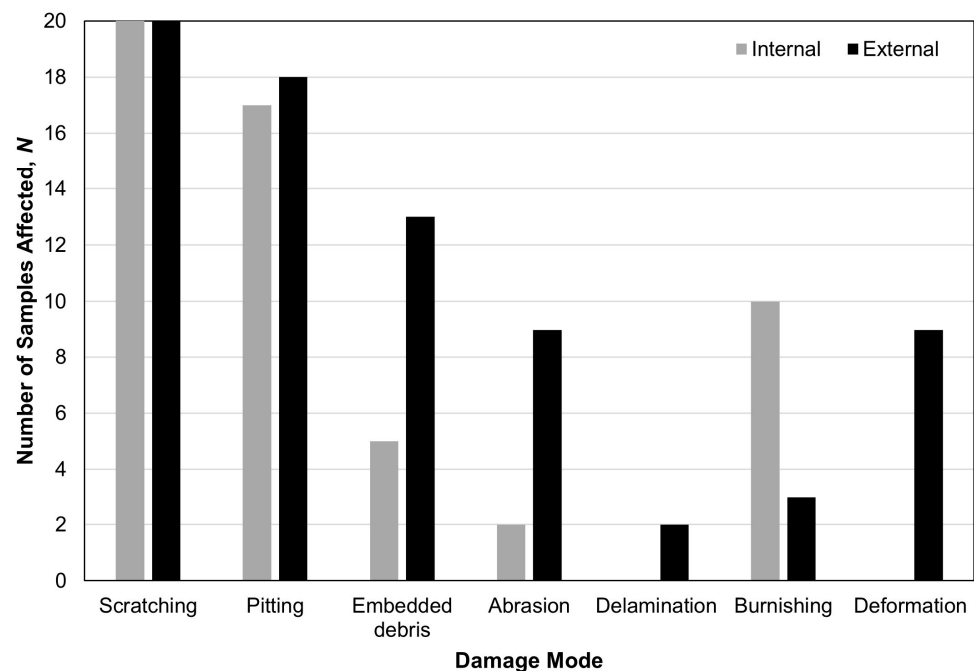
The frequency of each damage mode identified amongst the collection of retrieved liners is summarized in Figure 1, and examples of these are shown in Figure 2. With regard to the internal surface of the polyethylene liner, the most frequently observed modes of damage were scratching (100%), pitting (85%), and burnishing (50%). Additionally, embedded debris was identified on the internal surfaces of five liners (25%), and abrasion was observed on two liners (10%). There were no signs of delamination or deformation on the internal surfaces of any samples assessed in this study.

For the external surfaces, the most frequently observed modes of damage included scratching (100%), pitting (90%), and embedded debris (65%). Abrasion and delamination were identified on 45% of the samples, whilst burnishing (15%) and delamination (10%) were less common.

Residual machining marks were observed on the internal and external surfaces of 14 (70%) and 19 (95%) liners, respectively.

**Figure 1.** Frequency of damage modes observed on the internal and external surfaces of retrieved dual-mobility liners. Data reported as number of samples,  $N$ .
