Cuthill, F., Lopez Dubon, S., Vogel, C. et al. (3 more authors) (2025) Destructive testing and failure analysis of a full-scale composite tidal turbine blade. *International Marine Energy Journal*, 8 (3). pp. 279-285. ISSN: 2631-5548

# Destructive testing and failure analysis of a full-scale composite tidal turbine blade

Fergus Cuthill, Sergio Lopez Dubon, Christopher Vogel, Miguel Valdivia Camacho, Conchúr Ó Brádaigh and Eddie McCarthy

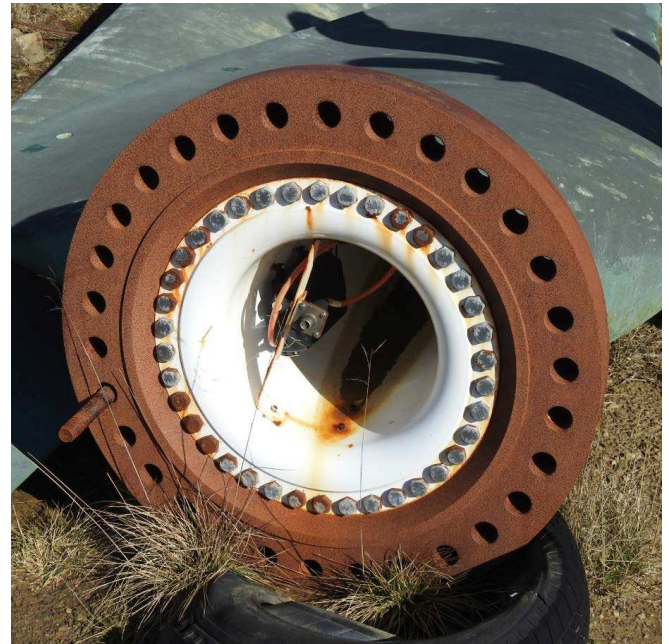
Following the successful deployment at EMEC, the turbine was later upgraded to 1 MW in January 2013 [11], this resulted in the blades from the 500 kW version lying in storage in Orkney as seen in Fig 2. The blades were stored uncovered, outdoors, for 8 years before being delivered to FastBlade in 2021 for testing. In

Fig. 2. 500 kW TGL Turbine blade stored outdoors in Orkney.

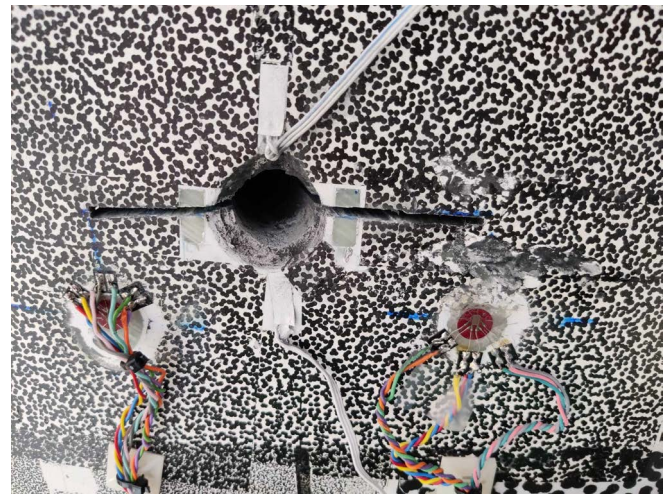
Fig. 5. Installation of Strain gauges around hole and notches in the blade.

When the strain level around the hole was noted to be 0.156 % and no failure around the hole was observed, notches were cut into the blade using the hole as the centre point with 100 mm notches extending towards the leading and trailing edges of the blade at 90° to the longitudinal axis of the blade. Strain gauge rosettes were applied approximately 50 mm from the tip of the notch; the gauge setup can be seen in Fig 5. This was to enable DIC speckle to be applied all around the tip of the notch, so that a full strain field could be determined, rather than just localised strain measurements from the gauges.

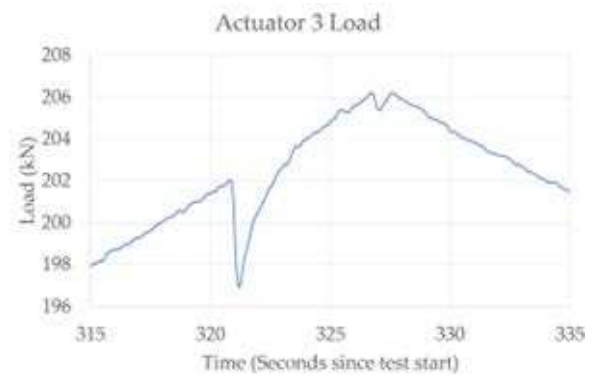
described in the timeline of blade testing above, the first detectable failure occurred at the root of the blade. The failure initially appeared as a debond between the glass fibre skin of the blade and the steel root connection, as shown in Fig 7. The failure occurred during a static test, targeting an actuator load of 220 kN at a loading rate of 1.467 kN/s; during the ramping, failure in the root occurred at 200.3 kN, with an average load drop of 5 kN on each of the 3 actuators. Nevertheless, the test was continued, as the load appeared to recover and stabilise after the initial failure; however, after a further failure at 206.2 kN, it was decided to stop the test for inspections. A graph showing the initial load drop for a single actuator can be seen in Fig 6. After the inspections identified the delamination root failure, the test was repeated, and the load of 220 kN was achieved and held for 150 seconds with no further failures detected. After this test, the decision was made to attempt to initiate a crack failure in the blade, as the first failure mode had been identified, and it was believed that pushing further would have resulted in further failures at the root with little extra information gathered about other areas of the blade.

Fig. 7. Graph showing 5 kN load drop during root failure, followed by further cracking and subsequent test halt.

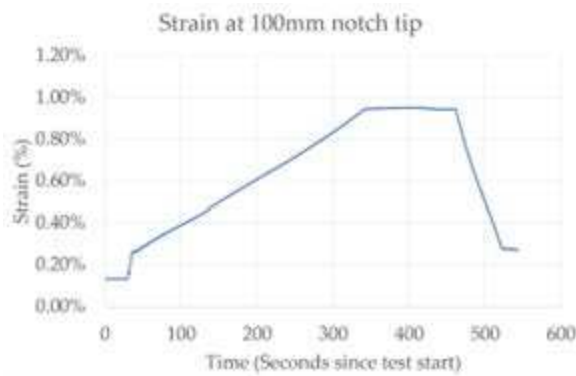
After the series of static tests and small fatigue tests, no failure or crack propagation from the edge of the 100 mm notches was detectable with imaging or DIC results. Although the strain level measured at one of the notches in the  $0^\circ$  direction (longitudinally down the blade) was measured to be 0.95 %, the other notch showed a strain of 0.5 %; thus, the decision was made to extend the notches to further accelerate failure. A graph showing the strain rise throughout a static test reaching a peak strain of 0.95 % can be seen in Fig 8.

Fig. 8. Strain at notch closest to blade trailing edge in the 0° (longitudinal) direction reaching a peak of 0.95 % strain.

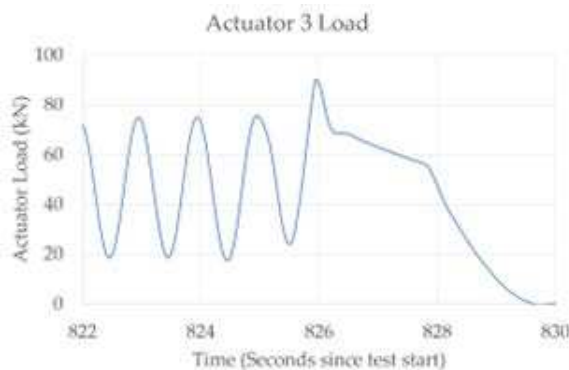
The final failure of the blade occurred during fatigue testing, where the aim was to further progress the cracks that had been detected at the notch tips. The bonded seam between the top and bottom skins of the blade, along the leading edge, suffered catastrophic debonding, with approximately 1 m of seam bursting open in less than 0.1 seconds. This seam then continued to open until the clamping force of the loading saddle restricted its further propagation along the leading edge. The seam burst on the cycle before the test was stopped, meaning the reduction in stiffness of the blade

Fig. 9. Graph showing load during blade seam failure, failure happened before peak load is reached causing control system to ramp up to compensate for failure, resulting in the measured peak load of 90.26 kN.

resulted in the control system increasing the oil flow required to deliver the additional displacement of the actuators. This resulted in an overshoot of the target load as seen in Fig. 9, with the test system reaching a limit state and shutting down. The seam failure near the leading edge of the blade is shown in Fig 10.
