Boyle, H. orcid.org/0000-0002-4935-6863, Norgren, S. orcid.org/0000-0003-1471-8307, Crawforth, P. orcid.org/0000-0002-1235-8494 et al. (3 more authors) (2023) Insights in  $\alpha$ -Al2O3 degradation in multilayer CVD coated carbide tools when turning IN718. In: Hanke, S., (ed.) Wear. 24th International Conference on Wear of Materials, 16-20 Apr 2023, Banff, Canada. Elsevier BV. Article no: 204786. ISSN: 0043-1648. EISSN: 1873-2577.

# Insights in $\alpha$ -Al2O3 degradation in multilayer CVD coated carbide tools when turning IN718

Henry Boyle <sup>a,\*</sup>, Susanne Norgren <sup>b,c</sup>, Pete Crawforth <sup>d</sup>, Katerina Christofidou <sup>a</sup>, Denis Boing <sup>b</sup>, Martin Jackson <sup>a</sup>

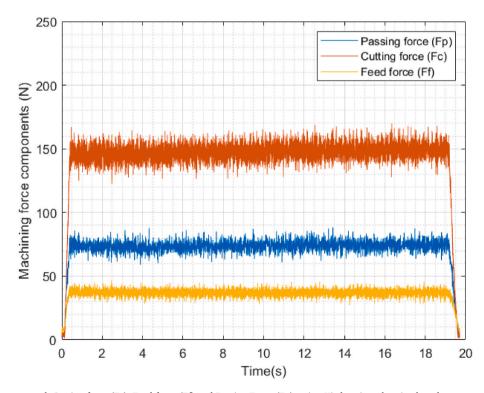
Fig. 2. Machining forces measured: Cutting force (Fc), Feed force (Ff) and Passing Force (Fp), using Kistler piezoelectric plate dynamometer during 32 m machined length test.

An example of the machining forces measured during the experiment is shown in Fig. 2. In all experiments performed the cutting force (Fc) was found to be the largest of all force components, followed by the passing force (Fp) and the feed force (Ff). The smooth gradient during the initial engagement indicates a stable entrance of the tool with no unexpected failure or abrupt wear, similarly there are no large variations during the cut either. The wear observed during the trials is shown after 2 m, 32 m and 128 m turned length in Fig. 3. After 2 m turned length, the workpiece material is adhered to the tool (Fig. 3a). By 32 m, the region covered by adhered material has increased significantly in thickness, a DOC notch and chip adhesion can also be observed (Fig. 3b). After 128 m (Fig. 3c) turned length, the thickness of the adhered material on the cutting edge has increased further. In addition, the DOC notch has continued to expand and a small trailing edge notch has started to develop (Fig. 3c).
