Forensic investigation of failure in a full-scale composite tidal turbine blade

Miguel A. Valdivia-Camacho ^a, Fergus Cuthill ^a, Edward D. McCarthy ^a, Sergio Lopez Dubon ^a, Conchúr M. Ó Brádaigh ^b, Parvez Alam ^a,* ^{ID}

Tidal turbine blades endure uniquely harsh, shear-dominated loads that distinguish them from wind turbines, yet their failure mechanisms remain poorly understood. In this study, we report the first full-scale failure investigation of a tidal blade made of glass fibre reinforced polymer (GFRP), carbon fibre reinforced polymer (CFRP) and cast iron. The blade was subjected to 26 static tests and 17 fatigue tests using a bespoke laboratory setup with three hydraulic actuators and saddle fixtures. Strain gauges, displacement transducers, and digital image correlation (DIC) were coupled to track local deformation and damage. Artificial defects accelerated damage progression, yielding roughly 97,000 fatigue cycles before ultimate failure. Two dominant failure modes emerged: de-bonding between the pressure skin and root connection under quasi-static loading at 216% of design load, and bondline failure between pressure and suction skins under fatigue at 119% of design

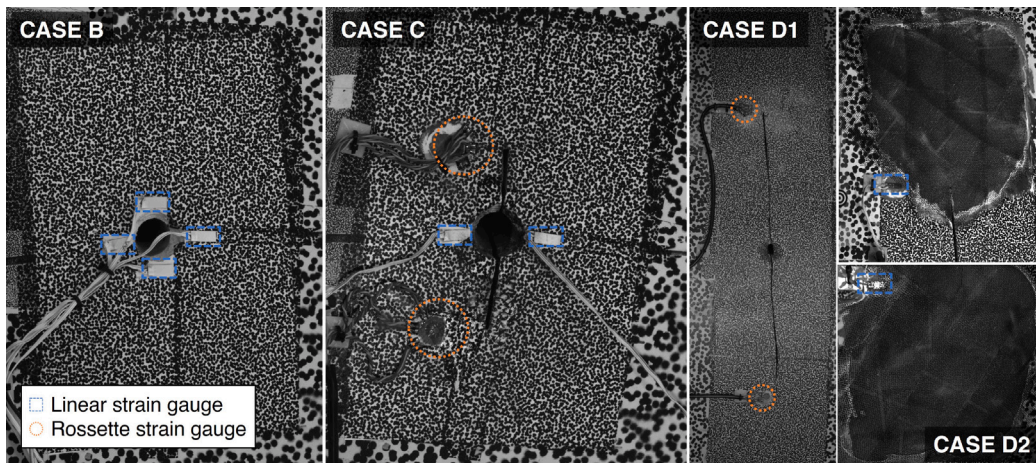
Test case	Static tests	Fatigue tests	Description
A	2	1	Reference test, no induced damage to the blade.
B	3	4	22 mm hole drilled at 1200 mm from the root, on the neutral z-axis.
C	16	6	Similar to Case B, with 50 mm notches at each side of the hole.
D1	2	3	Similar to Case B, with 300 mm notches at each side of the hole.
D2	3	1	Similar to Case D1, with different speckle pattern for DIC.

Fig. 5. Test conditions surrounding the initial hole on the surface of the blade. Case D2 shows only the crack tips.

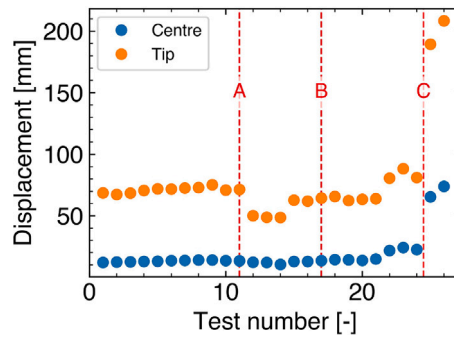
To compare displacement behaviour under consistent conditions, Fig. 10 shows the displacement at the centre and tip of the blade at a total load of 120 kN (or 40 kN per actuator), as not all static tests were conducted at identical load targets. For the first nine static tests, the introduction of a 22 mm hole (test case B) had negligible effect on the blade's global structural response. Although the hole was not intended to simulate impact damage, these results suggest the blade could remain functional with such a defect, underpinning the challenges of underwater maintenance [4].

Additionally, three critical events are identified in Fig. 10. The first, labelled "A", occurred during static test number 11. A target load of 600 kN was applied via a ramp lasting 20 min, followed by an intended hold phase for 2 min. However, failure occurred in the saddles due to high shear stresses. Further analysis and the adoption of a stiffer plywood saddle material are detailed in [41]. Additionally, the actuators were repositioned to align perpendicularly to the blade's final orientation rather than its initial configuration, in order to minimise second-order moments and reduce saddle slipping. These improvements align with Glennon's concerns about the adaptability of test rigs when loading blades beyond their design limits [35].

Subsequent damage was observed during failure event "B", the first to affect the blade itself. In this case, failure occurred at 617.65 kN after 327.4 s of ramp loading, despite a planned target of 660 kN. The failure was localised near the root section, as shown in Fig. 11b. This failure mode can be described as a root-skin interface debonding, confirming concerns on this adhesive joint raised in Zuo's and Hosseini-Toudeshky's studies on wind turbine blades [10,22].

Finally, failure event "C" marked the ultimate failure of the blade, after which the design load could no longer be sustained. This event occurred between static tests 24 and 25, during a fatigue test conducted slightly above the design fatigue load, with a mean actuator load of 47.5 kN and an amplitude of 27.5 kN. Fig. 11c highlights the final failure feature: pressure-suction skin interface debonding adjacent to the leading edge. Although prior studies have not reported this mode, Bir identified the leading edge as particularly vulnerable to impact in tidal blades [12], underscoring its critical role in structural integrity. Following these events, residual strength tests were conducted to quantify the degradation in stiffness. The next sections present additional analyses of the tests associated with these failure events.

Fig. 10. Displacement at the centre and tip of the blade for all the static tests at 40 kN of load applied per actuator. Dashed lines represent critical events.

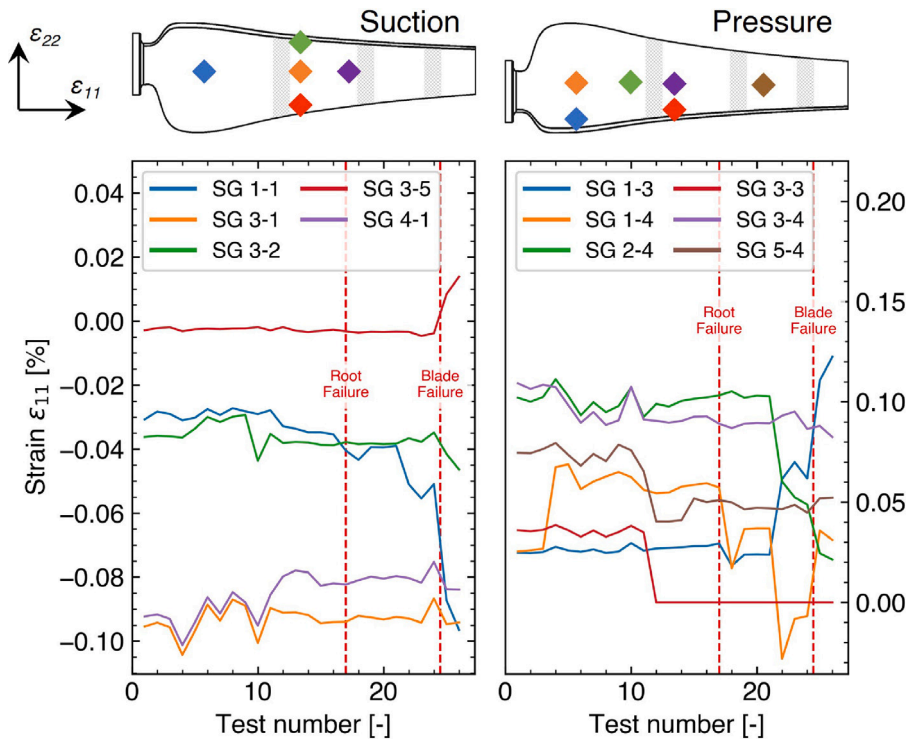
The strain measurements obtained from the various gauges installed on both sides of the blade are compared in Fig. 12, enabling the identification of the locations of the two failure events and their associated damage progression. Strain gauge 1–1, positioned closest to both failure events on the top surface of the blade, recorded increasing strain magnitudes as additional static tests were performed, indicating the progression of damage in this region. Since the displacement measurements did not exhibit a corresponding trend indicative of global stiffness degradation, it is inferred that the damage was localised and had a direct impact on this area. T

The pressure side of the blade, as shown in Fig. 12, exhibited a behaviour similar to that of the suction side, where regions located near the drilled hole and the subsequent failure features experienced the most pronounced changes in strain distribution. Strain gauges 3–3 and 5–4 recorded inconsistent data following the first critical event involving saddle failure; however, no changes in local stiffness were observed prior to that point.

Overall, the root failure event did not result in a noticeable alteration in stress distribution, as load transfer from the skin to the spar via the ribs was still maintained. Strain gauge 1–3, positioned closest to the second failure feature, recorded a significant

Fig. 12. Strain when a total load of 40 kN for all static tests is applied, for the suction side of the blade (left) and the pressure side of the blade (right).

disturbance in strain measurements. This region was found to absorb a substantial portion of the load, as load transfer to the suction side of the blade was no longer feasible.

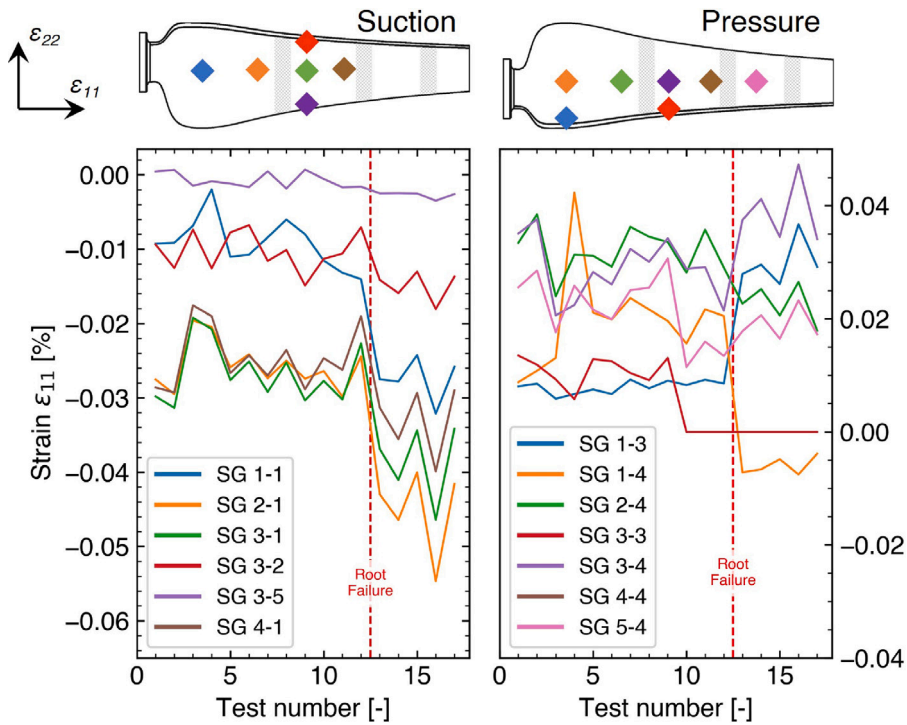
On the suction side of the blade, the strain gauges exhibited a gradual slope, indicative of damage progression once tests under test case “C” and beyond were conducted. This degradation in stiffness was further accelerated following the failure near the root, with the most pronounced damage observed in strain gauges located away from the trailing edge. Strain gauge 3–5, positioned nearest the trailing edge, registered only a slight increase in compressive strain, highlighting the important role of the rear spar to prevent damage initiation at the trailing edge reported in wind turbine blades [14,19,20].

On the pressure side of the blade, the consequences of failure event “B” were more distinctly captured in Fig. 13. The region between the root connection and the first actuator experienced a sudden reduction in load-bearing capability, as the skin was left free to move in the section where it was bonded to the iron root instead of the spar. This effect was not observed beyond the first actuator, where the skin remained bonded solely to the spar, although the trend continued at a reduced rate.

Fig. 13. Mean strain at the troughs of all fatigue tests, for the suction side of the blade (left) and the pressure side of the blade (right).

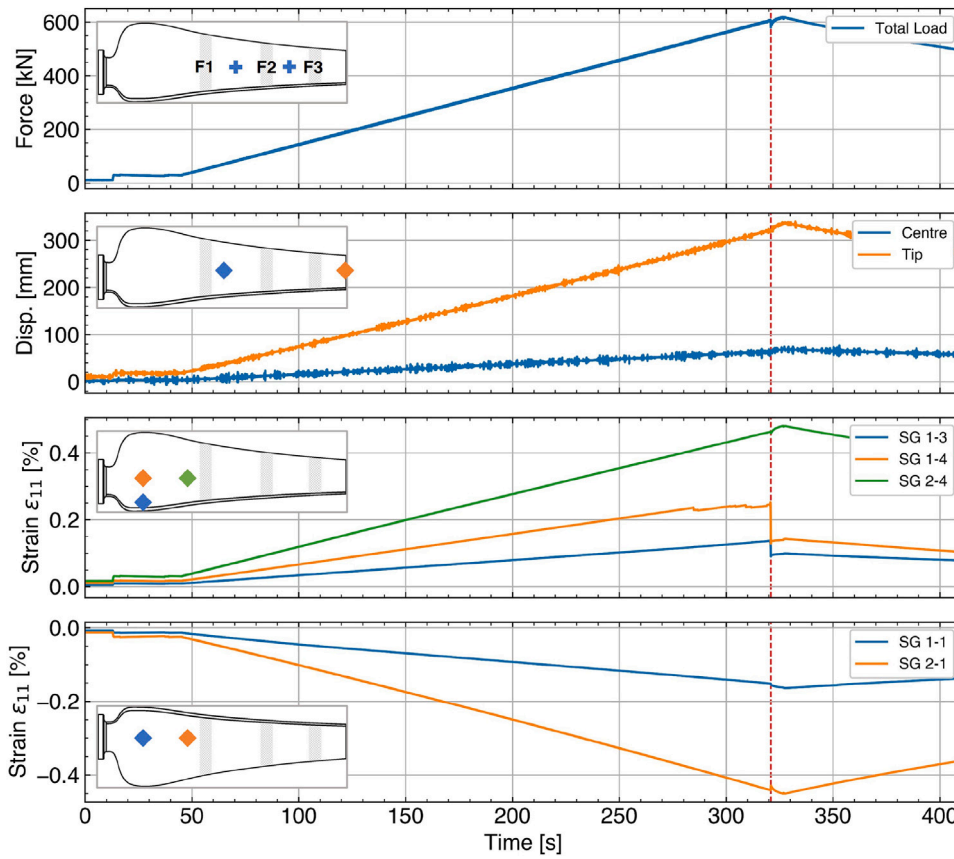
The first failure event occurred during static test 17 (test case C), in which we applied a total load of 660 kN at approximately 120 kN min^{-1} after the blade had accumulated roughly 86 256 cycles. Fig. 14 shows the load increment at four different stages behind the first actuator. Although no abrupt drop was recorded in the force or displacement measurements, the strain gauges captured a distinct redistribution of load along the blade. This behaviour is illustrated in Fig. 15, where the pressure side of the blade was more significantly affected than the suction side.

The red-dotted line denotes the exact moment at which the skin was de-bonded from the root connection. The de-bonding followed the contour of the skin around the root but did not complete a full circumferential separation, terminating upon reaching the top skin. This static skin–root debonding follows Zuo’s observations of interface damage under high shear stresses [22], while the involvement of accumulated cycles before separation aligns with Hosseini-Toudeshky’s findings of fatigue debonding at the same interface [10]. Gauges 1–4 and 2–4, located nearest the root, captured the distinctive redistribution that signalled the onset of failure.

Fig. 15. Static test number 17 sensor readings from top to bottom: Load cells, displacements, longitudinal strain gauges at the pressure side of the blade, longitudinal strain gauges at the suction side of the blade.

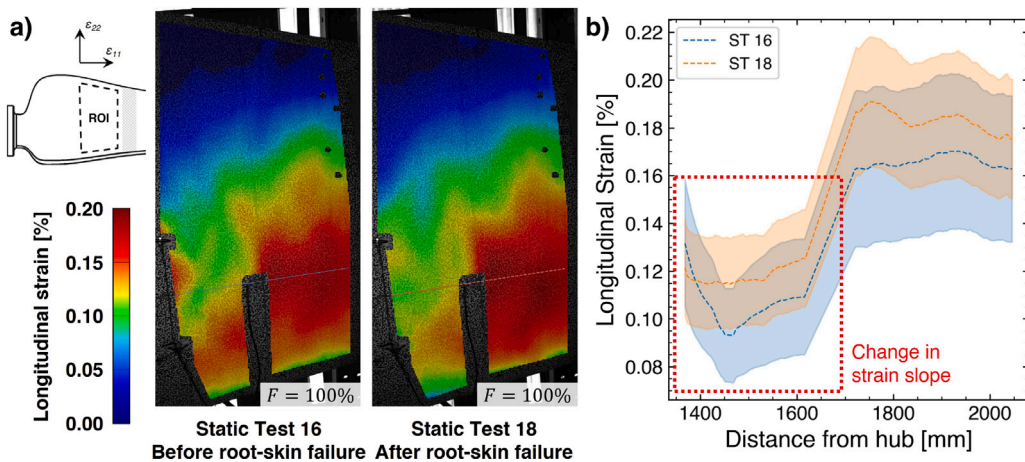
Fig. 17. Longitudinal strain comparison between static tests before and after the root-skin failure: (a) Strain maps at the ROI 1; (b) Strain along the neutral axis of the blade.

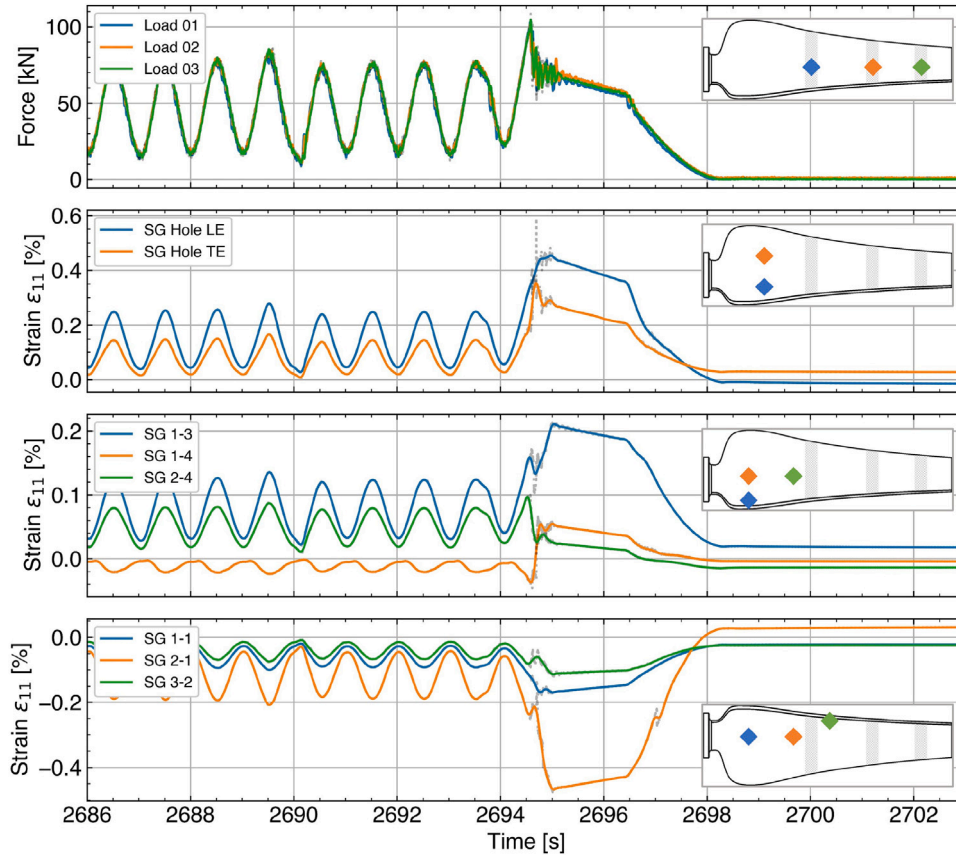
Fig. 20 shows data from sensors during the last cycles before the blade failed. The average maximum load applied at the peak of the cycles was 75 kN per actuator before suddenly increasing to 102 kN per actuator. It can also be observed that the strain gauge on the notch closer to the leading edge read a higher strain value during the cycles than the strain gauge located closer to the trailing edge. This difference swaps once de-bonding in the leading edge occurs, effectively transferring some of the load-bearing capacity to the rear spar. This phenomenon decreases along the span of the blade as the failure feature spread only to a distance of 2.42 m from the root.

Fig. 20. Last 10 cycles of the last fatigue test before ultimate failure. From top to bottom: Load applied per actuator, strain gauge measurements close to the hole notches, strain gauge measurements at the pressure side of the blade, strain gauge measurements at the suction side of the blade.

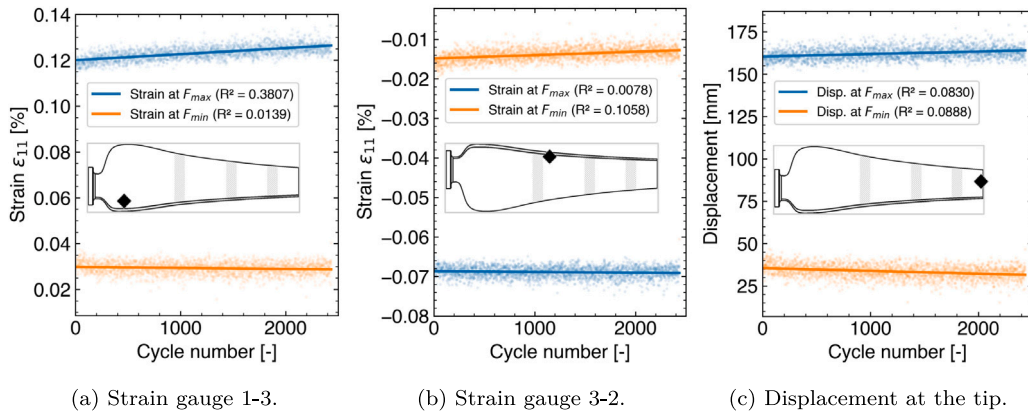
The steady increase in strain measurements was observed in most strain gauges during this test, in contrast to previous tests where peak values remained stable even after 20 000 cycles had been run continuously. For instance, Fig. 21(a) shows one of the strain gauges closest to the failure feature. During the test, the strain at the peak of each cycle was observed to increase gradually. The introduction of a trend line indicates that the strain increased at a rate of 0.00262% per 1000 cycles. This trend diminished as the distance from the failure location increased, with strain gauge 3-2 in Fig. 21(b) showing a strain rate of 0.000177% or $1.777 \mu\text{m m}^{-1}$ per 1000 cycles. The progression of damage throughout the test could not be detected by the load cells, as the system operated under load control. However, the displacement sensors recorded a steady increase, which was particularly magnified at the tip of the blade. This increase is shown in Fig. 21(c), where the strain rate is 1.45 mm per 1000 cycles.

Fig. 21. Peaks and troughs during the entire fatigue test that led to final failure.

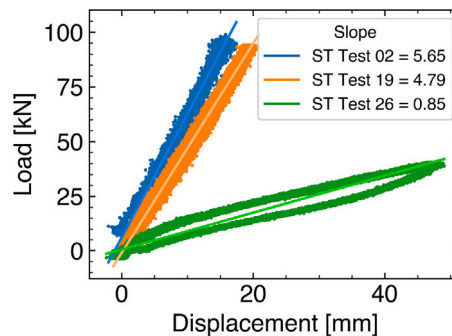
Fig. 23. Load vs. displacement comparison in the first actuator, between reference static test and static tests after failure events.

The stiffness drastically decreased for the final static test from 4.79 kN mm to 0.85 kN mm. The blade shows an overall 85% decrease in stiffness, which would not comply with the current testing certification frameworks. The last static test also showed a similar behaviour to a hysteresis loop; however, this is the result of further damage progression in the blade as the load was ramped up.

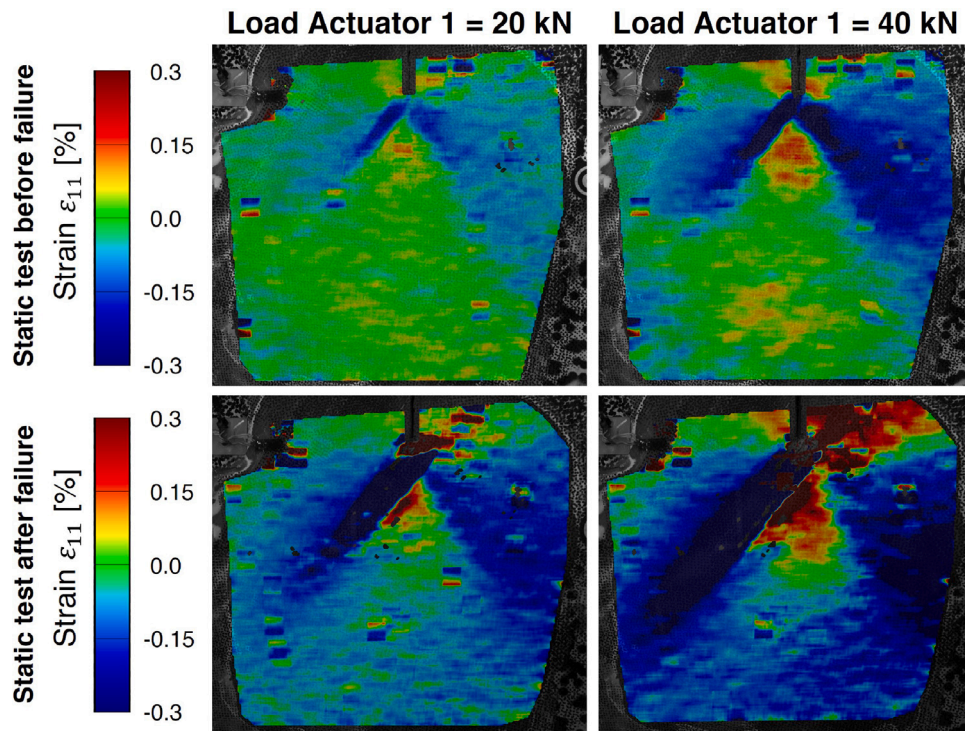
shifted during the course of the fatigue test, as the statistics indicated a higher average strain of $(0.421 \pm 0.401)\%$ in the trailing edge notch region compared to the leading edge region, which showed $(0.194 \pm 0.145)\%$. Finally, after the blade failure, the DIC analysis revealed that the leading edge notch transitioned into a shadow-stress zone, with the average strain in that region dropping to $(-0.028 \pm 4.131)\%$, exhibiting a high standard deviation that suggests rigid body motion was considered as strain. In contrast, the region surrounding the trailing edge notch largely remained above 0.1% strain.

Fig. 24. DIC comparison of the region close to the leading edge notch between static tests before and after the fatigue test where final failure occurred.

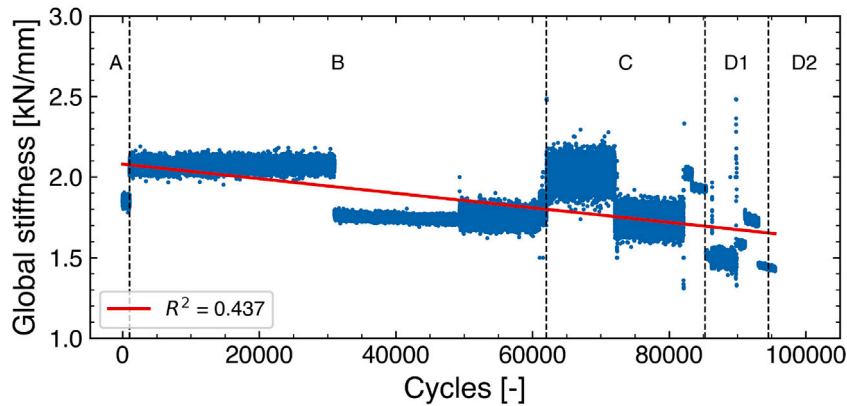
Fig. 29. Global stiffness metric against number of cycles, throughout the different test conditions.

Lastly, we introduce a global stiffness metric to capture the blade's damage progression over the entire experimental phase. We selected the tip displacement sensor as a reference, since it remained largely unaffected by changes in saddle material, actuator alignment, loading conditions, and individual failure events. Global stiffness is therefore defined as the total load from all three actuators divided by the tip displacement. Fig. 29 plots this metric over 97 000 cycles experienced by the blade, revealing a steady decline in stiffness that accelerates once artificial defects are introduced. This trend complements the observed reduction in natural frequency and underscores the importance of studying the integrity of adhesive interfaces layers over bulk material strength analyses.
