Valdivia-Camacho, M.A., Cuthill, F., McCarthy, E.D. et al. (2025) Forensic investigation of failure in a full-scale composite tidal turbine blade. *Engineering Failure Analysis*, 182, Part B. 110076. ISSN: 1350-6307

Forensic investigation of failure in a full-scale composite tidal turbine blade

This study tested a 5.25 m composite blade that was part of a 500 kW DeepGen tidal turbine deployed in Orkney, UK in 2010, as seen in Fig. 1a. Only one full scale blade was tested, reflecting both access constraints from the lending organisation and the substantial time and resource demands of a full failure campaign. The manufacture of a full scale blade can cost hundreds of thousands, making destructive testing economically demanding. Information regarding its design, internal structure, manufacturing process, and material properties was limited by the involved companies. However, the material systems and assembly procedures are representative of tidal blades, as this design drew on proven wind industry materials at the time of manufacture. The outer geometry of the blade was mapped using a 3D scan and several NACA 62XXX profiles were matched accordingly. Fig. 1b shows a top view of the

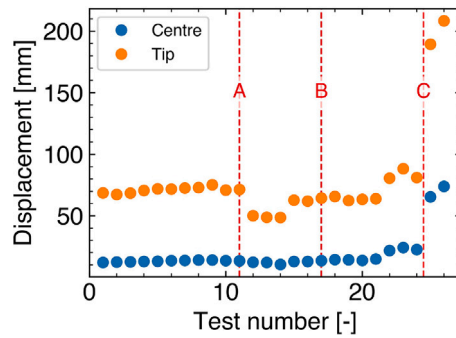
To compare displacement behaviour under consistent conditions, Fig. 10 shows the displacement at the centre and tip of the blade at a total load of 120 kN (or 40 kN per actuator), as not all static tests were conducted at identical load targets. For the first nine static tests, the introduction of a 22 mm hole (test case B) had negligible effect on the blade's global structural response. Although the hole was not intended to simulate impact damage, these results suggest the blade could remain functional with such a defect, underpinning the challenges of underwater maintenance [4].

Additionally, three critical events are identified in Fig. 10. The first, labelled "A", occurred during static test number 11. A target load of 600 kN was applied via a ramp lasting 20 min, followed by an intended hold phase for 2 min. However, failure occurred in the saddles due to high shear stresses. Further analysis and the adoption of a stiffer plywood saddle material are detailed in [41]. Additionally, the actuators were repositioned to align perpendicularly to the blade's final orientation rather than its initial configuration, in order to minimise second-order moments and reduce saddle slipping. These improvements align with Glennon's concerns about the adaptability of test rigs when loading blades beyond their design limits [35].

Subsequent damage was observed during failure event "B", the first to affect the blade itself. In this case, failure occurred at 617.65 kN after 327.4 s of ramp loading, despite a planned target of 660 kN. The failure was localised near the root section, as shown in Fig. 11b. This failure mode can be described as a root-skin interface debonding, confirming concerns on this adhesive joint raised in Zuo's and Hosseini-Toudeshky's studies on wind turbine blades [10,22].

Finally, failure event "C" marked the ultimate failure of the blade, after which the design load could no longer be sustained. This event occurred between static tests 24 and 25, during a fatigue test conducted slightly above the design fatigue load, with a mean actuator load of 47.5 kN and an amplitude of 27.5 kN. Fig. 11c highlights the final failure feature: pressure-suction skin interface debonding adjacent to the leading edge. Although prior studies have not reported this mode, Bir identified the leading edge as particularly vulnerable to impact in tidal blades [12], underscoring its critical role in structural integrity. Following these events, residual strength tests were conducted to quantify the degradation in stiffness. The next sections present additional analyses of the tests associated with these failure events.

Fig. 10. Displacement at the centre and tip of the blade for all the static tests at 40 kN of load applied per actuator. Dashed lines represent critical events.

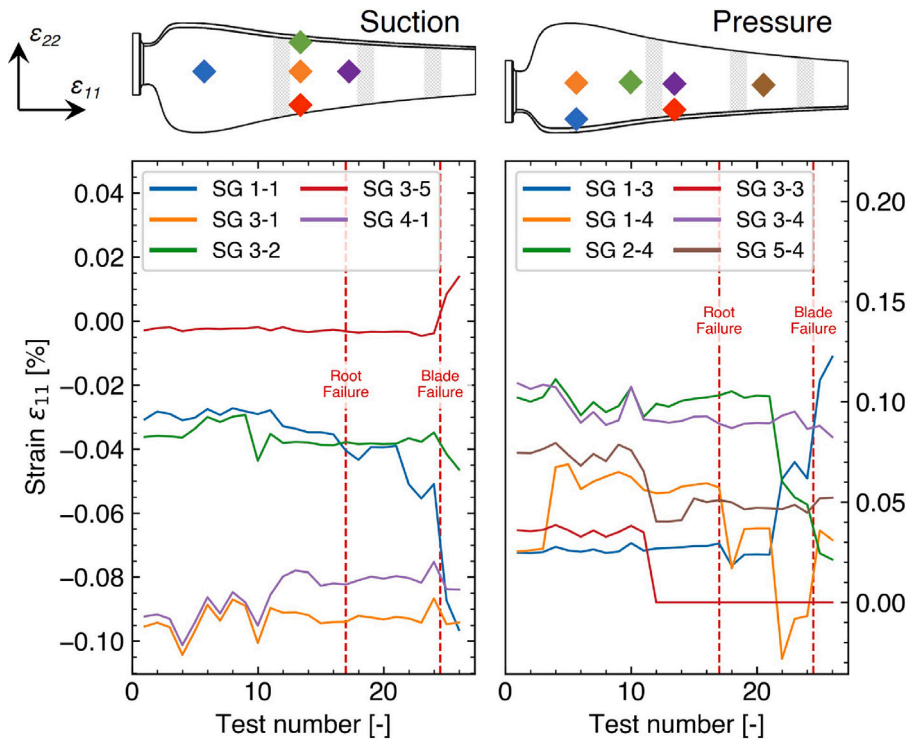
The strain measurements obtained from the various gauges installed on both sides of the blade are compared in Fig. 12, enabling the identification of the locations of the two failure events and their associated damage progression. Strain gauge 1–1, positioned closest to both failure events on the top surface of the blade, recorded increasing strain magnitudes as additional static tests were performed, indicating the progression of damage in this region. Since the displacement measurements did not exhibit a corresponding trend indicative of global stiffness degradation, it is inferred that the damage was localised and had a direct impact on this area. T

The pressure side of the blade, as shown in Fig. 12, exhibited a behaviour similar to that of the suction side, where regions located near the drilled hole and the subsequent failure features experienced the most pronounced changes in strain distribution. Strain gauges 3–3 and 5–4 recorded inconsistent data following the first critical event involving saddle failure; however, no changes in local stiffness were observed prior to that point.

Overall, the root failure event did not result in a noticeable alteration in stress distribution, as load transfer from the skin to the spar via the ribs was still maintained. Strain gauge 1–3, positioned closest to the second failure feature, recorded a significant

Fig. 12. Strain when a total load of 40 kN for all static tests is applied, for the suction side of the blade (left) and the pressure side of the blade (right).

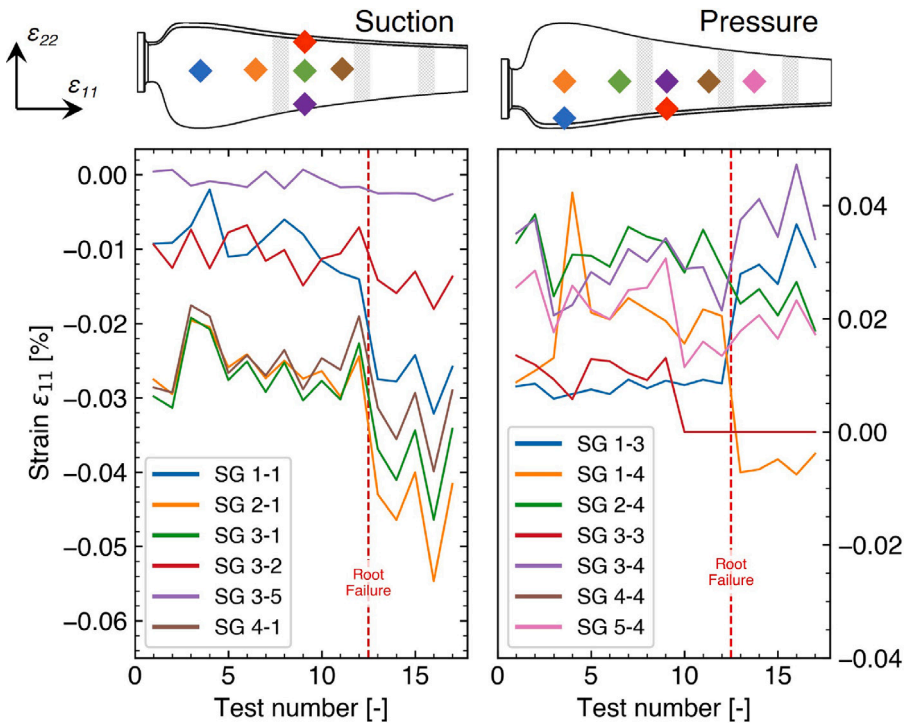
On the suction side of the blade, the strain gauges exhibited a gradual slope, indicative of damage progression once tests under test case “C” and beyond were conducted. This degradation in stiffness was further accelerated following the failure near the root, with the most pronounced damage observed in strain gauges located away from the trailing edge. Strain gauge 3–5, positioned nearest the trailing edge, registered only a slight increase in compressive strain, highlighting the important role of the rear spar to prevent damage initiation at the trailing edge reported in wind turbine blades [14,19,20].

On the pressure side of the blade, the consequences of failure event “B” were more distinctly captured in Fig. 13. The region between the root connection and the first actuator experienced a sudden reduction in load-bearing capability, as the skin was left free to move in the section where it was bonded to the iron root instead of the spar. This effect was not observed beyond the first actuator, where the skin remained bonded solely to the spar, although the trend continued at a reduced rate.

Fig. 13. Mean strain at the troughs of all fatigue tests, for the suction side of the blade (left) and the pressure side of the blade (right).

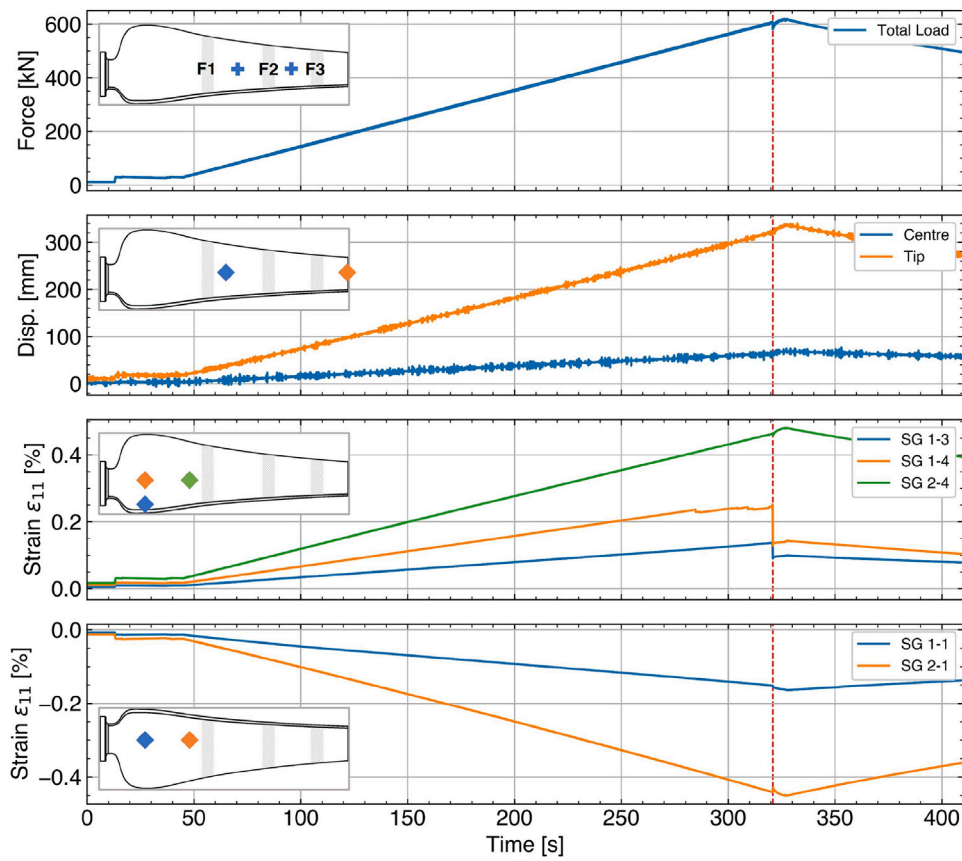
The first failure event occurred during static test 17 (test case C), in which we applied a total load of 660 kN at approximately 120 kN min^{-1} after the blade had accumulated roughly 86256 cycles. Fig. 14 shows the load increment at four different stages behind the first actuator. Although no abrupt drop was recorded in the force or displacement measurements, the strain gauges captured a distinct redistribution of load along the blade. This behaviour is illustrated in Fig. 15, where the pressure side of the blade was more significantly affected than the suction side.

The red-dotted line denotes the exact moment at which the skin was de-bonded from the root connection. The de-bonding followed the contour of the skin around the root but did not complete a full circumferential separation, terminating upon reaching the top skin. This static skin–root debonding follows Zuo’s observations of interface damage under high shear stresses [22], while the involvement of accumulated cycles before separation aligns with Hosseini-Toudeshky’s findings of fatigue debonding at the same interface [10]. Gauges 1–4 and 2–4, located nearest the root, captured the distinctive redistribution that signalled the onset of failure.

Strain gauge 2–4 registered the maximum strain on the pressure side, reaching 0.481%, a value insufficient to indicate fibre breakage in this region. The $\pm 45^\circ$ strain gauges in the rosette configuration recorded maximum values of 0.177% and 0.175%, respectively, consistent with shear-dominated loading but still below critical failure thresholds. Strain gauge 2–4 was less affected than adjacent gauges near the failure feature. This behaviour can be attributed to the internal rib structure, as the first rib is located at 700 mm from the root and the rib at 1100 mm appears to effectively transfer load from the skin to the spar, establishing a load transfer boundary. Additionally, strain redistribution may have been influenced by local stiffness variations, residual manufacturing stresses, or partial adhesive failure prior to de-bonding.

Fig. 15. Static test number 17 sensor readings from top to bottom: Load cells, displacements, longitudinal strain gauges at the pressure side of the blade, longitudinal strain gauges at the suction side of the blade.

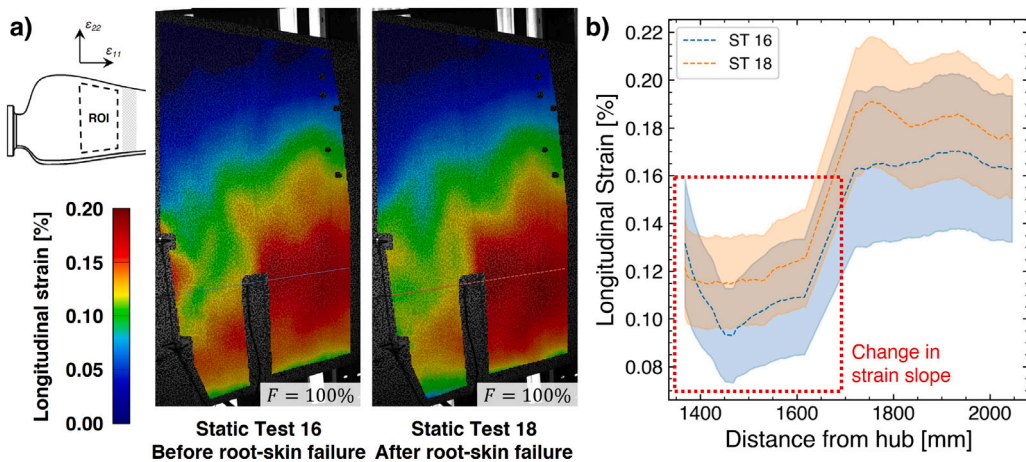
The hole and its notches are no longer the regions of highest stress concentration. Although the blade is designed to carry load primarily through the spar, the initial load path unexpectedly relied on the skin's bond to the root, likely due to large discontinuities between the skin and adjoining components. To address this, test case "D" introduced notches to deliberately weaken the spar box and encourage additional damage before complete skin de-bonding at the root. Moreover, the observed strain redistribution indicates a progressive shift in load path driven by damage evolution, underscoring the internal structure (ribs and spar) in sustaining load transfer even after partial skin detachment. This structural integrity can be observed in Fig. 17, where the longitudinal strain shows minor changes on top of the spar box.

Fig. 17. Longitudinal strain comparison between static tests before and after the root-skin failure: (a) Strain maps at the ROI 1; (b) Strain along the neutral axis of the blade.

Building on these insights, our study recommends a tidal specific optimisation that reflects shear dominated loading and the absence of a skin spar bond in the proximal region. The priority variables are rib spacing that could be denser near the root, geometry transitions, and regions without a skin spar interface; a variable rib thickness; rib material and lay up selection, including hybrid laminates; and rib flange length and bond detailing to control peel and shear at the skin and spar interfaces. We also recommend quality controls to minimise voids at rib to skin and rib to spar bonds.

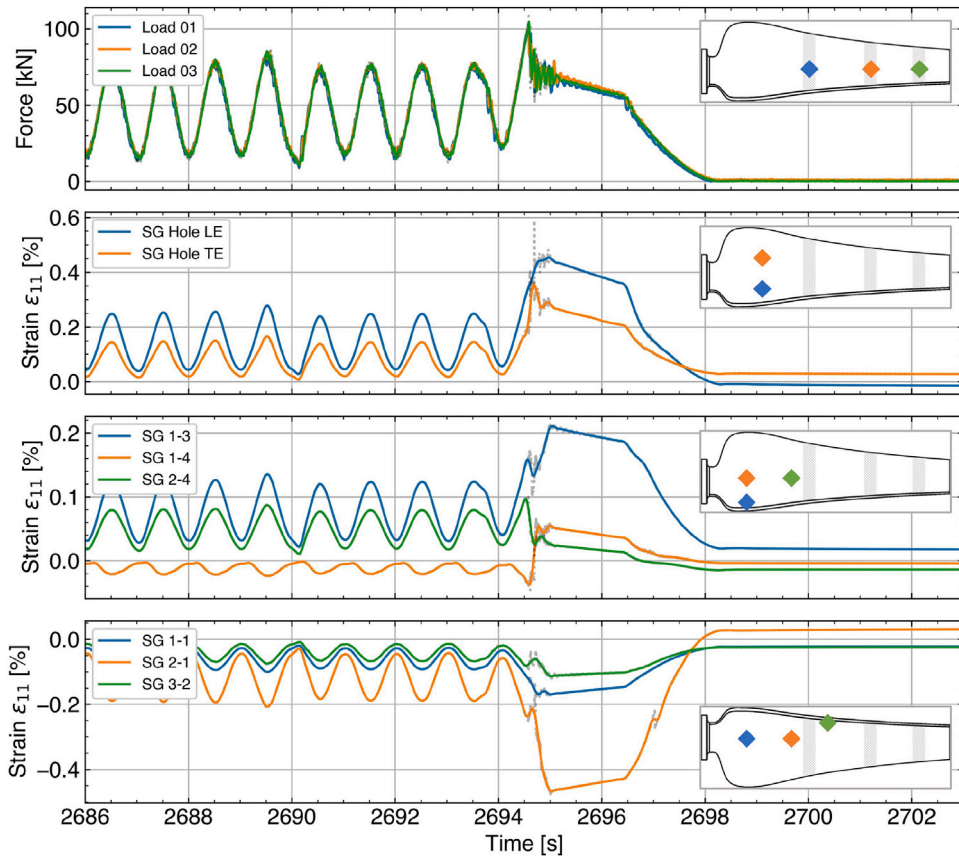
Fig. 20 shows data from sensors during the last cycles before the blade failed. The average maximum load applied at the peak of the cycles was 75 kN per actuator before suddenly increasing to 102 kN per actuator. It can also be observed that the strain gauge on the notch closer to the leading edge read a higher strain value during the cycles than the strain gauge located closer to the trailing edge. This difference swaps once de-bonding in the leading edge occurs, effectively transferring some of the load-bearing capacity to the rear spar. This phenomenon decreases along the span of the blade as the failure feature spread only to a distance of 2.42 m from the root.

Strain gauge 1–3 shows the biggest jump during failure amongst the strain gauges located on the pressure side of the blade, between the root connection and the first saddle. The reading drops to a minimum value of 0.101% and reaches a maximum value of 0.213%, despite the load decreasing to an average of (66.72 ± 3.98) kN per actuator. Strain gauge 1–4 shows a change from compression back to tension in strain given that this is located in a shadow-stress zone between the detached root and the drilled hole. On the other hand, the suction side of the blade shows less impact in its load distribution. Past the first saddle, strain variation is lower with strain gauge 3–2 reading a difference in strain of only 0.083% between the maximum and minimum value during the failure event. Strain gauge 2–1 shows the biggest change in strain on the suction side of the blade, with a difference of 0.299% in

strain between the onset of failure and the maximum strain reached. These readings suggest that de-bonding started in the region between the drilled hole and the first saddle.

Fig. 20. Last 10 cycles of the last fatigue test before ultimate failure. From top to bottom: Load applied per actuator, strain gauge measurements close to the hole notches, strain gauge measurements at the pressure side of the blade, strain gauge measurements at the suction side of the blade.

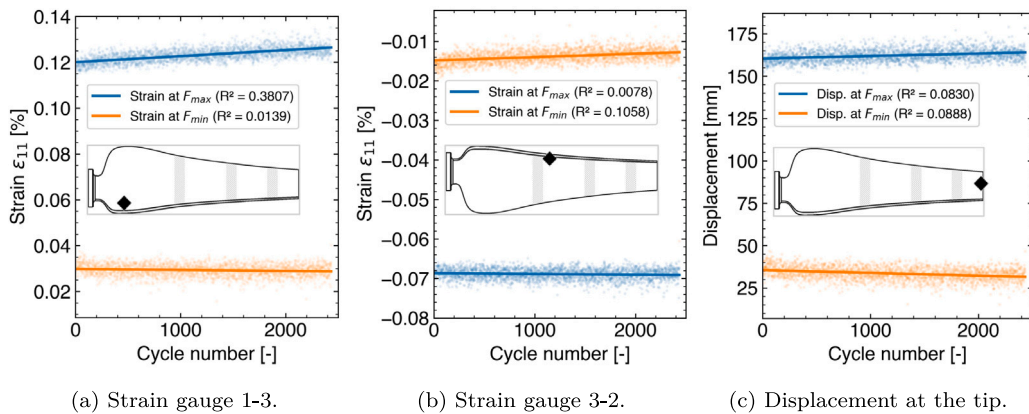
The steady increase in strain measurements was observed in most strain gauges during this test, in contrast to previous tests where peak values remained stable even after 20 000 cycles had been run continuously. For instance, Fig. 21(a) shows one of the strain gauges closest to the failure feature. During the test, the strain at the peak of each cycle was observed to increase gradually. The introduction of a trend line indicates that the strain increased at a rate of 0.00262% per 1000 cycles. This trend diminished as the distance from the failure location increased, with strain gauge 3-2 in Fig. 21(b) showing a strain rate of 0.000177% or $1.777 \mu\text{m m}^{-1}$ per 1000 cycles. The progression of damage throughout the test could not be detected by the load cells, as the system operated under load control. However, the displacement sensors recorded a steady increase, which was particularly magnified at the tip of the blade. This increase is shown in Fig. 21(c), where the strain rate is 1.45 mm per 1000 cycles.

Fig. 21. Peaks and troughs during the entire fatigue test that led to final failure.

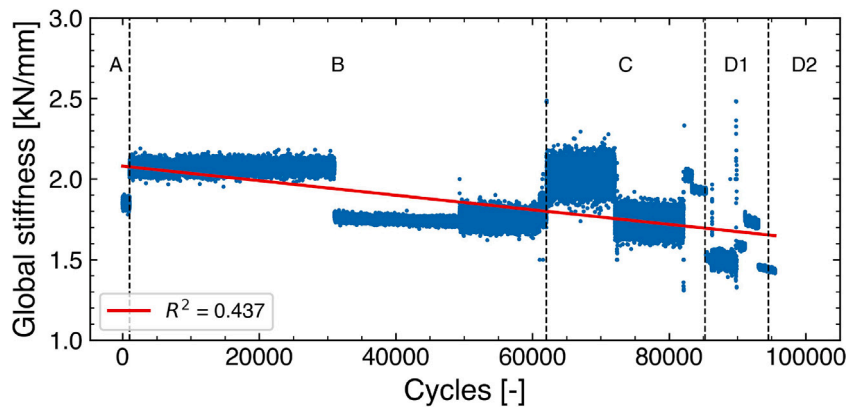
Lastly, we introduce a global stiffness metric to capture the blade's damage progression over the entire experimental phase. We selected the tip displacement sensor as a reference, since it remained largely unaffected by changes in saddle material, actuator alignment, loading conditions, and individual failure events. Global stiffness is therefore defined as the total load from all three actuators divided by the tip displacement. Fig. 29 plots this metric over 97 000 cycles experienced by the blade, revealing a steady decline in stiffness that accelerates once artificial defects are introduced. This trend complements the observed reduction in natural frequency and underscores the importance of studying the integrity of adhesive interfaces layers over bulk material strength analyses.

Fig. 29. Global stiffness metric against number of cycles, throughout the different test conditions.
