Formation Mechanism of Subsurface White Etching Area and White Etching Crack of Failed Bearings in Wind Turbine Gearbox

R. Dai and H. Long*

Bearings of some wind turbine (WT) gearboxes experienced premature failures due to bearing steel microstructural damage under rolling contact fatigue (RCF). However, the formation mechanism of the microstructural damage and its progression to the final bearing failure is still being debated. In this study, subsurface damage sustained in two bearing raceways of a failed gearbox from a field-operated WT is investigated. The study provides evidence of damage initiation and progression from non-metallic inclusions in the subsurface by using actually failed WT bearings as a case study. Damage characterisation has found various microstructural damage in the raceway subsurface including non-metallic inclusions, butterfly wing cracks, White Etching Areas (WEAs), and White Etching Crack (WECs). Complex interactions between cyclic rolling contact loading with inclusions and cracks are observed. Their roles in the formation of butterfly wing cracks, WEAs and WECs in the raceway subsurface are evaluated. It has been found that the butterfly wing cracks i

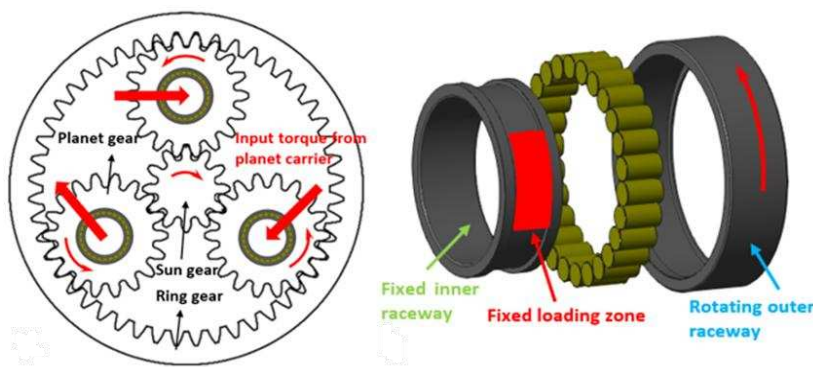
a Fixed loading zone of inner raceway of planetary bearings

in Appendix Table A.1. Fig. 1 shows the failed inner raceway of the upwind and downwind planetary bearings of the gearbox, respectively. The damaged surface with spalling area and indenting area can be seen clearly on the raceway surface. Each raceway has a concentrated damage area, caused by the fixed loading zone of the raceway, as illustrated in Fig. 1a. For the planetary stage of the WT gearbox, the upwind bearing is located on the rotor side of the gearbox, facing the wind, and the downwind bearing is positioned next to the upwind bearing but on the higher speed side of the gearbox. The upwind bearing raceway in Fig. 1b shows severe spalling damage than that of the downwind bearing raceway in Fig. 1c. This is due to the different levels of the radial load acting on each bearing. It is known that in the WT gearbox the upwind planetary bearing normally undertook 40% to 60% more loads than the downwind bearing [36, 37]. Accordingly, the upwind bearing raceway shows a relatively larger area of surface spalling.

Fig. 1 Inner raceways of planetary bearings: (a) Illustration of fixed loading zone; (b) damaged raceway of upwind bearing; (c) damaged raceway of downwind bearing

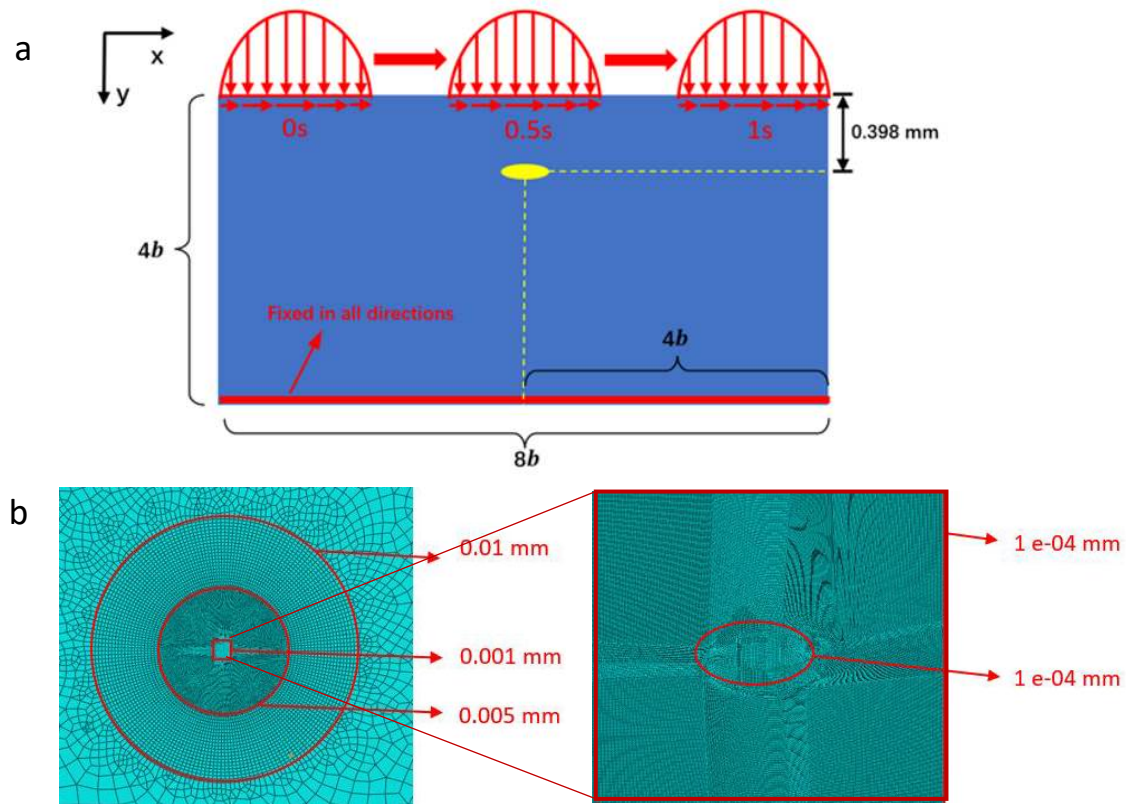
Fig.2 Finite element modelling of raceway rolling contact with subsurface inclusion: (a) global raceway model; (b) the global model mesh and partitions (on the left) and the sub-model mesh containing the inclusion (on the right, in square dimensions in $30\ \mu\text{m} \times 30\ \mu\text{m}$). The numerical values are the element sizes of the highlighted partitions of the FE meshes.

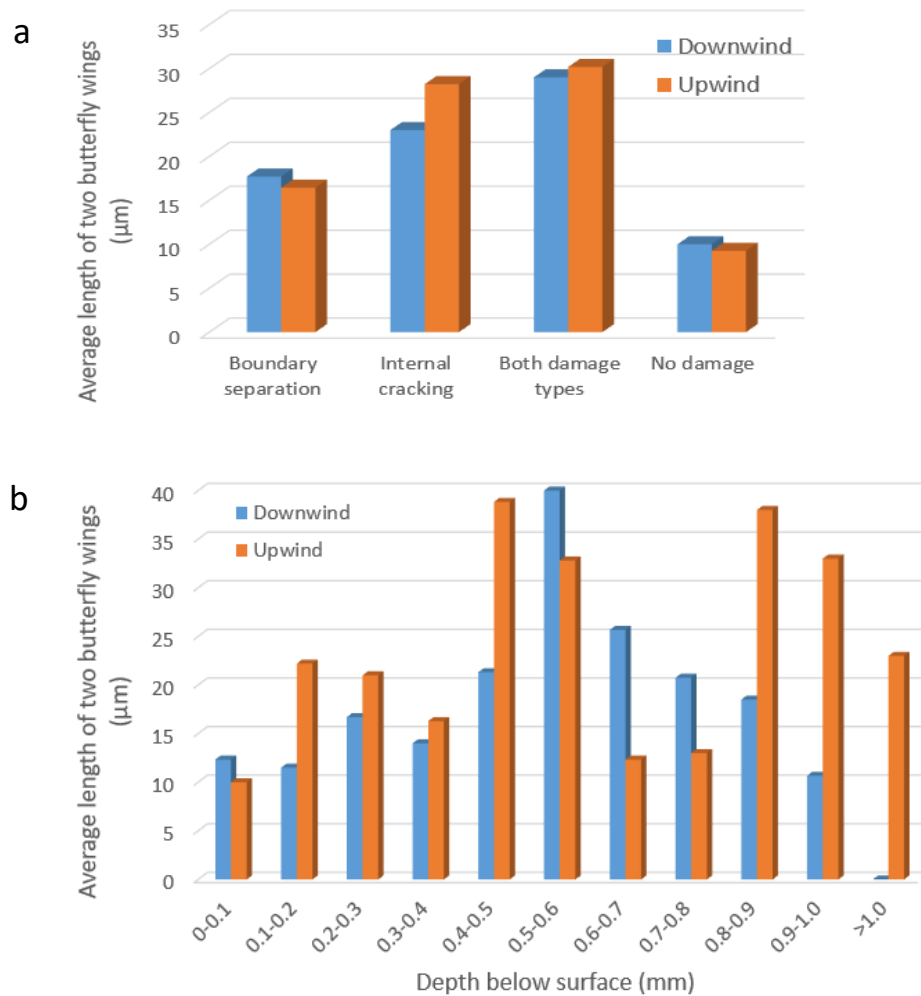
Fig.5 Average crack length of butterfly wings at inclusion: (a) Effect of inclusion damage types on crack length; (b) Correlation of crack length with subsurface depth

Statistical analysis of the subsurface damage results, based on all inclusions found in the subsurface of the damaged raceways, is conducted by relating the inclusion damage types to the average length of butterfly wing cracks at an inclusion, as shown in Fig.5a. Because internal cracks and boundary separations of inclusions can be found in the subsurface area at varied depths, the results of the statistical analysis are processed to show the correlation of crack lengths of the butterfly wings with the subsurface depth. It can be observed that the most harmful inclusion damage types to the raceway subsurface are the internal cracking and boundary separation of inclusions. It has been found that when an inclusion has both damage types, it creates the greatest average crack lengths of the butterfly wings, propagated from the inclusion. If only one damage type exists at an inclusion, the internal cracking of the inclusion has been found to be more harmful than the boundary separation of the inclusion.

Most butterflies are found to be located in the subsurface depth from 0.2 to 0.6 mm, as shown in Fig. 5b. It can be seen that the average length of the butterfly wings increases first with the increased depth but decreases towards greater depths. The maximum butterfly lengths are within the subsurface depth of 0.4 to 0.6 mm. However, longer butterfly wing cracks are also observed in the downwind raceway reaching to the subsurface depth of 1 mm from the contact surface. This may be related to the change in the contact area caused by surface spalling of the raceway, which in turn leads to higher stresses of the contact area. Section 4 will present FE stress analysis to explain these observations.

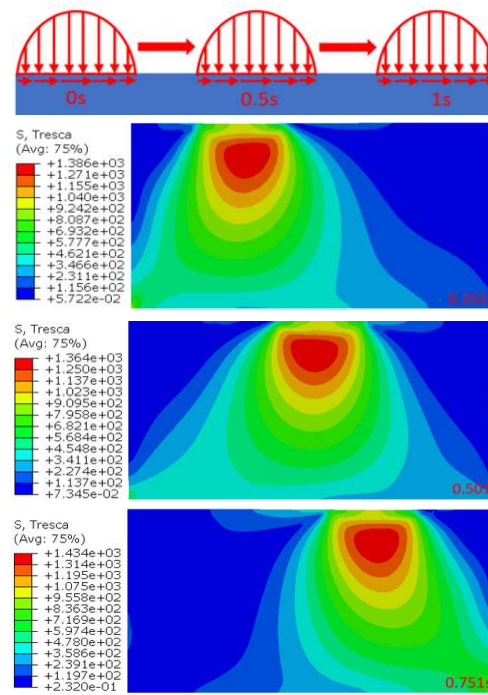
The developed global FE model has produced results of subsurface stress variations when the roller moves over the raceway surface. Fig. 11 shows how the Tresca stress varies over one rolling contact loading cycle without considering an inclusion in the subsurface. In Abaqus, the Tresca stress is defined as two times of the maximum shear stress. The maximum stress is located at the subsurface depth around 0.4 mm and an elevated stress zone in the subsurface covers the subsurface depth from 0 to 1.6 mm. Considering the bearings would undergo millions of loading cycles in operation, any inclusions located in these subsurface areas will experience varied stress conditions which result in fatigue damage to both the inclusions and the steel material surrounding them.

Fig. 11 Variation of Tresca stress under one rolling contact cycle: roller located at left (0.251s), centre (0.501s) and right (0.751s) of the raceway surface

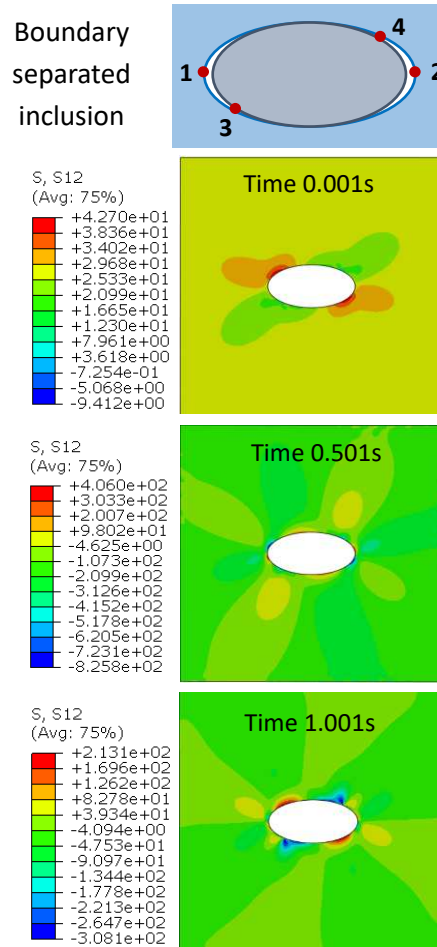
Fig. 12 Variations of orthogonal shear stress of boundary separated inclusion (four locations of highest stress variations are highlighted) when roller at far left (0.001s), centre (0.501s) and far right (1.001s) on raceway surface

The FE modelling results show for each condition of the inclusion when the roller moves over the raceway surface in one roller contact cycle, points 1~4 of the steel material immediate to the inclusion experience highest variations of the orthogonal shear stress, as shown in Fig. 12. Fig.13 shows a comparison of variations of the orthogonal shear stress at point 3 of the steel matrix due to different inclusion conditions. It can be seen that the maximum stress variation range of the internally cracked inclusion is 1629 MPa (from –933 MPa to 696 MPa), greater than 1516 MPa (from –614 MPa to 902 MPa) for the boundary separated inclusion. For the undamaged inclusion, the maximum stress variation range is less than 1000 MPa (from –576 MPa to 400 MPa).

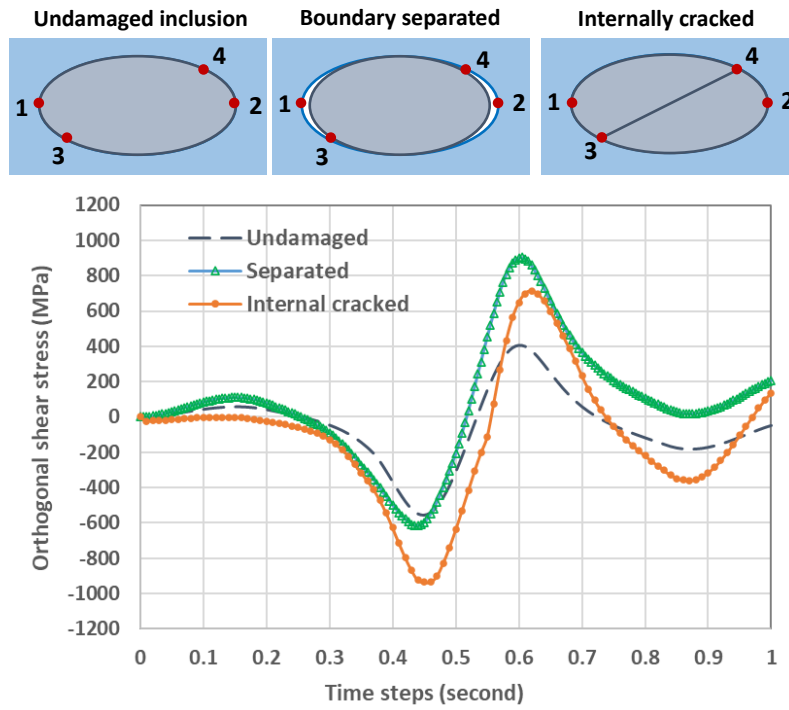
Fig.13 Variations of the orthogonal shear stress caused by different inclusion conditions

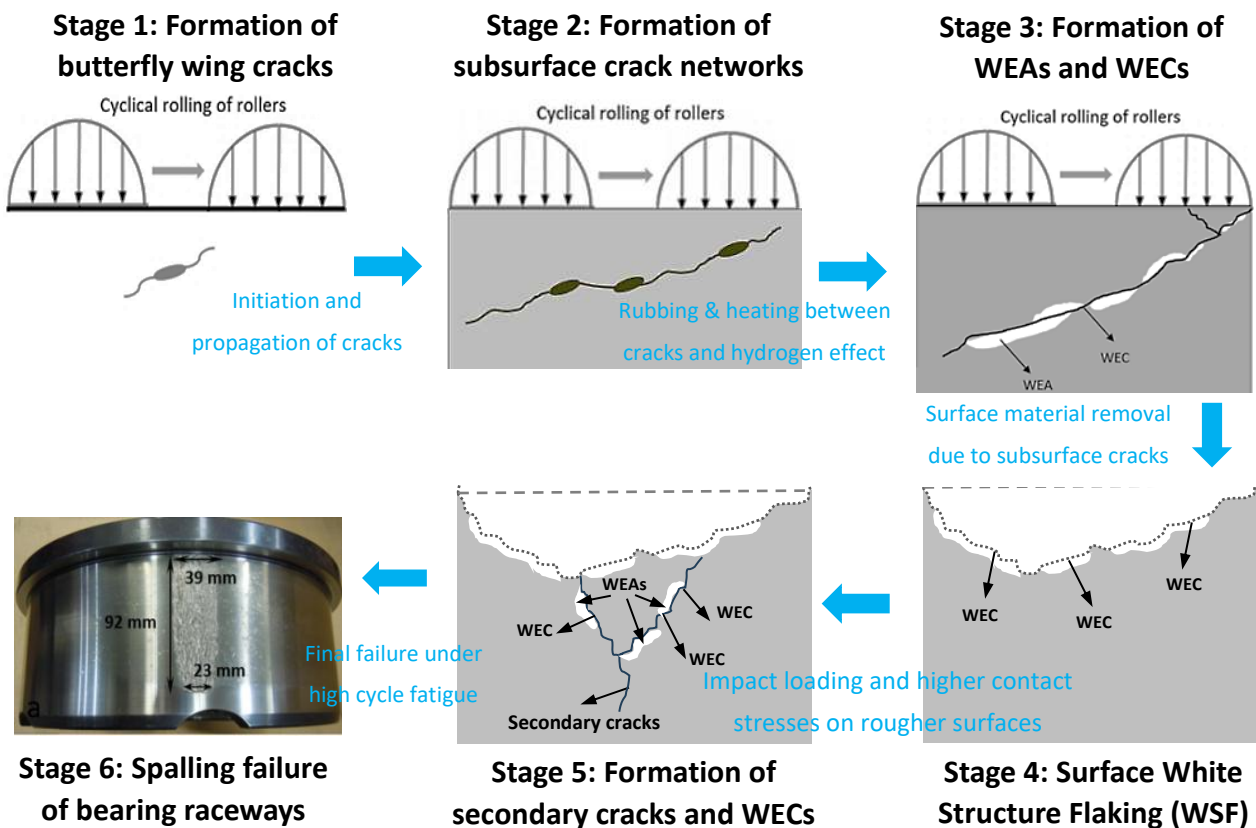
Based the evaluation of the microstructural damages presented in Sections 3.1, 3.2, and 3.3 as well as the discussion of the damage initiation and propagation mechanisms presented in Sections 4.1, 4.2 and 4.3, this study concludes that the failure of the two bearing raceways is initiated from the subsurface. A damage progression hypothesis of the failed bearing raceways is proposed, including six stages, as shown in Fig.16. It can be concluded that the butterfly wing cracks at damaged inclusions is the original cause of the raceway failure. Due to the propagation of micro cracks and the formation of WEAs of the butterfly wings at damaged inclusions, the WEC networks are formed and propagated to reach the raceway surface to cause white structure flaking. The following RCF loading cycles result in the formation of further secondary WEC networks in greater subsurface depths and severe damages to the surface, leading to the final spalling failure of the raceways.

Fig.16 Damage progression of bearing raceways under rolling contact fatigue
