Baggott, A., Mazaheri, M. and Inkson, B.J. orcid.org/0000-0002-2631-9090 (2019) 3D characterisation of indentation induced sub-surface cracking in silicon nitride using FIB tomography. *Journal of the European Ceramic Society*, 39 (13). pp. 3620-3626. ISSN 0955-2219

3D characterisation of indentation induced sub-surface cracking in silicon nitride using FIB tomography

In this study, a combination of 3D FIB tomography and incremental surface polishing has been used to characterize cracking beneath 0.5 kg and 1 kg Vickers indentations on silicon nitride. It is shown that a half-penny cracking regime exists even for low indentation loads with c/a ratios < 2 indicating that the c/a ratio cannot reliably be used to predict sub-surface crack morphology. For the first time, the presence of deep lateral cracks interconnected with radial cracks was also observed surrounding indentations of low loads on silicon nitride, and it is likely that these could contribute to material removal via spalling.

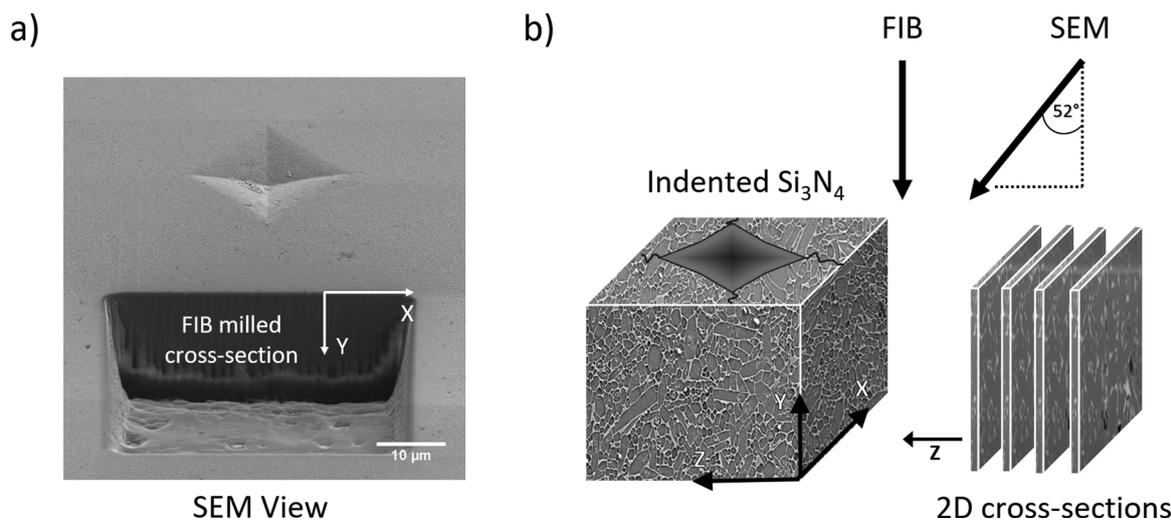
Fig. 1. (a) An SEM image with the 52° tilt showing a FIB milled cross-section adjacent to the indentation on the surface. (b) A schematic of the FIB-SEM milling process through an indentation: The FIB is used to mill away slices of material, after each slice the newly revealed cross-section is imaged using the SEM.

samples using 30 kV Ga^+ ions with a current of 65 nA. These trenches were subsequently polished using currents of 21 nA and 9.3 nA (Fig. 1(a)). FEI Autoslice and View software was used to incrementally sputter away slices of material with the FIB through the indentation sites. A current of 9.3 nA was chosen as the sputter rate was high enough to mill through the required volume of material whilst also obtaining a sufficient level of cross-section polishing. Each sputtered slice had approximate thickness $z = 750 \text{ nm}$ with cross-section dimensions $x = 40 \mu\text{m}$, $y = 30 \mu\text{m}$. The slice thickness was chosen as such to keep the experiment duration within a reasonable timescale (< days). The overall volume milled away around each indentation zone was $\sim 70,000 \mu\text{m}^3$. Sequential imaging of the milled cross-sections was carried out at a tilt angle of 52° with SEM SE images at 5 kV with a current of 1.6 nA. FIB ion-induced secondary electron (ISE) images were additionally taken at 30 kV and 9.3 nA after each mill, and drift was corrected for using a cross fiducial milled in to the surface of the sample. A schematic of the milling process is shown in Fig. 1(b).

For comparison, three whole indentations were milled: a 1 kg SN-1 indentation, a 1 kg SN-2 indentation, and a 0.5 kg SN-2 indentation. The direction of FIB milling approached towards the indentation corners in each case (as in Fig. 1(a)). In addition, to evaluate the importance of milling direction with respect to the indentation orientation, a second 1 kg SN-2 indentation was milled up to the indentation centre, but the approach angle was rotated by 45° to be towards one side of the indentation, not the corner.

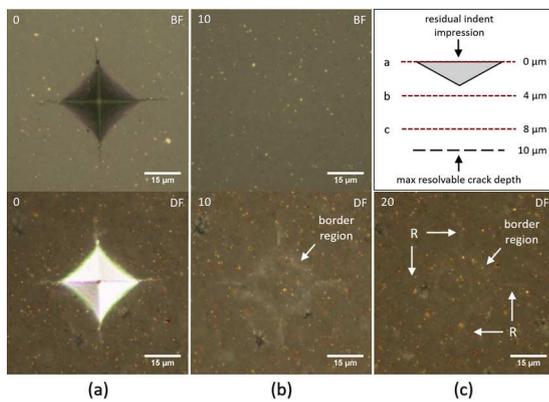
Fig. 2. Optical images in both bright field (top) and dark field (bottom) mode showing one of the 1 kg SN-1 indentations (a) before polishing (b) after the tenth increment of polishing, and (c) a schematic of where each image is in location to depth (top), as well as the dark field image after the twentieth increment.

To investigate the influence of directional FIB serial sectioning on the observed 3D crack patterns, additional 1 kg indentations on the SN-1 composition were sectioned ‘top down’ by serial polishing and imaged optically. Fig. 2(a) shows dark and bright field images of one of the 1 kg indentations on the SN-1 sample prior to polishing. Radial cracks can be seen extending out from the indentation corners to a length of up to 10 μm . No lateral cracking was observed in images of the 1 kg indentations prior to polishing (Fig. 2(a)). After ten polishing increments, the central residual indentation impression and radial cracks of the 1 kg indentations were no longer visible in bright field mode (as shown in Fig. 2(b)). However, under dark field the radial cracks are visible as well as a border zone (arrowed) surrounding where the residual indent impression previously was. The visible border zone scatters light in the same manner as the radial cracks, which suggests that it may consist of localized micro-cracking or a region of high dislocation density plastically deformed zone [23].

As the polishing depth increased, the visibility of the 1 kg indentation features decreased. This is particularly evident for the radial cracks seen in Fig. 2(c) after the twentieth polishing increment (a depth of -8 μm). The maximum depth at which features of the 1 kg indentations were resolvable by optical microscopy was after the twenty-fourth increment, i.e. a depth of -10 μm . Both the light scattering border region and the radial cracking were present at the maximum resolvable depth with the radial cracks being connected to the border at all depths.

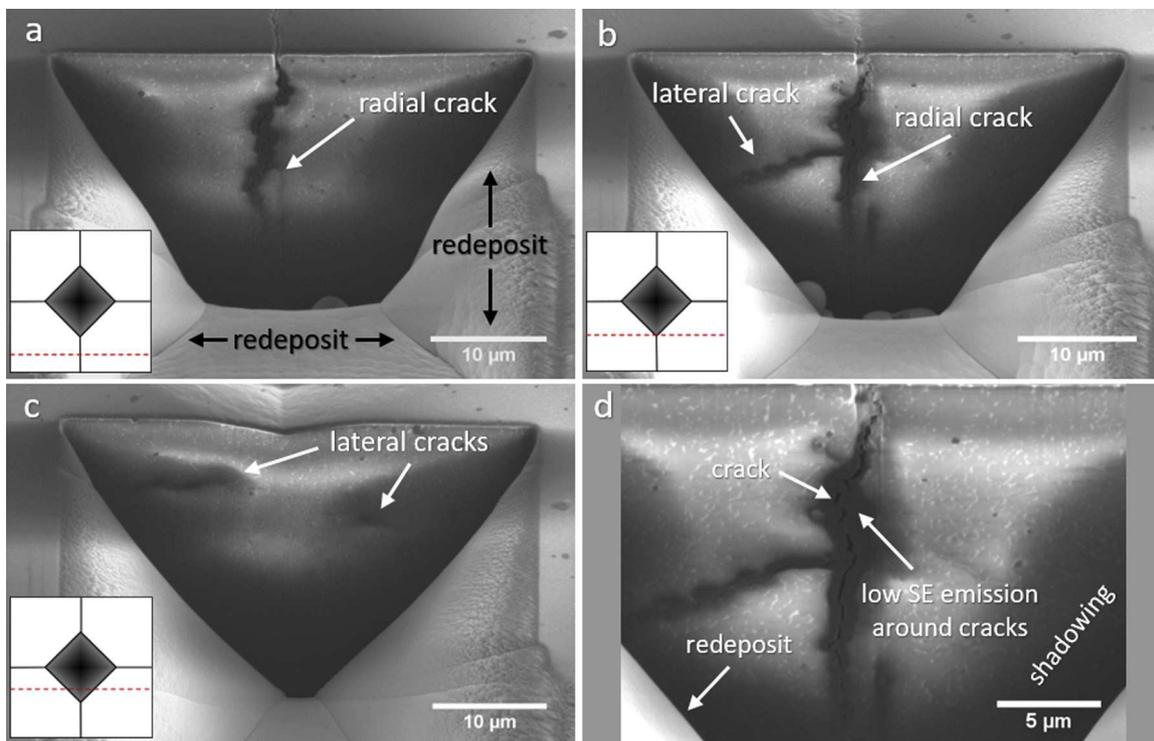
Fig. 3. SEM imaged cross-sections of the 1 kg SN-1 FIB-milled indentation taken at a tilt angle of 52°. The inset schematics in the bottom left show the cross-section location in relation to the indentation: (a) FIB slice through the radial crack (arrowed) emanating from an indentation corner. (b) Slice taken at the indentation corner showing both lateral and radial cracking. (c) Approaching the indentation center where lateral cracking is observed. (d) A close up of the cross-section in (b) Strong variations in SE contrast is due to localized voltage contrast (charging) and beam shadowing caused by the trench walls.

Fig. 3 gives examples of electron induced secondary electrons (ESE) imaged cross-sections of the 1 kg SN-1 sample at increasing proximity to the indent zone. In Fig. 3(a) a radial crack can be seen emanating to a depth of 20 μm beneath the surface. The jagged pathway of the crack suggests that cracking is intergranular in nature. As the milling approaches the indentation corner (Fig. 3(b)) crack branching occurred and a lateral crack appeared emanating from the sub-surface radial crack at a depth of -11 μm and an angle of -15° relative to the surface plane. This was later followed by a second lateral branching from the other side of the radial at the same depth and an angle of -19°. The cross-section in Fig. 3(c), shows that as the indentation corner is passed, and milling progresses to the residual indentation impression, the radial crack sectioned here (Fig. 3(a, b)) does not extend further under the residual indentation impression, whereas the lateral exists under this central zone. For some lateral cracks it was not possible to measure

The lateral cracks observed in Fig. 3(c) disappeared as FIB sectioning approached the mid-point between the already milled indentation corner and the centre of the indentation. In Fig. 4, the presence of a radial crack parallel to the mill direction emanating from one of the indentation corners is observed as a damaged region exhibiting interconnected micro-cracking. It is difficult to determine the depth of parallel radial cracks as their crack width and/or width of crack path is of the order of the FIB slice width. Directly beneath the centre of the residual indentation impression, but not intersecting with the surface, cracking is observed starting at a depth of -20 μm and extending to a minimum depth of -30 μm ; this type of cracking that has no intersection with the surface plane and extends beneath the residual indentation impression (arrowed in Fig. 4) has been determined here as half-penny cracking [11,24]. In the region directly below the residual indentation impression, there exists a crack free-zone where no cracking was observed.

It should be noted that in all the SE imaged cross-sections shown in Fig. 3, the milled trenches have a build-up of material (lighter contrast) located on the side walls as well as at the bottom of the trench caused by redeposition of sputtered material. Sputtered material can not only obstruct the view of the cross-section, but also has the potential to redeposit within cracks and hence decrease their visibility. In addition, there is also a variation in brightness across the face of the cross-sections due to different levels of SE emissions resulting from localised charge build-up on the insulating silicon nitride surface; this is particularly prominent around cracking (Fig. 3). The shadowing effect near the side and bottom of the trenches in Fig. 3 is caused by the presence of the trench walls that inhibit the SE from reaching the detector. These phenomena are highlighted in Fig. 3(d).

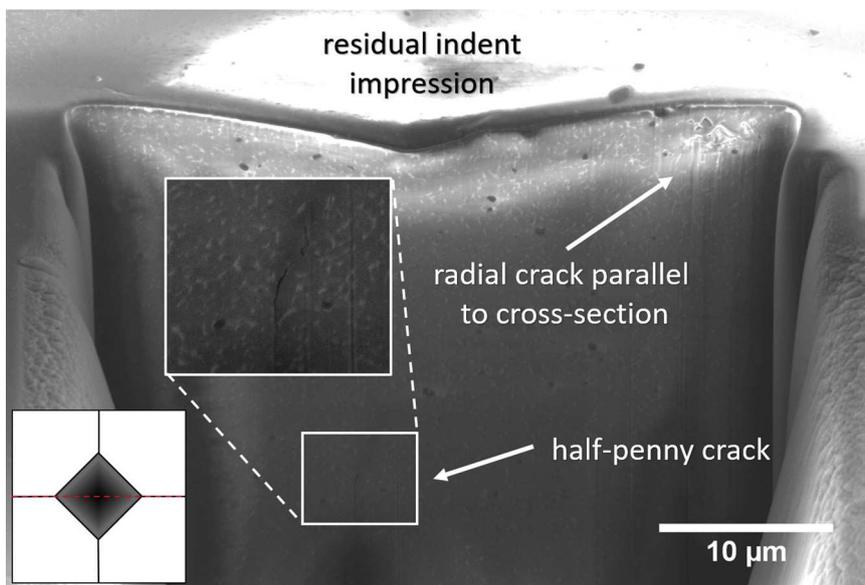
Fig. 4. An SEM imaged FIB cross-section through the centre of the 1 kg SN-1 indentation (sectioned in Fig. 3) taken at a tilt angle of 52°. A radial crack occurring predominantly parallel to the milling direction and a central half-penny crack (magnified inset) are identified.

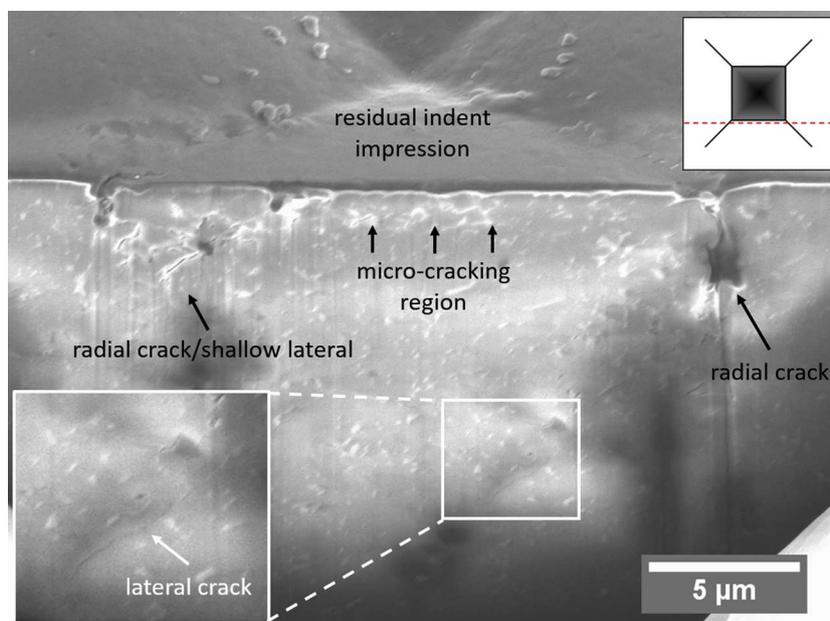
Fig. 5. An SEM imaged (tilt angle of 52°) FIB cross-section located at the edge of the 1 kg SN-2 indentation where the FIB milling approach was towards the indentation side. Two radial cracks are visible in addition to sub-surface micro-cracking along the indentation edge, and deep lateral cracking.

as highlighted in Fig. 5. In addition, near the indentation edge, deep laterals were identified at a maximum depth of -14 μm, as well as micro-cracking near the surface (arrowed Fig. 5). There was also evidence in one cross-section of half-penny cracking, observed beneath the indentation centre at a depth of -16 μm.

(depth $> 5\ \mu\text{m}$) lateral cracks surrounding the indentation. The shallow laterals were observed to be related to near-surface micro-cracking at the edge of the residual indentation impression and connected to radial cracks at the point they intersect with the surface (as seen in Fig. 5). These shallow laterals would be susceptible to propagation and material removal via chipping and flaking if high contact pressures were to be applied during operation conditions [29,30].

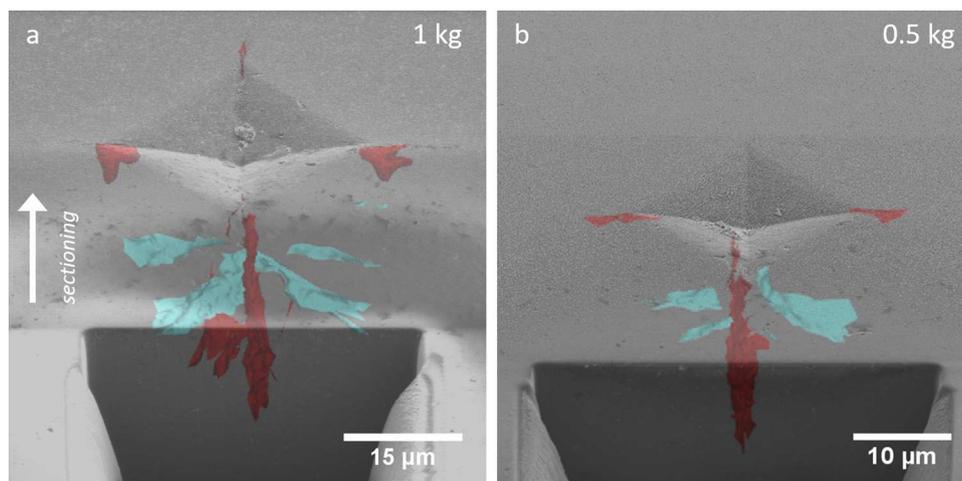
Fig. 6. Crack maps created using IMOD overlaid onto SEM images taken at a 52° tilt angle for the SN-2 (a) 1 kg indentation and (b) 0.5 kg indentation. Lateral cracks are coloured blue and radial cracks red (For interpretation of the references to colour in this figure legend, the reader is referred to the web version of this article).

3D reconstructions of the cracks identified in the SE imaged FIB cross-sectioned slices through indentations were carried out using IMOD software for both SN-1 and SN-2 samples to produce sub-surface crack maps of the FIB milled volumes. Fig. 6(a, b) shows the crack maps for the SN-2 0.5 kg and 1 kg indentations overlaid onto SEM images of

the indentations at a 52° tilt angle. Lateral and radial cracking is coloured blue and red respectively.

Both the shallow and deep laterals are located adjacent to the central indentation damaged zone, with the deeper laterals existing deep under the residual indentation impression/high compressive stress zone as seen in Figs. 6–8. The majority of the lateral cracks do not intersect the surface, however, there is evidence from the FIB sectioning that the lateral cracks frequently connect to adjacent radial cracks sub-surface (Fig. 8). Unlike in an investigation of lateral cracks generated by indentations of greater applied loads ($> 3\ \text{kg}$) [10], the lateral cracks observed here do not extend outwards from the indent centre to intersect with the tips of radial cracks. In a similar way to how half-penny cracks trace around the edge of the central plastically deformed/compressive stress zone (Fig. 7), the location and inner boundaries of the deep laterals also indicate the depth of this zone. The presence of half-penny cracks and laterals that are located at some depth beneath an indentation's surface could lead to significant material removal via spalling under applied pressure.

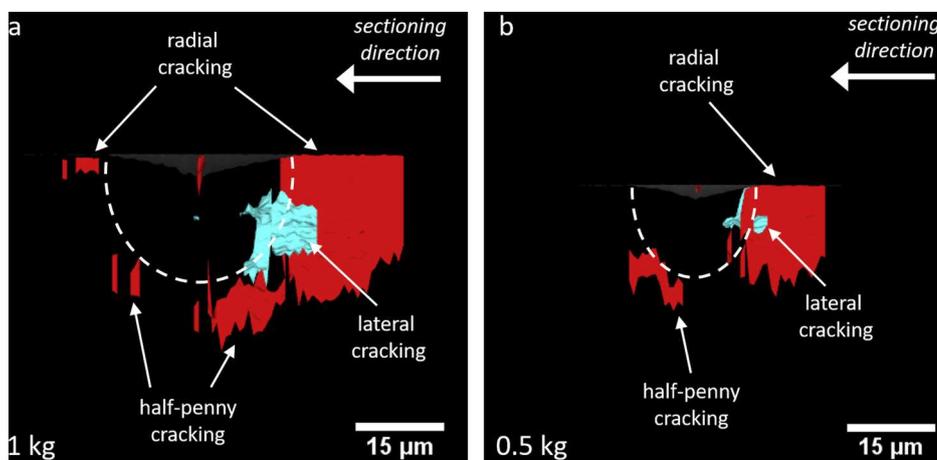
Fig. 7. Side view schematics of the sub-surface IMOD crack maps for the SN-2 (a) 1 kg indentation, and (b) 0.5 kg indentation highlighting the location of the different crack morphologies (arrowed). Lateral and radial cracks are coloured blue and red respectively. The region of compressive stress beneath each indentation is highlighted by the dashed semi-circle (For interpretation of the references to colour in this figure legend, the reader is referred to the web version of this article).

The depth of half-penny cracks beneath indentations, and their pathway, can be used as an indicator of the volume that the plastically deformed zone occupies. Cracks do not preferentially propagate into the plastically deformed zone due to the increased hardness high compressive stress present [10], although micro-cracking can exist in this zone [18]. Instead the crack pathway traces around the tensile stress region surrounding the deformation zone resulting in the half-penny cracking. In Fig. 7(a, b) side-on views of the IMOD crack maps

for the 0.5 kg and 1 kg SN-2 indentations are given, there is a hemispherical volume below the indentations (dashed line) with radius $-12\ \mu\text{m}$ and $-17\ \mu\text{m}$ respectively where there is minimal cracking; this is the volume taken up by the plastically deformed zone and equates to volumes of $-3000\ \mu\text{m}^3$ and $-11,000\ \mu\text{m}^3$.

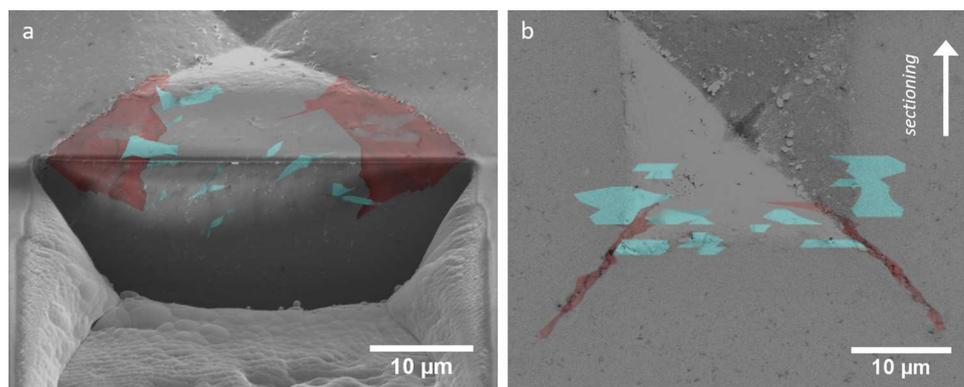
Fig. 8. Crack maps made in IMOD overlaid on to SEM images for the 1 kg SN-2 indentation that was milled towards the indentation side. (a) 52° view of the indentation (b) Top down view of the indentation. Lateral and radial cracks are colored blue and red respectively (For interpretation of the references to colour in this figure legend, the reader is referred to the web version of this article).

Considering the influence of crack milling direction, Fig. 8 shows the 3D crack map of the SN-2 1 kg indentation milled 45° to the indentation corner. There are both shallow (depth $< 5\ \mu\text{m}$) and deeper
