Stephen, J.T., Hardwick, C., Beaty, P. et al. (2 more authors) (2019) Ultrasonic monitoring of insulated block joints. *Proceedings of the Institution of Mechanical Engineers. Part F: Journal of Rail and Rapid Transit*, 233 (3). pp. 251-261. ISSN 0954-4097

Ultrasonic Monitoring of Insulated Block Joints

Insulated block joints are essential components used in railway tracks, to separate them into circuits used for train detection and signalling. However, they also represent a weak point in the track system, and have a finite life. Condition monitoring of these components in order to plan preventative maintenance is currently labour intensive, and can lead to significant costs for the rail operator.

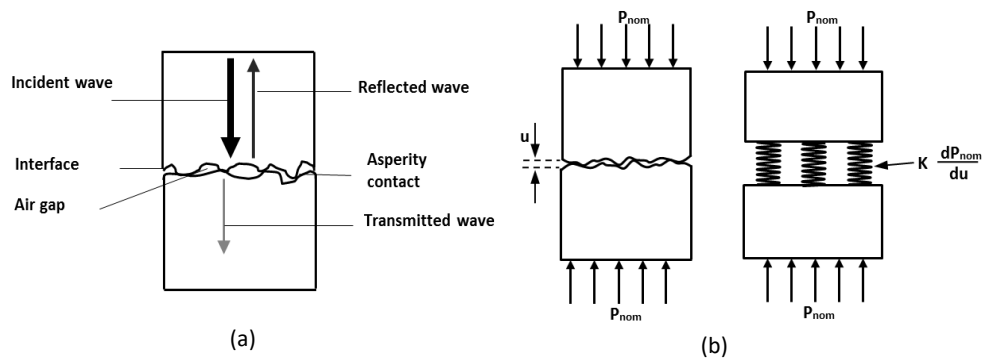
Figure 1: (a) Ultrasonic reflection at a rough surface interface and (b) Schematic representation of an interface using the spring model.

In a study conducted by Kendall and Tabor [23] on rough surface contacts, and followed up by Tattersall [24] on adhesive layers, the asperity interactions of the interface were modelled as a series of parallel springs (Figure

1b). They found that when the wavelength of the ultrasound was large compared to the scale of the surface roughness, the interface behaved as a unique reflector, and that the reflection coefficient depends on the interfacial stiffness, K , with the relationship between them governed by:

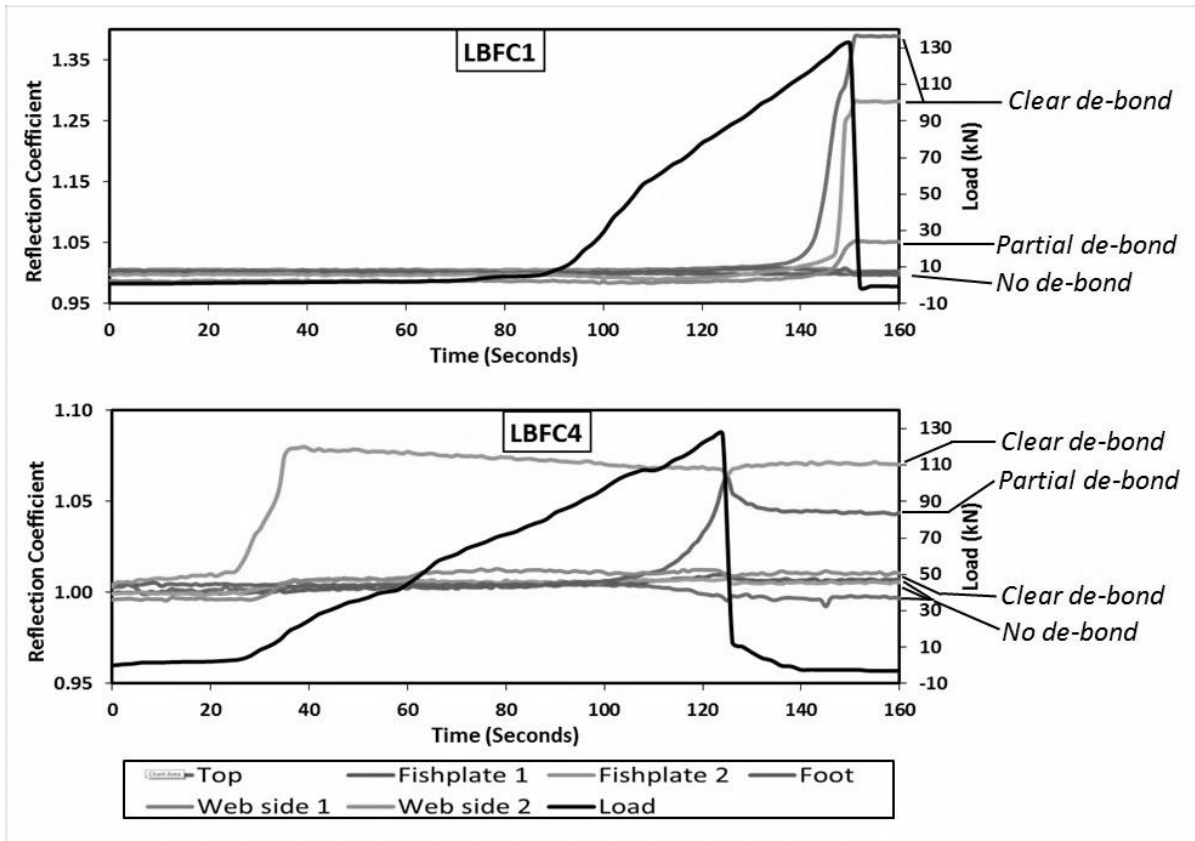
Figure 7: Measured reflection coefficients and shear load during the shearing test of IBJs with pultruded glass fibre (LBFC1) and flexible glass fibre sheet (LBFC4)

Figure 7 shows the results of the shear tests conducted on the two fishplates, where both the applied load along with the measured reflection coefficients from the previously detailed six sensor locations are shown. Similar failure loads were recorded in each case, where the value of the applied shear load increases from 0 to a maximum when the fishplates are sheared. Additionally, as in the case of the lap joints, elastic behaviour is also observed. It should also be noted that the tests were run under displacement control, accounting for the observed variation in load rate. As shown in both cases, reflection coefficients remain approximately uniform until approximately 90% of the shear load at failure has been applied. At this point, as failure begins to initiate, an increase in reflection coefficient for some of the sensors is observed. Sites where reflection coefficient increases were observed were investigated post-test, and found to correlate with where de-bonding had occurred, with the relative rise in reflection coefficient also linked to the degree of de-bond present. An exception occurs for the flexible glass fibre sheet specimen on the web side, where an early failure was detected. However, this does not appear to prejudice the overall integrity of the specimen, suggesting the failure is localised. Finally, it should also be noted that the flexible glass fibre specimen sustained a small amount of shear load post-failure, and in this case some shearing of the liner material was also observed.
