Damage Detection in a Laboratory Wind Turbine Blade using Techniques of Ultrasonic NDT and SHM

K. Yang^a, J.A. Rongong^b and K. Worden^{b1}

This paper presents a case study in the use of ultrasonic NDE/SHM techniques for detecting and locating damage in a real (but small) wind turbine blade. Two techniques are considered: (i) nonlinear acoustics, and (ii) guided-wave ‘pitch-catch’ SHM. While the nonlinear acoustics approach proved disappointingly insensitive to damage induced experimentally in the blade, the guided-wave approach not only detected the damage, but proved capable of locating it, using a ‘network of novelty detectors’ methodology. A first, slightly ill-conceived, programme of guided-wave tests actually provided valuable insight into attenuation of waves in the structure of interest and supported the idea that actuator-sensor networks of a feasible density could be used for wind turbine blade SHM.

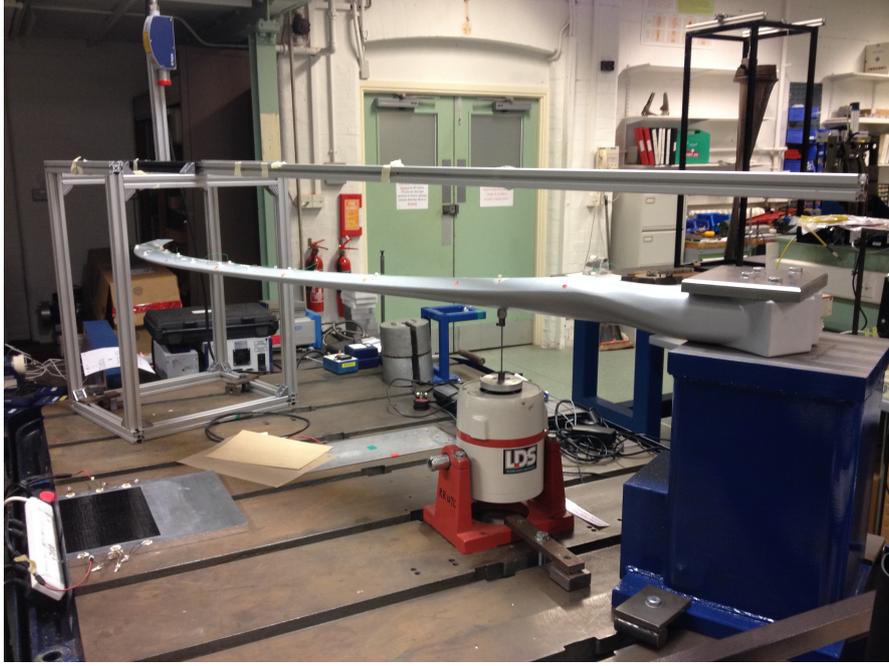
Figure 1: The experimental configuration of the WT blade, showing the geometric boundary conditions.

The structure was clamped at its base, to a substantial frame with four M10 bolts given a torque of 50Nm; this gave fixed-free (cantilever) boundary conditions (Figure 1). For the modal tests, the blade was excited using an LDS VS406 electromagnetic shaker attached to the lower part of the blade through a thin stinger, such that the force was applied perpendicular to the blade surface. The blade response was measured using unidirectional piezoelectric accelerometers, and a standard piezoelectric force transducer was used to record the excitation force. All data acquisition was accomplished using an LMS SCADAS III.
