Oladokun, A, Hall, RM, Neville, A et al. (1 more author) (2019) The evolution of subsurface micro-structure and tribo-chemical processes in cocrmo-ti6al4v fretting-corrosion contacts: What lies at and below the surface? *Wear*, 440-441. ARTN: 203095. ISSN 0043-1648

THE EVOLUTION OF SUBSURFACE MICRO-STRUCTURE AND TRIBO-CHEMICAL PROCESSES IN CoCrMo-Ti6Al4V FRETTING-CORROSION CONTACTS: WHAT LIES AT AND BELOW THE SURFACE?

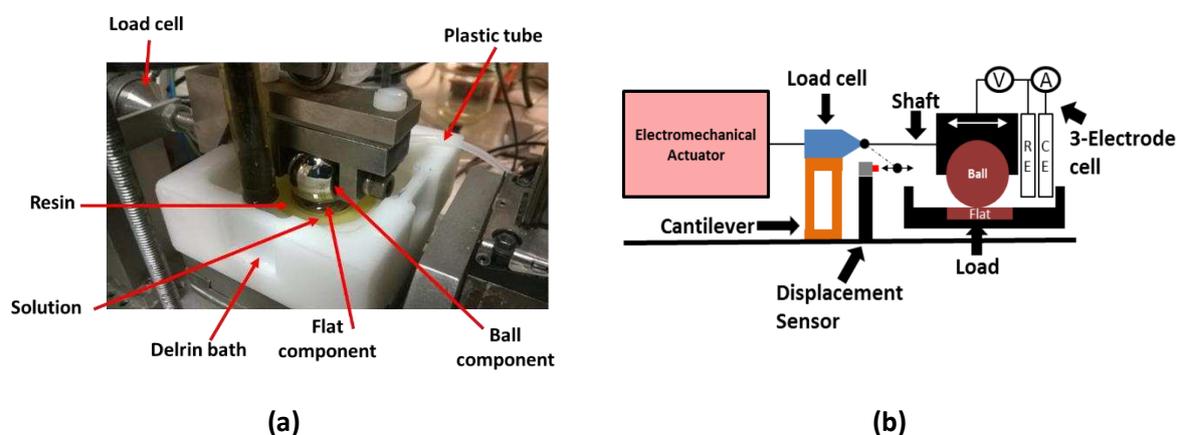
Fig 1 shows an image and schematic of the experimental set-up. Further details on the tribometer are presented in a previous study [1]. The image shows a delrin bath in which 12 mL of simulated physiological solution was placed. The temperature was kept at 37 ± 2 °C using thermostatically controlled hot water circulation within the delrin bath as shown in Fig 1. A 3-electrode electrochemical cell was integrated into the fretting tribometer consisting of the tribo-couple as the working electrode (WE) and a combination Ag/AgCl reference electrode (RE) and Pt counter electrode (CE) (ORP Redox, Orion 9179, Thermoscientific, USA). The open circuit potential (OCP) was measured as a semi-quantitative indication of corrosion at the interface, with a decrease in OCP at the start of sliding indicative of de-passivation processes. The OCP was measured at a frequency of 1 Hz using a PGSTAT101 (Autolab, NV)

Fig 1 - a) An image of the fretting corrosion set-up and b) schematic representation of the fretting-tribometer used in this study.

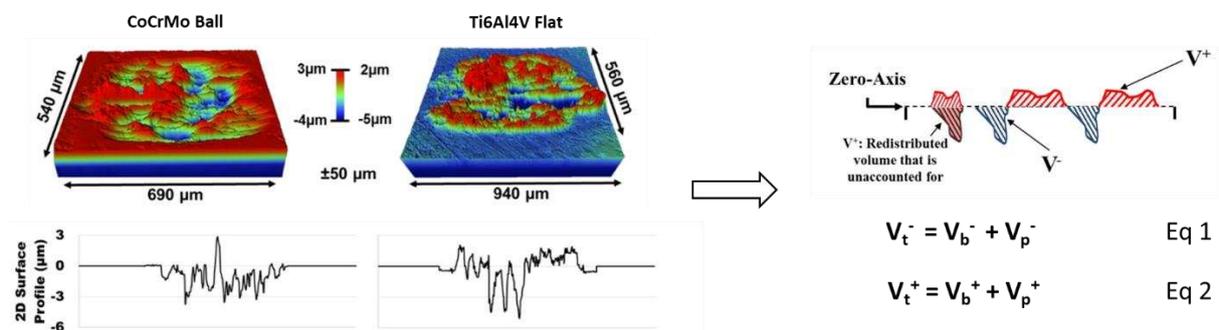
Fig 2 – Schematic representation of the determination of wear from the CoCrMo ball and Ti6Al4V surface after fretting corrosion where V_b^- and V_p^- are volume losses for the ball and plate, respectively. V_b^+ and V_p^+ represent volume gains for the ball and plate, respectively.

The total material lost from the fretting contact of the ball and flat components was measured using a NPFLX interferometer (Bruker, USA). Surfaces were scanned, corrected for curvature or Sphericity (in the case of the CoCrMo ball) and the volumes losses / gains determined using the Vision64 software (Bruker, USA). Fig 2 shows a schematic of the surface evaluation using VSI analysis. Negative (V^-) and positive (V^+) volume losses were determined about a reference zero-axis determined from areas not subjected to tribocorrosion.

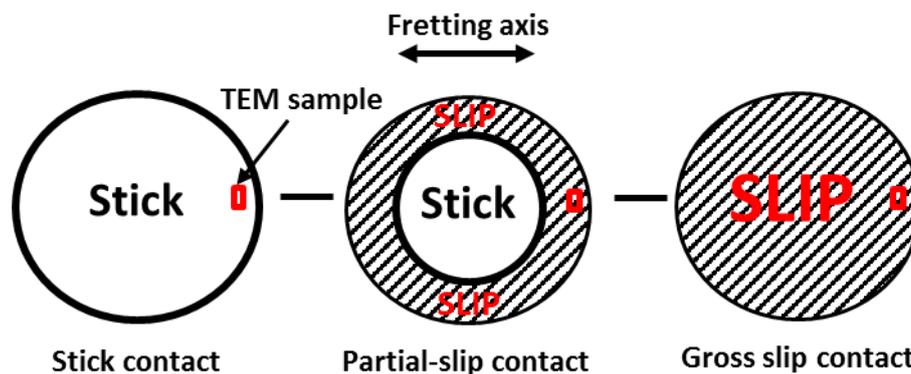
Fig 3 - A schematic diagram of fretting wear scars corresponding to different fretting regimes.

The subsurface refinement and microstructural changes of the Ti6Al4V alloy were characterised using TEM to obtain high resolution micrographs. The samples were prepared using the FEI Nova200 FIBSEM equipped with a Kleindiek micro-manipulator Focused Ion Beam (FIB). This was done following an established method outlined in a previous study by Bryant et al [29]. The region of interest of the Ti6Al4V surface was protected from ion-beam damage by coating with two layers of Platinum (Pt). Fig 3 shows a schematic diagram of a typical wear scar for three fretting regimes and illustrates the

composite contact conditions that typically exists at a fretting interface. A benefit of the ball-on-flat contact is that defined slip regimes can be easily identifiable. It is expected that the extent of microstructural variations incurred within the alloy would be site specific. TEM samples were obtained from a consistent region for all samples i.e. from an annulus nearer to the edge of the contact boundary as depicted in Fig 3. In all cases the TEM samples removed were orthogonal to the direction of the fretting axis. A TEM sample not subjected to fretting-corrosion was obtained from polished Ti6Al4V surface and taken as a reference microstructure. TEM samples were analysed using a FEI Tecnai F20 FEGTEM (200 kV) fitted with a Gatan Orius SC600 CCD camera running GMS1 software and an Oxford Instruments 80 mm² EDS SDD running AZtec software. Bright-field, dark-field and Selected Area Electron Diffraction (SAED) patterns were all captured using the digital camera, and scanning TEM (STEM)-EDX mapping was carried out while imaging in high angle annular dark field (HAADF) mode at magnifications of 7000 and 28000 X. An approximately 10 nm probe was used, and maps were collected for approximately 10 minutes. The contrast between bright and dark regions in the TEM micrograph are indicative of different crystal orientations.

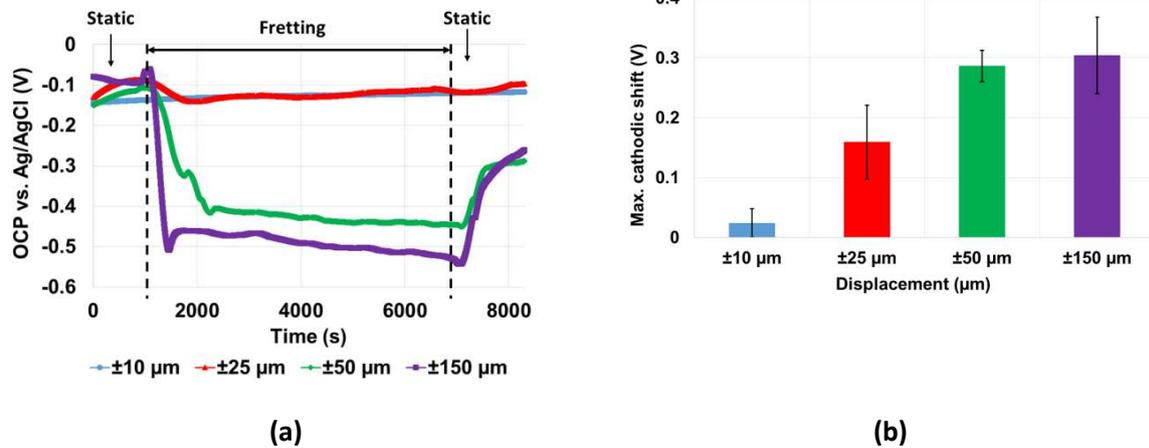
Fig 4a shows the evolution of OCP observed for CoCrMo – Ti6Al4V couples at the displacements studied. Prior to the start of fretting, a gradual ennoblement of the OCP was observed. At the start of fretting a cathodic shift in OCP was observed. The magnitude of the maximum cathodic shift in OCP was dependent on the fretting amplitude applied to the interfaces (Fig 4b). For $\delta_a = 10$ and $25 \mu\text{m}$, the OCP was seen to gradually increase with time during the application of fretting. After fretting, the OCP was monitored for a further 1000 seconds. In the case of $\delta_a = 10$ and $25 \mu\text{m}$, the OCP was similar to initial values of OCP observed ($\sim -0.1 \text{ V}$). For tribo-couples slid at $\delta_a = 50$ and $150 \mu\text{m}$, a sudden decrease in OCP was observed at the onset of fretting indicating abrasion and depassivation of the metallic

surfaces. The cathodic shift in OCP was sustained and seen to further decrease over the duration of the test until fretting was stopped. OCP was seen to enable after fretting was ceased although did not recover to values observed at the start of the test (- 0.27 to -0.30 V); indicative of the enhanced localised corrosion at the interface.

Fig 4 – a) Evolution of OCP and b) maximum cathodic shift in OCP at the displacement amplitudes studied (results show mean \pm standard error).

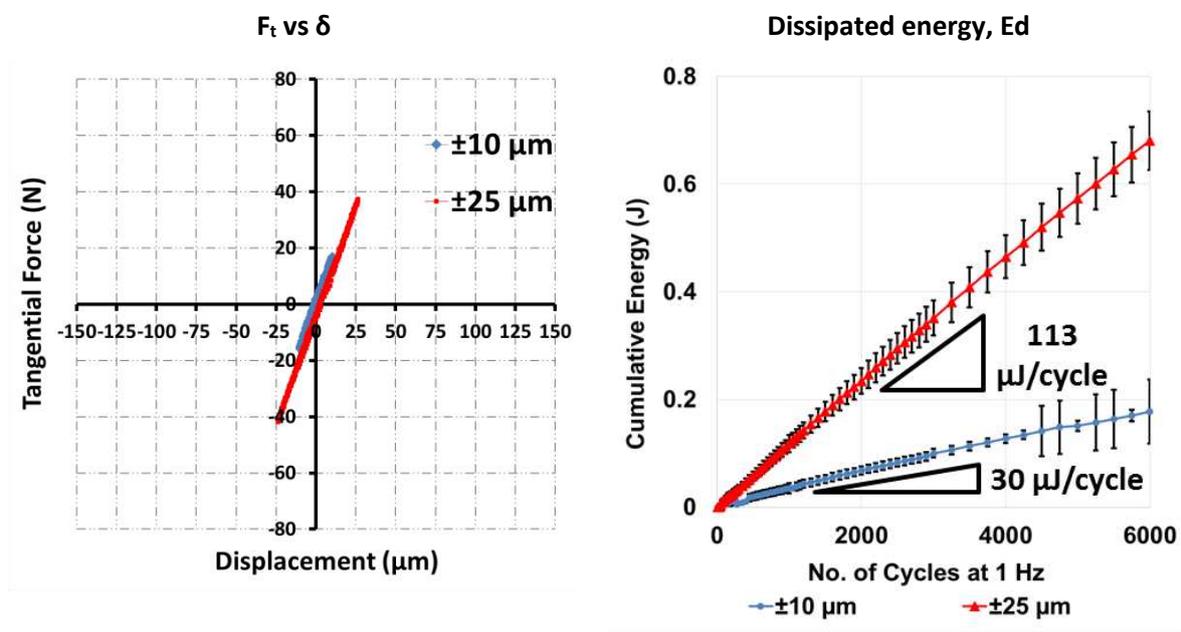
(a)

Fig 5 shows the tangential force (F_t) vs displacement (δ) and evolution of cumulative dissipated energy (E_d) as a function of number of cycles for the CoCrMo-Ti6Al4V couple subjected to fretting-corrosion. Upon initiation of fretting displacements at $\delta_a = \pm 10 \mu\text{m}$ and $\pm 25 \mu\text{m}$, a stick regime was observed with an increase in F_t being observed at $\delta_a = \pm 25 \mu\text{m}$ when compared to $\delta_a = \pm 10 \mu\text{m}$ (Fig 5a). The cumulative amount of energy dissipated at the contact for both $\delta_d = \pm 10 \mu\text{m}$ and $\pm 25 \mu\text{m}$ is also shown. A linear increase in the cumulative dissipated energy was observed for both displacements corresponding to and energy dissipation rate of $30 \mu\text{J}/\text{cycle}$ and $113 \mu\text{J}/\text{cycle}$ at $\delta_d = \pm 10 \mu\text{m}$ and $\pm 25 \mu\text{m}$, respectively. A sliding to displacement ratio of $\frac{\delta_s}{\delta_d} = 0.029 \pm 0.002$ and 0.068 ± 0.004 was observed for contacts subjected to $\delta_d = \pm 10 \mu\text{m}$ and $\pm 25 \mu\text{m}$ respectively. This is firmly in the stick regime as identified by Fouvry et al [37] and was seen to remain in the stick regime for the duration of the test.

Fig 5 – F_t vs δ and cumulative dissipated energy vs number of cycle for CoCrMo-Ti6Al4V couples at a) 10, 25 b) 50 and c) 150 μm

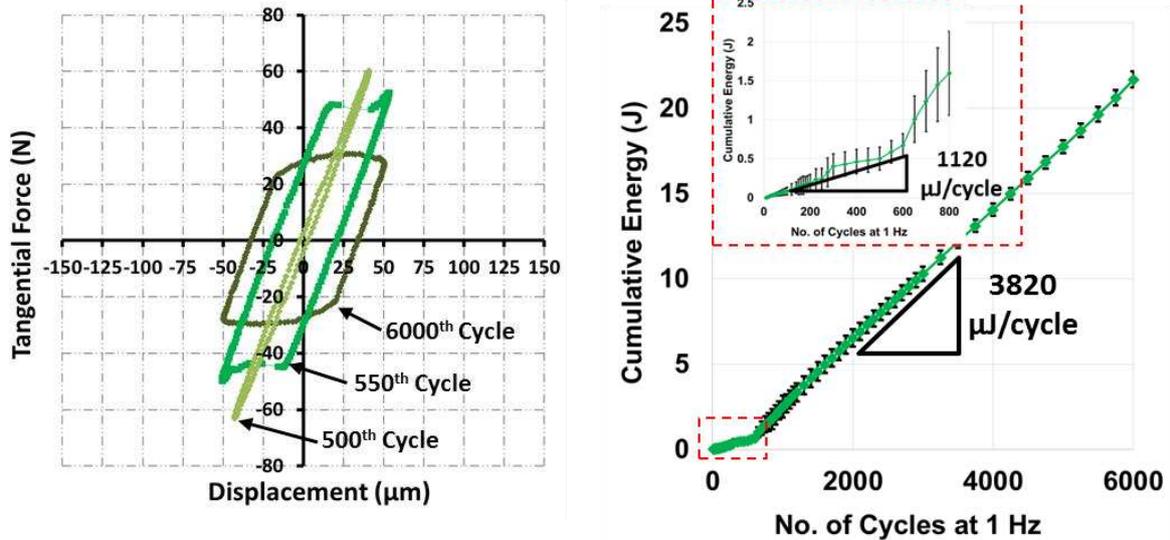
(b)

Fig 5b shows the different fretting loops observed at points during the test of a CoCrMo – Ti6Al4V contact subjected to $\delta_d = \pm 50 \mu\text{m}$. A ‘mixed’ fretting regime characterised by the transient nature of slip at the interface was observed. A partial-slip regime was observed in the first ~ 600 cycles of fretting transitioning into a gross slip regime for the remainder of the test. A representation of the partial-slip fretting loop is shown at the 500th cycle. A period was observed at the 550th cycle whereby the partial-slip regime accommodated a higher degree of ‘actual interfacial slip’ prior to transition into the full

gross slip regime. The transition to gross slip was accompanied with a significant reduction of the tangential force as depicted by the fretting loop obtained at the 6000th cycle. The graph of cumulative energy is also shown in Fig 5b. The rate of cumulative energy dissipation as a function of cycles differs for the two regimes. A transition in the rate of change of dissipated energy was observed at approximately 600 cycles from 1120 $\mu\text{J}/\text{cycle}$ to 3820 $\mu\text{J}/\text{cycle}$. This correlates with the observations made above. The energy dissipated per cycle at the gross slip regime was more than three times greater when compared to the partial-slip regime. Interestingly, a decrease in tangential force was observed in the gross-slip regime indicating that energy dissipation in the gross slip regime is slip dominated. The transition in the fretting regime at $\delta_d = \pm 50 \mu\text{m}$ was further confirmed by the slip ratio criteria. Below 500 cycles, $\frac{\delta_s}{\delta_d} = 0.21 \pm 0.11$ indicating a partial-slip regime. After 550 cycles, $\frac{\delta_s}{\delta_d} = 0.634 \pm 0.114$ indicating transition into the gross-slip regime.

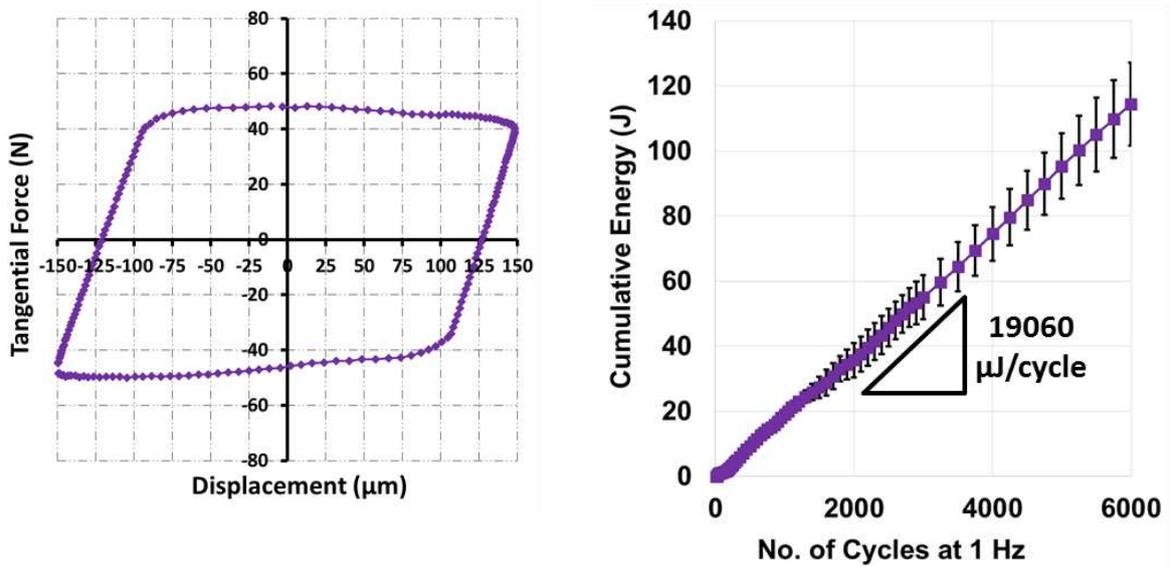
(c)

Fig 5c shows the fretting regime at $\delta_d = \pm 150 \mu\text{m}$. A gross slip regime was observed throughout the duration of the test. The cumulative dissipated energy graph (Fig 5c) shows constant energy dissipation per cycle throughout the duration of the test. An energy dissipation rate of 19060 $\mu\text{J}/\text{cycle}$ was observed when $\delta_d = \pm 150 \mu\text{m}$. The sliding – displacement ratio was seen to remain stable throughout the tests, $\frac{\delta_s}{\delta_d} = 0.85 \pm 0.01$ indicating a gross-slip regime.

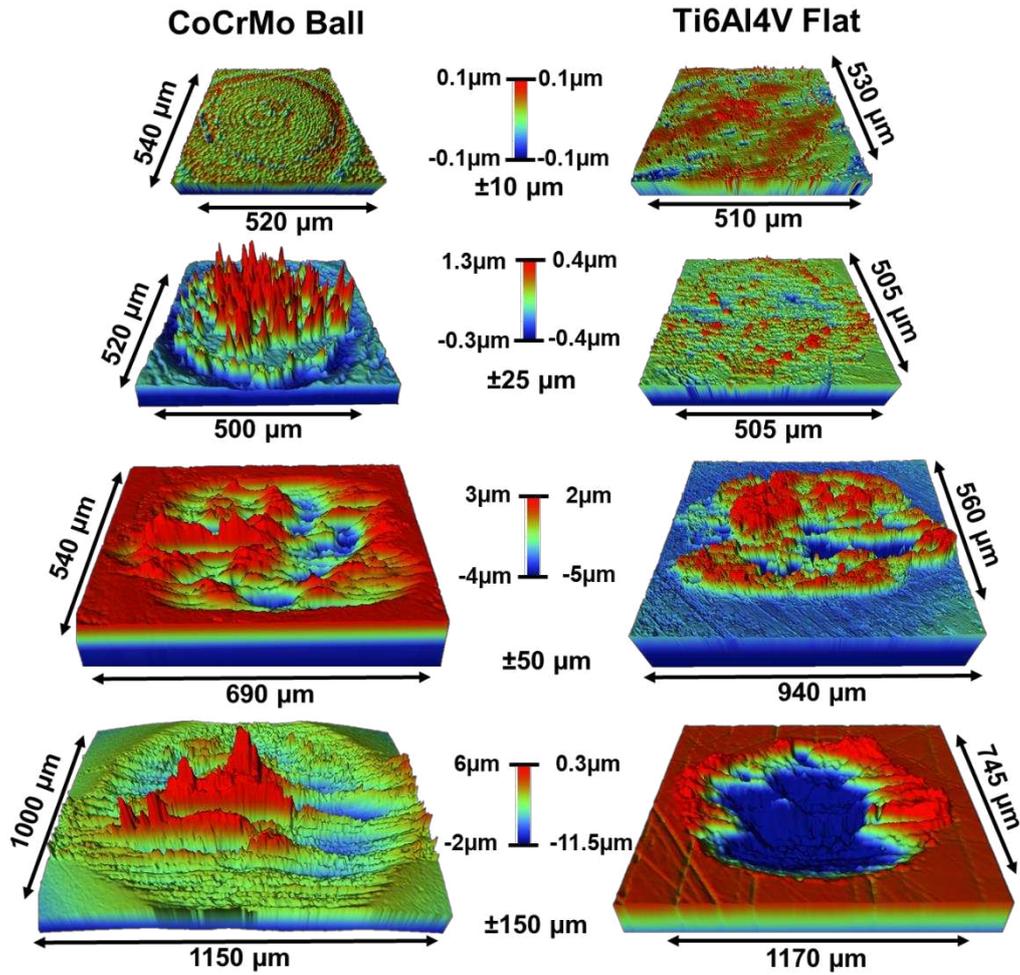
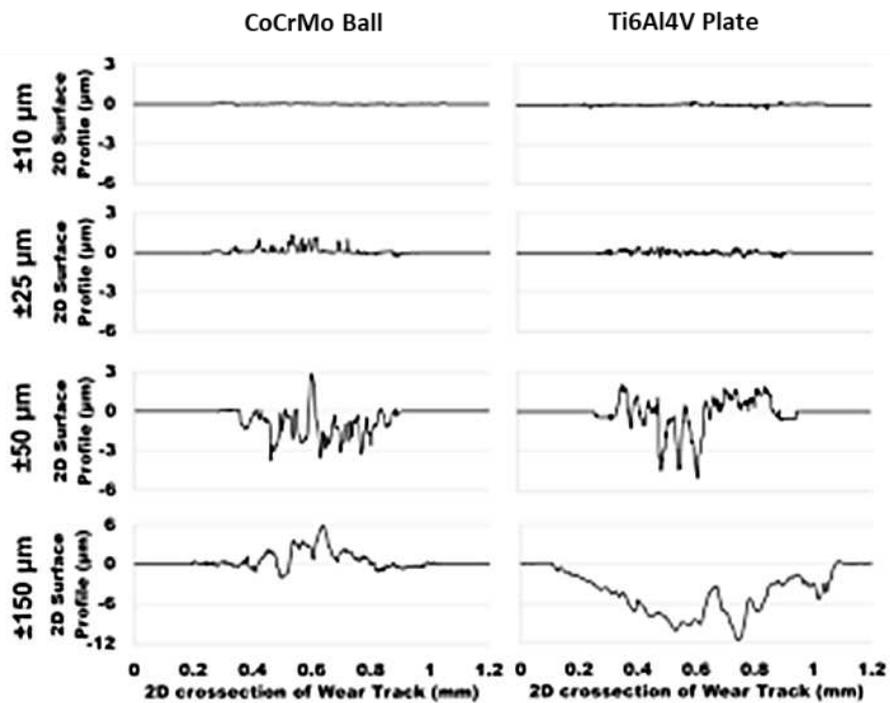
The 3D and 2D surface profiles of the CoCrMo – Ti6Al4V combination are shown in Fig 6a and 6b, respectively. At $\delta_a = \pm 10 \mu\text{m}$, no visible signs of material loss on the CoCrMo ball or Ti6Al4V flat could be observed. At $\delta_a = \pm 25 \mu\text{m}$, a thin annulus at the edges of the contact area on the CoCrMo ball showed evidence of materials loss. The maximum material loss within the annulus was $\sim 300 \text{ nm}$. Across the entire central partial-stick region, third-body materials generated from the contacting interface was observed. The Ti6Al4V flat showed no evidence of material loss although some material transfer was observed. At $\delta_a = \pm 50 \mu\text{m}$, both surfaces showed evidence of material loss and

redistribution of material within the contact area. Clear directionality in the resultant surface topography was observed. Both surfaces demonstrated evidence of positive volume with a thickness up to 3 μm with reference to the original surface. At $\delta_a = \pm 150 \mu\text{m}$ mass loss from both surfaces was observed. The Ti6Al4V surface was mainly characterised with larger wear depths (maximum depth $\sim 11 \mu\text{m}$) with no evidence of material build-up within the degraded area. Similar observations were made for the CoCrMo surfaces, although with some localisation of material build-up in the contact area. In general, the size of the wear contact surface for both ball and flat components at $\delta_a = 10 - 25 \mu\text{m}$ was similar to the initial Hertzian contact width ($2a = 500 \mu\text{m}$).

Fig 6 – a) 3D and b) 2D surface profiles of CoCrMo and Ti6Al4V areas after fretting-corrosion measured using VSI. Fig 6c and 6d show the material volume loss and material gain on each surface. Note the y-axis on Figs 6c and d are on a logarithmic scale. Volume losses were not measurable at $\delta_a = \pm 10 \mu\text{m}$

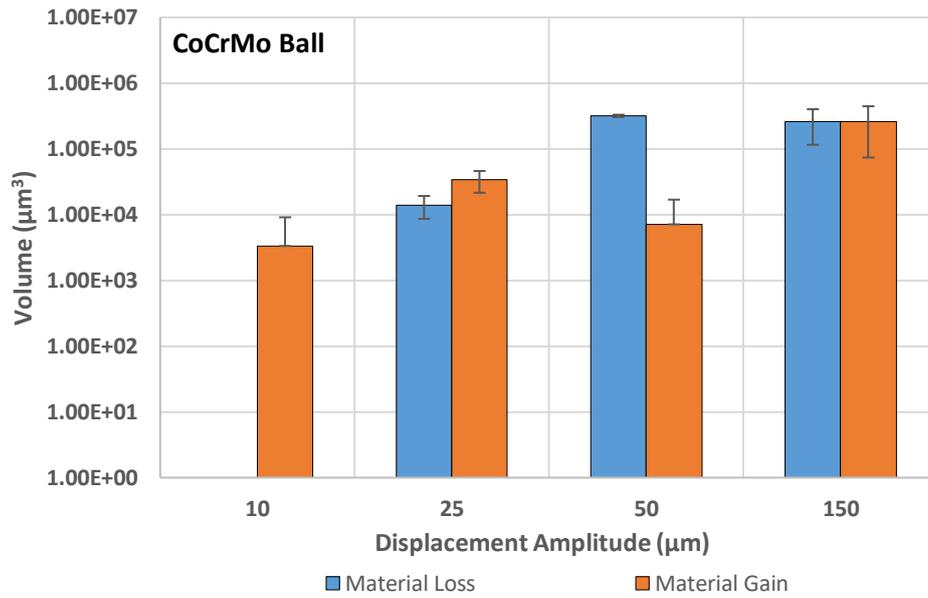
(c)

Fig 6c and 6d show the volumetric material loss (i.e. material below the datum) and material build-up (i.e. material above the datum) for the CoCrMo ball and Ti6Al4V plate, respectively. No measurable volume loss could be determined on the CoCrMo ball (Fig 6c) at $\delta_a = 10 \mu\text{m}$ and any surface deviations observed were in the order of the original surface roughness. An increase in material loss was seen with increasing displacement amplitudes from $\delta_a = 25 - 50 \mu\text{m}$, with no further increase in volume losses at $\delta_a = 150 \mu\text{m}$ when compared to $\delta_a = 50 \mu\text{m}$. Material build-up on the CoCrMo ball (Fig 6c) was seen to vary correlate with increasing displacement.

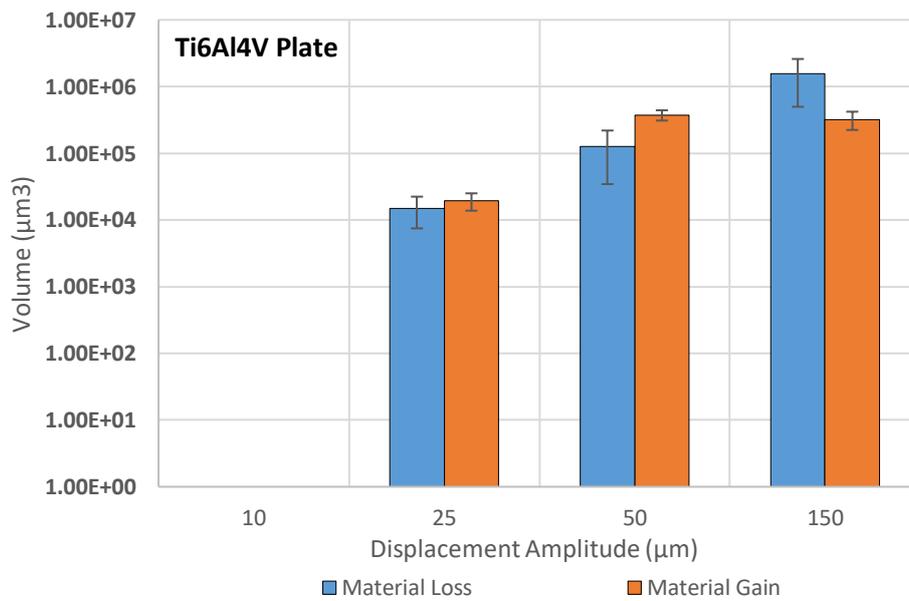
(d)

Fig 6d shows the volumetric material losses and build-up for the Ti6Al4V plate. No measurable volume loss could be determined on the Ti6Al4V plate at $\delta_a = 10 \mu\text{m}$ and any surface deviations observed were in the order of the original surface roughness. From $\delta_a = 25 - 150 \mu\text{m}$, an increase in volume loss was observed with increasing displacement amplitude. Material build-up was seen to increase from $\delta_a = 25 - 50 \mu\text{m}$ little changes in material build-up were observed at $\delta_a = 150 \mu\text{m}$ when compared to the lower displacement amplitudes.

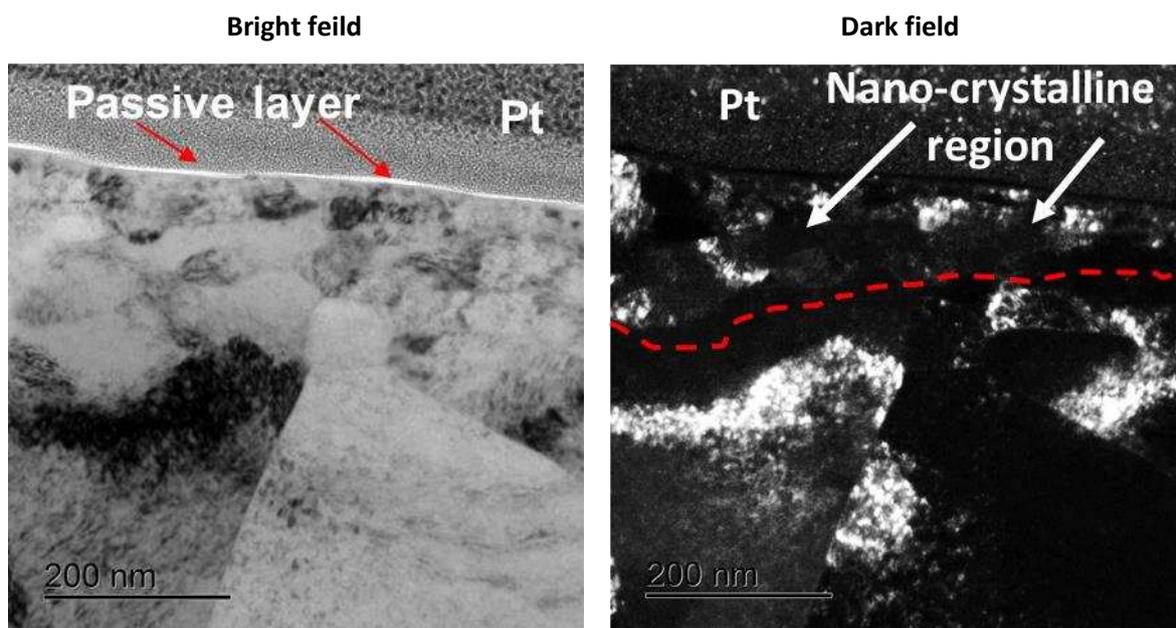
(a)

Fig 7 shows the bright and dark-field TEM micrographs obtained from the Ti6Al4V disc after fretting corrosion. Fig 6a shows a TEM micrograph of the polished Ti6Al4V alloy in the absence of fretting and corrosion. A naturally occurring thin protective oxide layer typically known as the “passive layer” was

visible from the bright-field image. Evidence of a nano-crystalline microstructure was observed within top 150 – 200 nm of the alloy surface, directly beneath the passive layer. The red dashed-line in Fig 7a is drawn to distinguish the nano-crystalline structure above from the single-crystal structure beneath it. The single-crystal structure beneath is identifiable by its larger grain size relative to the smaller grain-sizes above the red dashed-line, identifiable using dark-field imaging. The bright and dark-field micrographs of Ti6Al4V after fretting at $\pm 10 \mu\text{m}$ are shown in Fig 6b. When compared to Fig 7a, evidence of strain-induced re-orientation of the subsurface was observed. A similar, but more profound pattern was observed at $\delta_d = \pm 25 \mu\text{m}$ (Fig 7c).

Fig 7 – Sub-surface bright-field and dark-field TEM images for a) Reference polished Ti6Al4V surface and after being subjected to fretting-corrosion at b) 10 c) 25 d) 50 and e) 150 μm .

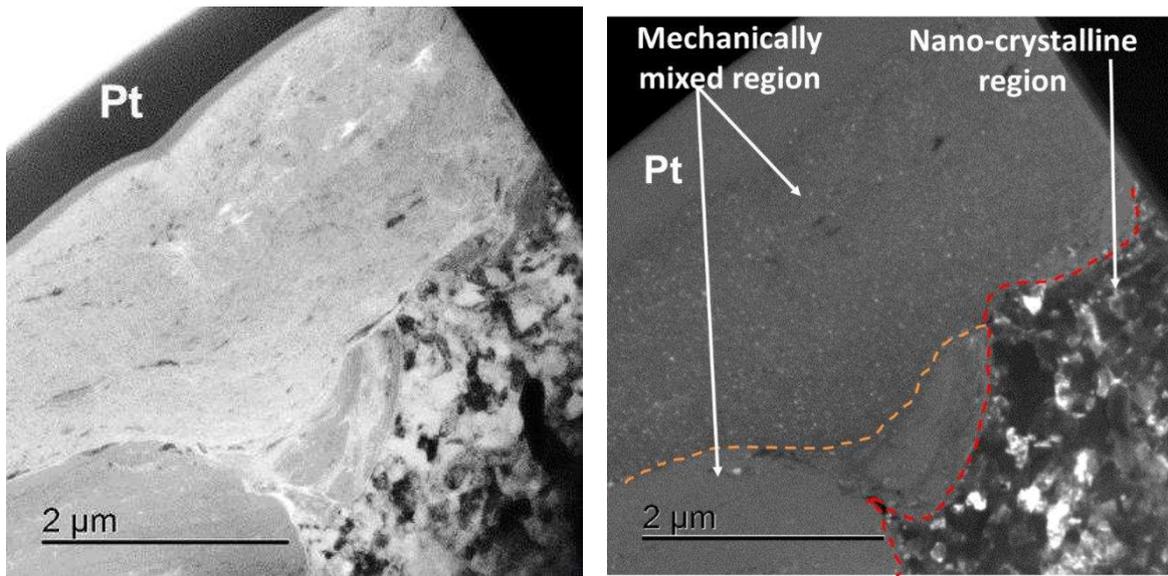
(d)

Fig 7d shows the bright and dark-field micrographs of the Ti6Al4V subsurface when subjected to fretting-corrosion at $\delta_d = \pm 50 \mu\text{m}$. When compared to lower displacements, significant changes in the sub/surface chemistry and crystallinity were observed. Directly beneath the two layers of protective Pt, a 2-3 μm thick 'mechanically mixed' layer was observed. This consisted of a fine nano-crystalline structure consisting of particulates and amorphous materials. Three distinct regions of this material was observed across the interface (boundary's highlighted in orange). Evidence of a poly-crystalline Ti6Al4V microstructure was seen directly beneath the surface layer with a grain size similar to the reference surface. Material transitioning into the layer from the bulk Ti-alloy can be seen.

Fig 8 shows the EDX and SAED analysis to further characterise the three different structures observed on Ti6Al4V surfaces subjected to $\delta_a = 50 \mu\text{m}$ (Fig 7d). Three different structures were seen; the fine particulate, mechanically mixed structure is denoted 'A'. The non-particulate structure directly beneath structure A is denoted 'B' and the nano-crystalline structure beneath both structures 'A' and 'B' is denoted 'C'. SAED confirms the structure 'A' to be nano-crystalline. Area 'B' appears to be amorphous as evidenced with the shroud of bright spots forming a ringed pattern. Structure 'C' is confirmed to be nano-crystalline Ti6Al4V material. EDX mapping of the cross-section shows that structure 'A' is a material rich in Co, Cr, Ti, Mo, V, Al, C O and Cl suggesting the material is complex

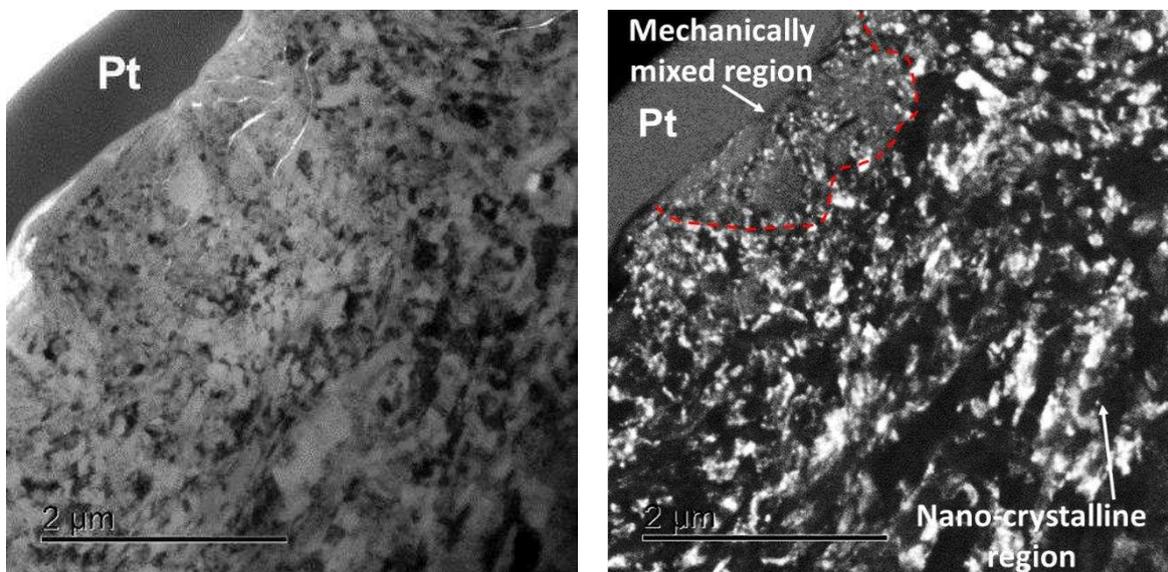
(e)

From the micrographs shown in Fig 7e ($\delta_d = \pm 150 \mu\text{m}$), subsurface strain-induced refinement of the Ti6Al4V microstructure was observed when compared to the reference samples. Evidence of cracking and mixing of organic species at and within the interface was visible.

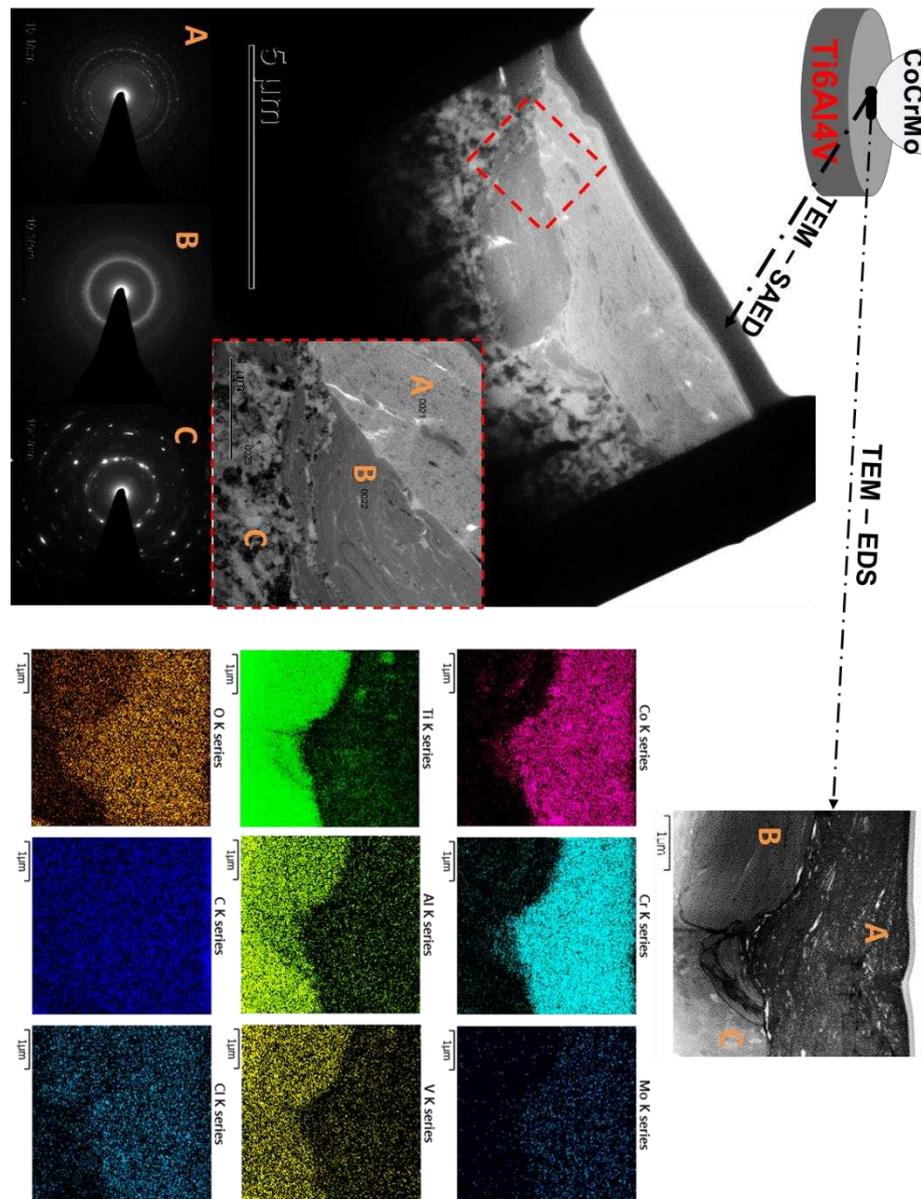
mixture of tribo-chemically mixed materials originating from the CoCrMo, Ti6Al4V and lubricant. The map also shows evidence of localisation of Ti within the mechanically mixed products of structure 'A' which may be indicative of Ti rich particulates. For structures 'B' and 'C', EDX mapping identifies the chemical constituents of both structures to have originated from the Ti6Al4V alloy. Evidence of O and Cl in amorphous structure of 'B' was observed. The combination of SAED and EDX mapping confirms structure 'C' to be a bulk Ti6Al4V material.

Fig 8 – Bright-field, EDX and SAED analysis of the three different structures observed on Ti6Al4V surfaces subjected to $\delta_a = 50 \mu\text{m}$.

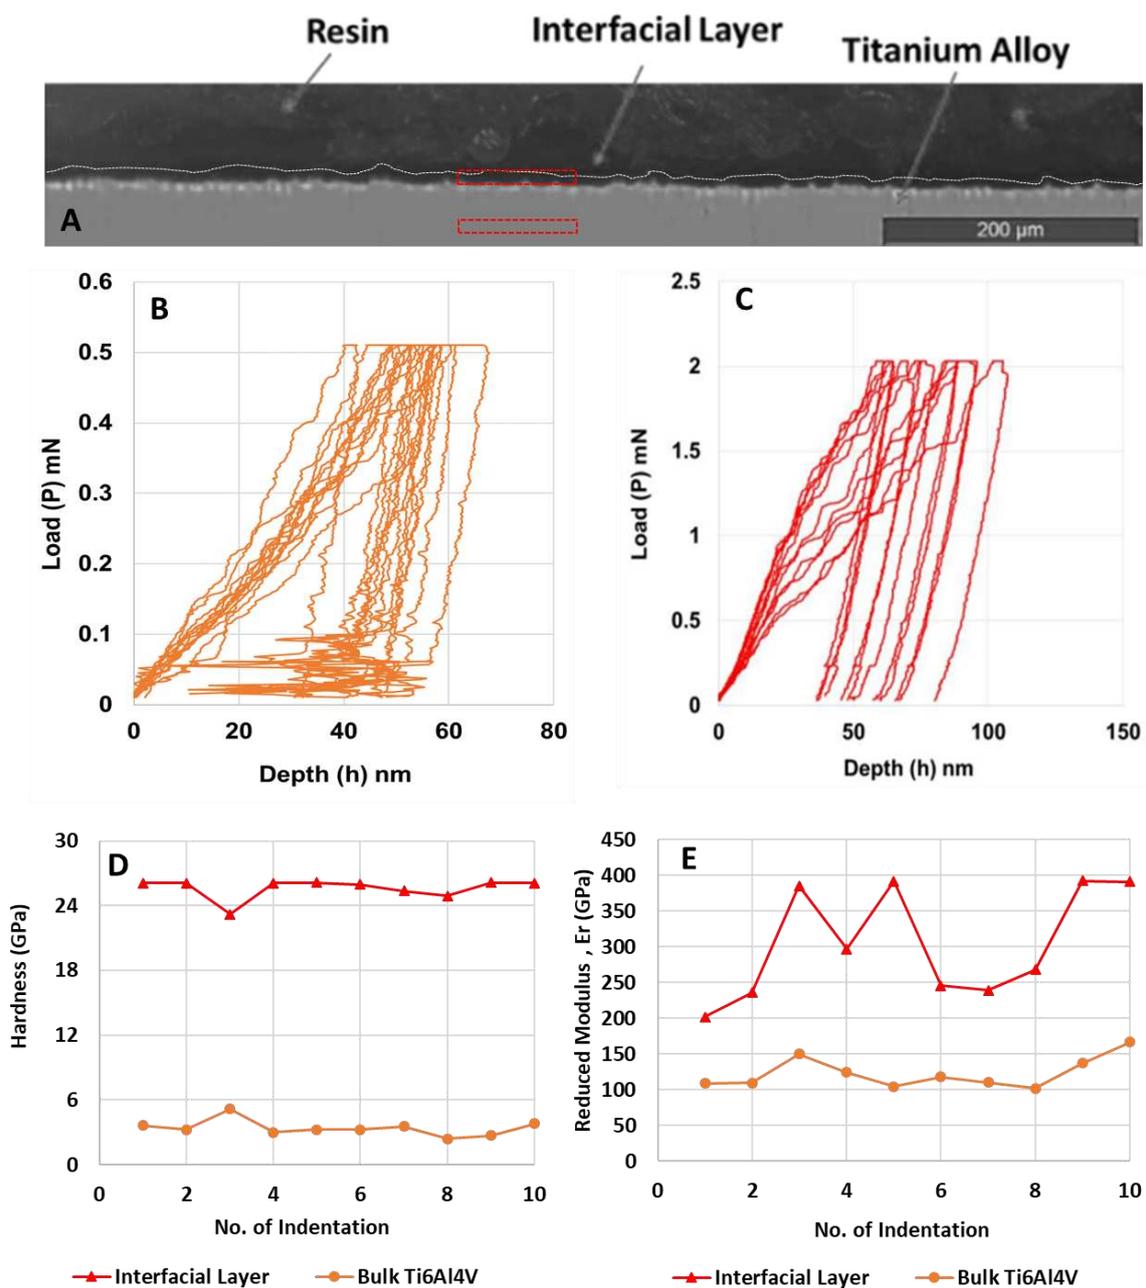
Nano-indentation was performed on cross-sections of the Ti6Al4V prior to and after simulated fretting corrosion (Fig 9a). Figs 10b and 10c show the obtained force displacement data for bulk Ti6Al4V and interfacial layer the when indented between $\sim 20 - 60$ nm, respectively. An increase in hardness (Fig 9d) and Reduced Modulus (E_r , Fig 9e) was observed for the tests subjected to fretting-corrosion when compared to the Ti6Al4V surface.

Fig 9 – a) cross-sectional optical microscope image showing the interfacial layer (white dashed) and the region where nano-indentation was made on the interfacial layer and bulk Ti6Al4V (red dashed). Fig 9b and c show the raw force-displacement obtained. Fig 9d and e show the hardness and Reduced Modulus data determined using the Oliver and Parr approach.

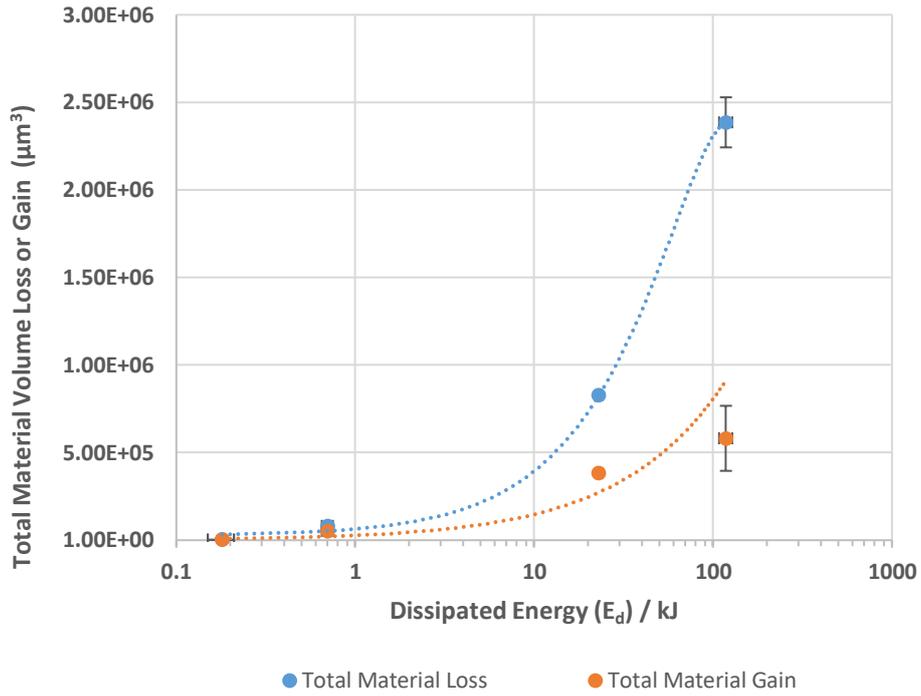
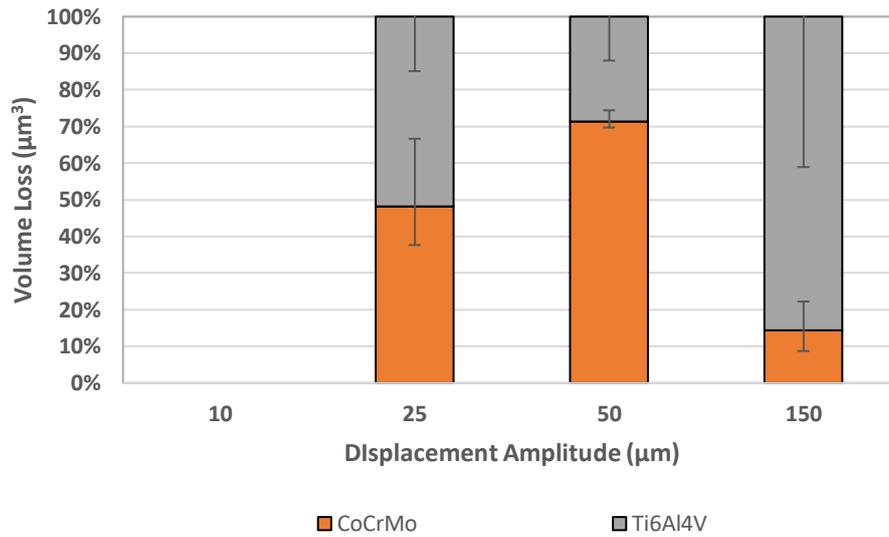
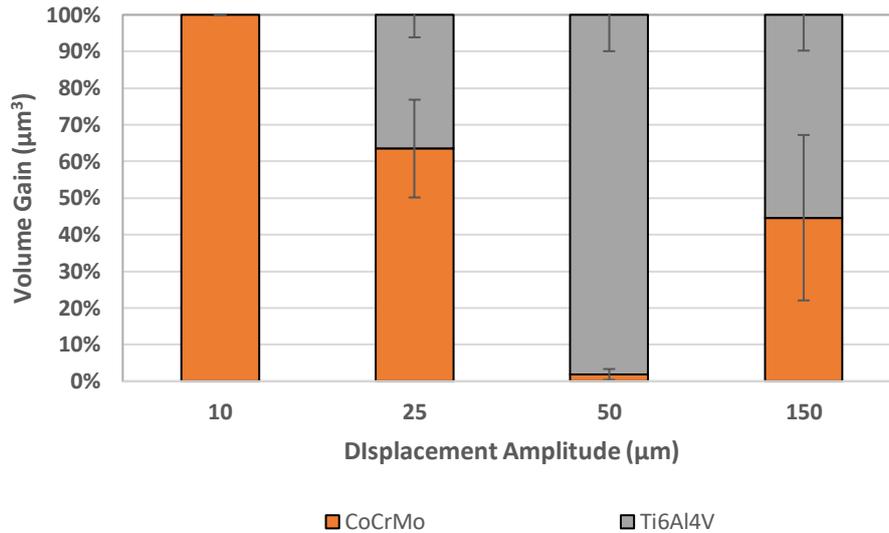
Fig 10 – a) Correlation of volume losses / gains with dissipated energy and percentage contribution of b) material loss or c) material gain from CoCrMo and Ti6Al4V surfaces.

As the nature of slip changes it is evident that the dissipative pathways change. At $\delta_a = 50 \mu\text{m}$, the fretting contact exhibits a partial slip, transient regime exists where energy is dissipated through wear and corrosion (indicated via OCP measurement), subsurface microstructural changes and tribochemical processes. This is further complicated by the elastic-plastic nature of the deformation within the fretting contact. TEM analysis shows that the nature of the interface changes significantly when compared to the control surface and tests conducted at $\delta_a = 10$ and $25 \mu\text{m}$. Refinement of the subsurface microstructure, the formation of localised areas of amorphous materials consisting of materials derived from the Ti-alloy and lubricant and the formation of a relatively thick nanocrystalline materials consisting of metal oxides and organic matter was confirmed by EDS and SAED analysis. The formation of these materials within the contact may explain the transient nature of the contact due to the gradual build-up and subsequent fracture of the interface layers, as evidenced in Fig 8. It also gives further insight into the observations made by Swaminathan who suggested that CoCrMo may dominate the outcomes for mixed-metal fretting-corrosion contacts. With the generation and retention of such layers within the contact, the nature of the interface that facilitates slip is significantly different compared to the original nascent surfaces. TEM-EDS analysis shows the interface is a complex mixture of mixed metal oxides, dominated by Co and Cr which provides further insight into the observations made by Swaminathan [35]. At $\delta_a = 150 \mu\text{m}$ and based on the initial predicted Hertzian and final nominal contact width measured by VSI, the contact is likely incipient sliding. It is evident that subsurface microstructural refinement occurs when compared to the control sample. The nature of the interface is also very different compared to the fretting-corrosion contacts slid at lower displacement amplitude. No evidence of the formation and retention of oxides within the contact was observed and it is likely that any debris generated is likely ejected from the contact. Evidence of subsurface cracking and mechanical mixing of the Ti-alloy was seen suggesting fatigue is a component of the degradation mechanisms, although at $\delta_a = 150 \mu\text{m}$ wear will likely dominate.
