# Epifluorescent microscopy of edge-trimmed carbon fibre-reinforced polymers: An alternative to computed tomography scanning

X-Ray computed tomography (XCT) can be used to detect edge-milled carbon fibre-reinforced polymer (CFRP) defects. Significantly this method is able to show subsurface defects that cannot be captured by traditional methods such as stylus-based or more novel areal methods of surface quality measurement. While useful, this method can be prohibitive due to high equipment cost, scanning time and image resolution. XCT can often produce artefacts which falsely predict damage or obscure damage and depending on machine X-ray power often cannot resolve damage to fibre diameter which is critical when observing milled quality of the surface/subsurface. This study utilises epifluorescent (EF) optical microscopy to provide high-quality optical images as an alternative to XCT to observe through-depth damage of CFRP materials. The method of computing the novel damage criteria is presented, as well as the validation of the method which compares EF to XCT. Subsurface damage of fabric and unidirectional (UD) materials in 0°, 45°, 90° and –45° orientations to the cutting edge i

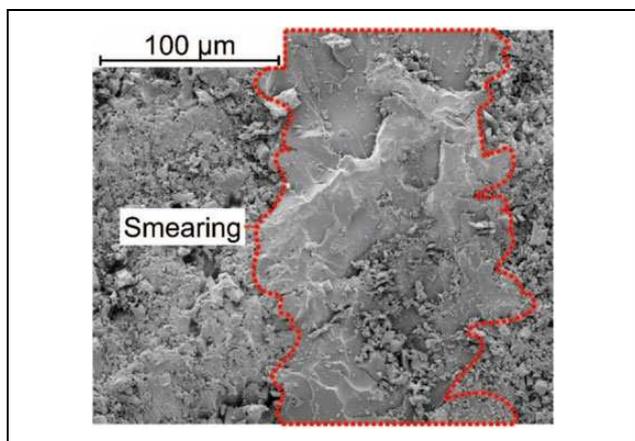
**Figure 1.** Smearing matrix observed on the trimmed surface by SEM for fibres oriented at  $90^\circ$  to cutting edge. SEM: scanning electron microscopy.

While improvements have been made to characterise the surface of the machined part quality, the full extent of damage may not be captured. Scanning electron microscopy (SEM) has confirmed that matrix smearing during edge-trimming operations can occur and occurs most predominantly in fibres oriented at  $90^\circ$  to the cutting edge<sup>9</sup>. Smearing occurs across the surface of edge-trimmed samples due to high cutting temperatures generated through the abrasive nature of cutting. This temperature exceeds the glass transition temperature ( $T_g$ ) of the CFRP reinforcement material, where  $T_g$  is the state at which the polymer becomes rubbery before its melting point.<sup>10</sup> The trochoidal motion of the tool during milling smears the rubbery polymer across the surface, potentially hiding defects. An example of this smearing is shown in Figure 1. This smearing may limit the results of areal methods of depth of damage recorded by authors<sup>7,8</sup> as the true depth of damage may be obscured and for some fibre directions ( $90^\circ$ ), the damage may be obscured entirely.

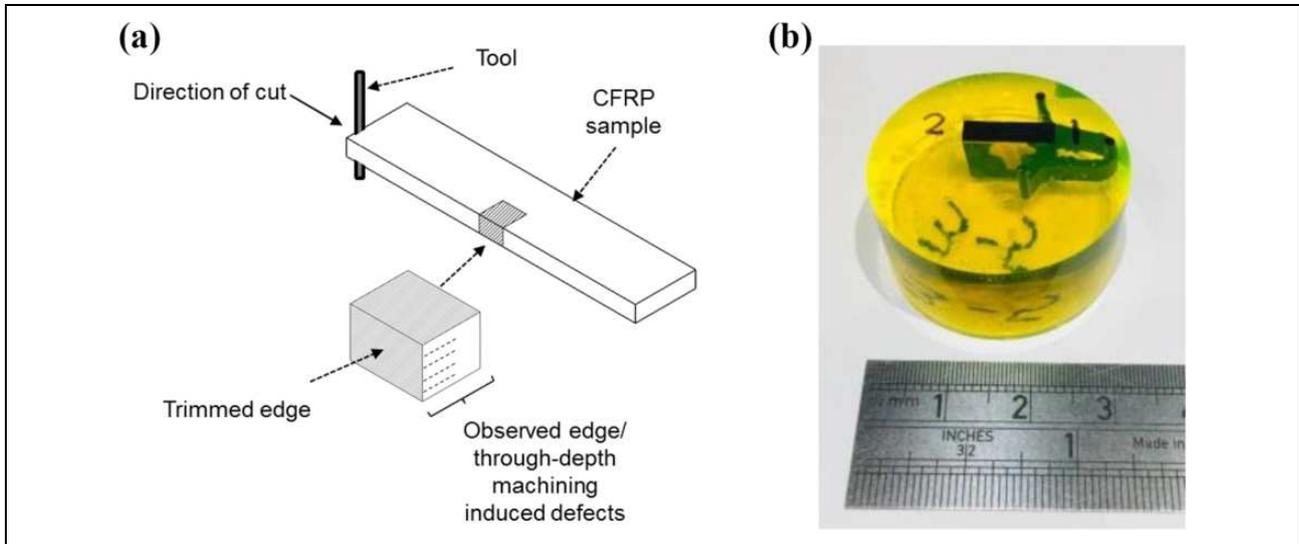
**Figure 2.** (a) Area of epifluorescent inspection of edge trimmed CFRP coupon and (b) CFRP sample mounted in fluorescent resin. CFRP: carbon fibre-reinforced polymer.

The proposed alternative to XCT requires through-depth observation of the edge-trimmed material as shown in Figure 2(a). Samples are trimmed to fit in a 30mm mounting cup using a water cooled tile saw (Erbauer) with a 1.6-mm-thick diamond disc cutter.

Following sectioning, the samples are mounted in Epo-fix which was mixed with Epo-dye (Struers, UK), an epoxy resin infused with fluorescent dye as shown in Figure 2(b). EF material has been used because of its ability to clearly show defects in damaged CFRP materials by providing extremely high contrast.<sup>13</sup> Cold mounting ensures that the damage caused by milling is not removed by heat which could potentially damage the CFRP material and change the specimen from its original machined condition. The mounted samples are placed in a vacuum of  $0.1 \text{ N mm}^{-2}$  for 5 min to ensure that the resin penetrates any cracks present in the CFRP. The samples are then cured for 24 h at room temperature. Samples were abrasively polished to remove the face of the material which may have been damaged by the Erbauer tile saw and finally polished to provide a smooth surface for optical observation using the polishing regime noted in Ashworth et al.<sup>14</sup>

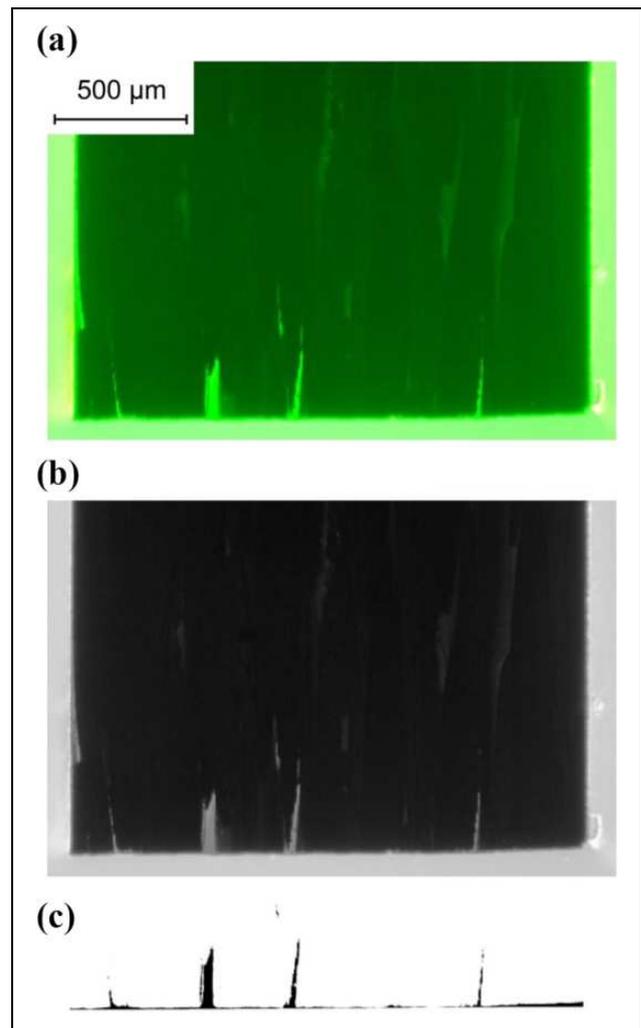
**Figure 3.** (a) Epifluorescent image showing through-depth damage, (b) Matlab processed greyscale image and (c) Matlab/Otsu processed binary image showing damage.

An X-Cite ultraviolet light box (Excelitas, Best Scientific, UK), a 5-MP digital camera (Pax-it, Best Scientific, UK) and microscope at  $2\times$  magnification were used to capture the EF sample, an example is shown in Figure 3(a).

The EF material has allowed a high contrast between the damaged and the un-damaged CFRP. To determine the amount of damage shown in Figure 3, the digital image can be subject to pixel thresholding. Thresholding of colour images is possible, however the image was changed to a greyscale for simplicity of Matlab (Mathworks). A Matlab script changes the colour image to a greyscale image as shown in Figure 3(b).

A further Matlab subroutine allows the user to define a straight edge which can be drawn across the edge of the image to represent a theoretical straight cutting line. Deviations from this cutting line are highlighted by the EF mounting material and thus represent damage. Automated Otsu thresholding<sup>15</sup> is then used within Matlab to yield a binary image of damaged areas as seen in Figure 3(c). Further Matlab calculations provide a novel damage metric which presents a pixel count/actual area (when used with

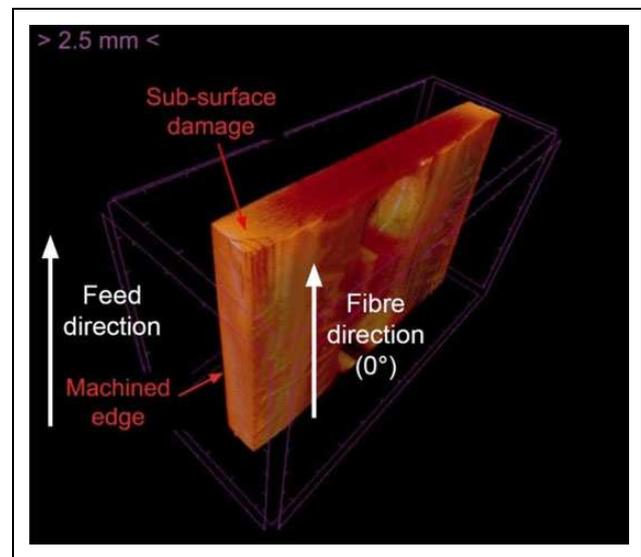
**Figure 4.** 3D XCT scan of UD fibres oriented at 0° to the cutting edge made from 1879 planar .tiff images to allow comparison to EF method. XCT: X-ray computed tomography; UD: unidirectional.

Post-processing of the images was completed using “CTvox v3.0 (Bruker)”, a free to download software to produce images that are shown in Figure 4. The 3D image is made of up to 1879 single planar slice .tiff images that can be used for direct comparison to EF images such as that

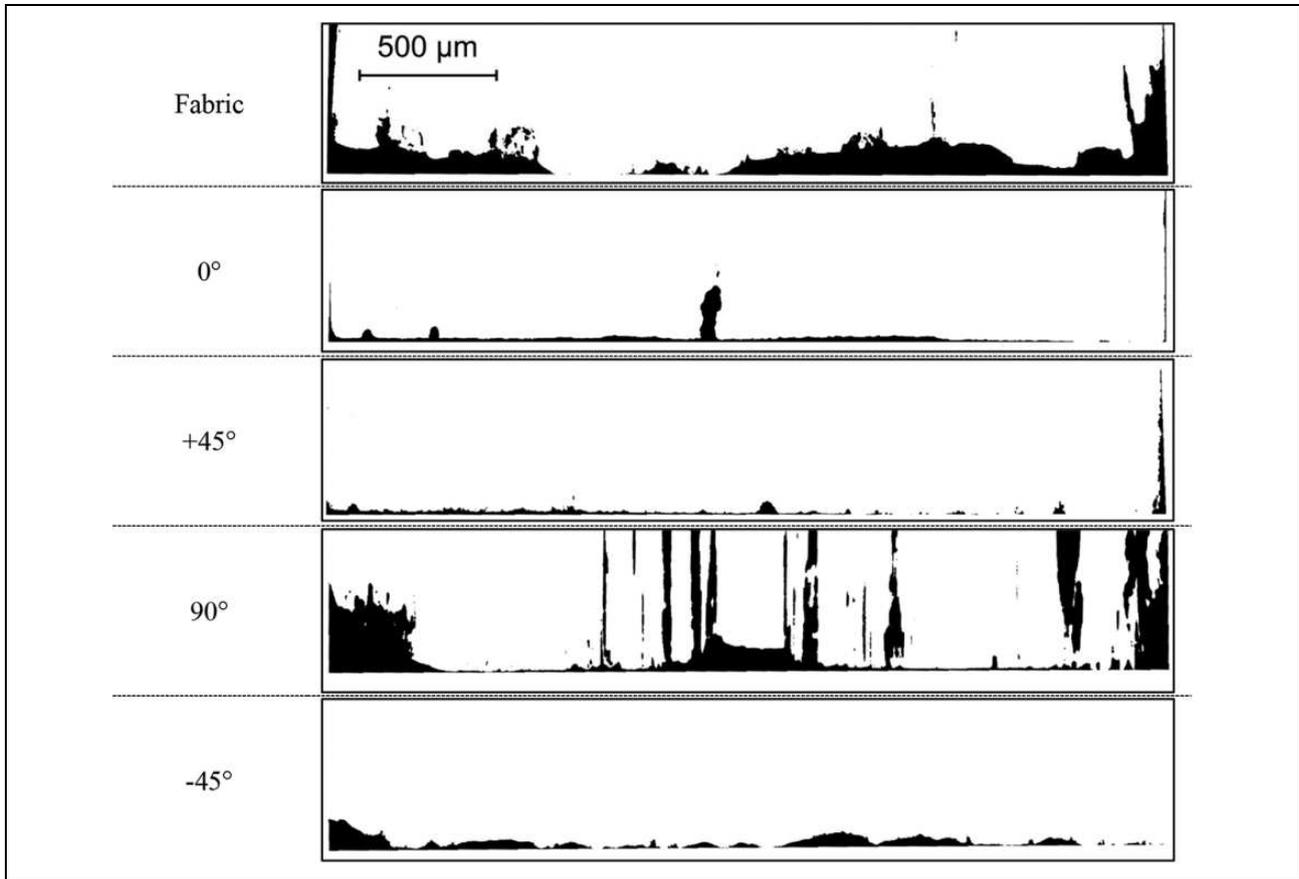
**Figure 5.** Binary images denoting damage obtained through novel metric calculations.

Figure 5 shows the binary images created through the use of the novel damage metric for the various fibre orientations used within this study. By applying the thresholding method described in the second section, the total amount of damage compared to the theoretically straight cut can be calculated. The amount of damage is shown in Figure 6, where error bars represent repeatability error of the novel process.

It can be seen that machining  $90^\circ$  fibres forms the greatest level of damage. Figure 5 shows large-scale damage along the length of the fibres/fibre–matrix interface. The damage occurring during machining of  $90^\circ$  is described by Wang et al.,<sup>19</sup> with the cutting force causing shear of the fibres and the force also causing a mode I type opening along the fibre–matrix interface. Various authors<sup>20,21</sup> described the cutting process of this fibre orientation as a

Figure 5 shows that subsurface defects have occurred for fabric,  $0^\circ$  and  $90^\circ$  fibres which would not have been captured with methods such as focus variation. While images show subsurface damage, it is noted that a larger population of sectioned material is required to draw full conclusions of cutting modes of differing fibre orientations.

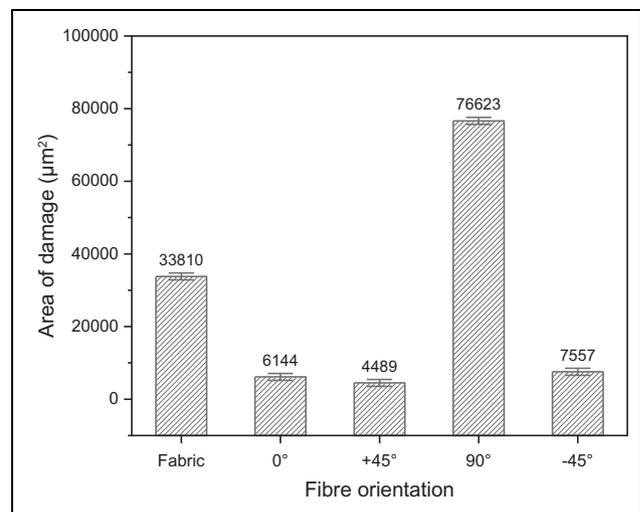
**Figure 6.** Novel metric damage results for differing fibre orientations to the cutting edge.

type I delamination where the failure mode propagates into the trimmed edge by some unspecified distance. Fibres at  $+45^\circ$  to the cutting edge exhibit the least amount of damage when using the novel metric even compared to  $0^\circ$  fibres which typically exhibit the least amount of surface damage according to the literature.<sup>3,21</sup> However, the subsurface

damage of the  $0^\circ$  fibre specimen may have occurred due to a void in the laminate which has been exposed by the machining process. Fibres at  $-45^\circ$  typically exhibit the most amount of surface damage due to the fracture below the cutting plane<sup>3,21</sup>; however, results show a low amount of subsurface damage compared to  $0^\circ$  and  $+45^\circ$  samples. It is noted that the measurements of damage provided by Sheikh-Ahmad<sup>3</sup> and Wang et al.<sup>19</sup> refer to surface damage and not subsurface damage. This may account for the differences observed and highlight the importance of measuring subsurface defects which would otherwise not be seen. Importantly, Sheikh-Ahmad et al.<sup>21</sup> have noted the presence of subsurface cracks in  $90^\circ$  and  $-45^\circ$  plies which can now be explored further and presented using the EF method for the first time. The fabric material shows the second highest level of subsurface damage and when compared to  $0^\circ$ ,  $+45^\circ$  and  $-45^\circ$  fibres, the trimmed edge is not as straight compared to theoretical. This may be a difference due to machine stability which is known to change the properties of the machined surface,<sup>9</sup> or it may be due to the individual ply orientations being supported at either side by differing fibre orientations. This may change the chip formation method and subsequent subsurface/surface damage. It is also noted that the fabric material uses 3 k fibre tows, while the UD material is made from 12 k fibre tows which may change the fracture mode causing differing levels of damage.

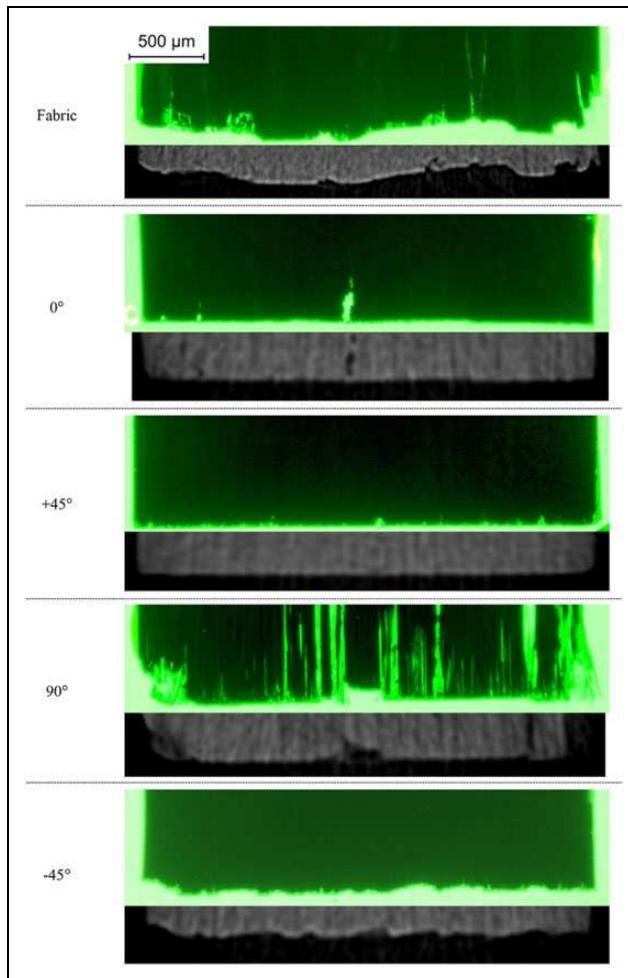
**Figure 7.** Verification of epifluorescent method by comparison with single-planar slice XCT. XCT: X-ray computed tomography.

Figure 7 shows the verification results when the EF method is compared to XCT images. While the resolution of the XCT is limited by relatively high distance between scan sections compared to fibre diameter, artefacts and ghosting, all of which do not allow individual fibres to be imaged, it can be seen that major areas of damage on the machined edge seen through XCT is replicated in the EF images. Importantly, the EF images do not exhibit further damage from the processing method. The machined edge shown for the  $-45^\circ$  XCT sample does not match the EF closely which may be due to the distance between individual images taken by the XCT equipment; however, the contrast available shows some light greyscale areas which can be interpreted to allow a match with the EF image.

Visible transverse cracks for  $90^\circ$  fibres can be seen in the EF image in Figure 7 and are observed to a less visible extent in the XCT image. This is due to power limitations in the XCT equipment which does not allow resolution to individual fibre level in addition to the production of artefacts which mask areas of no material.

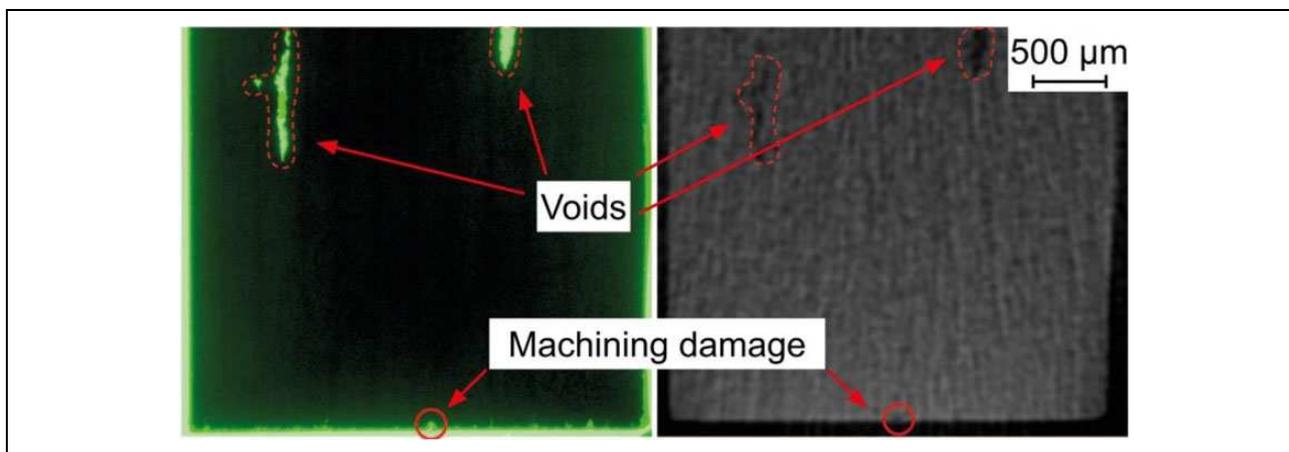
**Figure 8.** Further verification of damage to  $+45^\circ$  fibres.

the resolution limit of the XCT equipment used. However, Figure 8 shows validation through inspection of a deeper surface which shows that voids are seen alongside a small amount of edge damage which can be seen in the XCT image.

The observation of voids is also a useful attribute to the proposed novel method as defects such as this, in addition to machining damage, are likely to cause altered mechanical performance.<sup>22</sup> While further information is required to know whether the machining process has followed a void path, such as pre-machining XCT of the coupon, the final defects at the machined edge can be clearly seen and would contribute to a change in mechanical performance.
