Childerhouse, T. orcid.org/0000-0001-9669-3806, Hernández-Nava, E., Tapoglou, N. orcid.org/0000-0001-9126-5407 et al. (4 more authors) (2021) The influence of finish machining depth and hot isostatic pressing on defect distribution and fatigue behaviour of selective electron beam melted Ti-6Al-4V. *International Journal of Fatigue*, 147. 106169. ISSN 0142-1123

The influence of finish machining depth and hot isostatic pressing on defect distribution and fatigue behaviour of selective electron beam melted Ti-6Al-4V

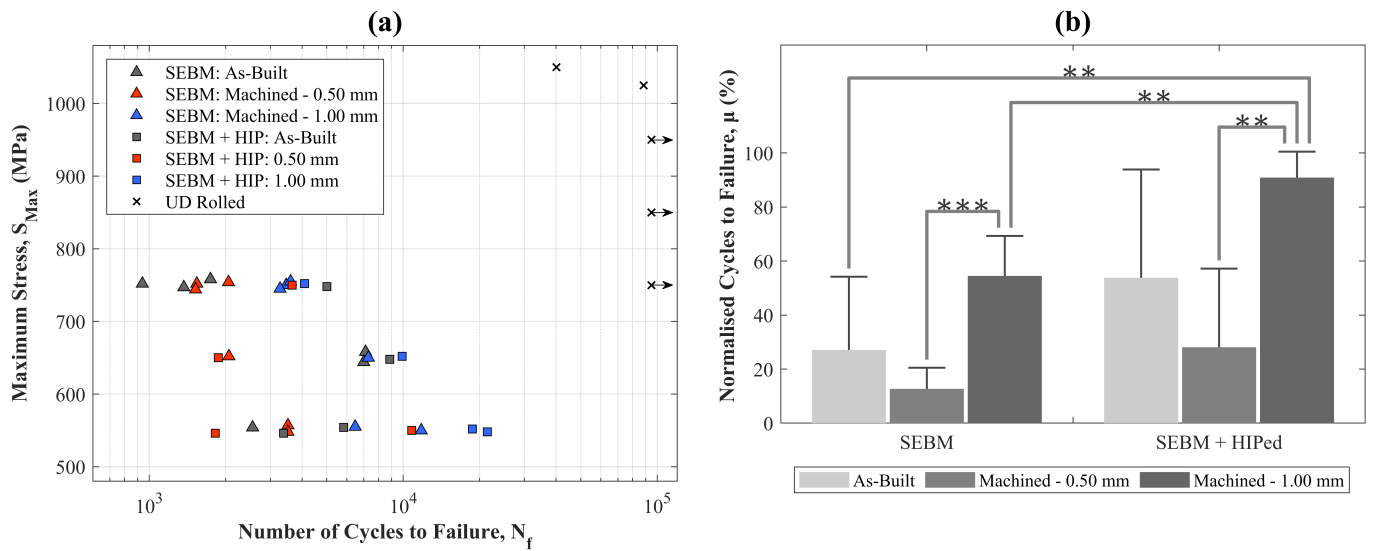
Figure 4: The fatigue performance of SEBM specimens investigated in the study - (a) S-N data for HIP'ed and non-HIP'ed SEBM specimens tested compared to specimens machined from conventional wrought (UD rolled) material and (b) normalised cycles to failure data for HIP'ed and non-HIP'ed SEBM specimens machined at each stock allowance condition (***) indicates a significant difference $p < 0.001$, ** $p < 0.01$). The error bars shown represent ± 1 standard deviation.

Fatigue cycles to failure data for the specimens tested in this study are presented in the S-N diagram given in Fig. 4a. Each specimen was tested to the point of failure with fracture of each specimen occurring in the maximum stress region shown in Fig. 2a. Failure of SEBM specimens occurred within the low cycle fatigue range (LCF) with failure of HIP'ed and non-HIP'ed specimens occurring in the 1,821 to 21,463 and 940 to 11,776 cycle ranges respectively. The fatigue performance of UD rolled material was superior with failure at $S_{Max} = 750$ MPa exceeding 5×10^5 cycles and failure in the LCF range ($<10^5$ cycles) occurring when $S_{Max} > 1025$ MPa.

The mean normalised data are shown in Fig. 4b. Comparison between the specimens machined at the different stock allowance conditions shows a significant performance increase when 1.00 mm of material was removed, with HIP'ed material enduring on average 69% more cycles prior to failure than those in the as-built condition and non-HIP'ed material enduring over 100% more cycles. A similar performance improvement is not observable for specimens machined to a depth of only 0.50 mm, which achieved on average fewer cycles than their as-built counterparts. Following HIP, the average cycles to failure increased for specimens at each machining condition. This was most evident for specimens which had undergone machining to a 1.00 mm depth, which achieved on average 67% more cycles than their non-HIP'ed counterparts. In addition to the increase in cycles to failure, specimens machined at the 1.00 mm depth condition also display significantly less scatter (10 and 27% for the respective HIP'ed and non-HIP'ed specimens) than those in the other two conditions ($> 60\%$).

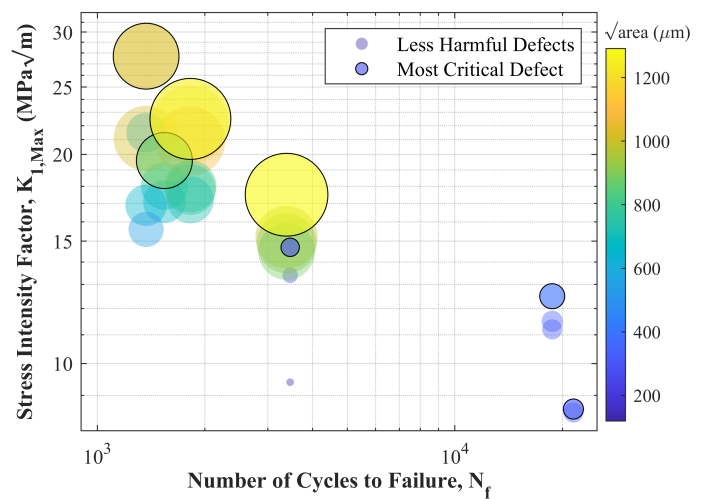
Figure 8: Correlation between fatigue cycles to failure data and stress intensity factor evaluated using Murakami's model [36] (Eq. 2). Marker area shown is proportional to measured defect area.

The approximate stress intensity factor, $K_{I,Max}$ associated with a defect subject to mode I can be evaluated using the \sqrt{area} model (Eq. 2) proposed by Murakami [36]. Whereby, the \sqrt{area} parameter is defined by the square root of the projected defect area on a plane perpendicular to the applied principle stress (i.e. the X-Y plane). The parameter C_1 is 0.65 in the case of surface exposed defects and 0.5 for sub-surface, or internal, defects and σ_0 is the maximum stress applied at the defect.

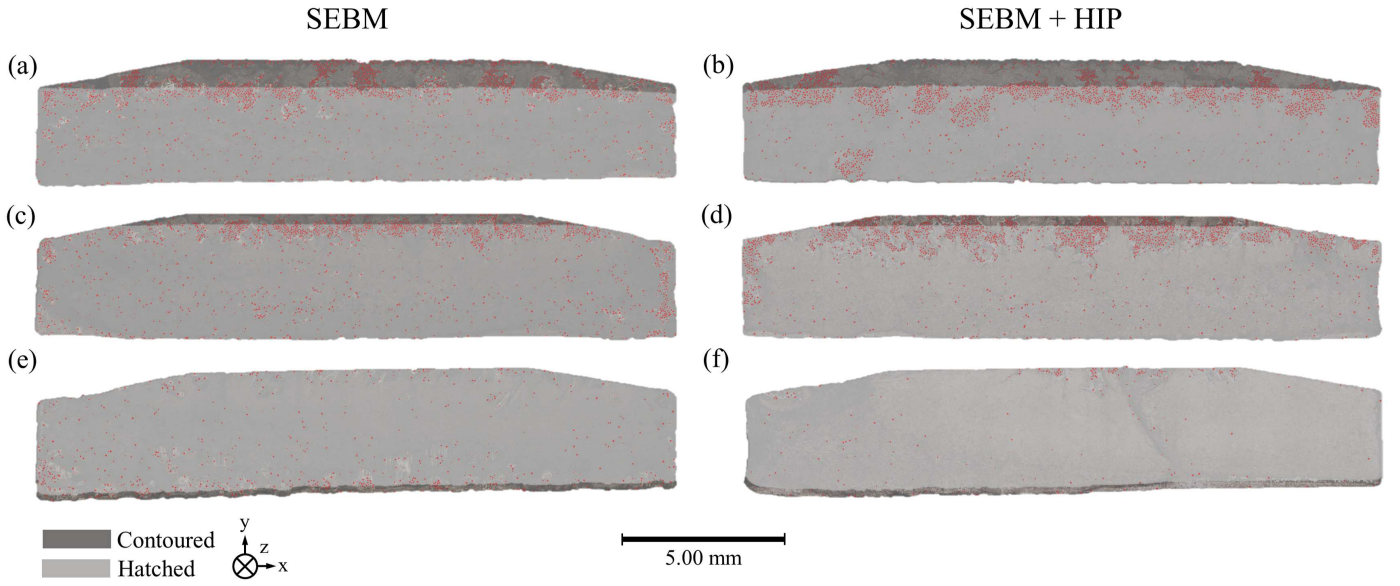
Figure 9: Fractographs of HIP'ed and non-HIP'ed SEBM specimens with regions unconsolidated powder particles detected on the fracture surface superimposed in red - (a-b) show specimens with the test surface in its as-built condition, (c-d) show specimens with the test surfaces machined to a depth of 0.50 mm, and (e-f) show specimens with the test surfaces machined to a depth of 1.00 mm.

The spatial distribution of the LOF defect population on specimen fracture surfaces was analysed using a circle detection image processing function in MATLAB. Unconsolidated powder particles present on the fracture surfaces are presented in Fig. 9 and their distribution in the y-direction from the specimen test surface is shown in Fig. 10. Areas of the build consolidated by either the *hatching* or *contouring* melt strategies are shown by the two shaded areas. The total area fraction of LOF defects present on each fracture surface relative to the overall cross sectional area for specimens in each condition tested are

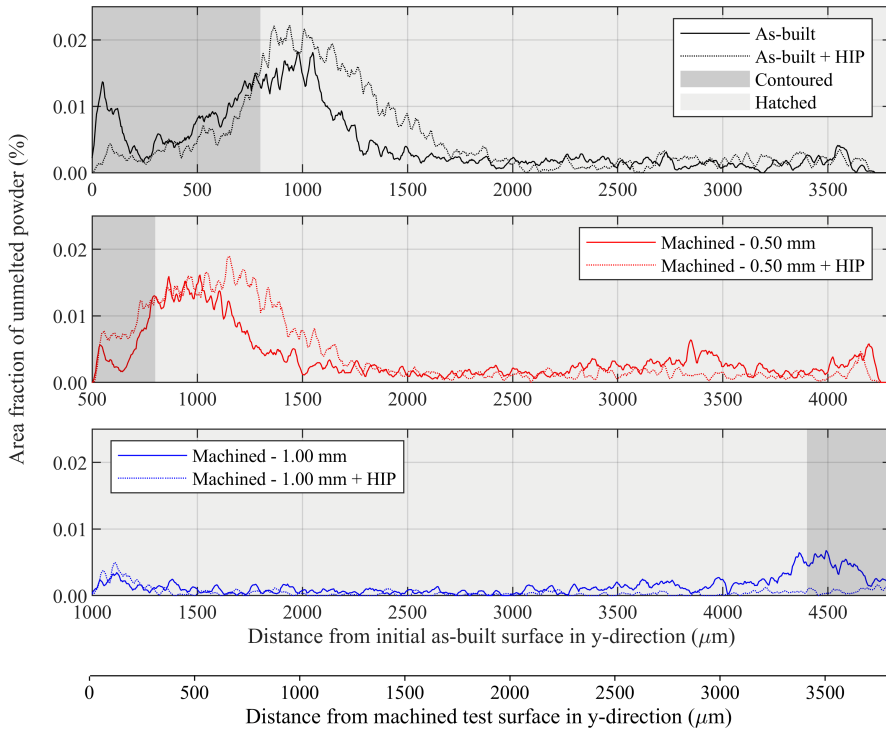
Figure 10: Spatial distribution of the LOF defect population detected on the specimen fracture surfaces shown in Fig. 9. Distribution is shown in the y-direction from the specimen test surface.
