This is a repository copy of *The effect of particle reinforcements on chip formation and machining induced damage of modified epoxy carbon fibre reinforced polymers (CFRPs)*.

The effect of particle reinforcements on chip formation and machining induced damage of modified epoxy carbon fibre reinforced polymers (CFRPs)

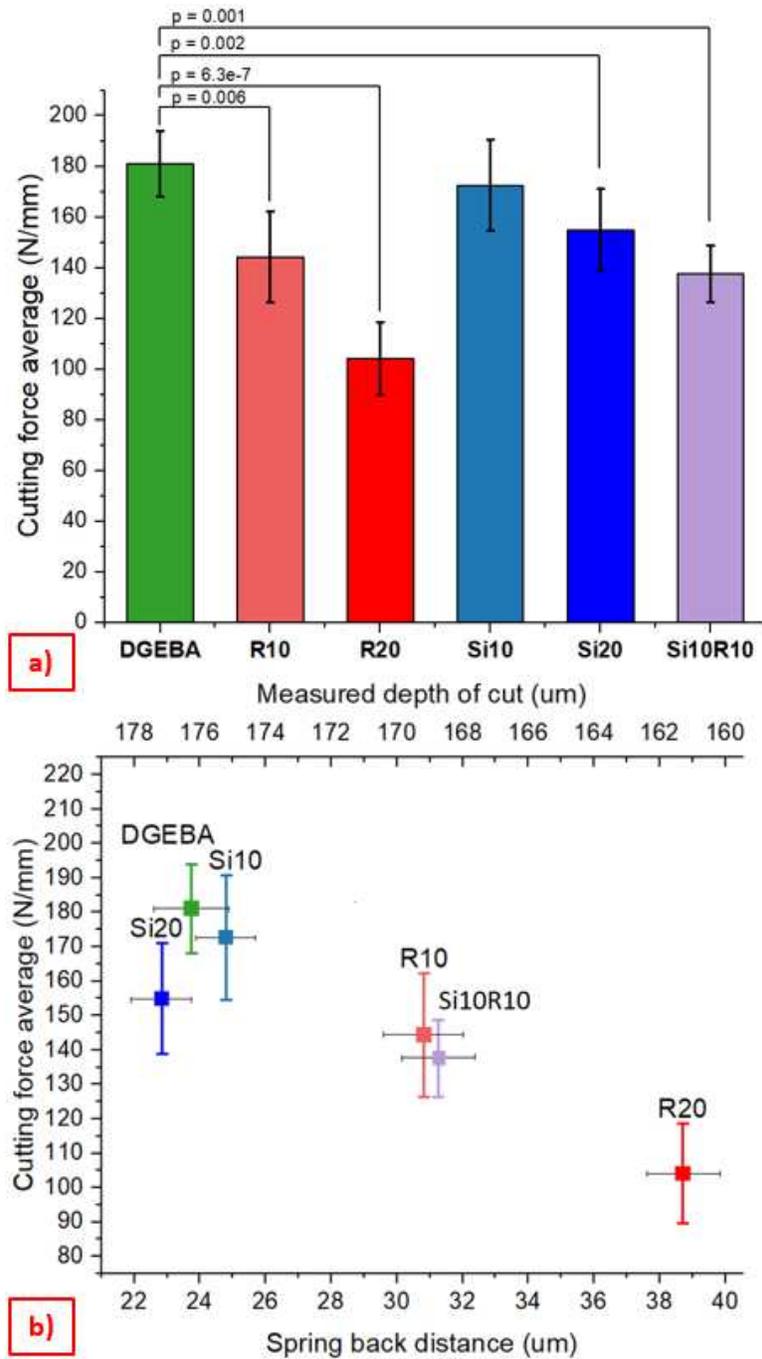
Figure 1 - Cutting force analysis graphs with error bars representing standard deviation of the test samples a) Cutting force average (only p-values which are statistically significant values are shown) b) Cutting force average vs spring back distance & actual depth of cut

Figure 1 – a) shows the average values of measured cutting forces for each material together with standard deviation error bars. Unpaired T-statistical tests were run to compare the difference between the cutting force magnitudes, and it was found that adding the particulate fillers will result in statistically significant differences in cutting forces between unmodified (DGEBA) and modified samples. A 20.2% decrease was found for R10, followed by a further 42.4% for R20 samples compared to DGEBA. The Si20 samples showed a decrease of 14.2% in cutting force magnitude, while ‘hybrid’ sample (Si10R10) showed a decrease of 24.1%. It is noticed that Si10R10 had similar cutting force magnitude to R10 specimens, which suggests that in a ‘hybrid’ composite the rubber microparticles are governing the material removal process.

The amount of spring back was measured after each cut using a digital micrometre (resolution $< 1 \mu\text{m}$) and further checked using the recorded cutting images as shown in Figure 1- b). The brittle-matrix epoxy represented by unmodified (DGEBA) and silica epoxy (Si10, Si20) experienced the lowest elastic recovery and highest cutting force. On the other hand, the presence of rubber microparticles (R20) increased the elastic recovery and the lowest cutting forces were recorded. The increased elastic recovery due to rubber particles is related to toughening mechanism and large strain to failure of rubber modified composites [28], [37], [38]. Additionally, the decrease in the cutting forces is correlated with a smaller volume of material removed, despite the large elastic deflection. Wang and Zhang [19] reported that in orthogonal cutting of UD-CFRPs the magnitude of spring back is related to the cutting edge radius of the tool, when all the other conditions are the same. Considering that all the cutting parameters in this study, including the tool geometry and cutting conditions are identical between the investigated samples, the observed trend in the measured spring back could only be due to the local mechanical properties of the modified epoxy matrix indicating that the presence of fillers has a significant effect on spring back. A difference of $16 \mu\text{m}$ was found between the largest springback distance (R20 sample) and lowest value (Si20 sample) as shown in Figure 1 – b).

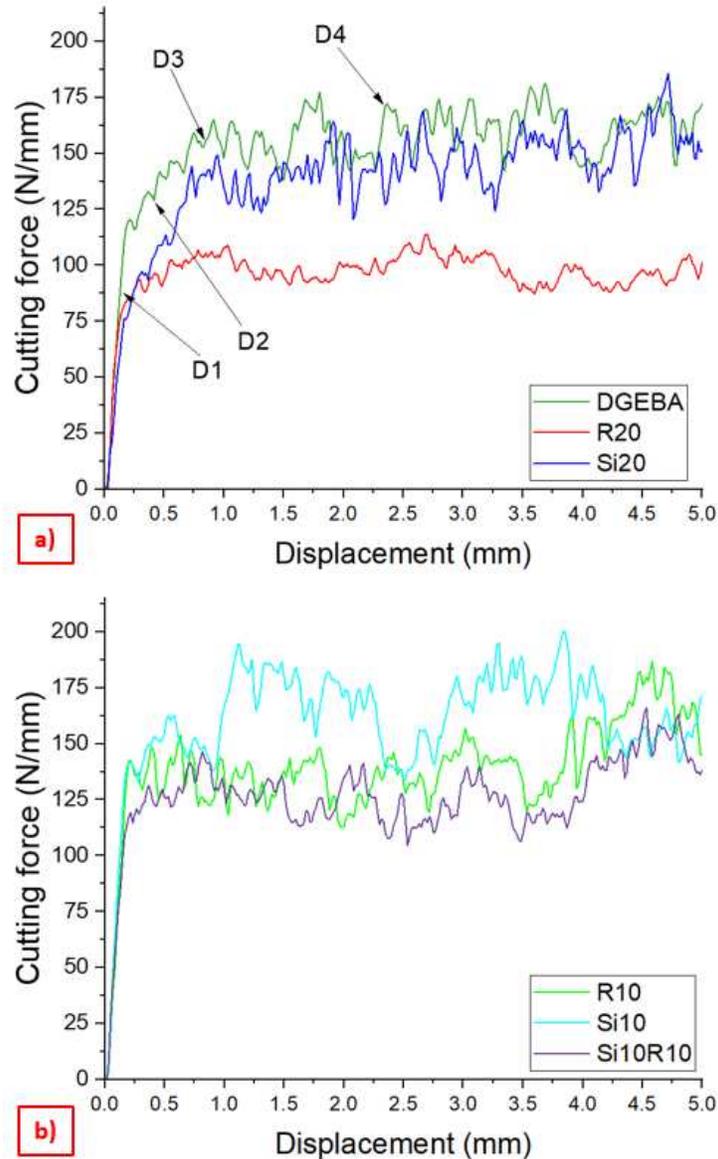
Figure 2 - Cutting force vs displacement for a) DGEBA, R20 and Si20 where D1, D2, D3, D4 indicate the time steps corresponding the cutting images in Figure 3, and b) Cutting force vs displacement for R10, Si10 and Si10R10

The evolution of cutting forces as the cut progresses (Figure 2) indicates that there is less variation in the cutting force when cutting rubber modified samples, while a large oscillation was observed in the graphs related to the reference material (DGEBA) and the silica-modified samples (Figure 2 – a)). The cutting force signal for R10 and Si10R10 samples (Figure 2 – b)) showed a similar pattern. This was previously observed in orthogonal cutting of rubber and silica modified epoxy polymers [39], where the chip formation process was mainly influenced by the presence of rubber microparticles, rather than silica nanoparticles in the ‘hybrid’ sample. It has been previously reported [28] that in a ‘hybrid’ modified CFRP, the rubber toughening mechanism is the dominant failure mechanism. This aspect and the effect of chip formation process in relation to particulate fillers and cutting force behaviour is further discussed in Section 3.3.

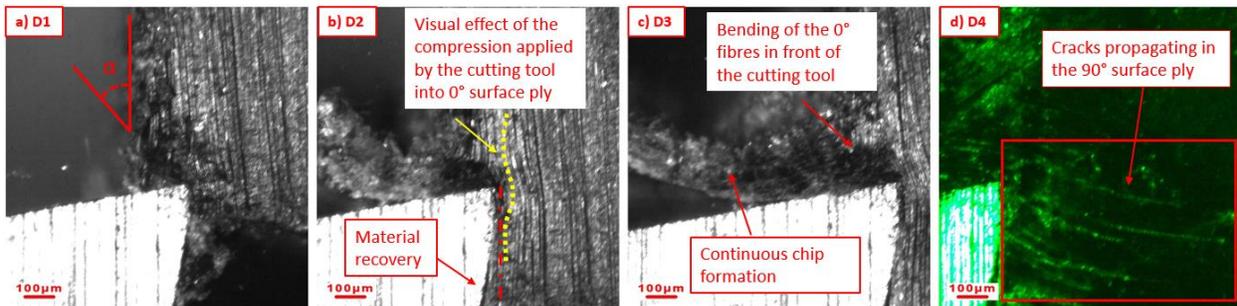
Figure 3 - Chip formation process images a-d) corresponding to the selected time steps of D1-D4 Figure 2 – a), d) D4 has a false colour black-green contrast to highlight the surface ply crack propagation for 90° fibre orientation

Figure 3 shows the evolution of chip formation from the side view of the samples during cutting as observed by the High Speed DIC system where the individual frames are correlated to the time steps shown in the force-displacement diagram of Figure 2 – a). As the tool advances into the work piece, the fibres at 0° are compressed (shown by curved dash line of Figure 3– b)) and by further displacement of the cutting edge a chip forms on the rake face of the cutting tool (Figure 3 – b)). Relaxation and material recovery occurs at

the flank side of the tool (shown by straight dash-dot line in Figure 3 – b)). The material pile on the rake face of the tool and a continuous chip is formed, while 0° fibres are bending and fracture in front of the cutting tool (Figure 3 – c)). This is primarily due to the low cutting speed and high bending limit of the 0° fibres used for this experiment. Considering the 2x2 twill woven fibre architecture of the samples (carbon fibre placed in a $0/90^\circ - 45/135^\circ$ configuration with $0/90^\circ$ on the top/ bottom plies), the tool will encounter 0° and 90° fibres on the top plane as the sample is cut. As the tool enters a region with 90° fibre orientation, large cracks ($>500 \mu\text{m}$) are generated in the matrix between fibres on the top ply (Figure 3 – d)) due to excessive bending of fibres along their axis. These long cracks are only present on the top ply, as fibres can readily deform-out of plane and cracks are formed from a combination of bending and debonding from the matrix. CT-scan images did not show these features on the layers below the surface. This aspect is further discussed in Section 3.4. No noticeable difference was found between side view images of the particle-modified samples and DGEBA specimen, the chip formation process shows the same behaviour.

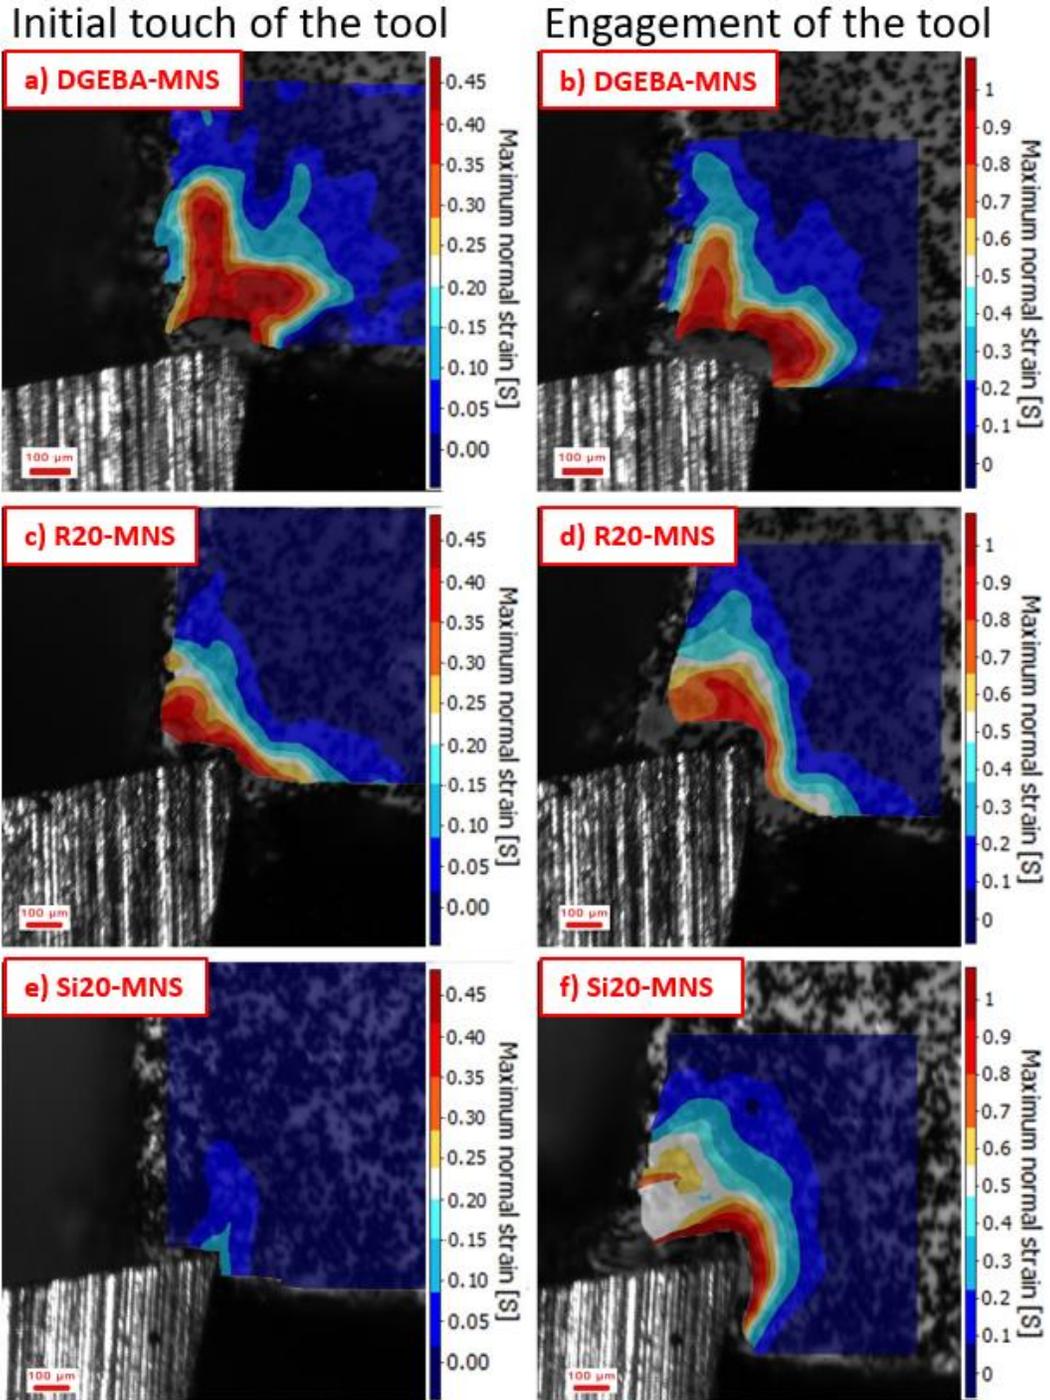
Figure 4 - Maximum normal strain [S] (MNS) maps for a - b) DGEBA c - d) R20 e - f) Si20 corresponding to the time force points marked a - f on Figure 6

Strain maps shown in Figure 4 and 5 are linked to the cutting force signal of Figure 6. Maximum normal strain (MNS) and shear strain (SS) have been calculated for each test condition according to the parameters given in Table 2 and represent the onset of steady state cutting zone (Figure 4 and 5 – a), c), e)) and full engagement of the cutting tool with the material which starts to build up on the rake face of the cutting tool (Figure 4 and 5 – b), d), f)). MNS maps of DGEBA (Figure 4 – a)) showed a larger deformation zone compared to rubber modified samples (Figure 4 – c)) in which strain contours are situated close to the cutting tool. On the other hand, Si20 sample had the lowest MNS value of 0.11 [S], followed by R20 sample

with 0.27 [S] and DGEBA with 0.45 [S]. Si20 sample (Figure 4 – e)) showed a more localised strain map, which is linked to the stiffness of the silica nanoparticles. As the material is deformed due to further penetration of the cutting tool, the local strain values increase for all samples, while strain contours are still localised in front of the cutting tool for R20 and Si20 samples ((Figure 4 – d, f)). DGEBA sample (Figure 4 – b)) shows the highest MNS value of 1.1 [S], however the strain contours are dispersed around the cutting tool in two zones: (i) one that is extended ahead of the cutting tool (ii) one that penetrates approximately 45° into the subsurface. The high value of MNS of DGEBA sample and the strain contours dispersion is attributed to the deformation and fracture of the material. In the case of rubber modified sample, toughening mechanism took place [28], [37], which increased the plastic zone ahead of the cutting tool, hence limiting the fracture and deformation of material. SS maps (Figure 5) show a compression area (negative value of SS) formed across the relief face of the tool, while a tensile area (positive value of SS) is formed on the rake face. Similar to MNS contours, R20 sample (Figure 5 – c, d)) showed the SS contours distributed close to the cutting tool edge. On the other hand, silica sample (Figure 5 – e, f)) experienced the largest compression deformation zone. The increased stiffness of the silica particle should make a contribution to the load carrying capacity of the composite, however, the stress concentration effect due to presence of silica nanoparticles weakens the material [29]. The effect of particle toughening and failure mechanism which occurs during the material removal process is further discussed in Section 3.6.

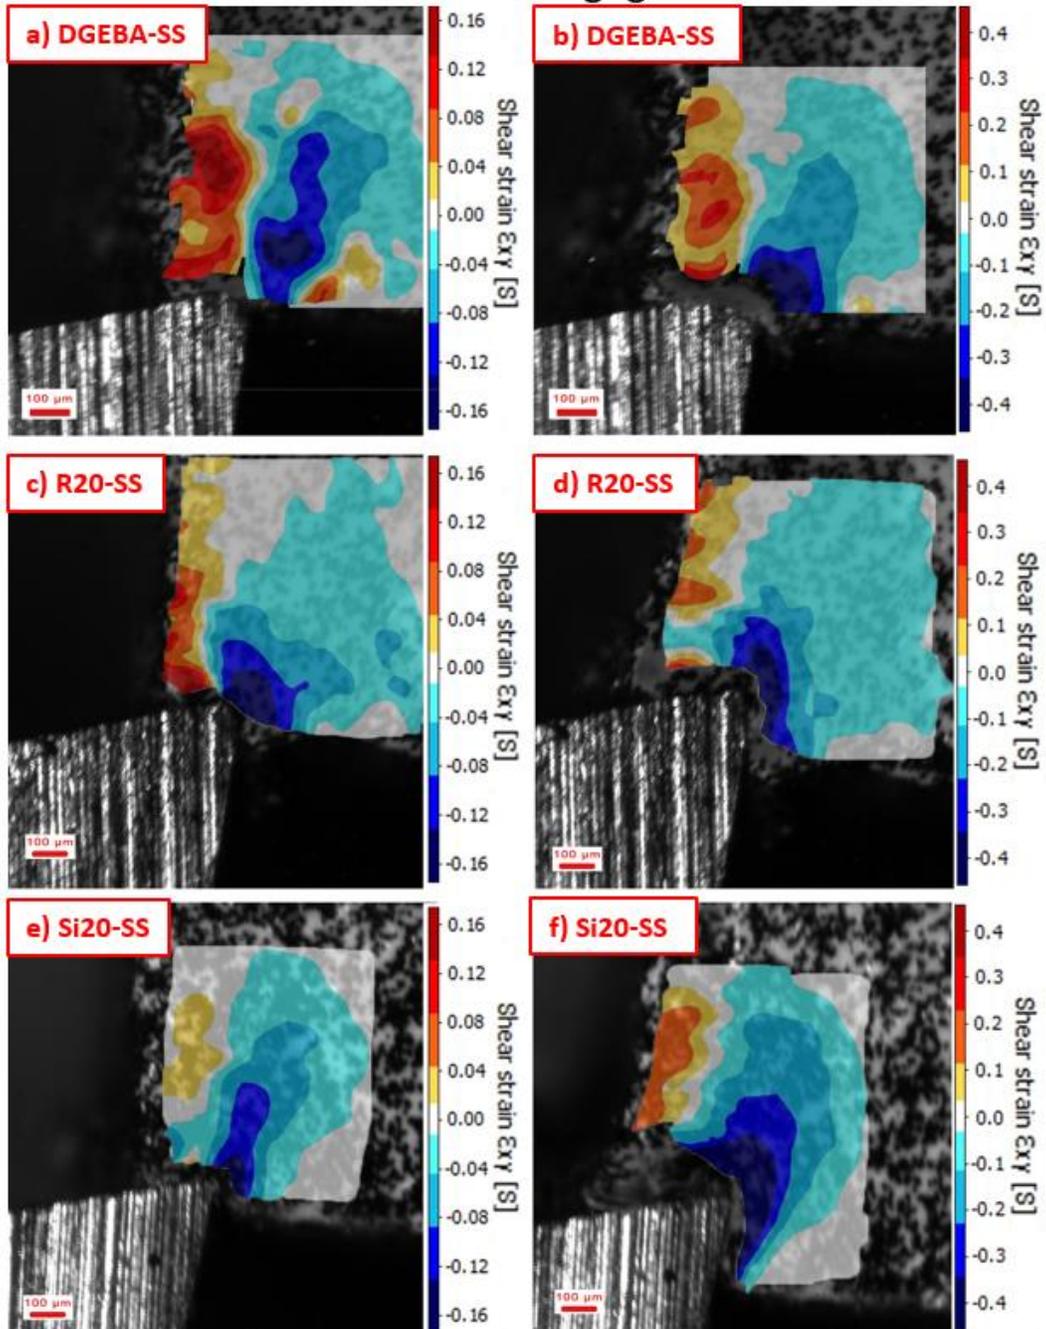
Figure 5 - Maximum shear strain [S] (SS) maps for a - b) DGEBA c - d) R20 e - f) Si20 corresponding to the time force points marked a - f on Figure 6, with negative values corresponding to compression force due to the flank face compression

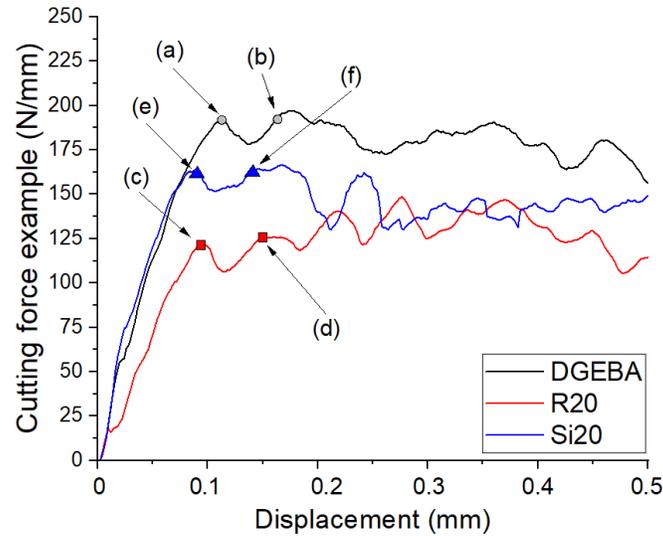
Figure 6 - Cutting force vs displacement for D, Si20 and R20 samples where (a) – (f) have corresponding time stamps to equivalent strain maps of Figure 4 and 5

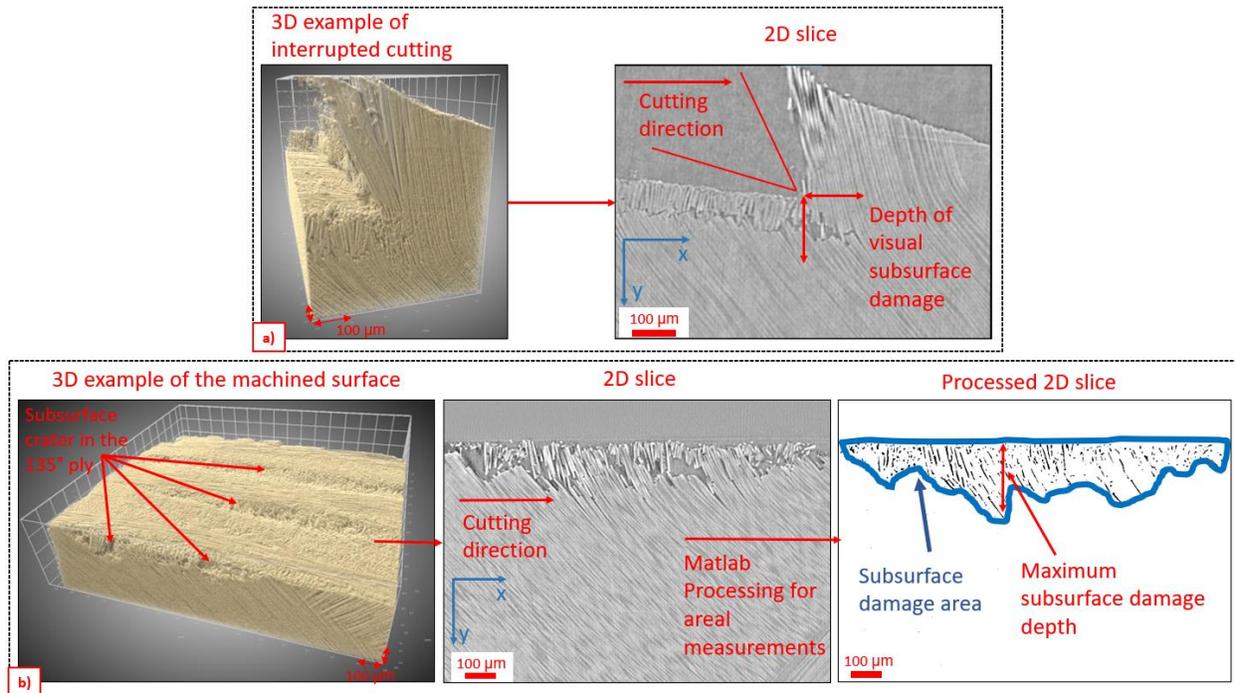
Figure 7 – a) Subsurface damage measurement example of DGEBA sample for chip formation process in an interrupted cutting
 b) Subsurface damage assessment

The cutting process was interrupted in the middle of the cut and the sample was analysed with 3D micro-CT to quantify the subsurface damage both under the machined surface and ahead of the cutting tool during the chip formation process as shown in Figure 7. 2D slices were extracted for processing from the middle of the specimen ensuring that the chosen part of material was cut in plane-strain conditions. The subsurface damage was quantified in terms of maximum damage depth and area of damage. As we cannot discriminate between damage induced by the cutting edge or damage from compression due to the flank face, then damage refers to any type of defect which is induced by the orthogonal machining process. Depending on the fibre orientation, this can include matrix cracks, fibre breakages, fibre bending, matrix/ fibre pull-outs and uncut fibres. A MATLAB® script [40] was used to calculate the damage area. The volume of indentations (craters) observed on the 135° plies was calculated using the Dragonfly CT segmentation software (Figure 7 – b)). These have previously reported during machining of CFRPs [12], [13] and it was found that they adversely affected the mechanical properties of the samples namely flexural and compressive strength [14], [41], [42].

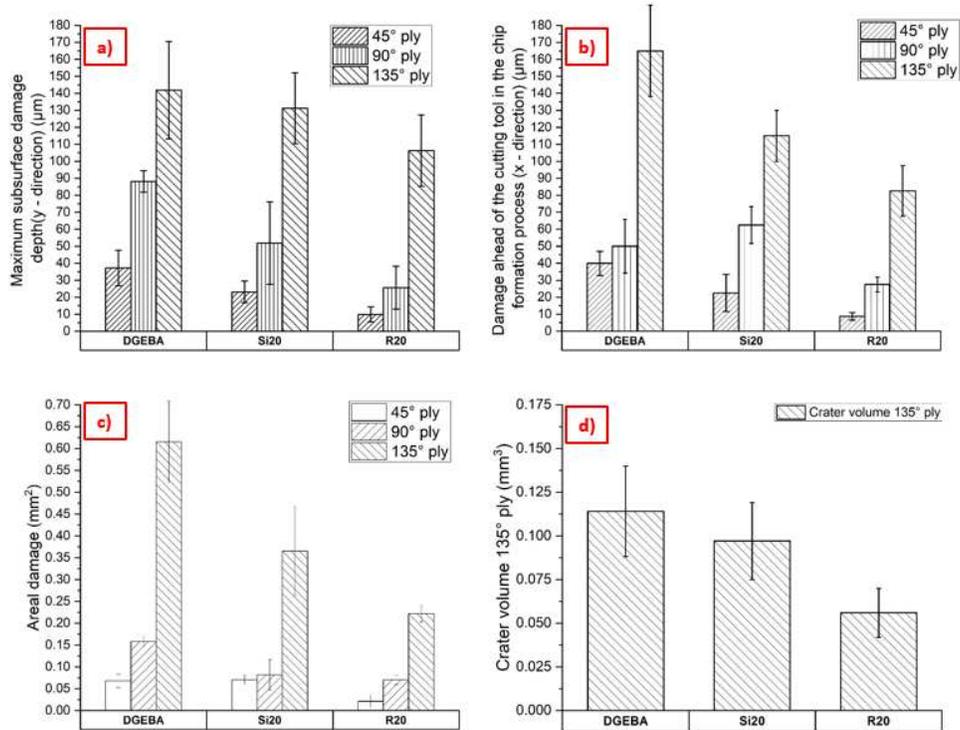
Figure 8 - Subsurface damage assessment with error bars showing the standard deviation of the assessed images a) Maximum subsurface damage b) Damage in front of the cutting tool c) Areal damage d) Crater volume (0° fibre orientation did not show damage by these measurements)

All the machined surfaces showed significant matrix smearing across all fibre orientations. Figure 8 shows the calculated subsurface damage for the machined materials. For a single material, changing the fibre orientation from 45° to 135° , shows an increase in the damage area. However, within an individual fibre orientation, defined by a ply layer, the addition of rubber or silica fillers results in reduced subsurface damage. The calculated maximum subsurface damage depth (Figure 8 – a)) shows a decrease for all fibre orientations when silica or rubber was added to the epoxy matrix. Moreover, the R20 sample had the lowest level of damage, which can be attributed to rubber toughening mechanism which is active during material removal. Experimental evidence is discussed in Section 3.6. Moreover, damage in front of the cutting tool, areal damage and crater volume has the lowest values for the R20 samples. An increase in damage in front of the cutting tool was found for Si20 sample in the 90° fibre orientation, however the measured values are within the standard deviation of the control. No quantifiable surface intrusion or subsurface damage was identified for 0° fibres, therefore Figure 8 does not include 0° orientation in damage comparisons.

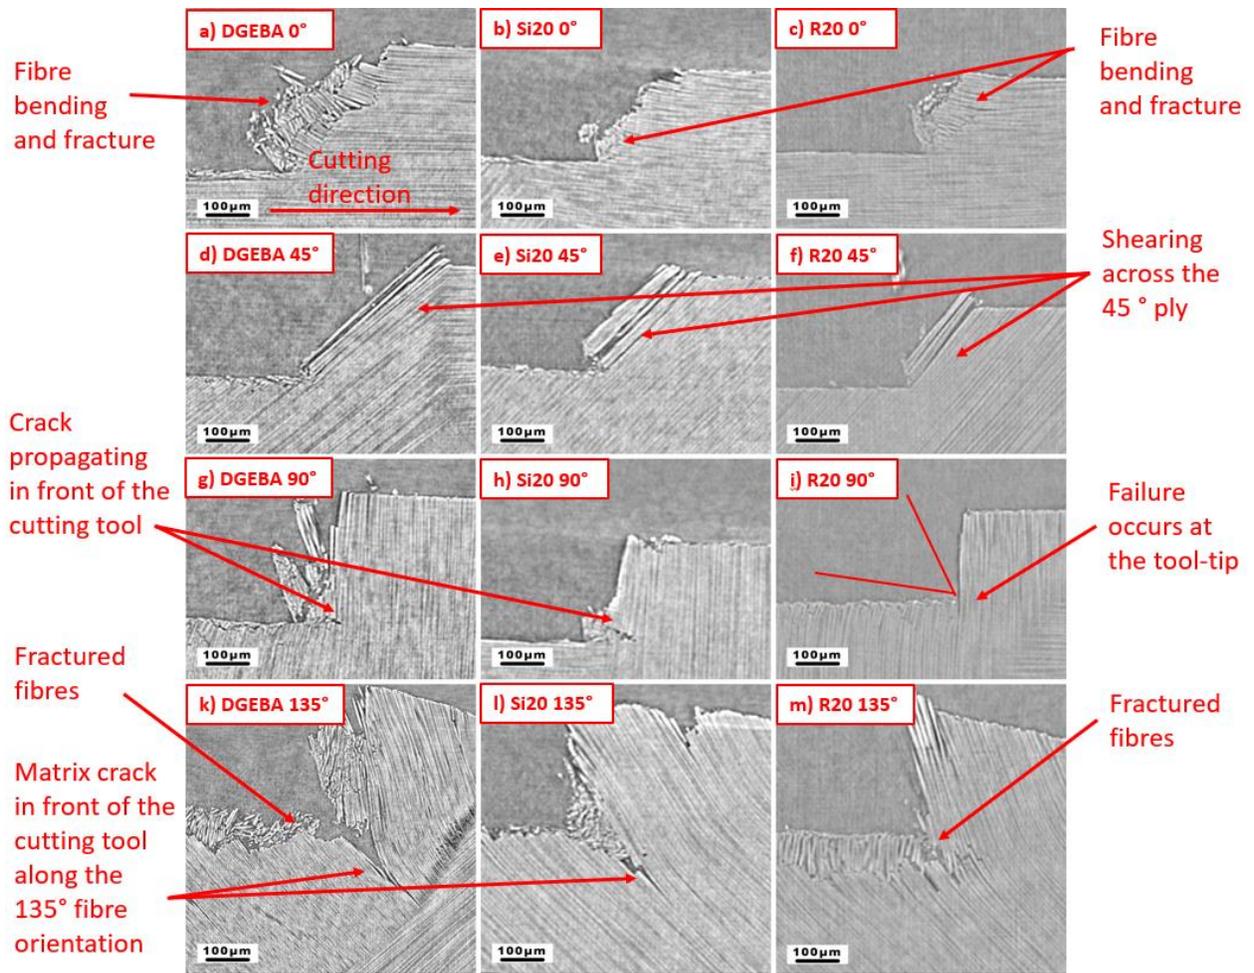
Figure 9 – 2D slice examples of interrupted cutting for DGEBA (a, d, g, k), Si20 (b, e, h, l) and R20 (c, f, i, m) samples showing machining induced damage

The measured subsurface damage is further explained when considering fibre orientation and the fracture mechanism, based on the 2D interrupted cutting images (Figure 9) and the representative subsurface damage examples (Figure 10). The cutting mechanism in the multidirectional ply laminate is similar to the UD laminate, with a slight difference in the 90° and 135° fibre orientation as the result of the influence from adjacent plies as previously discussed by Arola and Ramulu [16]. Excessive out-of-plane damage in multidirectional occurs at 90° or greater in UD laminates, while the damage in multidirectional laminates, at these angles, is limited due the support of adjacent plies. This facilitates the analysis of the material removal mechanism for each ply and fibre orientation based on analogous UD laminates.

According to [43] the cutting mechanism can be grouped as Type I, III, IV and V chip formation process depending on the fibre orientation. Type I chip formation describes 0° fibre cut via crack propagation ahead of the tool where the fibres are peeled from the surface then bend and fracture (Figure 9 – a), b), c)). Fibres on the machined surface fracture perpendicular to their long axis due to the compression from the cutting tool applied against the front surface. For 0° fibre orientation, the reinforcement particles did not show any noticeable effect on the chip formation process or subsurface damage.

In Type V for 135° fibre orientation, bending is caused by flank face compression – as the tool advances of the cutting tool into the material. This causes the matrix to crack and fibres to fracture (Figure 9 and 10 – k), l), m)). This further results in material becoming detached and allowing material to pull-out, which leads to the formation of craters below the cut surface. The calculated crater volumes are shown in Figure 8 – d). A 50.8 % decrease is found between R20 and DGEBA samples, while the subsurface damage area and maximum damage depth for 135° plies decreased by 63 %, and 25 %, respectively. These results are linked with the high fracture toughness of the rubber modified epoxy, limiting the crack growth along the matrix in 135° fibre orientation, thus decreasing the amount of pull-out material and subsurface damage.

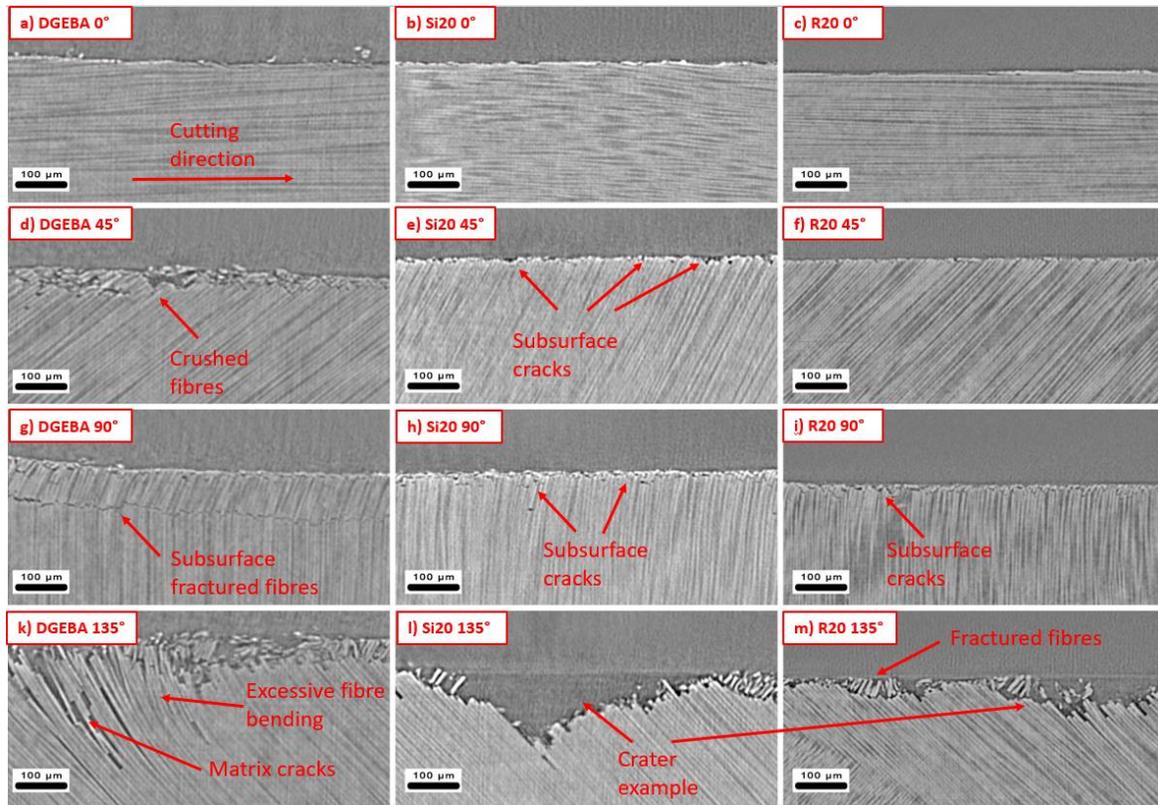
Figure 10 – 2D slice examples of subsurface damage for DGEBA (a, d, g, k), Si20 (b, e, h, l) and R20 (c, f, i, m) samples

showed the lowest S_v value (Si10R10: S_v - 42), followed by rubber (R20: S_v - 61), silica (Si10: S_v - 63, Si20: S_v - 92) and DGEBA sample (DGEBA: S_v - 102). CT-scan images (Figure 10 – k, l, m)) showed that the maximum depth of damage occurs in the 135° fibre orientation plies and surface metrics are measured on the entire surface of the specimens, therefore the measured S_v values are attributed to the 135° plies. However, it is noted that maximum depth of subsurface damage (Figure 8 – a)) is 35 – 40 % higher than S_v measurements (Figure 11 – b)). This is accounted for by the fractured fibres and matrix which were not completely pulled out and remained on the bottom of subsequently generated craters, hence influencing the topography measurements (example in Figure 10 – k, m)). This highlights the fact that surface metrics assessment of the machined surfaces is insufficient to characterise machining induced damage.

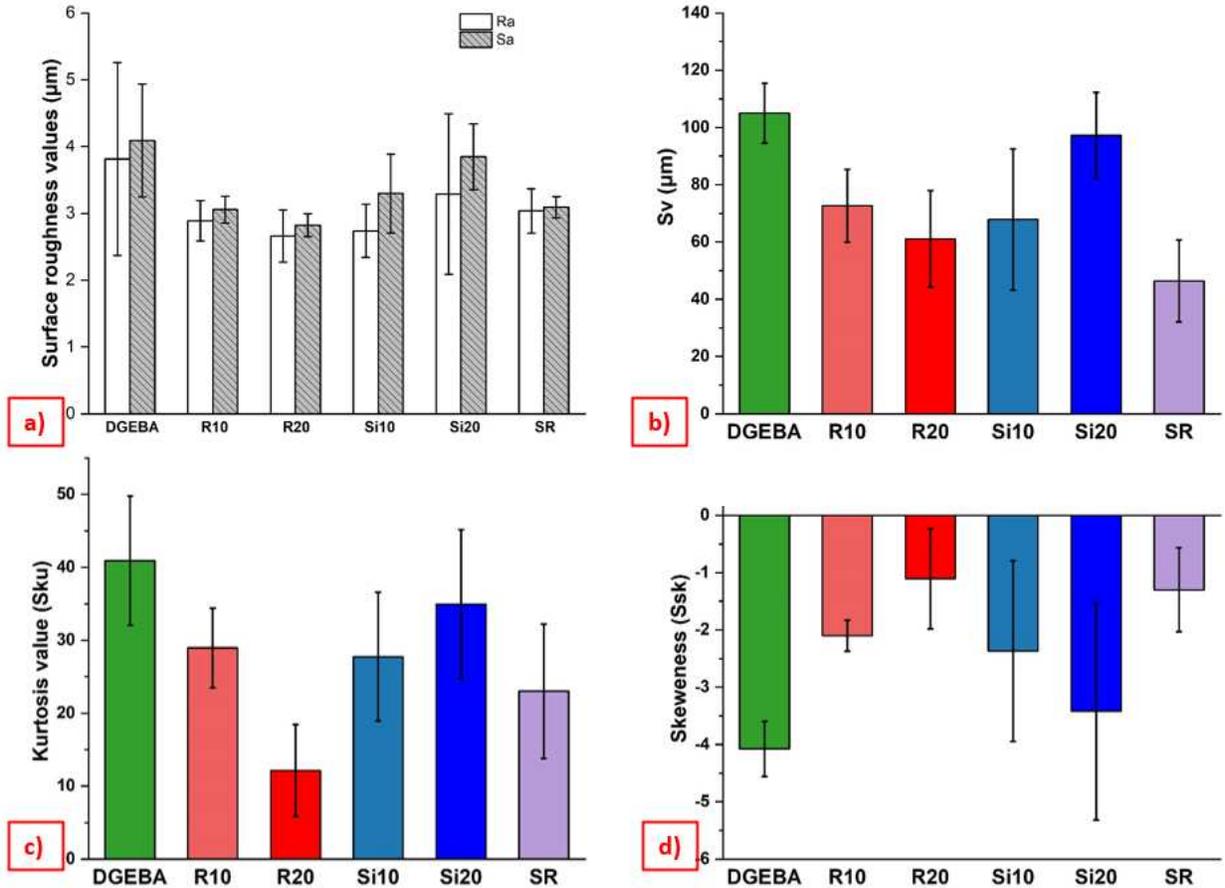
Figure 11 - Surface metrics measurements a) Surface roughness (R_a , S_a) b) Maximum valley depth (S_v) c) Kurtosis (S_{ku}) d) Skewness (S_{sk})

Figure 11 shows the variation of selected metrics to investigate machined surfaces in the samples. Due to waviness and twill-weave architecture of the carbon fibre plies of the CFRP material, individual ply surface topography analysis was not possible; hence, measurements across the full-machined surface were used. As shown in Figure 10 and previously in the literature [12], [13], [40], fibre orientation has a strong influence on the generated surface topography after machining. DGEBA samples represent the reference material in Figure 11. As the rubber content increases (Figure 11 – a)), the S_a (average height of scanned area) parameter decreases. R_a parameter (average roughness of profile) shows a similar trend, however it is reported that S_a provides greater reliability of roughness measurement for multidirectional laminates [45]. Adding silica nanoparticles from 10% to 20% wt. causes S_a to increase. These have been balanced in the ‘hybrid’ Si10R10 sample which contains 10% silica and 10% rubber. A similar trend was found for the S_v (maximum valley depth of scanned area) measurements Figure 11 – b). Interestingly, Si10R10 sample

The variation of surface Kurtosis (S_{ku}) and surface Skewness (S_{sk}) parameters (Figure 11 – c), d)) show that DGEBA and silica modified composites (Si20) had the highest value of Kurtosis indicating a surface with sharp peaks and valleys. A negative Skewness was found for all samples, which is a characteristic of a surface with deep cracks and voids. This type of features is typical for 135° plies, as CT results (Figure 10) showed no similar features for the other fibre orientations. Similar to subsurface damage results discussed in Section 3.4, R20 experienced the lowest S_{sk} value (Figure 11 – d)) which is correlated with limited material pull-out that is linked with the rubber toughening mechanism, followed by silica and unmodified epoxy composite. As the fact that the most damage is created in the 135° plies was previously reported in the literature [46], [47], S_{sk} is considered an effective parameter which is able to link the subsurface damage to surface metrics results for 135° fibre orientation.

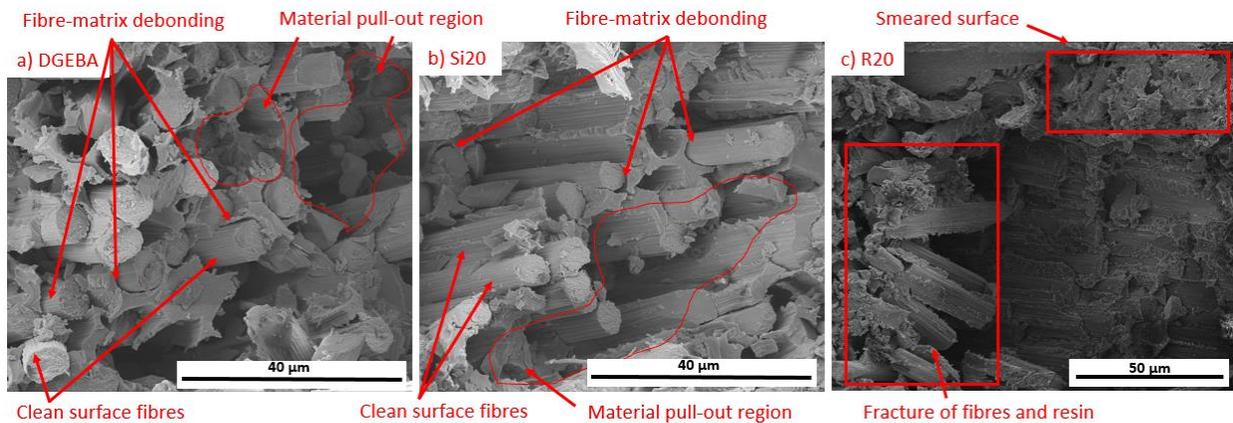
Figure 12 – Typical micrographs of machined surface of a) DGEBA b) Si20 and c) R20 samples, where ‘Clean surface fibres’ means the fibres have debonded from the matrix by adhesive failure

Even though the machined surfaces showed significant smearing across all fibre orientations, various craters and material pull-out regions were used for fractographic analysis. Material pull-out regions and fibre-matrix debonding are observed for DGEBA and silica sample (Figure 12 – a, b)). Moreover, the fractured fibres show a clean surface which leads to the conclusion that the composite material failed at the interface region between the fibre and matrix. On the other hand, fractured material of R20 sample (Figure 12 – c)) showed fibres with matrix attached, which indicates that polymer debonding did not occur fully. The debonding is directly related to the fibre and matrix adhesion and the particle reinforcement of the epoxy does not have a significant role in the individual fibre toughening mechanism (e.g. fibre debonding, fibre pull-out). However, the presence of rubber microparticles and their subsequent toughening

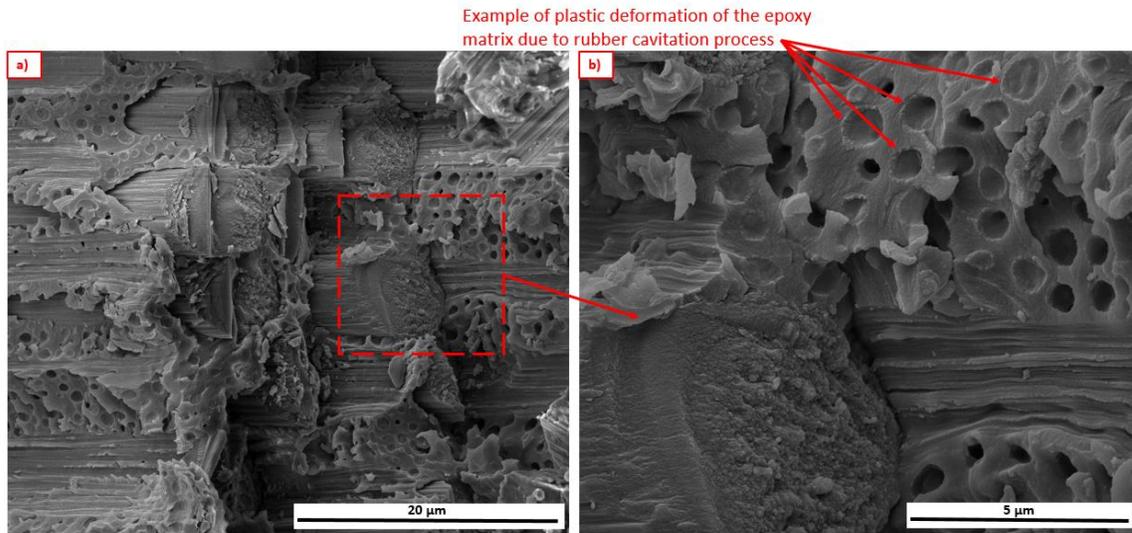
Figure 13 - High-resolution FEG-SEM micrographs of R20 machined surface a) Fibre and rubber cavitation process artefacts b) High-magnification example of plastic deformation of matrix due to rubber cavitation process, where rectangle shows a fibre bonded to the surrounding matrix

The principal toughening mechanism of rubber micro-particle and silica nanoparticle were previously demonstrated in the literature [23], [24], [28], [29], [38] and identified in the machined surface micrographs. High-resolution FEG SEM images of the rubber machined surface (Figure 13 – a)) shows that the particles cavitate. This is followed by plastic void growth of the polymer matrix. The original mean diameter of the rubber micro-particles was $0.54 \mu\text{m}$ [28], while the cavitated areas were measured to be $1.02 \pm 0.16 \mu\text{m}$. Plastic deformation of the epoxy matrix is visible on the edge of the voids generated on the polymer matrix surface due to the cavitation process (Figure 13 – b)). It is also noticed that fibres are attached to the machined surface and are still encased in epoxy matrix, which further highlights the fact that fibre-matrix interface failure does not occur in rubber-modified samples. The rubber toughening mechanism allows the fracture energy to be dissipated, this limits the extent of subsurface damage from the compression induced by the flank face. These are correlated with the low oscillations of cutting force signal shown in Figure 2 – a).

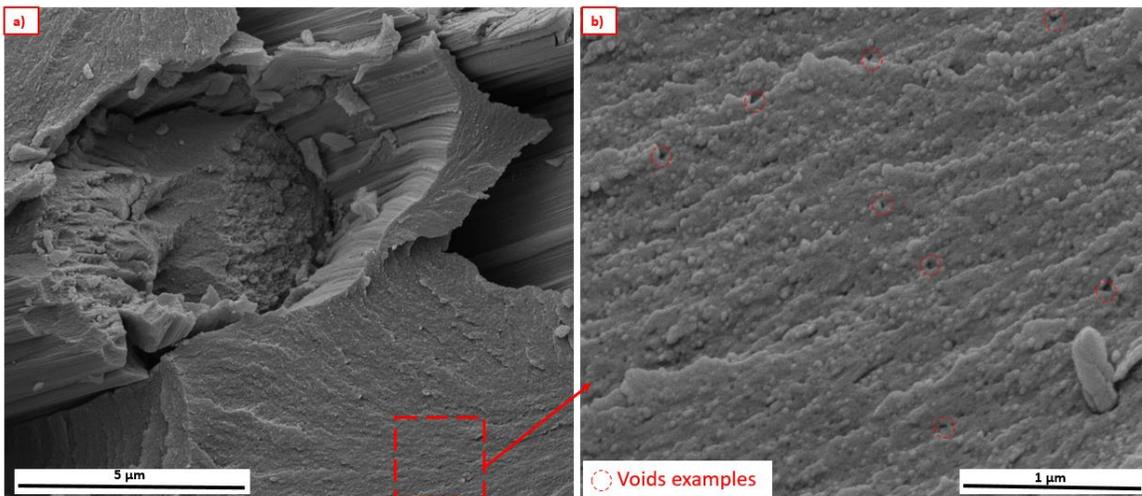
Figure 14 – High-resolution FEG-SEM micrographs of Si20 machined surface a) Fibre pull-out and fibre-matrix debonding b) Debonding of silica nanoparticles

High-magnification FEG SEM images of Si20 fractured surface (Figure 14 –a)) clearly illustrate the fibre pull-out and fibre-matrix debonding. The fractured surface of the matrix is relatively smooth, which is typical for a thermoset polymer. Similar features were found on high-magnification images of unmodified epoxy composite. Feather markings are observed, which are caused by crack forking due to the high energy associated with the relatively fast crack growth. Again, this was previously identified and is typical for a brittle epoxy material [23]. The presence of voids and silica nanoparticles on the high-resolution image indicates that plastic void growth of the material was initiated by the debonding of silica nanoparticles (Figure 14 –b)). Even though the samples were gold coated prior to SEM analysis, the voids and silica nanoparticles were not observed on the coated surfaces of unmodified epoxy composite. This shows that the identified voids are not an artefact of the applied gold coating. The measured voids have a diameter of $39 \pm 4.53 \text{ nm}$, while the silica nanoparticles are within the range of 20-25 nm. However, it can be seen that
