Hu, Y., Tan, D.Q., Xu, C. et al. (2022) Influence of high temperature on the tribological properties of hybrid PTFE/Kevlar fabric composite. *Tribology International*, 174. 107781. ISSN: 0301-679X

# **Influence of high temperature on the tribological properties of hybrid PTFE/Kevlar fabric composite**

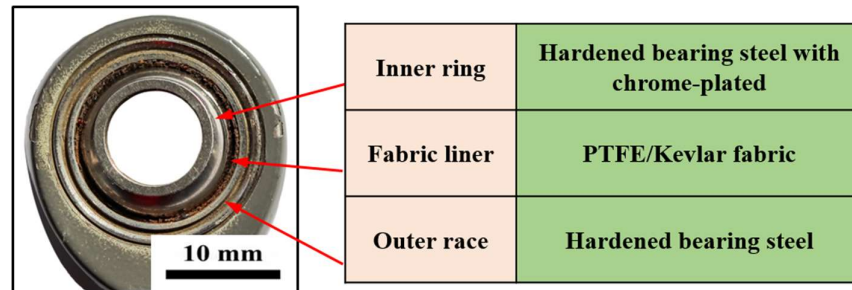
Fig. 1. Application of PTFE/Kevlar fabric composite in the joint bearings of the main helicopter rotor.

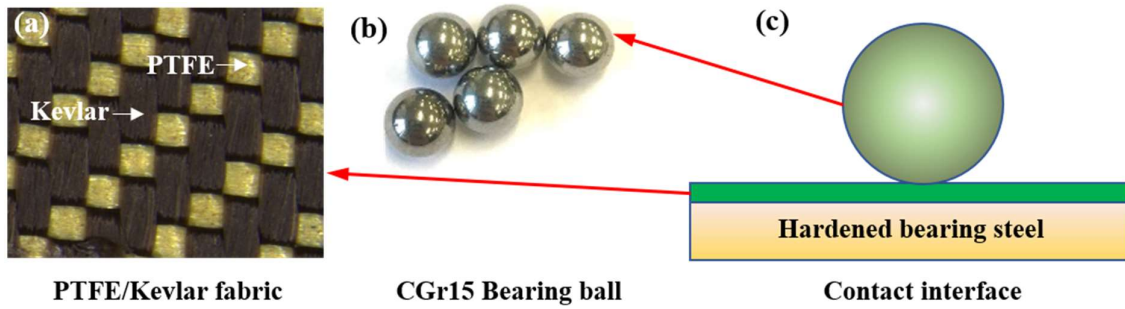
A ball-on-flat contact mode was used in the present wear tests. The flat sample was PTFE/Kevlar fabric with a flexible double-layer fabric through twill weave. As shown in Fig. 2a, the black-brown part is PTFE with good self-lubricating properties, and the yellow part is Kevlar fiber with high strength and good wear resistance. To facilitate the friction test, the woven fabric was glued on the surface of a 45 steel-based material using epoxy resin, detailed information of preparation can be found in Ref. [21]. Subsequently, the flat PTFE/Kevlar fabric sample was cut with a size of  $36 \times 17 \times 3 \text{ mm}^3$ , and the fabric thickness was 0.384 mm.

The ball samples, with a diameter of 6.35 mm, were machined from CGr15 bearing steel, as shown in Fig. 2b. The ball surface was hardened and electroplated with hard chromium, and the roughness was  $0.05 \text{ }\mu\text{m}$ .

Fig. 2c shows the contact interface of CGr15 bearing ball-on-PTFE/Kevlar fabric flat. The basic mechanical properties of Kevlar and PTFE fiber bundles, as well as the main components and mechanical properties of the GCr15 material can be seen in Ref [21].

Fig. 2. Sample details: (a) PTFE/Kevlar fabric; (b) CGr15 bearing ball; (c) Contact interface in wear experiments.

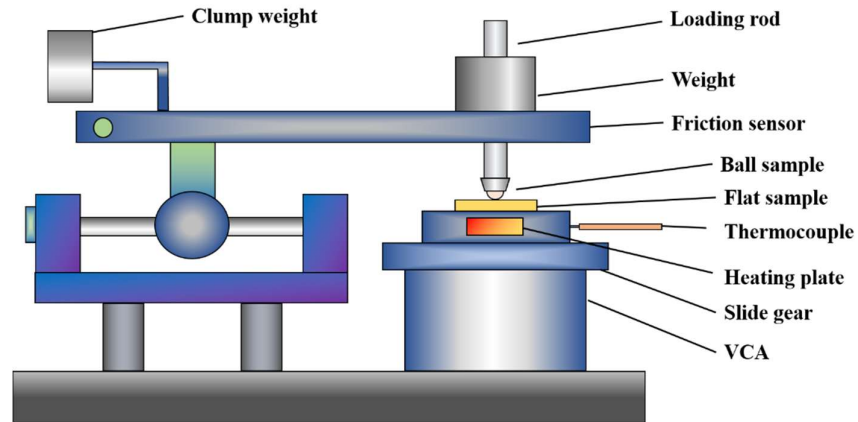
The experiments were performed through a high temperature reciprocating friction and wear rig (MXW-1, China), which allows a ball to reciprocate linearly with a flat specimen under controlled forces and temperatures. The structure diagram of the rig is shown in Fig. 3. The set loads can be obtained by controlling the spring loading device. The motor drives the slide gear to make the flat specimen run a periodic reciprocating linear motion. In this study, the sliding direction was unified perpendicular to the PTFE fiber bundle and parallel to the Kevlar fiber bundle. The required ambient temperature conditions can be achieved and maintained through the coordinated action of the heating plate and the thermocouple. The reciprocating friction and the coefficient of friction (COF) of the sample were measured by the friction sensor on the lever.

Fig. 3. Schematic diagram of MXW-1 high temperature reciprocating wear testing rig.

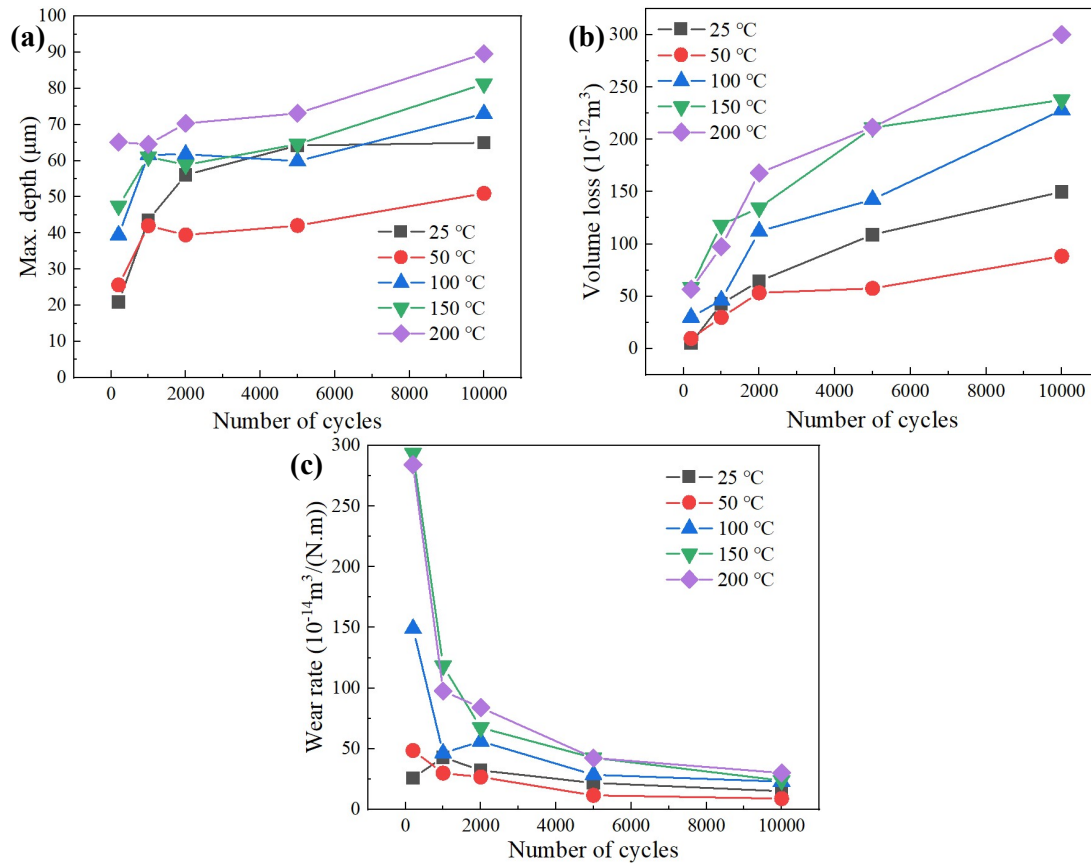
The worn surface of PTFE/Kevlar fabric as a function of reciprocating cycle was detected using 3D-OM. Subsequently, the maximum depth of wear scar, volume loss and wear rate were obtained, and the results are shown in Fig. 5. The maximum depth increases overall as the test progresses, but slight decreases can be seen during some tests (Fig. 5a). This can be attributed to the formation and transfer of the self-lubricating PTFE film during the test. For different temperature conditions, the volume losses of hybrid PTFE/Kevlar fabric increase with the increase in cycle numbers (Fig. 5b). Notably, as the test progresses, the wear rates of

PTFE/Kevlar fabric first decrease and then stabilize under high temperature conditions (Fig. 5c). The significant decrease in the wear rate in the early stage of tests may be related to the formation of the self-lubricating transfer film.

Compared with the wear behavior at room temperature (25 °C), the maximum depth, volume loss and wear rate of PTFE/Kevlar fabric are relatively lower at higher temperatures of 50 °C and 75 °C (not given here). A similar slight reducing trend with increasing temperature was observed in Ref. [27]. Besides, as the temperature continues to increase, the wear gradually increases. Higher volume losses and wear rates can be seen at temperatures beyond 100 °C than those at room temperature. Interestingly, the wear rates are significantly higher at high temperatures than that at 25 °C in the early stage of tests (Fig. 5c).

Fig. 5. Wear of PTFE/Kevlar fabric at different temperatures: (a) maximum depth; (b) volume

loss; (c) wear rate.

At a higher temperature of 50 °C, the worn surface is still dominated by damage of PTFE fiber, while no obvious fractured PTFE debris is observed (Fig. 7). Therefore, compared with room temperature, the damage at 50 °C is milder, corresponding to the lower wear rate shown in Fig. 5.

Fig. 11 shows the partial 3D-OM results of the PTFE/Kevlar wear scar at different temperatures (after 10,000 cycles). Corresponding to the wear data in Fig. 5, the fabric material wears only slightly at 50 °C. When the temperature increases from 50 °C to 200 °C, both width

Considering the wear rate in Fig. 5, two regimes, rapid wear (the wear rate  $\geq 100 \times 10^{-14} \text{m}^3/(\text{N.m})$ ) and slow wear (the wear rate  $< 100 \times 10^{-14} \text{m}^3/(\text{N.m})$ ), are identified in the wear map (Fig. 18a). Among them, the rapid wear regime is dominated by severe adhesive wear mechanism of the softer PTFE, while the slow wear regime includes mild adhesive wear and slight abrasive wear of PTFE, as well as the thermal fatigue wear of the harder Kevlar at high temperatures.

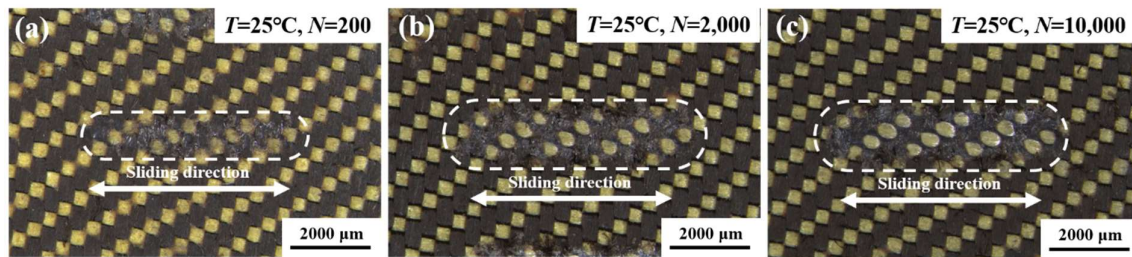
Figs. 6-9 show the evolution of PTFE/Kevlar fabric wear scars with reciprocating cycles at temperatures of 25 °C, 50 °C, 100 °C and 200 °C. It is observed that the width of the wear scar and the damage increase gradually as the number of cycles increases. The worn PTFE/Kevlar fabric at a temperature of 25 °C is characterized by fragmentation and abrasion of PTFE bundles, and gray-black fibrous debris caused by the mechanical shearing force during the friction process can be observed in Fig. 6.

Fig. 6. SM images of worn surface of PTFE/Kevlar fabric at temperature of 25 °C: (a) 200 cycles; (b) 2,000 cycles; (c) 10,000 cycles.

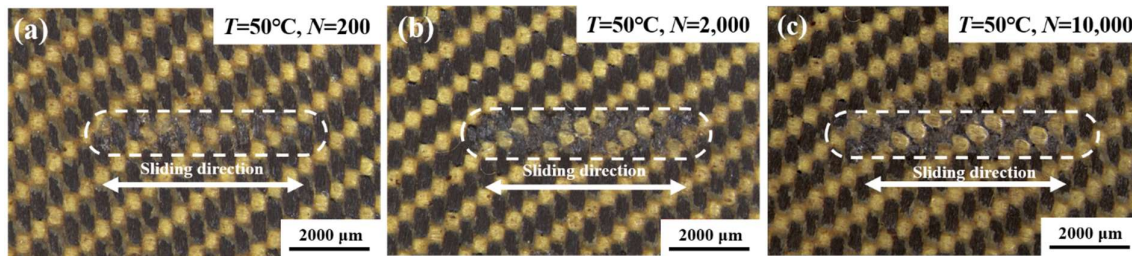
Fig. 7. SM images of worn surface of PTFE/Kevlar fabric at temperature of 50 °C: (a) 200 cycles; (b) 2,000 cycles; (c) 10,000 cycles.

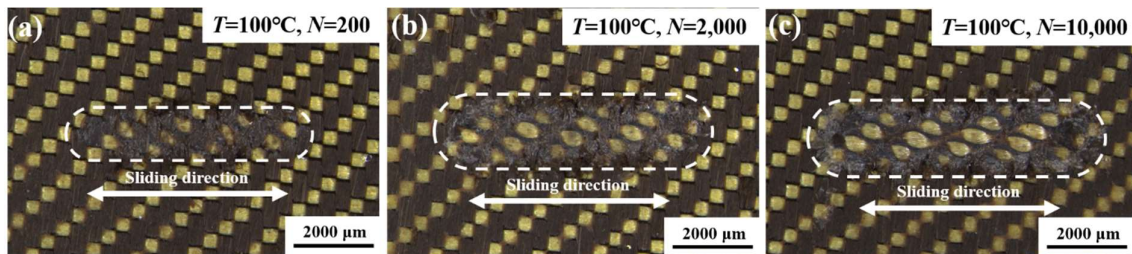
When the temperature increases to 100 °C, the fabric wears fast and severely. After running 200 cycles, the broken PTFE fibers adhering to the Kevlar surface can be observed in Fig. 8a. At cycles of 2,000, the PTFE material in the center of the contact zone is completely broken and begins to shift in the sliding direction (Fig. 8b). When it reaches 10,000 cycles, the fabric damage is further aggravated, severe plastic deformation and loss of fabric feature has occurred. Specifically, the raised PTFE debris is observed at the edges of the wear scars, while only a little of PTFE material adheres to the concavity of the Kevlar fibers in the center of the wear scars. Meanwhile, the Kevlar bundles also begin to shift in the sliding direction.

Fig. 8. SM images of worn surface of PTFE/Kevlar fabric at temperature of 100 °C: (a) 200 cycles; (b) 2,000 cycles; (c) 10,000 cycles.

The profile analyses of the fabric wear scar at different reciprocating cycles and temperatures were performed using 3D-OM. Fig. 10 shows the results of 2D and 3D profiles of PTFE/Kevlar fabric at a temperature of 100 °C. Obviously, the width and depth of the wear scar increase with the increasing cycles. After testing 10,000 cycles, the maximum width of the wear scar reaches 1.738 mm (Fig. 10a). Meanwhile, there is a raised structure on the edge of the wear scar, combined with SM observation in Fig. 8, it can be assumed to be the accumulation of transferred PTFE debris. An obvious peak and valley structure is observed in the center of the wear scar, and the peak should be the high-strength Kevlar bundle. At 10,000 cycles, the height of the peak is up to 38.04 μm. It is indicated that the PTFE material around the Kevlar fibers has been transferred and squeezed to the surroundings during the friction process (corresponding to Fig. 8).

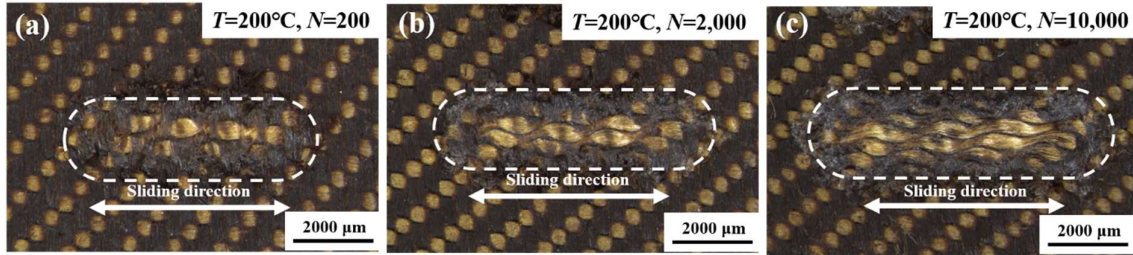
become more significant with increasing temperature, as shown in Fig. 9. At a temperature of 200 °C, the PTFE fibers wear rapidly, leaving the Kevlar materials completely exposed and elongated in the sliding direction, further forming a “wave-like” structure (Fig. 9c).

Fig. 9. SM images of worn surface of PTFE/Kevlar fabric at temperature of 200 °C: (a) 200 cycles; (b) 2,000 cycles; (c) 10,000 cycles.

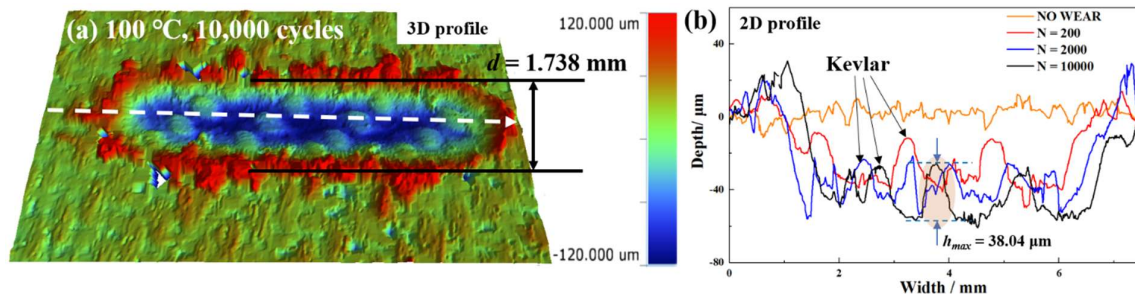
Fig. 10. 3D-OM results of worn PTFE/Kevlar fabric at temperature of 100 °C: (a) 3D profile after 10,000 cycles; (b) 2D profile as a function of cycles.

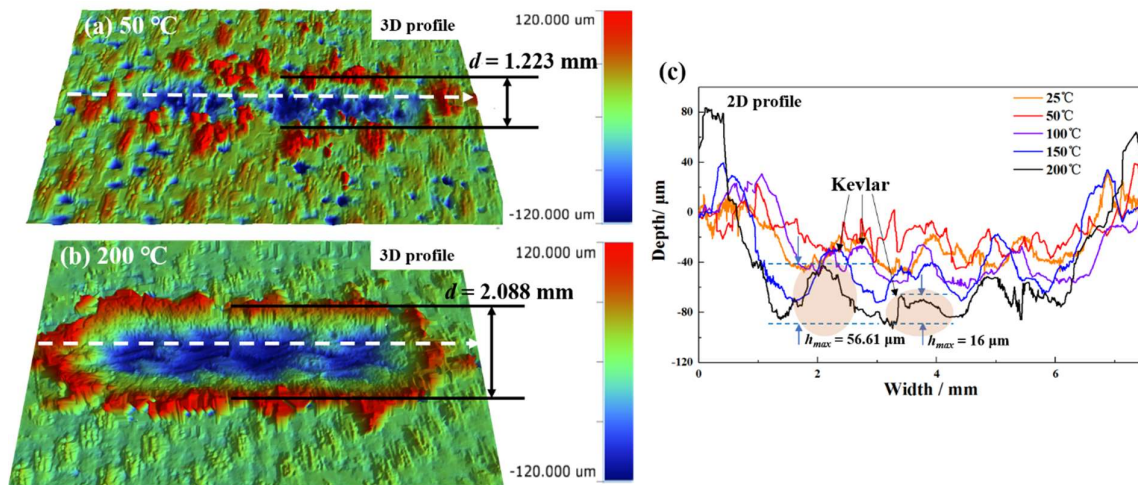
and depth of the wear scars increase. At a temperature of 200 °C, the maximum width of the wear scar is 2.088 mm, and the height of the Kevlar peak is up to 56.61 μm. However, a low peak of 16 μm height in the center of the wear scar is observed, implying that the Kevlar material has undergone severe wear and breakage under this condition (Fig. 11b).

Fig. 11. 3D-OM results of worn PTFE/Kevlar fabric at different temperatures (10,000 cycles): (a) 3D profile at temperature of 50 °C; (b) 3D profile at temperature of 200 °C; (c) 2D profile as a function of temperature.

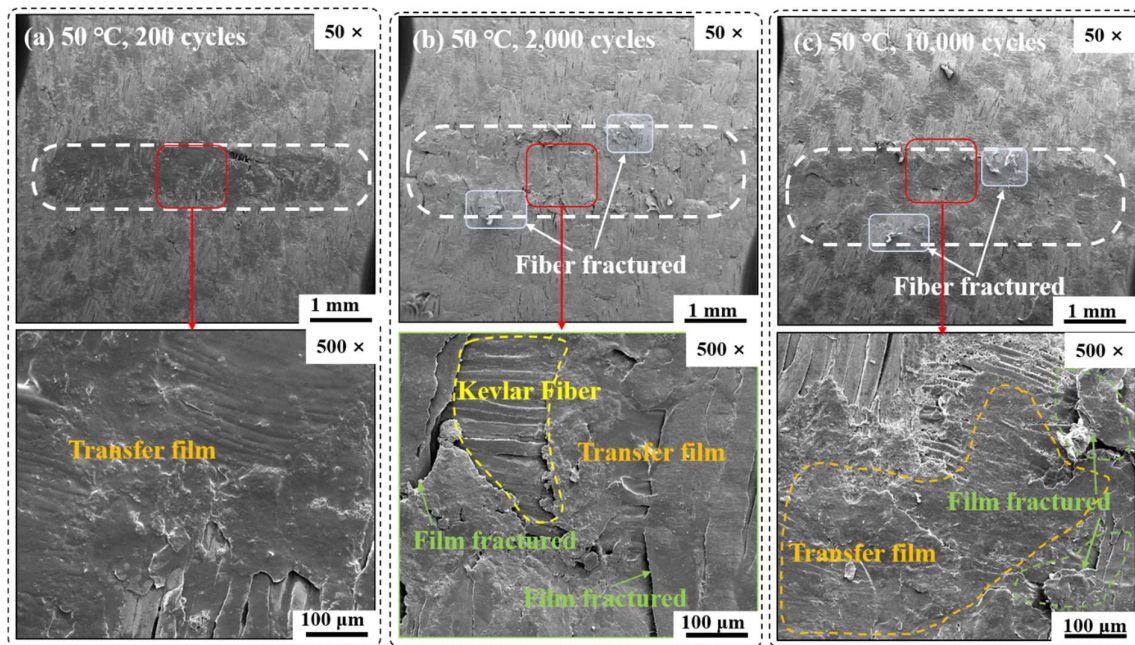
Fig. 12 shows the SEM results of the wear scar of PTFE/Kevlar fabric with reciprocating cycles at a temperature of 50 °C. In the early stage of this test (Fig. 12a), the PTFE material quickly adheres to the surface of the fabric under the action of sliding load and exhibits a good lubricating effect, resulting in a good wear resistance (Fig. 5). When it reaches 10,000 cycles, only slight fiber breakage is observed at the edge of the wear scar, as shown in Fig. 12c.

Fig. 12. SEM images of worn surface of PTFE/Kevlar fabric at temperature of 50 °C: (a) 200 cycles; (b) 2,000 cycles; (c) 10,000 cycles.

The above SEM analysis indicates that a desired high temperature can effectively promote the adhesion of PTFE material to the contact surface, enhance the self-lubricating effect, and produce adhesive wear (Fig. 12). However, as the temperature increases, the PTFE transfer film accelerates consumption and peels off from the surface under the combined action of mechanical and thermal effects, causing the Kevlar fiber to lose the protection of the self-lubricating PTFE material and become exposed. Finally, the exposed Kevlar fiber suffers severe fatigue damage (Figs. 13-14).

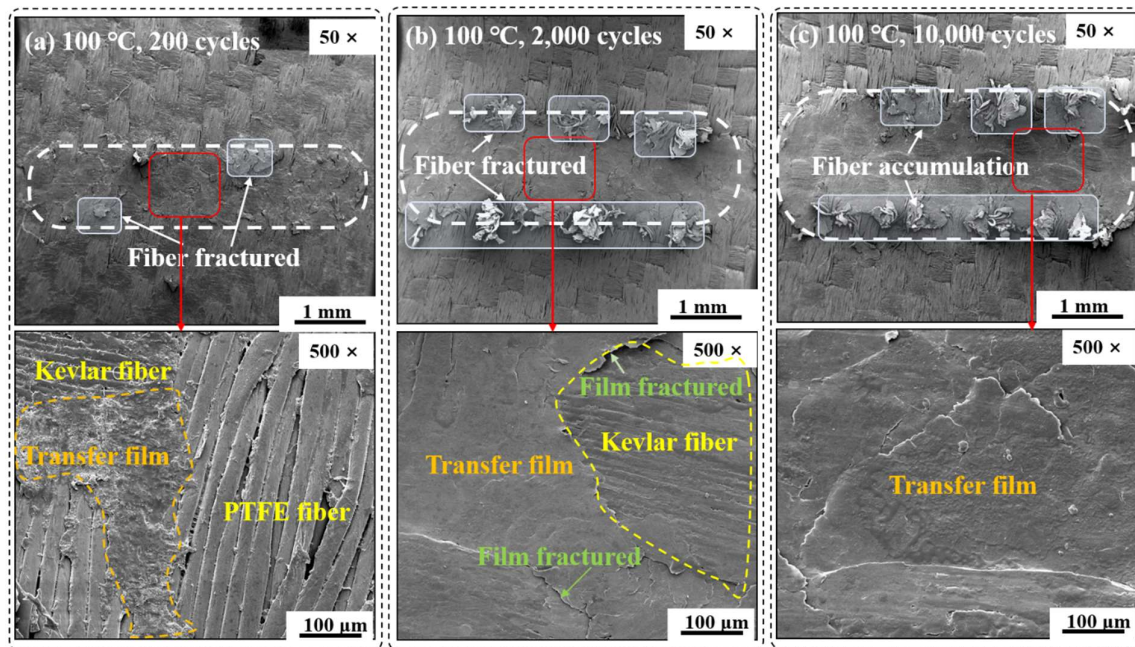
Fig. 13a-c presents the formation and accumulation of PTFE transfer film at a higher temperature of 100 °C. Comparing the SEM results at temperatures of 25 °C and 50 °C, it can be inferred that the increase in temperature will further aggravate the damage of the fabric material, which is manifested by an increase in the fiber fracture and its accumulation at the edge of the wear scar, as well as a stronger flow of PTFE. After testing 10,000 cycles, a large area of PTFE transfer film is formed in the middle of the wear scar. Meanwhile, it is hard to observe the fiber structure, as shown in Fig. 13c.

Fig. 13. SEM images of worn surface of PTFE/Kevlar fabric at temperature of 100 °C: (a) 200 cycles; (b) 2,000 cycles; (c) 10,000 cycles.

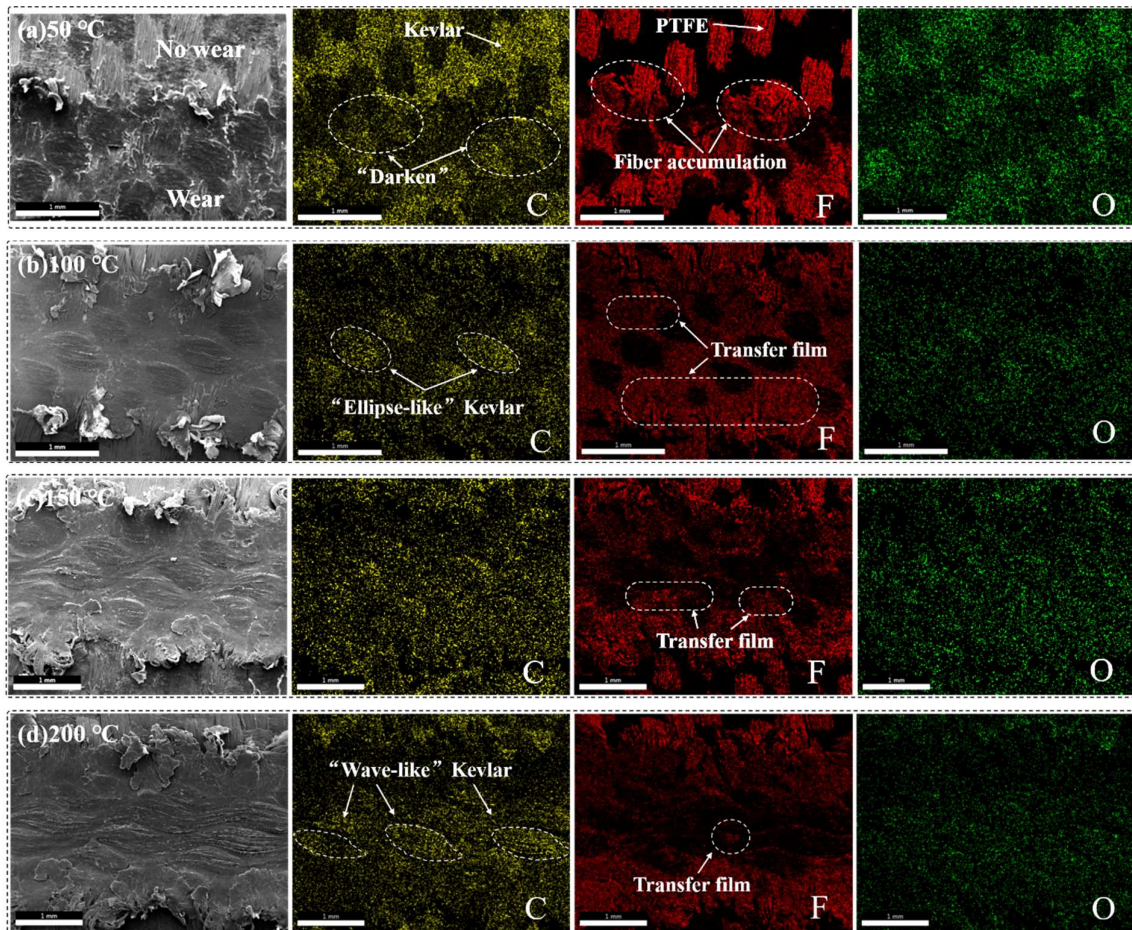
In order to explore the effect of high temperatures on the transfer and distribution of elements at the friction interface, EDS mapping scanning analysis of the PTFE/Kevlar wear scars was performed at temperatures of 50 °C, 100 °C, 150 °C, and 200 °C. The results are shown in Fig. 15. It should be pointed out that it is difficult for EDS to detect the C element in the PTFE because the F element covers the C-C main chain in the PTFE. Therefore, the F elements in the EDS observations all came from PTFE fibers, while the C and O elements were derived primarily from Kevlar fibers whose chemical structure is  $(-\text{CO}-\text{C}_6\text{H}_4-\text{CONH}-\text{C}_6\text{H}_4-\text{NH}-)_n$ .

Fig. 15a shows that the distributions of C, F, and O elements on the surface of the fabric behave fibrous structures at temperature of 50 °C due to the slight wear. However, the decrease in the distribution of C (the "yellow" area is obviously darkened) and the tendency of F to transfer to Kevlar fibers can still be found in the wear scar.

When the temperature increases to 100 °C (Fig. 15b), the fabric is severely worn. It is hard to observe the element with fibrous distribution. Meanwhile, the distributions of C and O become weakened, and an "ellipse-like" C distribution is observed in the middle of the wear scar. On the contrary, the F element is distributed in the entire scanning area and covers the Kevlar fiber.

Fig. 15c shows that at a higher temperature of 150 °C, the distribution of the F at the edge of the wear scar is much stronger than that in the middle of the wear scar, which indicates that the PTFE transfer film is rapidly being worn or peeled off under this condition.

As the temperature further increases to 200 °C (Fig. 15d), the C element in the wear scar becomes strong again, and appears "wave-like" as similar as the Kevlar. Whereas, the distribution of F in the middle of the wear scar is further weakened. It is suggested that at high temperature, as the fabric wears rapidly, the PTFE is continuously flattened and squeezed to edges of the wear scar, exposing the Kevlar fiber, which is consistent with the result in Fig. 14.

Fig. 15. EDS mapping scanning results of worn PTFE/Kevlar fabric at high temperature conditions (10,000 cycles): (a) 50 °C; (b) 100 °C; (c) 150 °C; (d) 200 °C.

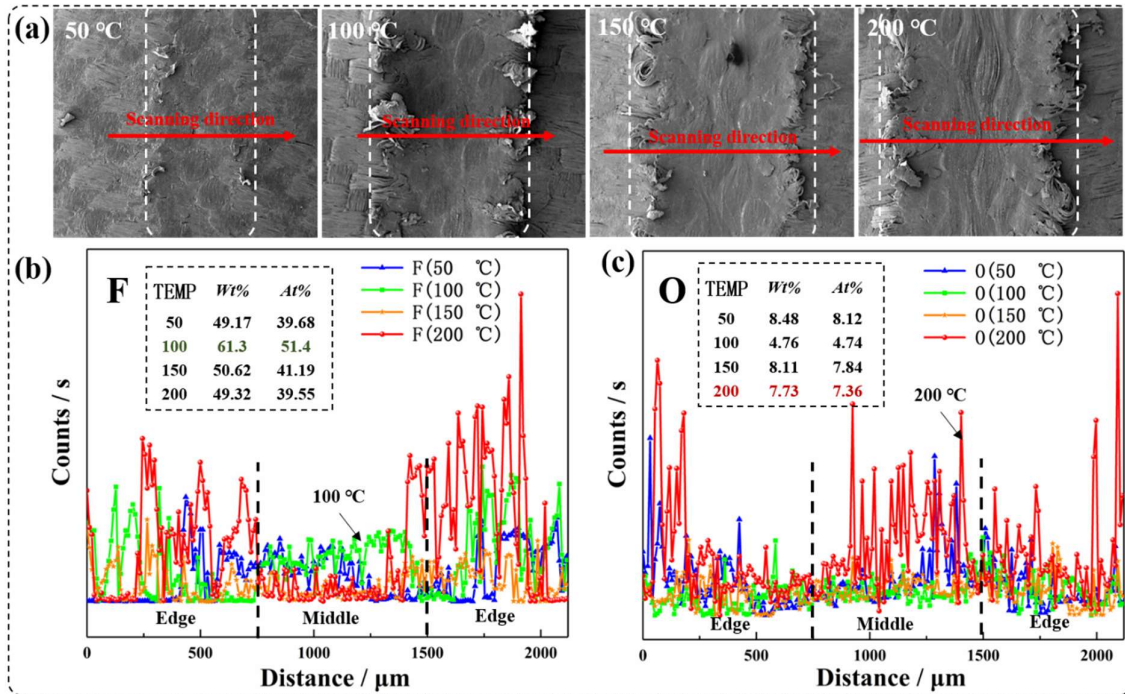
temperature conditions. The scanning area is shown in Fig. 16a, and the distributions of F and O are presented in Fig. 16b and Fig. 16c, respectively.

Fig. 16b shows that under high temperature conditions, the F element is distributed strongly on both sides of the wear scar and weaker in the middle. This proves once again that the PTFE fiber is destroyed and squeezed to edges of contact interface during the reciprocating sliding process (corresponding to Figs. 6-9). Besides, the content of F in the middle of the wear scar at a high temperature of 100 °C is more than that under other temperature conditions. Combined with SEM images (Figs. 12-14), it is indicated that the PTFE transfer film is formed well at temperature of 100 °C.

Contrary to the distribution of F element, the distribution of O is stronger in the middle of the wear scar and weaker on both sides, as shown in Fig. 16c. Meanwhile, the lowest content of O in the middle of the wear scar at temperature of 100 °C once again proves its best formation of transfer film. In addition, the high content of O in the middle of the wear scar at a high temperature of 200 °C may be related to the exposure of the Kevlar fiber or oxidative wear.

Fig. 16. EDS line scanning results of worn PTFE/Kevlar fabric at high temperature conditions (10,000 cycles): (a) 50°C; (b) 100°C; (c) 150°C; (d) 200°C.

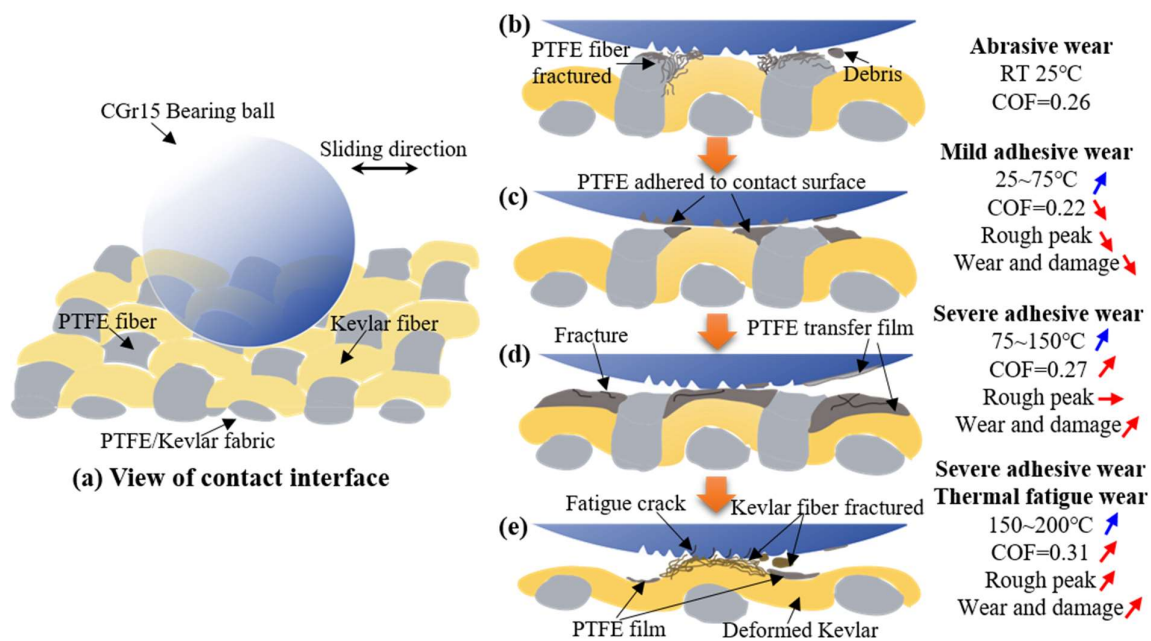
Fig. 17 shows the schematic of the proposed wear mechanism and how it changes with

increasing temperature. Theoretically, the contact interface between the CGr15 bearing ball and the fabric material inevitably have rough peaks, although it looks smooth (Fig. 17a). With the reciprocating sliding load, the softer PTFE fibers will break first, forming wear debris, and further aggravate the wear, as shown in Fig. 17b. Wear like this at room temperature due to particles or protuberances forced against and moving along a solid surface is abrasive wear (three/two body respectively) [21][30][32].

Fig. 17. Schematic of wear mechanism changes with the temperatures: (a) macroscopic view of contact interface; (b-e) magnified view of contact interface under high temperature conditions.

At high temperatures, the surface of PTFE/Kevlar will soften [33], whereas the wear debris will become easily susceptible to slip and dynamic adhesiveness, resulting in an adhesive wear mechanism [31][34]. When the ambient temperature was in the range of 25~75 °C, the PTFE/Kevlar underwent slight adhesive wear, as seen in Fig. 17c. Specifically, the local softened PTFE flakes were torn from the fibers and adhered to the gaps in the fabric material

When the ambient temperature rose to 75~150 °C, severe adhesive wear occurred on the surface of the fabric material (Fig. 17d). At this moment, it was observed that PTFE material adhered to the Kevlar fiber in a large area to form a transfer film (Figs. 8,13,15b-c). Usually, the existence of the transfer film is conducive to self-lubrication that reduces wear and damage [27]. However, the transfer film is prone to fracture under the thermal-mechanical action, peeling off from the surface and forming shear furrows, which will further expose Kevlar fibers, or clumps adhering to the surface of the bearing ball for repeated friction. Therefore, a more severe wear loss and surface damage was detected in Figs. 5, 8 and 13 compared with the lower temperature conditions.

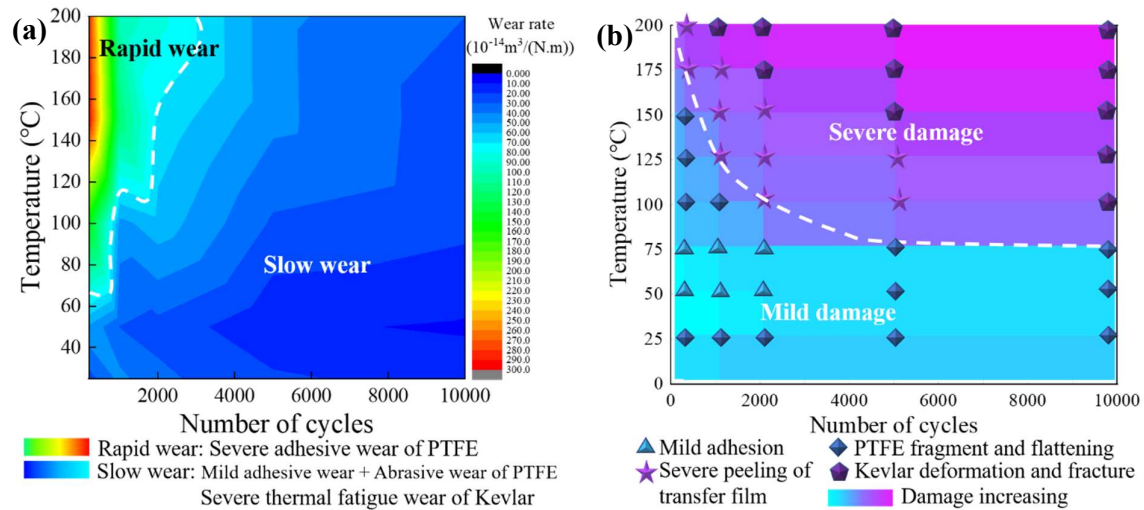
Fig. 18. Wear and damage transition map of PTFE/Kevlar fabric: (a) wear map; (b) damage map; (c) the interaction of wear and fatigue damage.

Subsequently, the damage map in Fig. 18b can be divided into two regimes based on the severity of the surface damage of PTFE/Kevlar fabric: mild damage and severe damage. Specifically, the damage behaviors in the mild damage regime include the slight adhesion at temperatures of 50~75 °C and slight PTFE fragment at room temperature, whereas severe surface damage behaviors, such as severe peeling of PTFE transfer film, exposure, deformation and fatigue fracture of Kevlar induced by thermal-mechanical load at high temperatures of above 100 °C, can be usually observed in the severe damage regime.

Fig. 18c presents the relationship between wear loss and surface damage. A mechanism of competition and restriction between wear and damage can be concluded [36]. The failure plot

From the analysis above, there is a transition of wear mechanism and damage behaviors with the increasing temperatures and testing cycles. As it is known, the wear map, which was widely applied in the prediction and numerical simulation, is an effective way to distinguish the wear regimes and transition processes [31][35], as well as to understand the influence of various test conditions on the contact surfaces in the space-time framework of wear. In the present study, the transition maps of wear and damage behaviors in terms of reciprocating cycle and ambient temperature were concluded by examining the successive changes in the wear loss and surface damage of the PTFE/Kevlar fabric, as shown in Fig. 18.
