WEAR AND FATIGUE OF RAILWAY TRACK CAUSED BY CONTAMINATION, SANDING AND SURFACE DAMAGE

R.S. Dwyer-Joyce, R. Lewis, N. Gao and D.G. Grieve

The University of Sheffield, Department of Mechanical Engineering,
Mappin Street, Sheffield, S1 3JD
UK

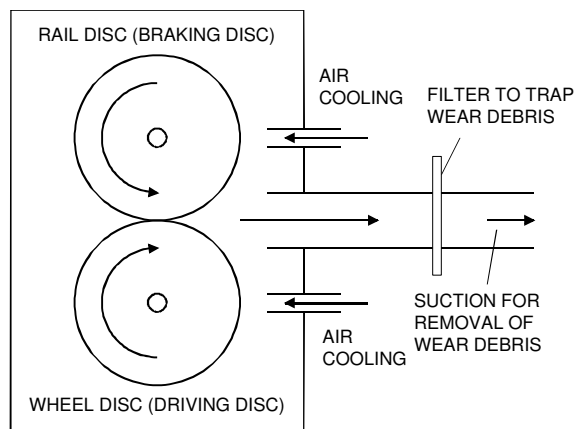
figure 1 Schematic of the test head from the twin disc machine

A twin disc testing machine was used to carry out the rolling contact experiments. The machine has been specifically designed to investigate wheel/rail contacts and is described in detail elsewhere [4]. A pair of steel discs is orientated one above the other with their axes horizontal and parallel (*figure 1* shows a picture of the disc test head).

The discs are loaded together hydraulically and driven independently by two electric motors. An advanced control system allows the discs to be driven at fixed stable slide roll ratios. The driving torque and rotational speeds were measured by means of a torque transducer and rotary shaft encoders. A load cell continually monitors the force compressing the two discs. The wheel discs are rotated faster than the rail discs so that the wheel acts as a driver whilst the rail disc is driven (i.e. the follower disc).

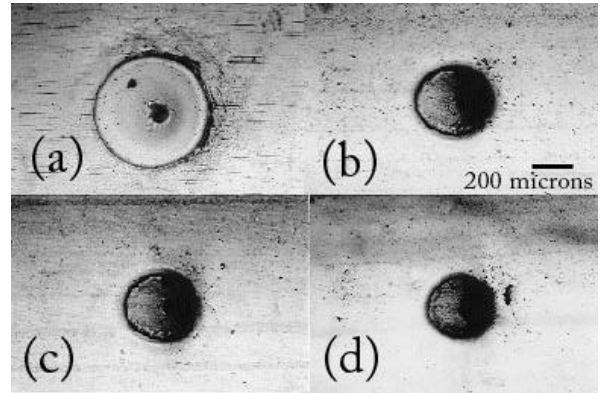
figure 2 A sequence of micrographs of a conical surface indent during an oil lubricated test (a) at the start of the test, (b) after 131k cycles, (c) after 465k cycles, and (d) after 866k cycles. Rolling and traction directions from right to left

Figure 2 shows a series of photographs from a single oil lubricated test captured at different stages during the test. The initial dent was generated using a Rockwell indenter and is rapidly reduced in size during the first few cycles. This process occurs by plastic flow of the dent side walls. Over the whole test, the weight loss is negligible so there is little effect of dent removal by a surface wear process. The Rockwell indentation leaves some dent shoulders on the rail surface. These shoulders and the side walls of the indentation collapse under contact loading. The dent then shakes down to a stable shape and little further deformation occurs (see figure 3a).

A fatigue crack initiates at the trailing edge of the defect that later propagates to a spall. Interestingly, the initiation point appears to be coincident with the edge of the original dent and not the final deformed dent. It is likely that the edge stresses are relieved by the plastic flow thus making a site slightly away from the edge of the point of peak stress. In this case we expect an elastohydrodynamic lubricant film to be present during testing. The thickness of the film will be modified by the presence of the dent [6]. At the trailing edge the slope change (i.e. convergent) is more favourable for

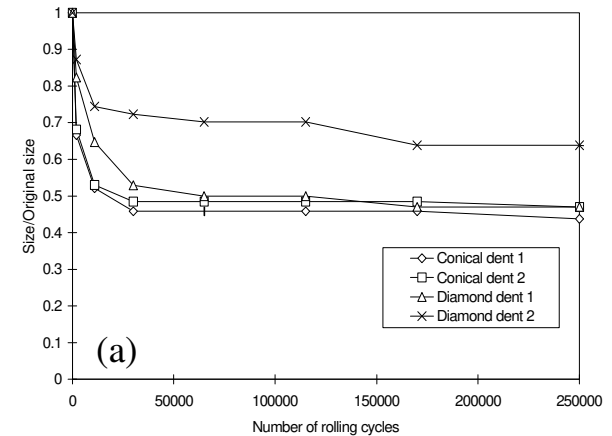
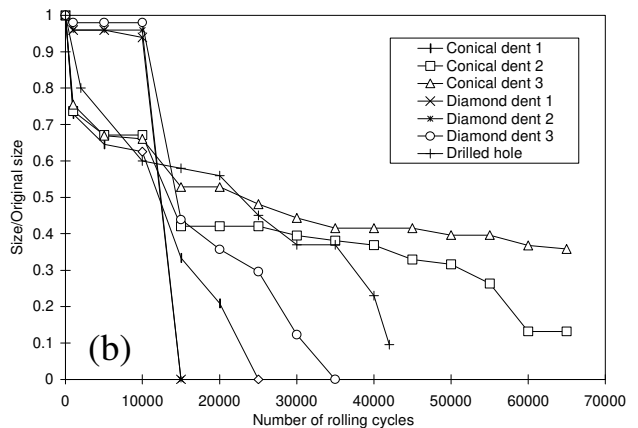
figure 3 The change in size of the indentations during (a) oil, and (b) water lubricated tests

If water is used as the lubricant a different process takes place (see *figure 4*). Again the dent is deformed, but this time deformation continues throughout the test until the dent is completely closed (see *figure 3b*).

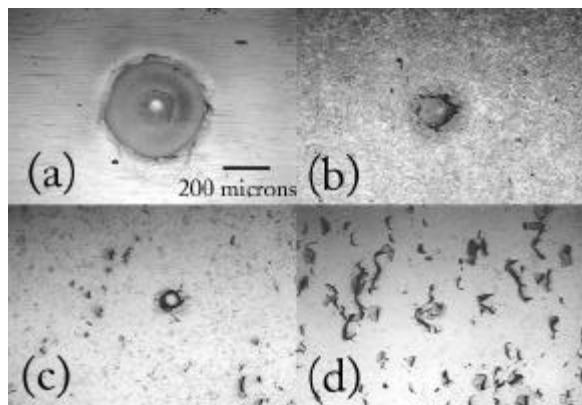
figure 4 A sequence of micrographs of a conical surface indent during a water lubricated test (a) at the start of the test, (b) after 5k cycles, (c) after 15k cycles, and (d) after 40k cycles. Rolling and traction directions from right to left

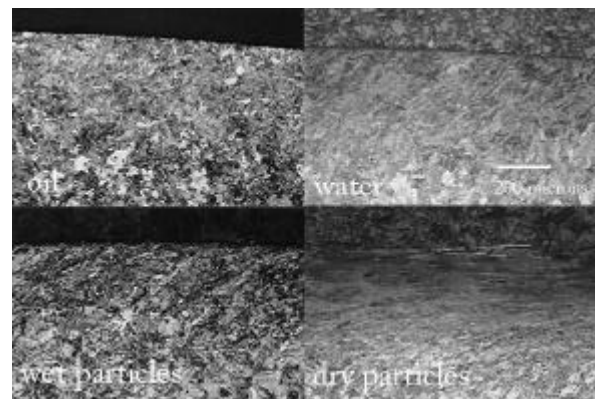
figure 5 Cross section through the running surface showing different morphologies for lubricated and contaminated situations. (a) oil, 1150k; (b) water, 50k; (c) wet contaminant 0.5k + water 27k; (d) dry contaminant, 40k cycles. Rolling and traction direction from left to right

Figure 5 shows sections through oil, water, and particulate (ballast) contaminated surfaces. For all except the oil case, the surface layer is sheared across in the direction of sliding (left to right). The severest plastic flow is caused by the presence of dry solid particles.

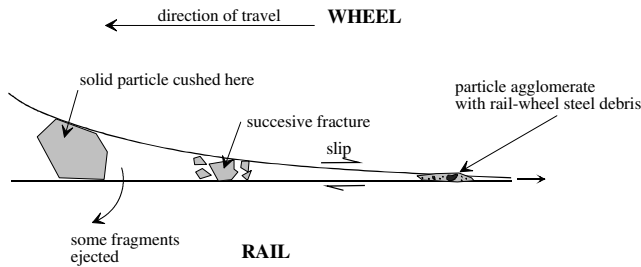
figure 7 Detail of the 'mechanism' of ballast debris entrapment in a rolling/sliding rail wheel contact. The contaminant is trapped, crushed, entrained and finally agglomerated as it passes through the contact of the wheel/rail

The surface damage is, however, still relatively minor; no deep dents were found, and the roughness was only increased to $R_a = 1 - 2 \mu\text{m}$. The ballast material is brittle and crushing the particles did not cause severe damage. The remaining fragments then indent the surface (as shown in *figure 7*); interestingly these fragments tend to agglomerate and there is evidence that the agglomerated fragments plastically shear under the very high local pressures [13].

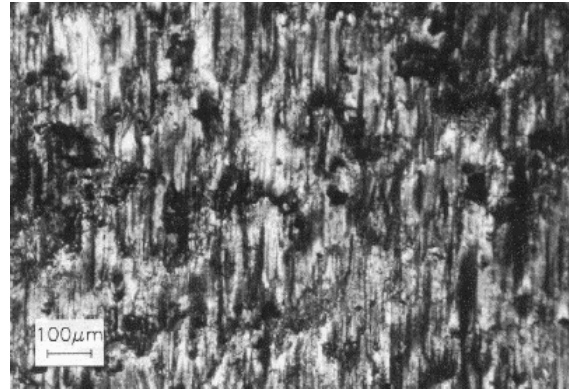
figure 8 Rail steel disc surface after 3000 cycles of operation with sand particles

severity of the abrasive score marks on the rail disc surface indicates that initially a similar two body abrasive process to that with ballast dust is occurring, with crushed sand particles embedding in the softer wheel steel and abrading the harder rail material. The low cycle fatigue process observed leads to the greater wheel disc wear since it is the softer of the two materials.

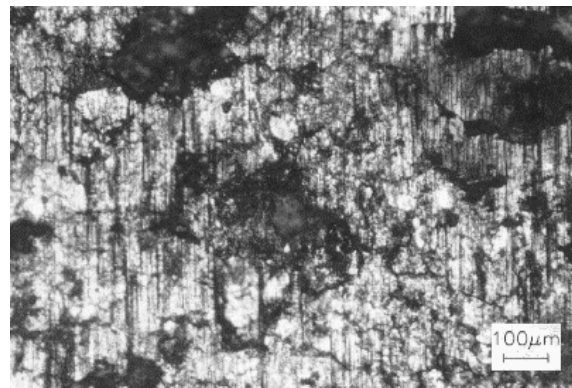
figure 9 Wheel steel disc surface after 3000 cycles of operation with sand particles

Clearly the removal of the steel debris particles that has led to the formation of the voids observed on the wheel disc surface (see figure 9). The greater

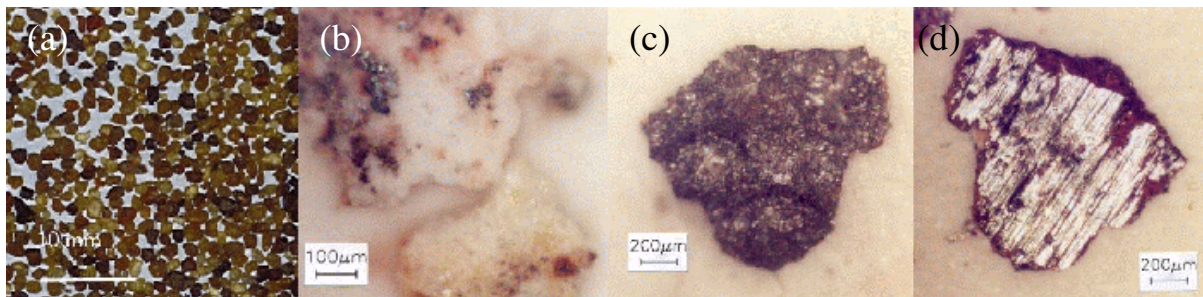
figure 10 (a) Sand particles before testing, (b) crushed sand particles (agglomerated with metal debris) after testing, (c) bottom and (d) top faces of a steel debris particle

Inspection of the wear debris showed that it consisted of the fine crushed sand particles and large chunks of steel. Figure 10 shows the sand particles before and after testing, and photographs of two opposite faces of a steel debris particle.

Evidently the sand is crushed to a fine (sub-micron) dust powder. However, the steel debris particle is also of interest; the form indicates that two wear mechanisms have taken place. Firstly the top surface (figure 10d) shows abraded scratches, these have been caused by the sand particle fragments as they are entrained into the contact and undergo relative motion. The reverse side (figure 10c) is rough and irregular similar to the appearance of a fatigue spall. It appears some fatigue wear process is also taking place, whereby a large chunk of material is removed from the surface, probably by the growth of a crack subsurface. The blocky shape of the wear debris is also typical of fatigue [14].

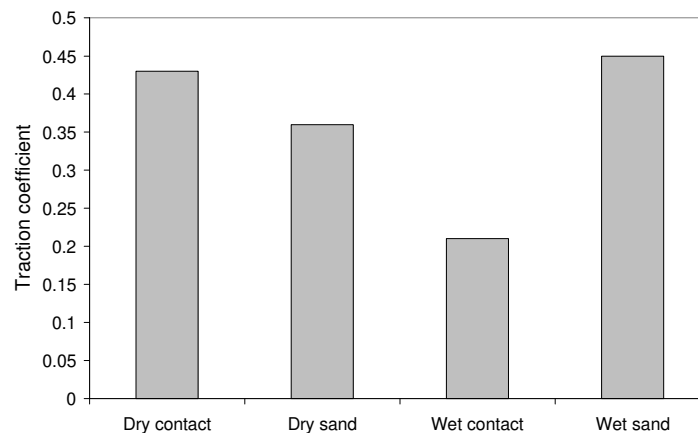
figure 11 Comparison of the traction coefficients recorded for disc machine tests with and without sand and/or water

The resulting traction values are shown in *figure 11*. The sand has a large influence on traction for wet rail surfaces, but actually slightly reduces friction in the dry case. In this case it appears that the sand is acting as a (poor) solid lubricant. This is likely to be because the relative sliding between the disc surfaces is accommodated by the fine sand grains sliding over one another rather than sliding metal to metal contact. Wear rates are very high and dependent on the flow of sand into the contact (typically wear rates of 1000-9000 $\mu\text{g}/\text{cycle}$ were recorded).
