13th International Conference on Computing and Control for the Water Industry, CCWI2015

Non-Destructive *In-Situ* Condition Assessment of Plastic Pipe Using Ultrasound

Juanjuan Zhu^{a,b*}, Richard P. Collins^a, Joby B. Boxall^{1 a}, Robin S. Mills^b,
Rob Dwyer-joyce^b

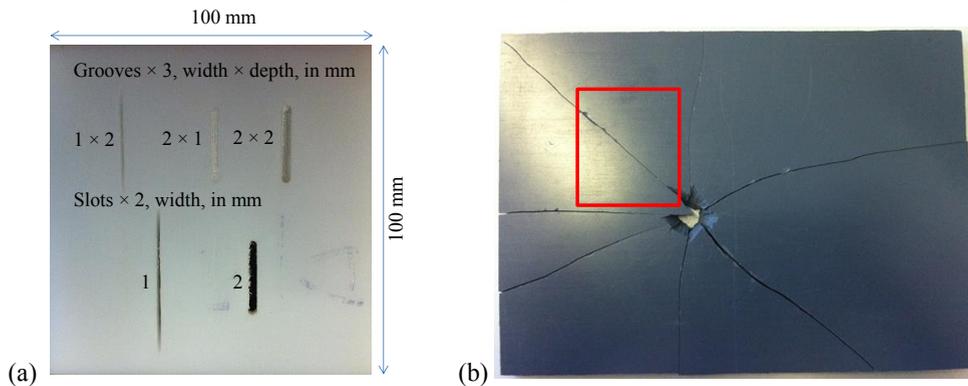
Fig. 1. (a) Size of grooves and slots machined on HDPE plate for experiment 1; (b) photo of cracked PVC plate with ultrasonic scanned area highlighted for experiment 2.

In the first experiment (material loss experiment), a 100×100mm HDPE plate with a thickness of 6 mm was considered. In order to represent different sizes of material loss on water pipe wall, three grooves and two slots with varying sizes were machined on the plate, as shown in Figure 1 (a). The widths of those linear grooves and slots were assumed to be 1 mm or 2 mm. Due to the size limitation of drilling tool, the grooves with width of 2 mm were cut by drilling tool while the ones with width of 1 mm were cut by slitting saw. The depths of the grooves cutting by slitting saw varied along the length, which was lowest in the middle and shallowing towards the end.

In the second experiment (crack experiment), a 135×100 mm PVC plate with thickness of 6 mm was considered. In order to simulate the cracks in the material, the plate was struck by an impact rig. Several cracks were produced, of which one was selected for ultrasonic scanning, as shown in Figure 1(b).

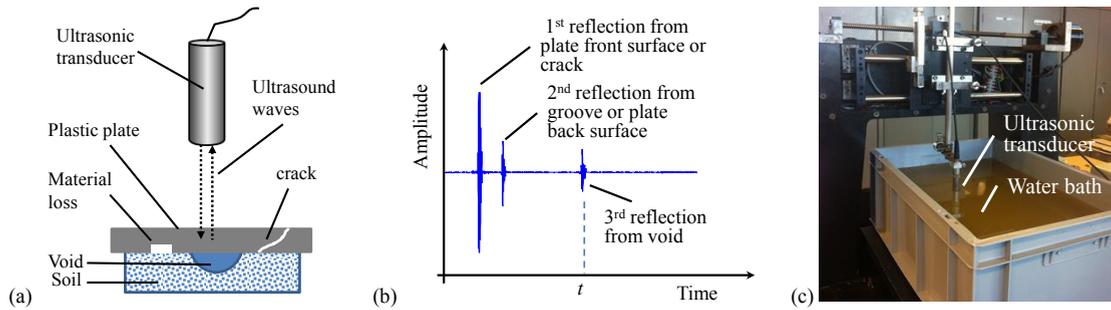
Fig. 3. (a) sketch of ultrasonic measurement; (b) photo of Ultrasonic scanning setting up; (c) .example of ultrasound signal.

A water-coupled focused ultrasound transducer with central excitation frequency of 10 MHz and a focal distance of 75 mm was used for ultrasonic testing. Figure 3 (a) shows the sketch of the testing configuration. The high frequency sound waves are excited and sent out, targeting on the test plastic plate. On the interface where an acoustic discontinuity existing, i.e. the first interface composed of couplant water and plastic material, some of the sound waves are reflected back while others continue to travel through the medium. The ultrasonic transducer should be aligned vertically to the plate surface in order to have high reflected energy transmission, otherwise, the signal will be scattered away without returning to the transducer. Figure 3 (b) presents an example of ultrasound signal where reflections from varying interfaces are marked. When an ultrasonic pulse reaches the plastic wall, the energy of the pulse is divided, with one part being reflected (the first echo) and the other part being transmitted into the material of the wall (ignore energy loss from scattering). When the transmitted pulse reaches the second interface of the wall, it is reflected back against the first interface. Reflected time series ultrasound signal is acquired through LabVIEW during scanning and the transducer location at each ultrasonic pulse is recorded. Information of time of flight (TOF) and signal amplitude for ultrasound signal is extracted from those peaks, which is further used for reconstructing plastic plate, material loss, cracks and void surfaces. The distances from transducer to individual boundaries are worked out when sound speed in each medium is measured. It should be noted that all three reflection signals presented on one figure is only the case for void detection test. In assessing of grooves or cracks, only the first two pulses appear.

Figure 3 (c) shows the ultrasonic scanning facility. The transducer is mounted to the gantry driven by a stepper motor, performing reciprocating sliding movement while the gantry table is driven by another stepper motor with a pre-set feed speed. Interfaces between the water, upper and bottom plate, groove and crack surfaces, and/or supporting substrate soil form three boundaries which will result in respective ultrasound energy reflection. Movement of transducer and the gantry table in two axes accommodate a 2D scanning. For voids detection test, location information of the table and transducer during scanning is recorded, which will be analysed for coordinate of voids (X and Y). Together with calculated depth (Z) from TOF of ultrasound for each scanned point, a 3D reconstruction of voids could be obtained.

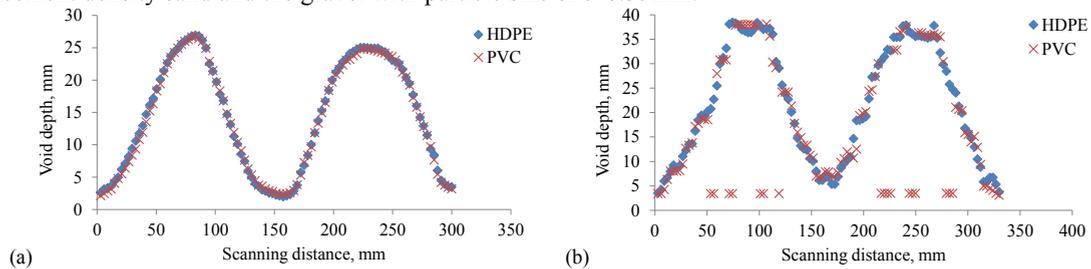
Fig. 4. Change of void shapes for (a) replacement density sand (voids profile of hexagonal star left and cube right); and (b) gravel with particle size of 5-6.35mm (voids profile of hexagonal star left and cube right).

Figure 4 (a) compares the detected void cross section profile with placing two plastic plates, HDPE and PVC for RD sand. It can be clearly seen that same void profile was detected for both plates. There is no change for the void shapes and the dimensions during two separate ultrasonic scanning. Figure 4 (b) presents the same result for gravel. Even though noise signal was captured for PVC case, both materials show good repeatability for void cross section shapes and depths. Therefore, it can be concluded that no disturbance from applying and lifting plastic plate has been introduced during the test. The ultrasonic method for void detection is valid for both fine and coarse particle soils.

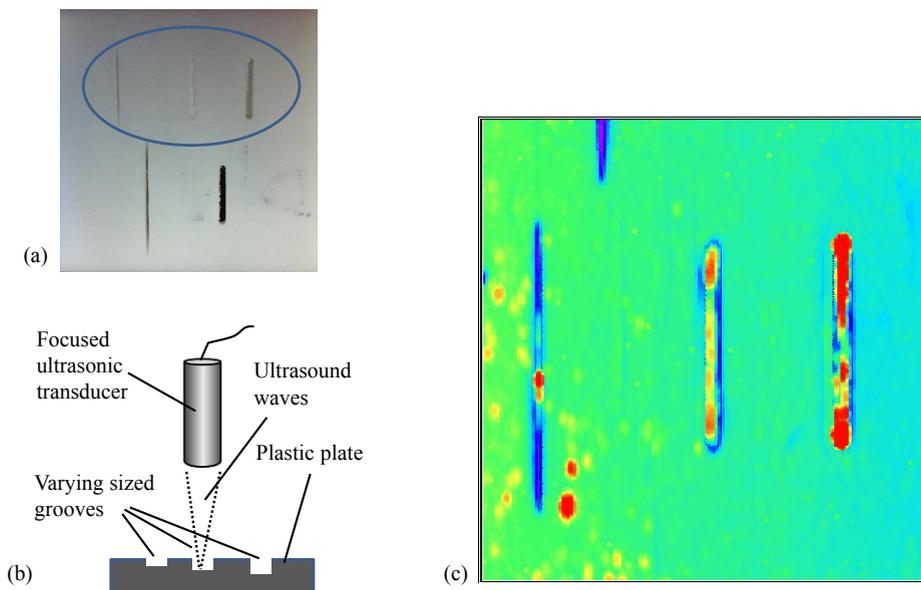
Fig. 5. Grooves detection test, (a) tested grooves highlighted; (b) ultrasonic testing sketch; and (c) detection result.

Figure 5 (a) highlights tested grooves while (b) indicates the groove detecting principle. The focused sound waves are sent out by water-coupled transducer (not shown on the figure for simplification), reflected from water-plate interface and recorded. The amplitude of reflected signal shown as 2nd peak shown on Figure 3 (b) is of interest in this test. Due to sound wave energy attenuation in material bulk, reflection sound amplitude from grooves is expected to be greater due to thinner material thickness. Figure 5 (c) presents detection result for three grooves with varying depth from 1 to 2 mm and width from 1 to 2 mm. Deeper grooves produce higher ultrasonic reflection shown as red due to shorter sound travelling distance. It should be noted that along the boundaries of these grooves, much lower ultrasonic reflection has been found. This indicates the sound energy loss due to scattering while travelling along those boundaries.

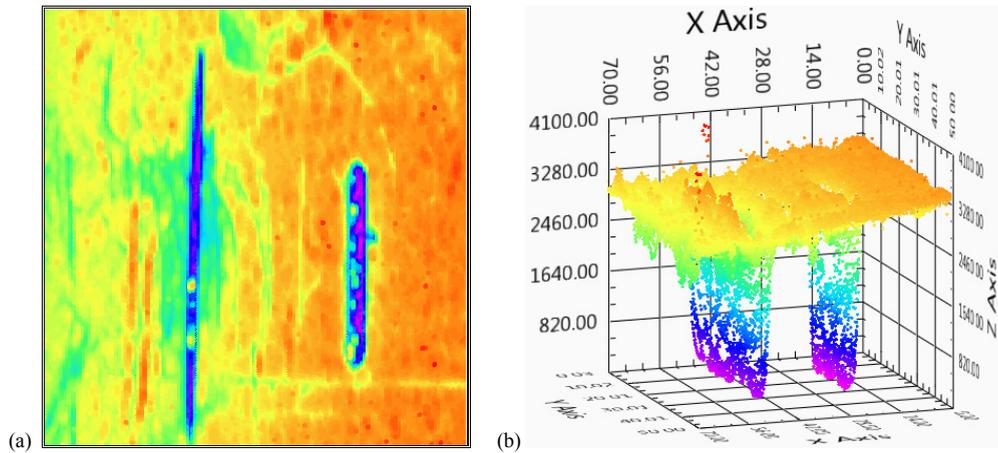
Fig. 6. Slots detection test, (a) top view of detected slots; (b) 3D of slots detection.

Figure 6 shows two slots detection results. An area of 50×70 mm covering two slots is scanned by the ultrasonic transducer. The 1st reflection signal on Figure 3 (b) is selected for analysis in this test. While the sound waves are arriving on the top surface of the plate, greater reflection is received by the transducer due to acoustic mismatch between water and plastic material, shown as a background colour. On the position of slots, the ultrasound waves travel through without being reflected. Therefore recorded reflection signal amplitude approaches zero, especially in the middle of the slot, shown in Figure 6 (b). The reflection signal over the slot is gradually dropping down from the boundary to the middle, making a wedge shape.

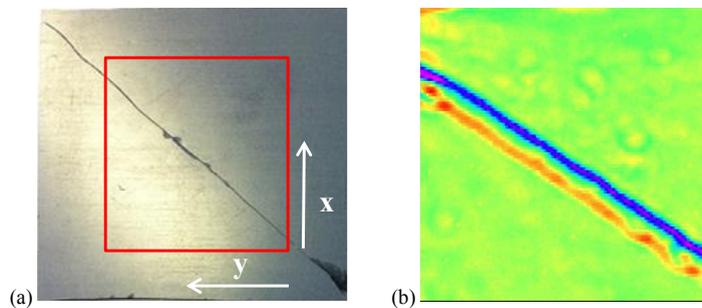
Fig. 7. Crack detection test, (a) photo of crack; (b) top view of detected crack.

Figure 7 shows tested crack on PVC plate. The testing setting up is the same as groove detection test as the plate is water immersed. The amplitude of the first reflection in Figure 3 (b) is analyzed to distinguish the one reflected from crack. Detection result is shown by Figure 7 (b), from which the location of the crack can be clearly observed. However, along two boundaries of the crack, the reflected signal amplitude is found to be higher on one side but lower on the other side. There are two contributions to this phenomenon. On one hand, on the edge of the crack, ultrasound signals are scattered, which lead to lower reflection amplitude. On the other hand, it has been noticed that the crack along the material bulk is not vertical to the plate surfaces. Therefore the signals travelling through the crack gap may be multi-reflected from fracture surfaces which will result in amplitude superposition.

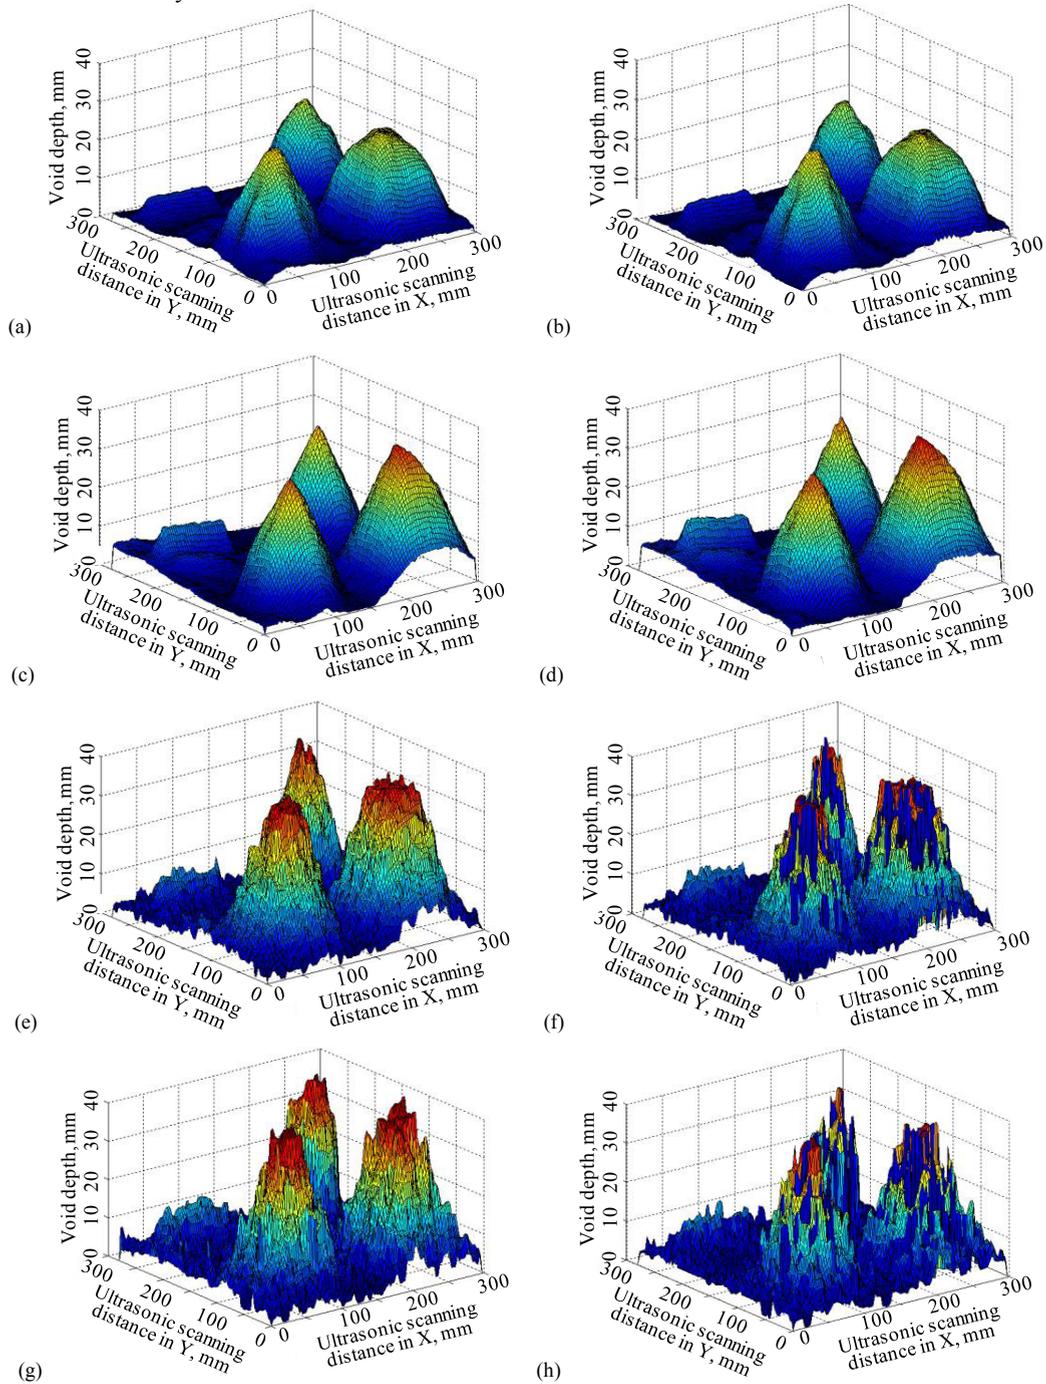
Fig. 8. Voids 3D reconstruction for HDPE and PVC, (a) and (b) for replacement density sand; (c) and (d) for David Ball Fraction C sand; (e) and (f) for gravel 5-6.35mm; (g) and (h) for gravel 8-9.5mm.

Figure 8 shows 3D reconstruction of four voids based on the measurement from the RD sand, DB sand and two gravels, with HDPE and PVC pipe materials. Figure 8 (a), (c), (e), and (g) presents voids detection results for HDPE while (b), (d), (f), and (h) for PVC. The sketch of ultrasonic detection for voids beyond plastic materials is shown in Figure 3(a). Ultrasound waves are excited and sent out, travelling through plastic material until arriving on void surfaces in the soil. Part of those waves are reflected and travelling back to the transducer, which are recorded and used for extracting information of voids. The recorded reflection signal is shown on Figure 3 (b), while the first two reflections correspond to the top and bottom surface of the plate and the third one is from void

surface. The recorded TOF for ultrasound signal is used to calculate the distance from the plastic plate bottom surface to soil surface by multiplying ultrasound wave fling time with sound wave speed in water, which is taken as 1480m/s in this study.

The depth of voids in mm is indicated by Z axis in figure 8, where a value of zero represents the soil surface contacting with plastic bottom surface. Four voids with varying shapes and dimensions are clearly detected and presented by ultrasound method, especially for finer soils. During testing, it has been noticed that sharp edges and flat bottom are difficult to be maintained due to collapse of fully saturated sand when the former was pulling out. Sand collapse also decreases voids depth. In contrast, gravel voids tend to be easily maintained. For replacement density sand, the maximum depth of cube was found to be 26 mm for HDPE and 25 mm for PVC while the former has a maximum depth of 40mm. For gravel with size of 8-9.5 mm, the corresponding depths are 43 mm and 39 mm respectively, which are more close to the former's size. The void depth greater than 40mm was deemed to indicate the depth of the gap between adjacent gravel particles.

From Figure 8 it can also be found that, for RD and DB sands, the distribution and shapes for four voids are distinctly reproduced. However, with increasing particle size, void boundaries become blurred and indistinct. The most extremely case is gravel with size of 8-9.5mm, detected void zones have been found to be discontinuous for either HDPE or PVC. This is because coarse particles produce an un-evenly surface which scatters ultrasonic pulses. Less reflection signal is recorded for void reconstruction. For the same soil, it is found that HDPE produces better detection results than PVC, especially for coarse soils. This is due to the fact that more ultrasound energy is lost during travelling though PVC bulk material due to the higher sound attenuation of PVC than HDPE. In spite of this, voids with varying shapes and dimensions could be successfully detected by the ultrasonic method regardless of the soil mediums and plastic materials.
