# **Formation of white etching cracks at manganese sulphide (MnS) inclusions in bearing steel due to hammering impact loading**

**T. Bruce, H. Long\*, T. Slatter, R. S. Dwyer-Joyce**

**Department of Mechanical Engineering, The University of Sheffield, United Kingdom**

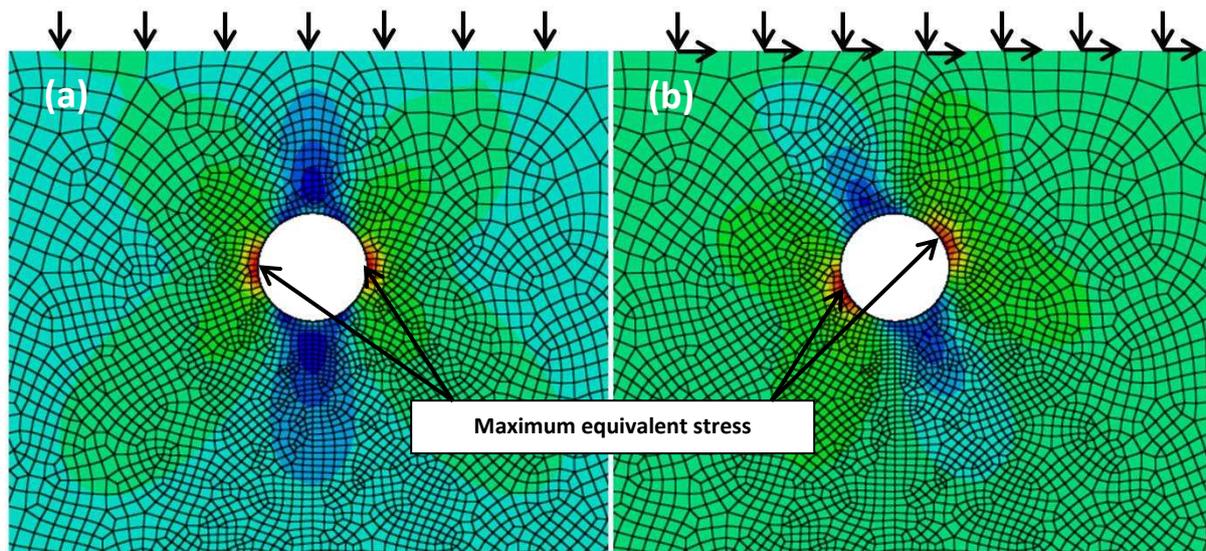
**Figure 1: Stress concentrations around a void under (a) arbitrary compressive load: (b) arbitrary compressive load and arbitrary surface traction (load directions indicated by arrows above plots)**

MnS inclusions became elongated under load because they deform more than the surrounding matrix [21, 22]. Cracks can be initiated along the highly deformed flattened MnS inclusions [21], due to: (1) micro-crack initiation at localised deformation bands in the vicinity of the inclusions; (2) high stress concentration in the middle of the elongated inclusions leading to interfacial debonding and void formation, which are potential crack initiation sites; (3) break up the inclusions because of its lower plastic limit, causing the cracks to form within the inclusion [22], which may propagate into the bulk material [18]; or (4) by high stress concentration at the lowest radius of curvature inclusion tips that coincide with the position of maximum subsurface equivalent stress as shown in Figure 1.

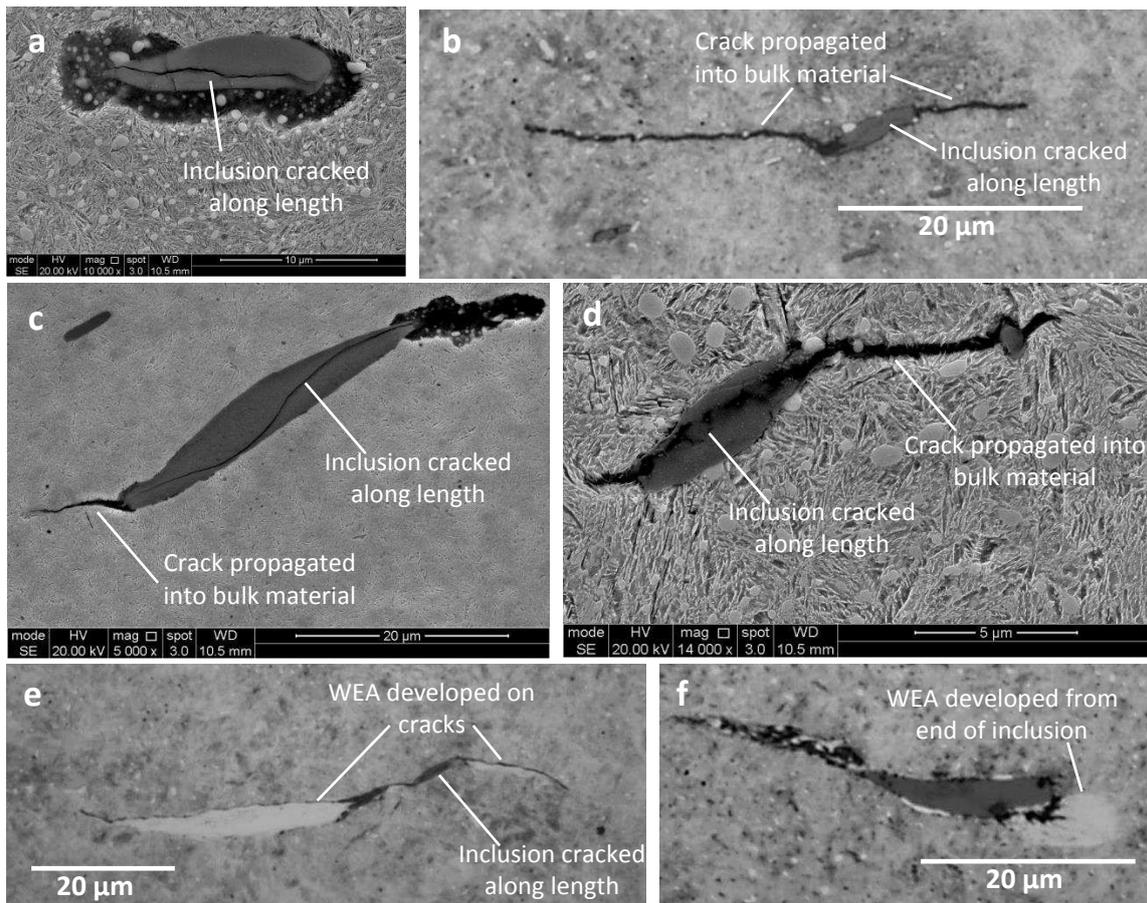
**Figure 2: Crack development at MnS inclusions from a failed WTGB a) Cracked along length of inclusion b) Crack propagated into bulk material c) & d) Split inclusion with crack propagating into bulk material e) WEA developing at split MnS inclusion e) WEA developing at MnS inclusion with no split (adapted from [23]). Images (a) and (f) are from axially sectioned specimens (over-rolling direction into the page), images (b)-(e) are from circumferentially sectioned specimens (over-rolling direction left to right).**

As shown in Figure 2, one form of WEC damage can initiate at defects below the raceway surface. Therefore, it seems logical to design experiments that create subsurface plastic deformation, but do not exceed the material yield strength on the surface. Commercial software Abaqus was used in Finite Element Analysis (FEA) to simulate the impact between the steel ball and specimen. Explicit analysis was used to model the contact stresses caused by the impact of a correctly dimensioned steel ball, with the effective mass of the striker, upon a specimen. **The steel ball was given velocity equal to the velocity of impact for each test condition and the resulting contact pressures during impact were calculated by the dynamic FEA model.** The material properties listed in Table 3 along with its stress-strain behaviour, were used to define the material. The stress-strain curve found from a tensile test of through hardened 100Cr6 bearing steel (also tempered at 260 °C) was used [35], which has very similar stress-strain behaviour to 100CrMo7 bearing steel [34]. Compressive stress-strain data was not available and although tensile behaviour cannot accurately model compressive behaviour close to the material's ultimate strength, it has been assumed that the results are accurate enough to approximate the surface contact stress, which is below the yield strength of the material for all tests and is the key result from FEA simulations. Maximum stress levels on the surface and subsurface were recorded from the equivalent stress (von Mises) distribution calculated using FEA.

Cracking was found on a number of inclusions, examples can be seen on inclusion 6, 9, 12 and 13. Inclusion 9 is cracked along its length, similarly to inclusions a-e presented in Figure 2. These findings show that compound impact creates more damage at inclusions and it may be that it is necessary in order for damage to propagate significantly into the surrounding steel matrix.

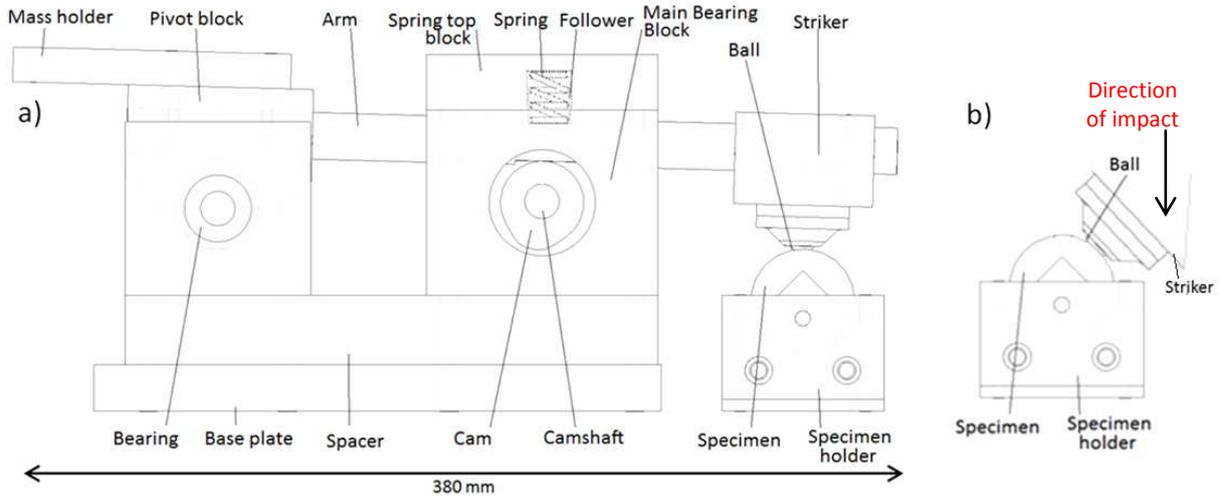
Figure 3: Modified impact test rig a) normal impact b) compound impact

A test rig that was developed by Slatter and used extensively for previous work of material surface wear [31, 32, 33] was modified for use in this study as shown in Figure 3a. The rig provided a repeatable way to apply a set level of impact force to a specimen, at a set impact angle, at set time intervals for a set number of impact cycles. Compound impact was introduced by using a separate striker component, which was angled at 45° allowing the impacting ball to slip along the specimen surface during impact. The specimen and striker were aligned so that the impacting ball hit its surface at an angle of 45° as shown in Figure 3b. The main modifications to the rig were:

shown in Figure 3. Note that the position of the specimen is such that the impacting ball hits the specimen normal to its surface.

Six specimens were subjected to high cycle number impact tests. Each was hit 1 million times at the maximum impact energy that the test rig could provide. Two specimens were exposed to normal impact loading and four at an angle of 45 degrees (compound impact) in order to introduce surface traction. Impact angle was altered by replacing the striker shown in Figure 3 with an angled alternative. Table 4 summarises the described test schedule.

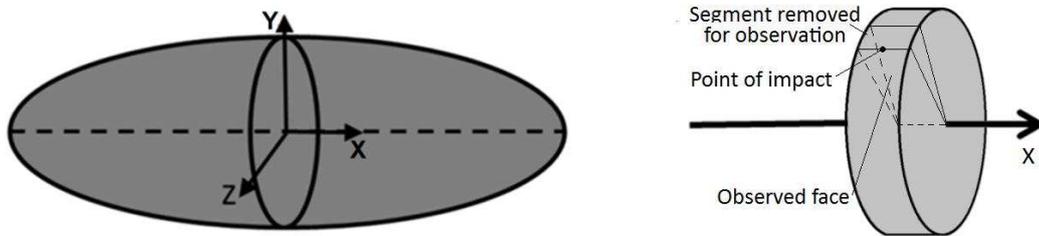
Figure 4: Orientation of MnS inclusions in specimens

As previously discussed, it is important to consider the orientation of MnS inclusions in bearing raceways. Inclusions in the specimens were orientated with their longest dimension orientated parallel to the axis of the test specimens, as shown in Figure 4. The chemical composition of a number of MnS inclusions from the specimens was tested to verify their composition. Element weight and atomic percentages of a typical inclusion are shown in Figure 5. After testing the specimens were sectioned in the axial direction, mounted in conductive bakelite resin, ground to the level of the centre of the impact zone, polished to a surface roughness of 0.06  $\mu\text{m}$  and etched in 2% nital solution, before observation took place using both optical and scanning electron microscopy. All inclusions within the section made through the impact zone were observed and photographs were taken of those that had initiated damage. All measurements of inclusion lengths and their depths from the contact surface were made using the measurement tool built into the control software of the microscopes used. Six examples of MnS inclusions in an undamaged specimen are displayed in Figure 6 for comparison to damaged inclusions discussed in section 3. The inclusions in the undamaged specimen display no damage from the heat treatment or sectioning processes. Although other inclusion types were found within the specimens, only MnS-type inclusions were found to have initiated damage.

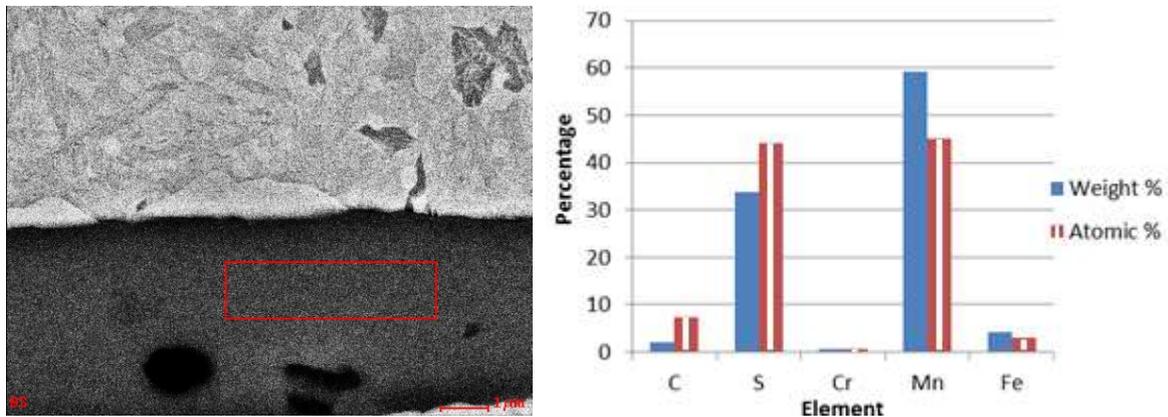
Figure 5: Weight and atomic percentages of an example MnS inclusion from a hammering impact specimen

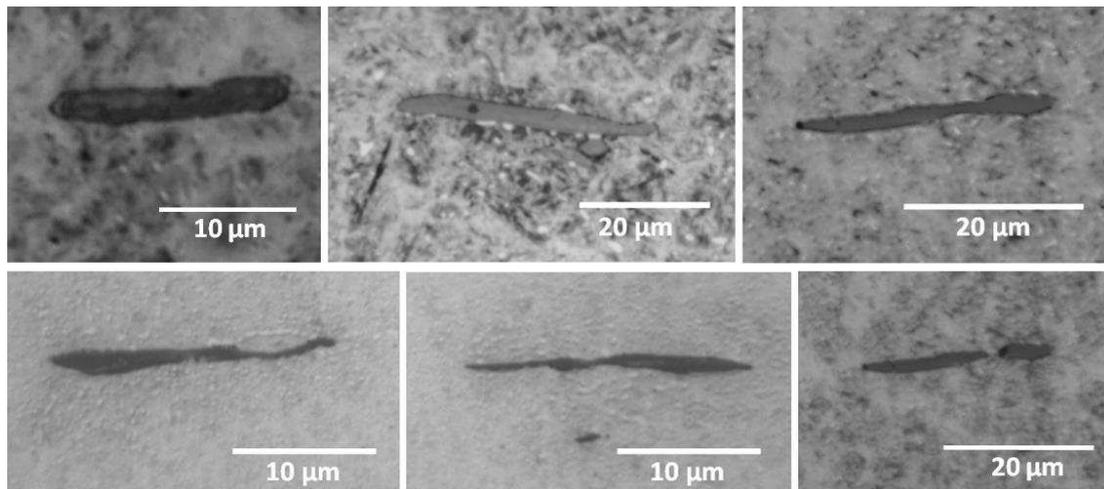
Figure 6: Typical MnS inclusions in undamaged specimen

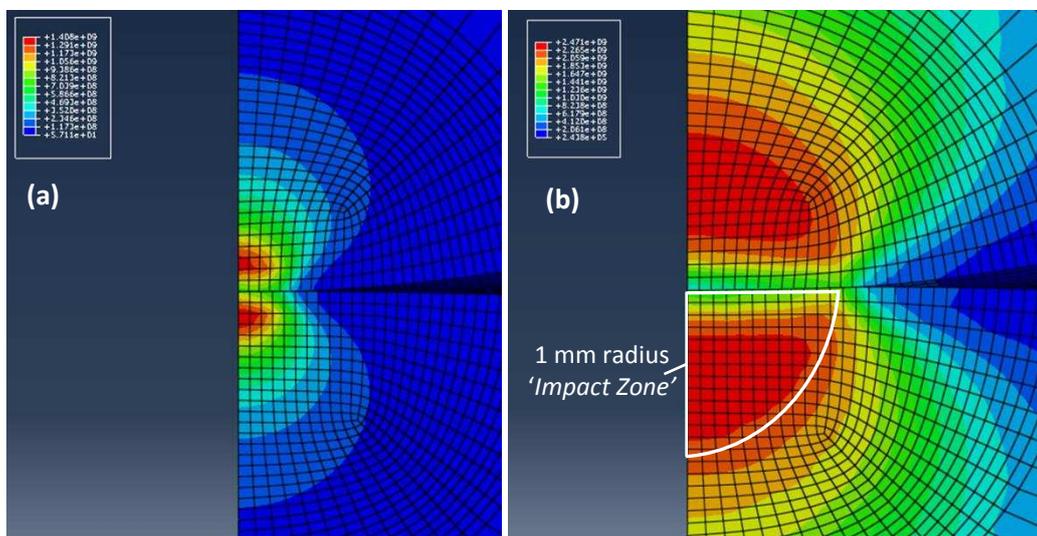
Figure 7: Equivalent stress distribution for 0.4 m/s impact velocity at (a) initial contact (b) max loading, stress unit N/m<sup>2</sup>

Figure 7a shows the initial stress distribution under impact loading at the first point of contact. The stress distribution, perhaps intuitively, experiences its maximum level directly under the point of contact between ball and specimen. However, it can be seen that the equivalent stress level at the point in time when maximum contact stress is experienced, is not directly underneath the point of impact, rather, at two symmetric points either side of the centre of impact (Figure 7b). For the example shown (0.34 joules impact energy), this distance is approximately 1 mm either side of the point of impact. The implications of this are that the area around the point of impact is of interest and any features found in the microstructure away from its direct vicinity may also be linked to the hammering impact loading. The semi-circular area with a 1 mm radius around the point of impact both on the surface and subsurface, will be named the “impact zone” (IZ), and will be observed in detail for all test specimens. Table 4 shows the calculated maximum surface contact stresses and subsurface equivalent stresses for all investigated impact conditions.

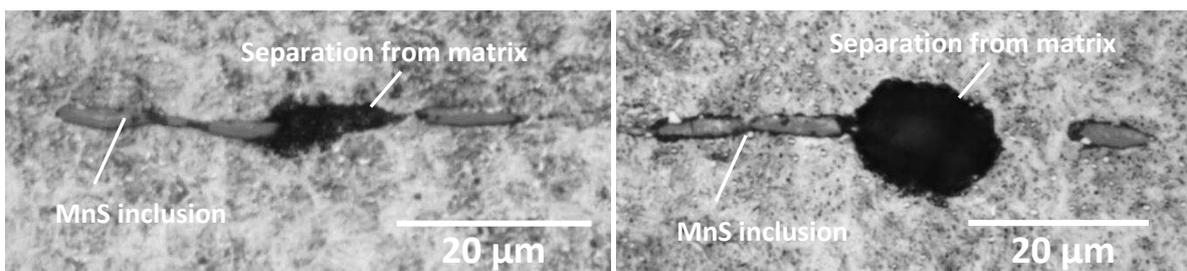
Figure 8: Examples of damage initiation at MnS inclusions during initial tests

Initial tests were carried out on specimens 1-3, which were each impacted 100,000 times, under a maximum subsurface equivalent stress of 2.58 GPa. The purpose of these initial tests was to investigate the extent of damage experienced under such conditions. Figure 8 presents examples of the damage observed at two MnS inclusions found during initial testing. This finding proved that damage was being caused under these conditions and further testing was designed in order to attempt to find the threshold at which damage begins.

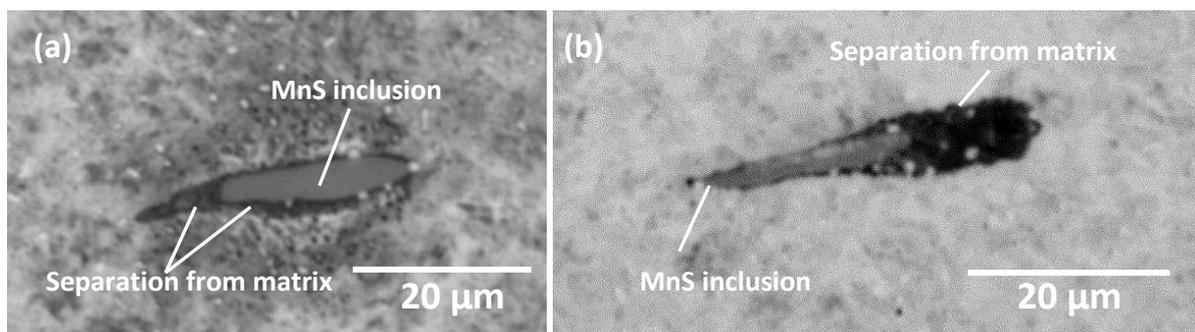
**Figure 9: Examples of damage at MnS inclusions during tests at varying number of impact (a) 50,000 (b) 100,000**

It was clear that damage at MnS inclusions was sensitive to the number of impacts experienced. Many inclusions were found to have separated from the surrounding matrix, two examples are shown in Figure 9. Separation damage, leading to the creation of free surfaces was considerably more common in the specimens that had been exposed to more impacts. The number of damaged inclusions observed in the IZ for each specimen is shown in Figure 9.11. At least 4 inclusions had initiated damage for samples that had been exposed to over 50,000 impacts. One damage initiating inclusion was found in the specimen that had been impacted 25,000 times and none were found on the sample with 12,500 impacts. These results suggest that separation of inclusions from the matrix is very much dependent on the number of impacts experienced and that there is a threshold at which MnS inclusions separating from the surrounding material and/or to initiate cracks. After around 50,000 impacts, it seems that the material defects that may initiate damage, are likely to have done so.

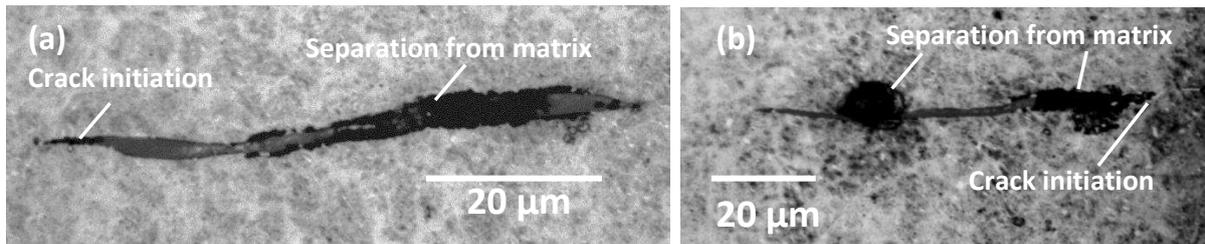
Figure 10: Example of damage at MnS inclusions during tests at varying subsurface stress (a) 2.48 GPa (b) 2.60 GPa.

Specimens 10-14 were impacted 50,000 times, a quantity that was determined to be above the threshold required for subsurface damage to initiate by observing the damaged samples from Test 1. The maximum subsurface equivalent stress was increased from 2.15 GPa to 2.60 GPa (test conditions are presented in Table 4), by altering impact velocity to increase impact energy and therefore the surface contact stress level, to investigate the effect of changing this factor on the resulting damage. Two examples of damaged inclusions found during varying contact stress tests are presented in Figure 10. Figure 11 shows that as the subsurface equivalent stress increased, so did the number of damaged inclusions. There seems to be a threshold for damage initiation (not exclusively) above subsurface equivalent stresses of 2.48 GPa.

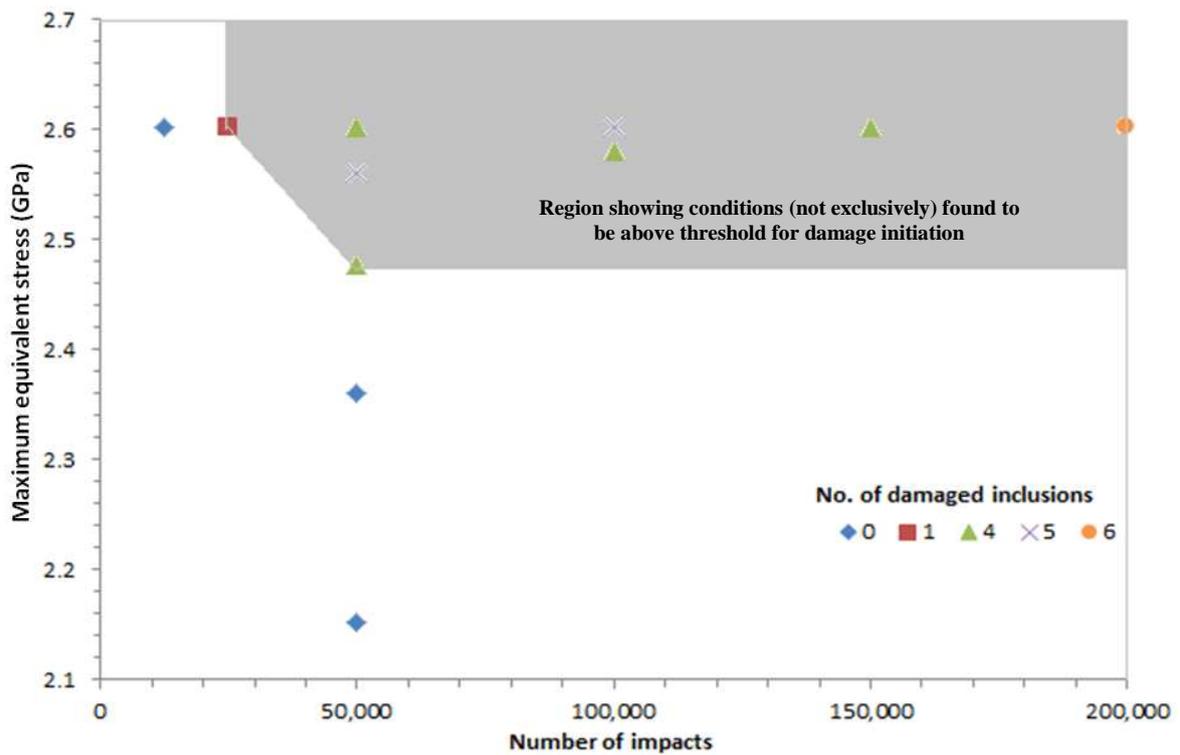
Figure 11: Number of damaged inclusions for each test when subjected to various testing conditions

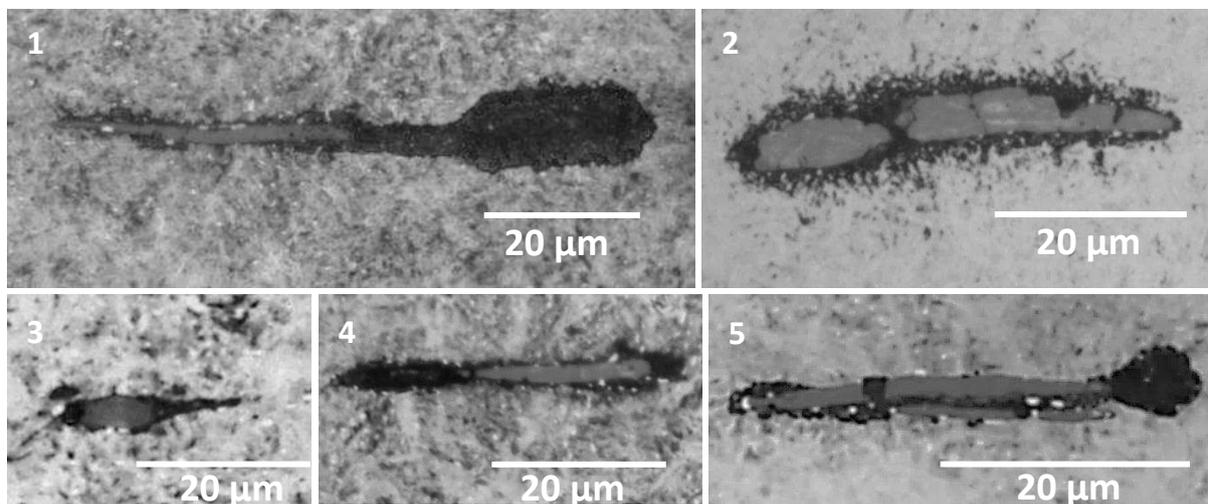
Inclusion no.	Inclusion depth ( $\mu\text{m}$ )	Inclusion length	Damage description
1	89	31	Inclusion elongated, major separation to right side
2	130	37	Major break and cracking within inclusion, separation from surrounding matrix
3	144	8	Separation on left and right, crack propagation on right side
4	285	20	Separation and possible crack propagation on left side
5	95	32	Inclusion cracked, separation to left and right, significantly to right side

**Figure 12: Five example inclusions damaged under normal impact loading of high impact cycles**

Figure 12 displays images of five damaged inclusions found at depths of up to 285  $\mu\text{m}$  beneath the surface in specimens 15 and 16 (high cycle number tests with no surface traction). Major separation, cracking of inclusions and crack initiation at inclusion tips has been observed. The table presented in Figure 12 describes the damage in more detail. In summary, although the damage in specimens 1-2 is fairly extensive, the location of the damage is fairly local to the inclusions and crack propagation has not occurred to any great extent. This is in agreement with the theory that mode 1 loading may cause crack initiation and short growth, but some shear loading is required for further propagation.

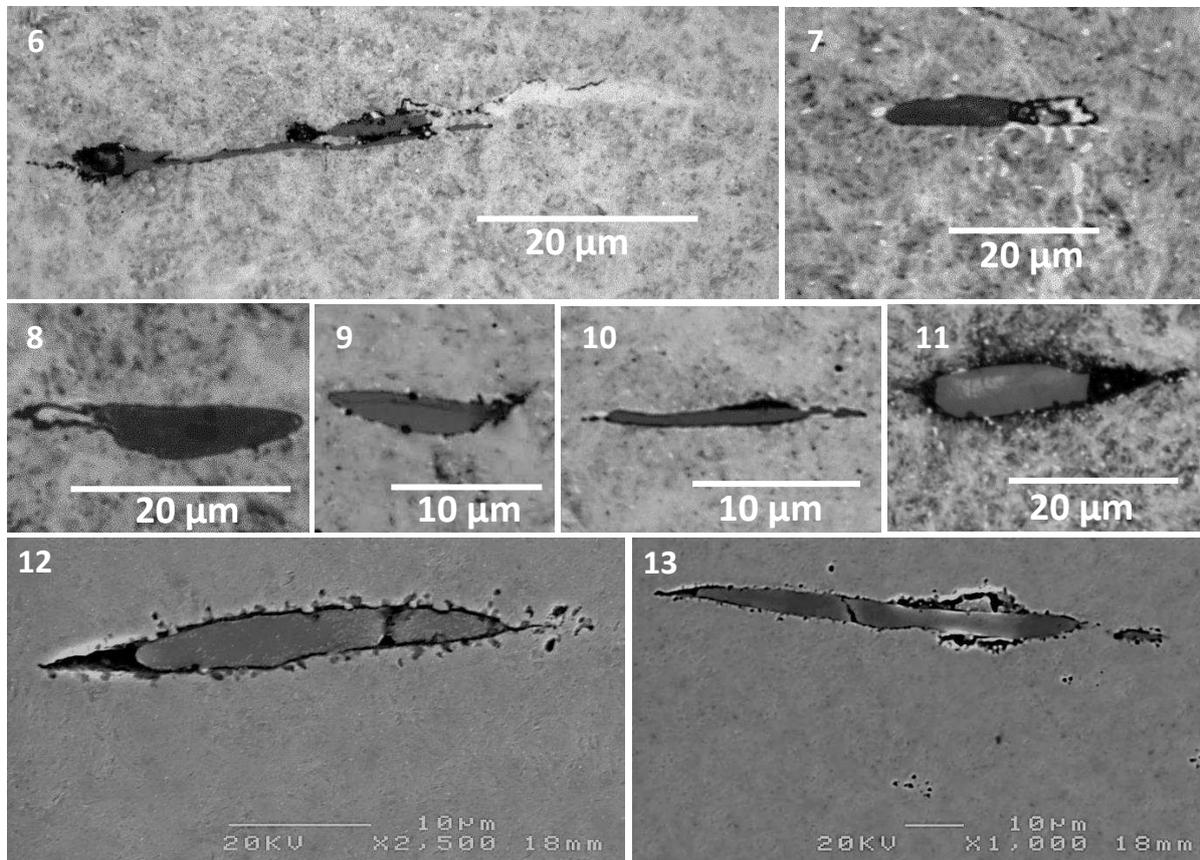
Inclusion no.	Inclusion depth (μm)	Inclusion length	Comments
6	98	38	Major break up of inclusion, separation, cracking to left and right, major WEA to right
7	93	19	Cracking and possible small WEA to right
8	290	17	Cracking and possible small WEA to left
9	111	12	Inclusion split along length, crack from right side
10	220	18	Small crack to left, separation along right side and bottom
11	106	18	Separation to left and right, crack initiation to right
12	176	24	Inclusion split vertically, separation to left, crack initiation to left and right
13	178	67	Inclusion split, separation above and below, crack initiation to left

**Figure 13: Example inclusions damaged (specimens 17-20) under compound impact testing of high impact cycles**

Figure 13 displays that significantly more damage was caused by compound impact testing. Damage found in specimens 15-16 was seen to a greater extent in specimens 17-20 after all specimens were impacted 1,000,000 times. A WEC was found to be connected to inclusion 6 and possibly on a number of others. Inclusion 6 was situated directly below the impact site at a depth of 98  $\mu\text{m}$ . It appears to have been internally cracked and broken up as well as initiating cracking in the bulk material from its tips and WEA formation from its right hand end. The WEA seems to have formed beneath a crack that has propagated from the right hand side. It is hypothesised that the increased levels of Mode II/III shear loading caused by the surface traction force were necessary to propagate the crack. The free surfaces created by the crack may then have rubbed against one another over thousands of shear loading cycles and caused the formation of the WEA.
