THE EFFECTS OF FRICTION MANAGEMENT MATERIALS ON RAIL WITH PRE EXISTING RCF SURFACE DAMAGE

Dr. C. Hardwick¹, Prof. R. Lewis², Dr. R. Stock³

Abstract

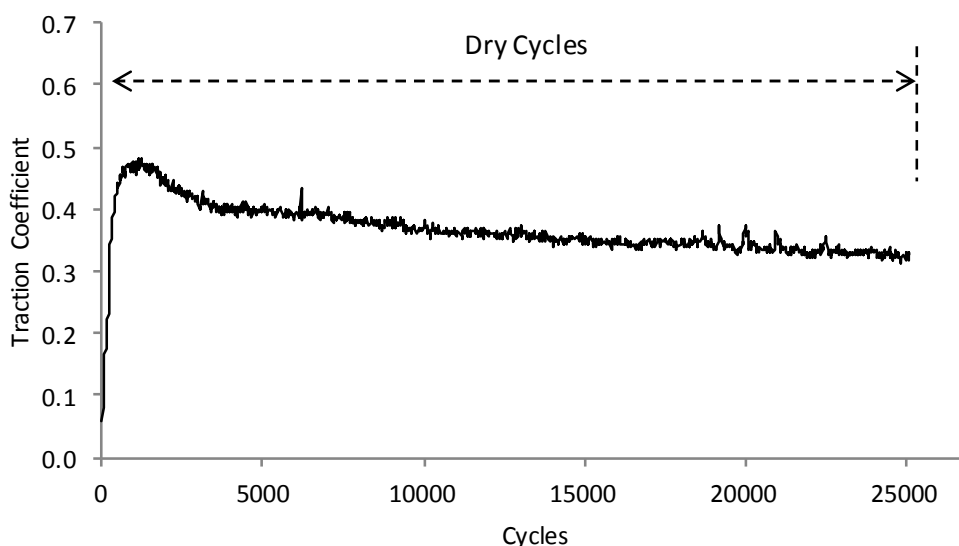
Figure 2: Traction Coefficient Dry (1500MPa, 1% Creep, 400 rpm)

The frictional force between the specimens was recorded for the duration of all tests. Traction data plots are shown in Figure 2 – 8. The periods of dry cycles and product application are identified on the plots.

The initial baseline test over 4000 cycles provided an average dry coefficient of traction between 0.36 - 0.40, typical of test run under these condition on this test platform. The slight reduction in the coefficient of traction over time is most likely due to temperature generation within the contact. The imparted surface damage is minimal as seen in Figure 10 sample 1. No surface cracks were observed and analysis of the cross section indicated that short shallow cracks of lengths ranging from 250 μm – 500 μm with a depth between 30 μm – 70 μm had developed.

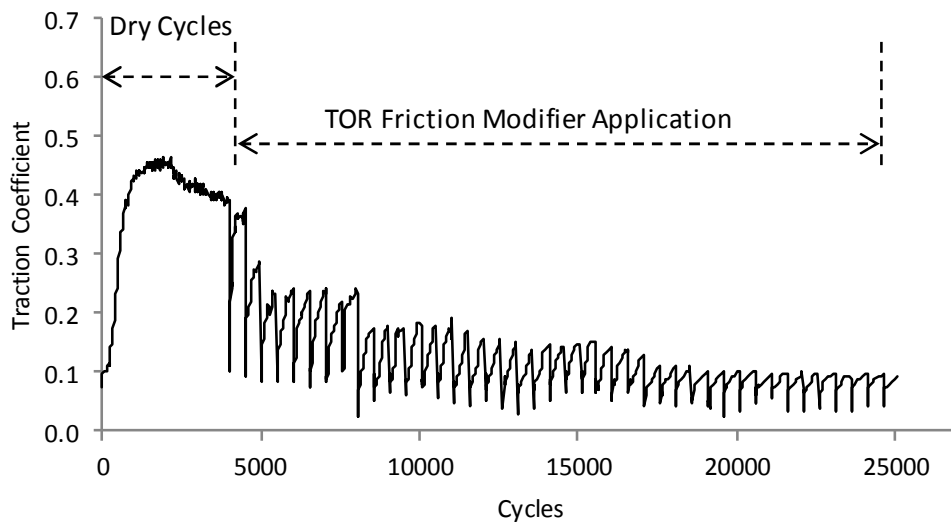
Figure 4: Traction Coefficient TOR FM (1500MPa, 1% Creep, 400 rpm)

The application of the water based friction modifier reduced the traction coefficient to 0.12 although it must be stated that it took multiple applications until this stable level was reached (see Figure 4). No data exists pertaining to the amount of product entrained in to the contact patch under real-world applications, it should be understood that the amount used was based on recommendations and kept constant for all products. This allows for this investigation of the product, rather than application rate.

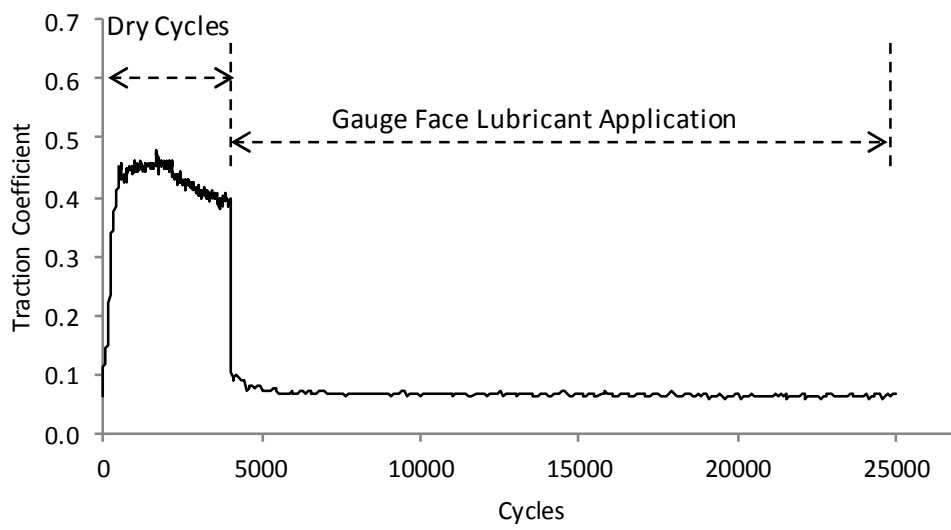
Figure 5: Traction Coefficient GF Lubricant (1500MPa, 1% Creep, 400 rpm)

The gauge face lubricant reduced the coefficient of traction to 0.06 – 0.07 and it remained constant for the test duration (see Figure 5). This traction is as expected for lubricants. Application also reduced wear over the dry baseline case by 73% as measured by mass loss. However, visual inspection of the disc surface showed regions of surface cracking and the initiation of delamination. This was consistent with testing performed in the development of the Network Rail lubricant performance standard [1]. The cross section overview of the rail

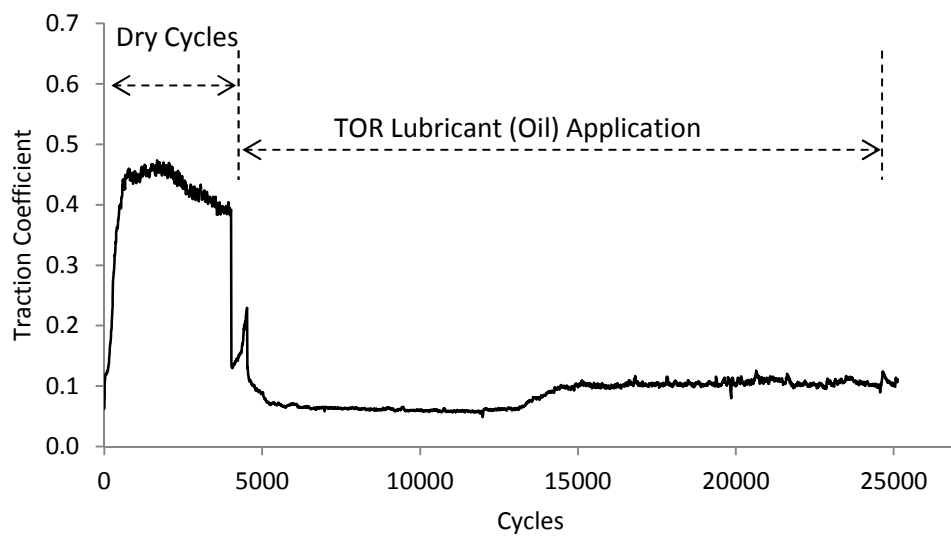
Figure 6: Traction Coefficient TOR Lubricant (Oil) (1500MPa, 1% Creep, 400 rpm)

The application of a synthetic oil based TOR lubricant also reduced the coefficient of traction to between 0.06 – 0.07, as expected for a lubricant. There was an increase that remained constant to the end of the test starting at about 15000 cycles (see Figure 6). This increase was probably caused by the large degradation of the specimen surfaces, the collapse of the lubricating film and the entrainment of wear particles leading to three-body abrasion. The application of the oil based product increased the wear mainly due to crack delamination and spalling by a 1248%. The disc surface was similar in appearance to that witnessed with water, showing large amounts of deformation and delamination (see Figure 10). There were numerous cracks running for a long distance parallel to the surface before propagating down into the bulk material at a constant angle. The low viscosity and low coefficient of traction of the TOR lubricant would suggest that accelerated crack growth may occur due to a combination of both hydro-pressurisation owing to the similarities with water (shallow cracks and delamination) and crack flack lubrication (increased spalling) as seen with the gauge face lubricant.

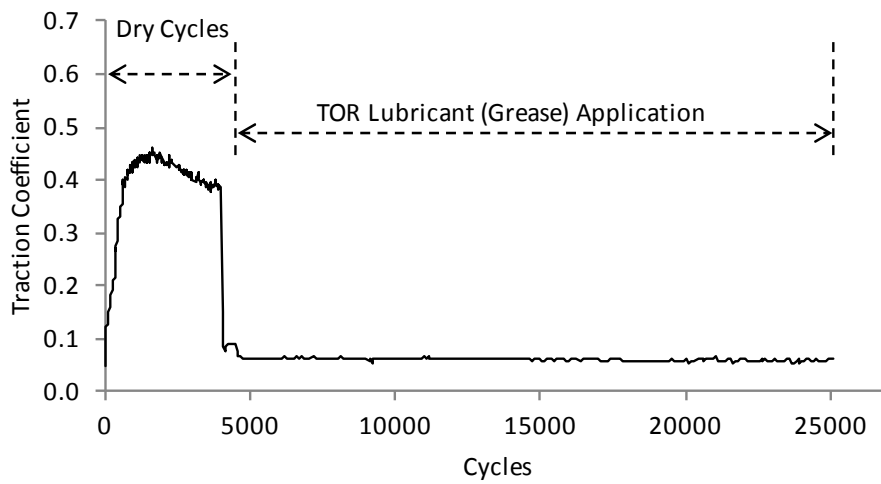
Figure 7: Traction Coefficient TOR Lubricant (Grease) (1500MPa, 1% Creep, 400 rpm)

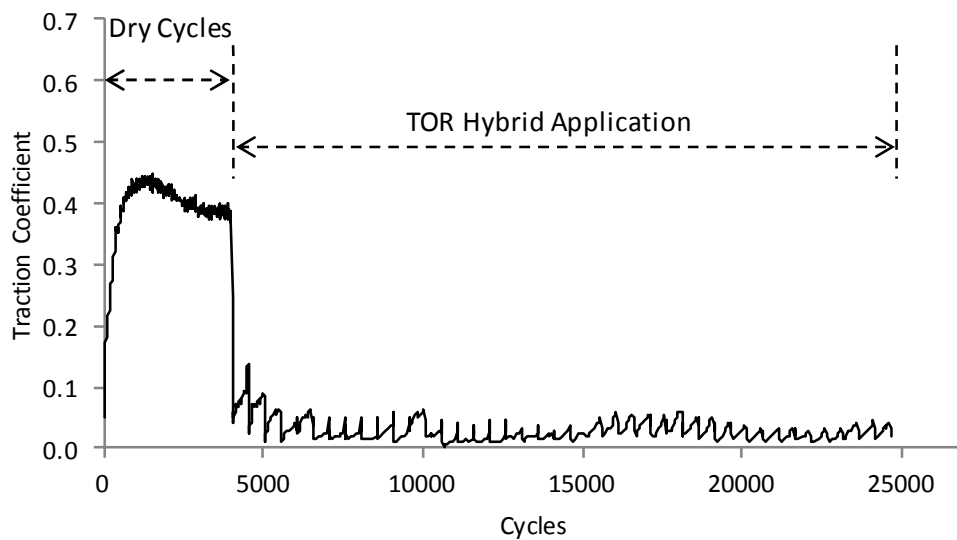
Figure 8: Traction Coefficient TOR Hybrid (1500MPa, 1% Creep, 400 rpm)

The TOR hybrid material (an oil-in-water emulsion) provides a stable, but very low (0.02) coefficient of traction. Surface damage is characterised by shallow spalling and pitting (see Figure 10 Sample 8), similar to that of the gauge face lubricant and the grease based TOR lubricant. An 11% reduction in wear as measured by mass loss and compared to the dry baseline is observed. Subsurface investigation (see Figure 18) shows a number of spalling areas, some up to 1.9mm in length. Cracks tend to propagate in the rail material and then diverge often with one branch heading towards the surface leading to spalling. Crack lengths were measured up to 900 μm with depths up to 500. Despite its limited water content this material stayed wet on the disk surface during the whole test.
