Yang, K., Rongong, J.A. and Worden, K. (2018) Damage detection in a laboratory wind turbine blade using techniques of ultrasonic NDT and SHM. *Strain*, 54 (6). e12290. ISSN: 0039-2103

Damage Detection in a Laboratory Wind Turbine Blade using Techniques of Ultrasonic NDT and SHM

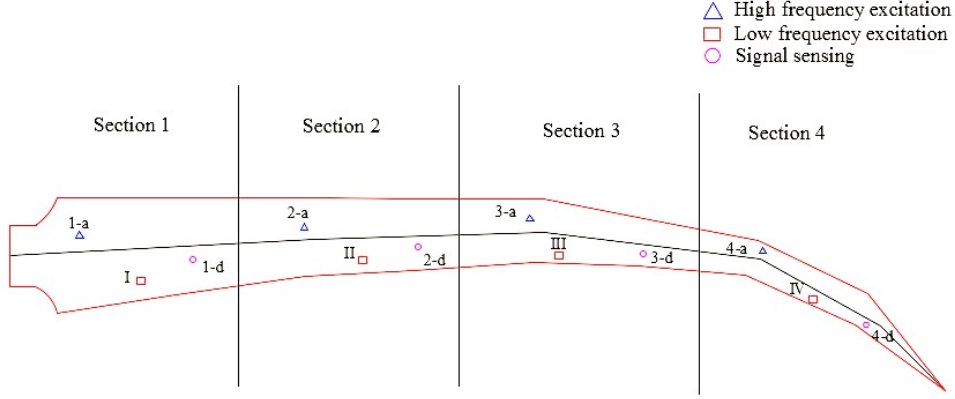
Figure 7: The arrangement of sensors. Blue triangle represents a high frequency excitation transducer. Red rectangle represents a stack actuator. Pink circle represents a receiving sensor.
