Impact of Solar Cell Cracks Caused During Potential Induced Degradation (PID) Tests

Mahmoud Dhimish, *Member, IEEE*, Jeff Kettle, *Member, IEEE*

Index Terms—Solar cells; PID, cracks, electroluminescence, performance analysis.

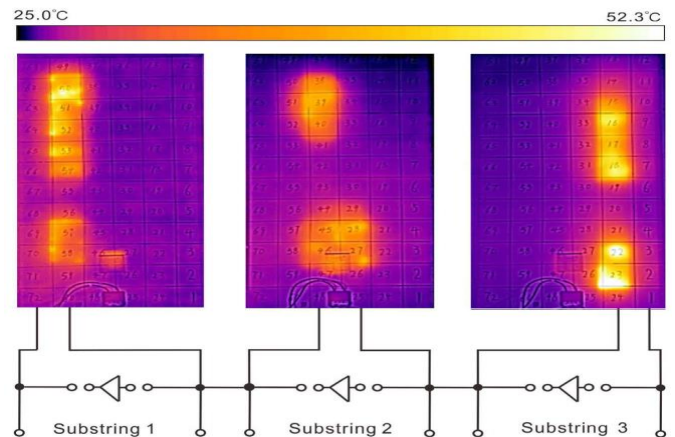
Fig. 1. Thermographic image of three substrings of module 3 under reverse 160 V bias [6].

In a recent study, [6], a PV module subjected to a reverse bias of 160 V voltage was shown to exhibit severe PID, leading to the formation of hotspots which appeared on the

modules, as presented in Fig. 1 for three different PV modules connected in series. This study showed that the PID resulted in a reduction of the current density and the open-circuit voltage. Improved testing has been the focus of much recent research; for example, in [7], authors have presented an approach to test the reversible and irreversible PID testing to bifacial PERC solar cells. Other researchers [8, 9] have reported that cracks in solar cells can accelerate PID due to the localized heat caused by the cracks. This work was supported by studies conducted using electroluminescence (EL) imaging before and after PID testing. This affirmed that cracks could lead to hotspots in the solar cells, and as a result, PID is expected, yet there were no discussions on the type/size of cracks and their expected impact upon PID.

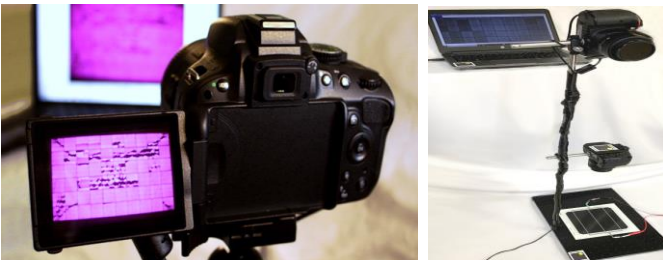
Fig. 3. EL imaging setup.

Initially, we have used the EL imaging setup shown in Fig. 3. The EL comprises a digital single-lens reflex camera with a resolution of $6k \times 4k$ pixels, and the filter is removed and calibrated to allow sensitivity to electroluminescence picture (peak wavelength 1150nm). The camera lens is $18\text{-}55 \text{ mm}$, and a programmable 15A , 60V power supply is available to connect with the solar cell. To capture the finest EL images, the solar cells were connected to a power supply under I_{sc} current (8.07 A).

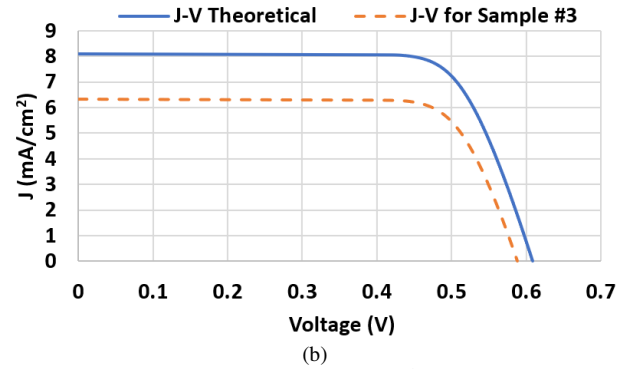
Fig. 11. (a) The solar cell is exposed to 1000 W/m^2 illumination, (b) Measured J-V curve under STC conditions.

As the solar cell exhibits significant losses in the J_{sc} we have decided to test the cell under standard test conditions (illumination of 1000 W/m^2 and cell temperature 25 degrees), as shown in Fig. 11(a). The resultant current-voltage (J-V) curve compared with the theoretical values (taken from the solar cell datasheet) is shown in Fig. 11(b). The current density at short circuit conditions dropped by 20.5%, calculated using (1), whereas 4.9% was the drop in the V_{oc} calculated using (2). This concludes the fact that dark areas in EL images likely means that the cells are being impacted with severe PID.

$$\text{Drop in } J_{sc} = \frac{\text{Theoretical } J_{sc} - \text{Measured } J_{sc}}{\text{Theoretical } J_{sc}} \times 100 = \frac{38.1 - 30.3}{38.1} \times 100 = 20.5\% \quad (1)$$

$$\text{Drop in } V_{oc} = \frac{\text{Theoretical } V_{oc} - \text{Measured } V_{oc}}{\text{Theoretical } V_{oc}} \times 100 = \frac{0.61 - 0.58}{0.61} \times 100 = 4.9\% \quad (2)$$

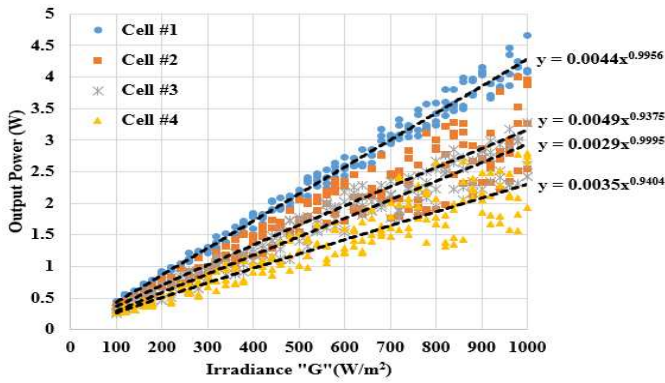
Fig. 14. (a) Output power of the cells under illumination from 100 to 1000 W/m², and cell temperature is 25 degrees, (b) Boxplot of the output power vs irradiance.

The solar simulator was used to test the performance of the cells, and the output power at maximum power point vs irradiance is presented in Fig. 14(a). The irradiance ranges from 100 (0.1 Sun) to 1000 (1 Sun) W/m², while the cell's temperature was maintained at the standard test condition, 25°C.

For sample #1, affected by minor cracks, the cell generated more output power, with an average power output of 2.36 W. Cells #2 and #3 show similar levels of cracking (as demonstrated by the dark areas in the EL image); so, their output averaged power at 1 Sun irradiance equals 1.81 W and 1.62, respectively. Finally, the maximum drop in the averaged power was observed for the last solar cell sample #4, which exhibited the most severe cracking and showed an output power of only 1.32 W.
