Monoranu, M., Mitchell, R.L., Kerrigan, K. et al. (2022) The effect of particle reinforcements on chip formation and machining induced damage of modified epoxy carbon fibre reinforced polymers (CFRPs). *Composites Part A: Applied Science and Manufacturing*, 154. 106793. ISSN: 1359-835X

The epoxy matrix of a carbon fibre reinforced polymer (CFRP) was modified by addition of silica nanoparticles, rubber microparticles and a combination of both to determine the effect of particle reinforcements on chip formation and machining induced damage. The effect of epoxy particle reinforcement on the machinability of CFRPs was studied experimentally under orthogonal cutting conditions. The results show that the chip formation process is affected by the presence of particulate fillers regardless of individual ply fibre orientation. Subsequently, the measured cutting forces showed a representative behaviour for each particle type and concentration. Rubber modified samples showed the lowest subsurface damage and measured surface metrics, followed by silica and unmodified epoxy samples. This behaviour was linked with the toughening mechanism of rubber and silica particles, which was found to take

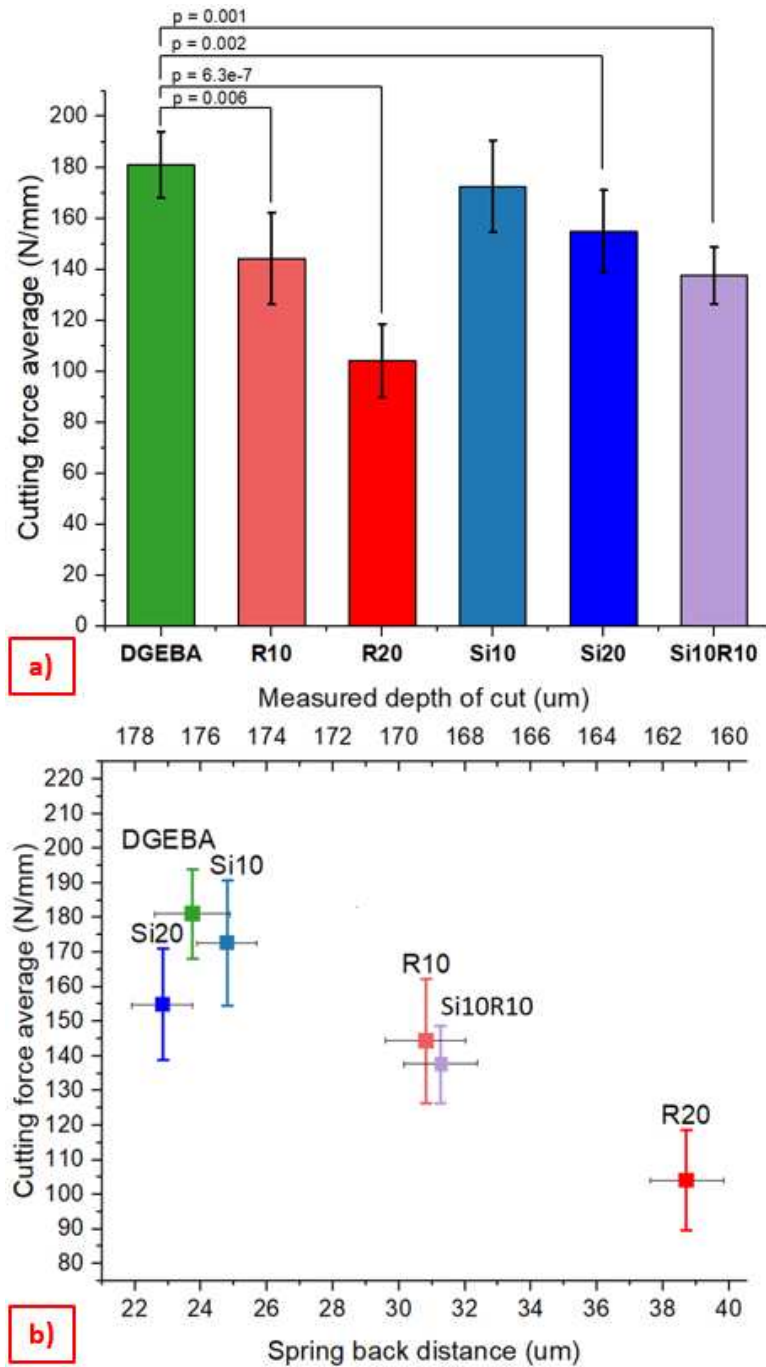
Figure 1 - Cutting force analysis graphs with error bars representing standard deviation of the test samples a) Cutting force average (only p-values which are statistically significant values are shown) b) Cutting force average vs spring back distance & actual depth of cut

Figure 1 – a) shows the average values of measured cutting forces for each material together with standard deviation error bars. Unpaired T-statistical tests were run to compare the difference between the cutting force magnitudes, and it was found that adding the particulate fillers will result in statistically significant differences in cutting forces between unmodified (DGEBA) and modified samples. A 20.2% decrease was found for R10, followed by a further 42.4% for R20 samples compared to DGEBA. The Si20 samples showed a decrease of 14.2% in cutting force magnitude, while ‘hybrid’ sample (Si10R10) showed a decrease of 24.1%. It is noticed that Si10R10 had similar cutting force magnitude to R10 specimens, which suggests that in a ‘hybrid’ composite the rubber microparticles are governing the material removal process.

The amount of spring back was measured after each cut using a digital micrometre (resolution  $< 1 \mu\text{m}$ ) and further checked using the recorded cutting images as shown in Figure 1- b). The brittle-matrix epoxy represented by unmodified (DGEBA) and silica epoxy (Si10, Si20) experienced the lowest elastic recovery and highest cutting force. On the other hand, the presence of rubber microparticles (R20) increased the elastic recovery and the lowest cutting forces were recorded. The increased elastic recovery due to rubber particles is related to toughening mechanism and large strain to failure of rubber modified composites [28], [37], [38]. Additionally, the decrease in the cutting forces is correlated with a smaller volume of material removed, despite the large elastic deflection. Wang and Zhang [19] reported that in orthogonal cutting of UD-CFRPs the magnitude of spring back is related to the cutting edge radius of the tool, when all the other conditions are the same. Considering that all the cutting parameters in this study, including the tool geometry and cutting conditions are identical between the investigated samples, the observed trend in the measured spring back could only be due to the local mechanical properties of the modified epoxy matrix indicating that the presence of fillers has a significant effect on spring back. A difference of  $16 \mu\text{m}$  was found between the largest springback distance (R20 sample) and lowest value (Si20 sample) as shown in Figure 1 – b).

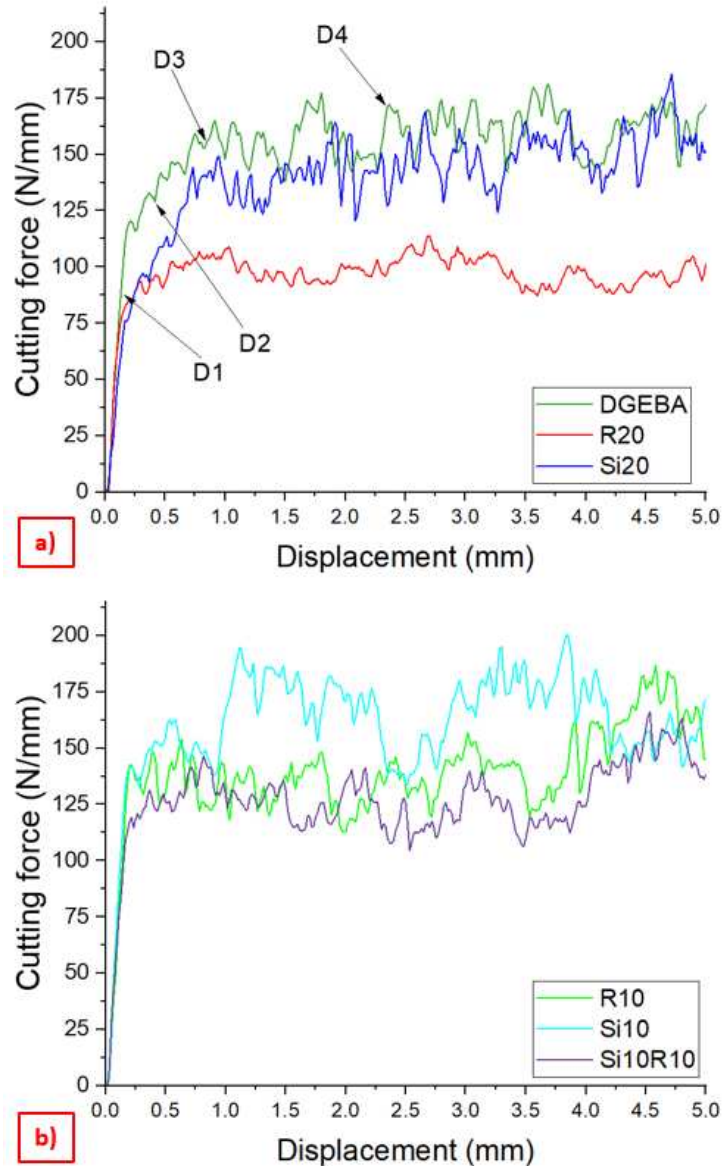
Figure 2 - Cutting force vs displacement for a) DGEBA, R20 and Si20 where D1, D2, D3, D4 indicate the time steps corresponding the cutting images in Figure 3, and b) Cutting force vs displacement for R10, Si10 and Si10R10

The evolution of cutting forces as the cut progresses (Figure 2) indicates that there is less variation in the cutting force when cutting rubber modified samples, while a large oscillation was observed in the graphs related to the reference material (DGEBA) and the silica-modified samples (Figure 2 – a)). The cutting force signal for R10 and Si10R10 samples (Figure 2 – b)) showed a similar pattern. This was previously observed in orthogonal cutting of rubber and silica modified epoxy polymers [39], where the chip formation process was mainly influenced by the presence of rubber microparticles, rather than silica nanoparticles in the ‘hybrid’ sample. It has been previously reported [28] that in a ‘hybrid’ modified CFRP, the rubber toughening mechanism is the dominant failure mechanism. This aspect and the effect of chip formation process in relation to particulate fillers and cutting force behaviour is further discussed in Section 3.3.

The principal toughening mechanism of rubber micro-particle and silica nanoparticle were previously demonstrated in the literature [23], [24], [28], [29], [38] and identified in the machined surface micrographs. High-resolution FEG SEM images of the rubber machined surface (Figure 13 – a)) shows that the particles cavitate. This is followed by plastic void growth of the polymer matrix. The original mean diameter of the rubber micro-particles was  $0.54 \mu\text{m}$  [28], while the cavitated areas were measured to be  $1.02 \pm 0.16 \mu\text{m}$ . Plastic deformation of the epoxy matrix is visible on the edge of the voids generated on the polymer matrix surface due to the cavitation process (Figure 13 – b)). It is also noticed that fibres are attached to the machined surface and are still encased in epoxy matrix, which further highlights the fact that fibre-matrix interface failure does not occur in rubber-modified samples. The rubber toughening mechanism allows the fracture energy to be dissipated, this limits the extent of subsurface damage from the compression induced by the flank face. These are correlated with the low oscillations of cutting force signal shown in Figure 2 – a).

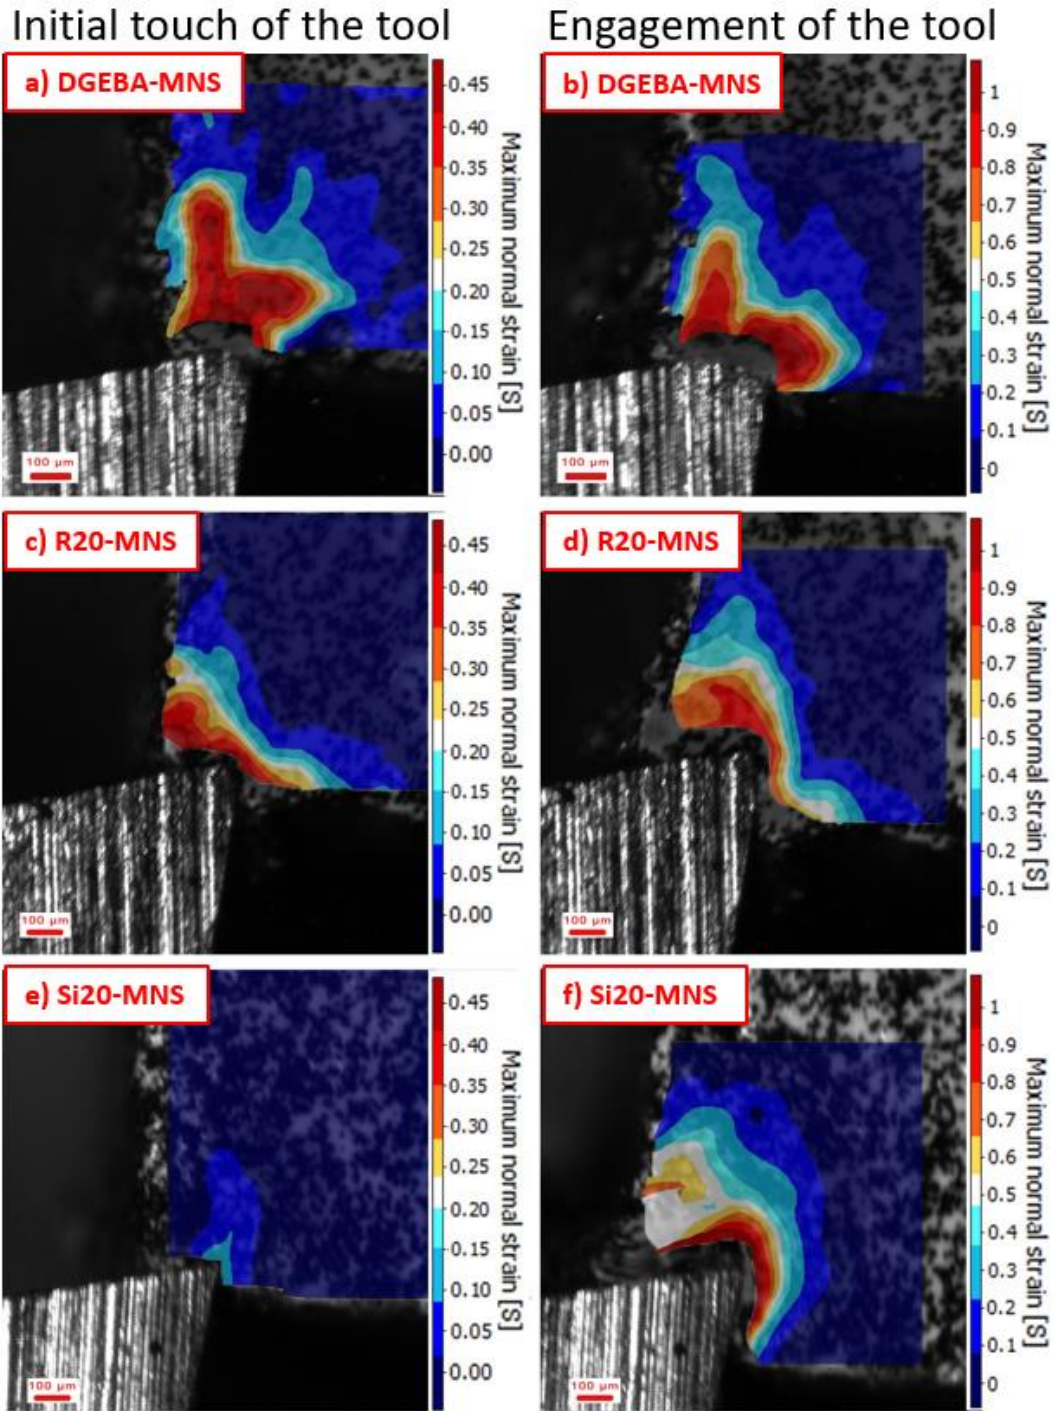
Figure 4 - Maximum normal strain [S] (MNS) maps for a - b) DGEBA c - d) R20 e - f) Si20 corresponding to the time force points marked a - f on Figure 6

Strain maps shown in Figure 4 and 5 are linked to the cutting force signal of Figure 6. Maximum normal strain (MNS) and shear strain (SS) have been calculated for each test condition according to the parameters given in Table 2 and represent the onset of steady state cutting zone (Figure 4 and 5 – a), c), e)) and full engagement of the cutting tool with the material which starts to build up on the rake face of the cutting tool (Figure 4 and 5 – b), d), f)). MNS maps of DGEBA (Figure 4 – a)) showed a larger deformation zone compared to rubber modified samples (Figure 4 – c)) in which strain contours are situated close to the cutting tool. On the other hand, Si20 sample had the lowest MNS value of 0.11 [S], followed by R20 sample

with 0.27 [S] and DGEBA with 0.45 [S]. Si20 sample (Figure 4 – e)) showed a more localised strain map, which is linked to the stiffness of the silica nanoparticles. As the material is deformed due to further penetration of the cutting tool, the local strain values increase for all samples, while strain contours are still localised in front of the cutting tool for R20 and Si20 samples ((Figure 4 – d, f)). DGEBA sample (Figure 4 – b)) shows the highest MNS value of 1.1 [S], however the strain contours are dispersed around the cutting tool in two zones: (i) one that is extended ahead of the cutting tool (ii) one that penetrates approximately  $45^\circ$  into the subsurface. The high value of MNS of DGEBA sample and the strain contours dispersion is attributed to the deformation and fracture of the material. In the case of rubber modified sample, toughening mechanism took place [28], [37], which increased the plastic zone ahead of the cutting tool, hence limiting the fracture and deformation of material. SS maps (Figure 5) show a compression area (negative value of SS) formed across the relief face of the tool, while a tensile area (positive value of SS) is formed on the rake face. Similar to MNS contours, R20 sample (Figure 5 – c, d)) showed the SS contours distributed close to the cutting tool edge. On the other hand, silica sample (Figure 5 – e, f)) experienced the largest compression deformation zone. The increased stiffness of the silica particle should make a contribution to the load carrying capacity of the composite, however, the stress concentration effect due to presence of silica nanoparticles weakens the material [29]. The effect of particle toughening and failure mechanism which occurs during the material removal process is further discussed in Section 3.6.

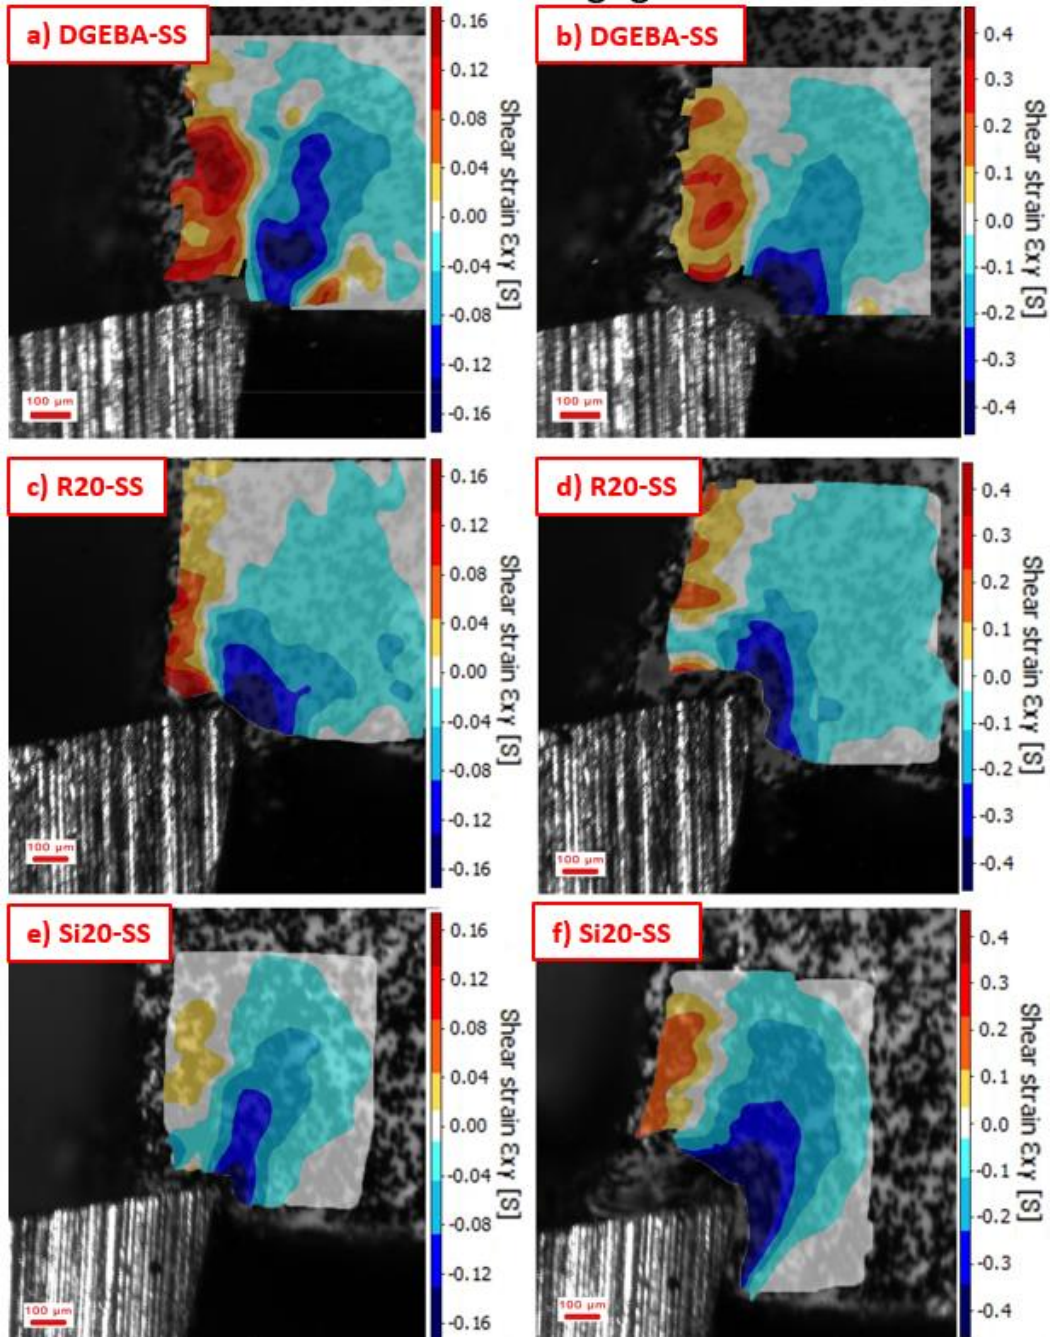
Figure 5 - Maximum shear strain [S] (SS) maps for a - b) DGEBA c - d) R20 e - f) Si20 corresponding to the time force points marked a - f on Figure 6, with negative values corresponding to compression force due to the flank face compression

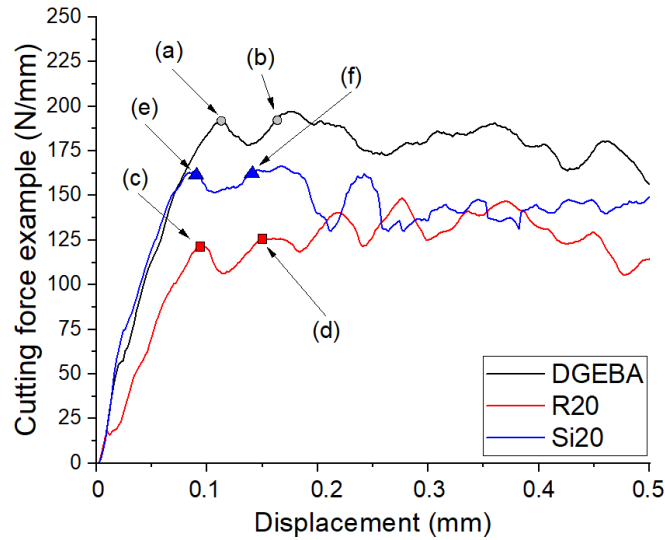
Figure 6 - Cutting force vs displacement for D, Si20 and R20 samples where (a) – (f) have corresponding time stamps to equivalent strain maps of Figure 4 and 5

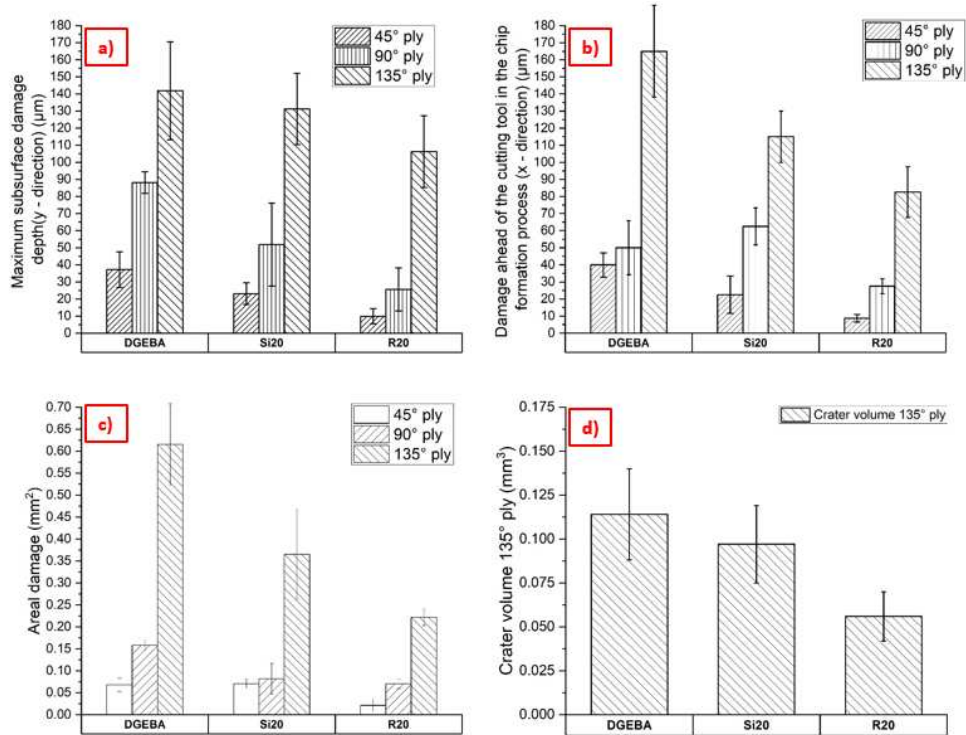
Figure 8 - Subsurface damage assessment with error bars showing the standard deviation of the assessed images a) Maximum subsurface damage b) Damage in front of the cutting tool c) Areal damage d) Crater volume (0° fibre orientation did not show damage by these measurements)

All the machined surfaces showed significant matrix smearing across all fibre orientations. Figure 8 shows the calculated subsurface damage for the machined materials. For a single material, changing the fibre orientation from  $45^\circ$  to  $135^\circ$ , shows an increase in the damage area. However, within an individual fibre orientation, defined by a ply layer, the addition of rubber or silica fillers results in reduced subsurface damage. The calculated maximum subsurface damage depth (Figure 8 – a)) shows a decrease for all fibre orientations when silica or rubber was added to the epoxy matrix. Moreover, the R20 sample had the lowest level of damage, which can be attributed to rubber toughening mechanism which is active during material removal. Experimental evidence is discussed in Section 3.6. Moreover, damage in front of the cutting tool, areal damage and crater volume has the lowest values for the R20 samples. An increase in damage in front of the cutting tool was found for Si20 sample in the  $90^\circ$  fibre orientation, however the measured values are within the standard deviation of the control. No quantifiable surface intrusion or subsurface damage was identified for  $0^\circ$  fibres, therefore Figure 8 does not include  $0^\circ$  orientation in damage comparisons.

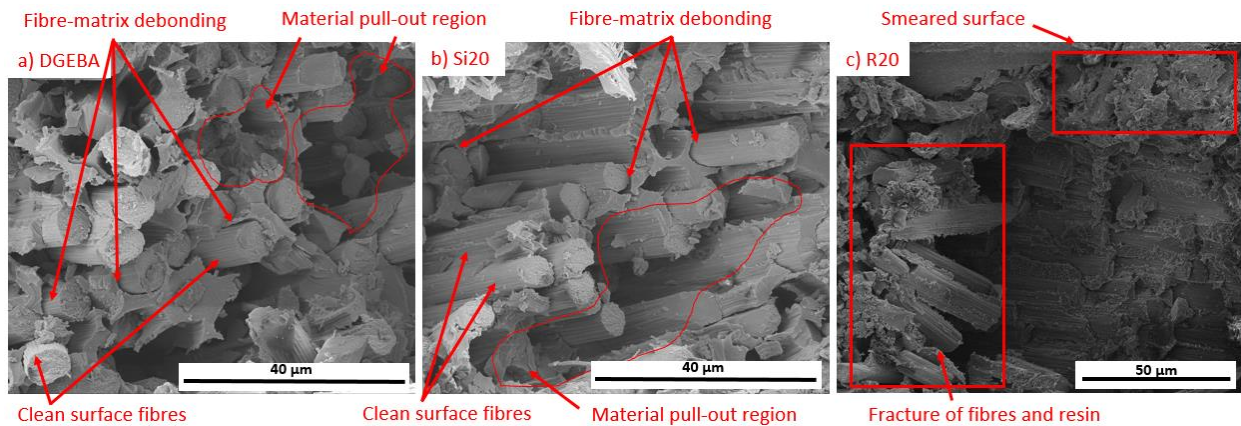
Figure 12 – Typical micrographs of machined surface of a) DGEBA b) Si20 and c) R20 samples, where ‘Clean surface fibres’ means the fibres have debonded from the matrix by adhesive failure

Even though the machined surfaces showed significant smearing across all fibre orientations, various craters and material pull-out regions were used for fractographic analysis. Material pull-out regions and fibre-matrix debonding are observed for DGEBA and silica sample (Figure 12 – a, b)). Moreover, the fractured fibres show a clean surface which leads to the conclusion that the composite material failed at the interface region between the fibre and matrix. On the other hand, fractured material of R20 sample (Figure 12 – c)) showed fibres with matrix attached, which indicates that polymer debonding did not occur fully. The debonding is directly related to the fibre and matrix adhesion and the particle reinforcement of the epoxy does not have a significant role in the individual fibre toughening mechanism (e.g. fibre debonding, fibre pull-out). However, the presence of rubber microparticles and their subsequent toughening

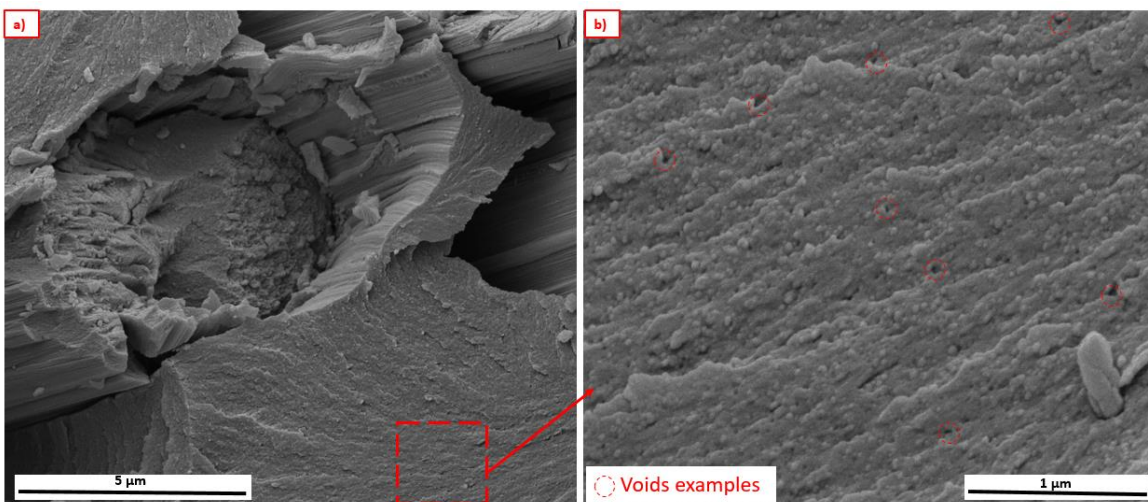
Figure 14 – High-resolution FEG-SEM micrographs of Si20 machined surface a) Fibre pull-out and fibre-matrix debonding b) Debonding of silica nanoparticles

High-magnification FEG SEM images of Si20 fractured surface (Figure 14 –a)) clearly illustrate the fibre pull-out and fibre-matrix debonding. The fractured surface of the matrix is relatively smooth, which is typical for a thermoset polymer. Similar features were found on high-magnification images of unmodified epoxy composite. Feather markings are observed, which are caused by crack forking due to the high energy associated with the relatively fast crack growth. Again, this was previously identified and is typical for a brittle epoxy material [23]. The presence of voids and silica nanoparticles on the high-resolution image indicates that plastic void growth of the material was initiated by the debonding of silica nanoparticles (Figure 14 –b)). Even though the samples were gold coated prior to SEM analysis, the voids and silica nanoparticles were not observed on the coated surfaces of unmodified epoxy composite. This shows that the identified voids are not an artefact of the applied gold coating. The measured voids have a diameter of  $39 \pm 4.53 \text{ nm}$ , while the silica nanoparticles are within the range of 20-25 nm. However, it can be seen that
