Influence of high temperature on the tribological properties of hybrid PTFE/Kevlar fabric composite

Y. Hu^a, D.Q. Tan^{a*}, C. Xu^a, X.Q. Yang^a, Q. He^a, H.Y. Gao^a, R. Lewis^b

Abstract: The tribological properties of PTFE/Kevlar fabric is extremely important for the service behavior of joint bearings in aviation, aerospace and other fields. Reciprocating wear tests were carried out to investigate the tribological properties of hybrid PTFE/Kevlar fabric composite at high ambient temperatures. The results indicated that as the ambient temperature increased from 25 °C to 200 °C, both of the coefficient and the wear loss of PTFE/Kevlar fabric slightly decreased and then rapidly increased. At high temperatures above 100 °C, the wear rates of PTFE/Kevlar material first significantly decreased and then stabilized with increasing reciprocating cycles. Analysis of the wear mechanisms and their transitions showed that with the increase in the ambient temperature and reciprocating cycles, the wear mechanism of the PTFE/Kevlar composite underwent a transition from abrasive wear to mild adhesive wear, then to severe adhesive wear, and finally to the combined wear of severe adhesive and ther

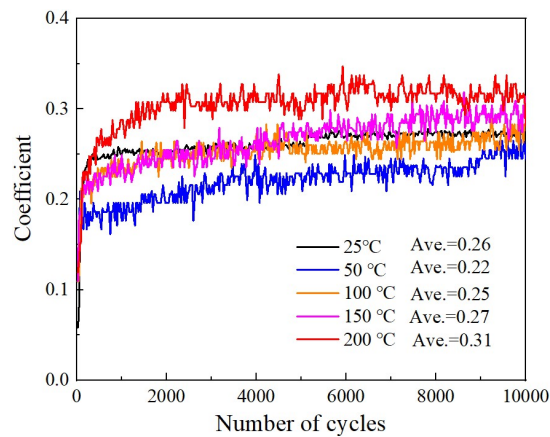
Fig. 4 shows the COF under different temperature conditions. It can be seen that the COF remains stable at about 0.26 at room temperature (25 °C). Interestingly, at a higher temperature of 50 °C, the COF drops to a value of 0.22. As the temperature continues to increase, the COF gradually increases, especially it is significantly higher at temperature of 200 °C than that at room temperature.

Fig. 4. Friction coefficient at different ambient temperatures.

and the recesses of the bearing ball, which reduced the roughness of the contact interface and increased the self-lubricating performance, thereby reducing COF (Fig. 4), and then wear and surface damage were decreased (Figs. 5,7,12).

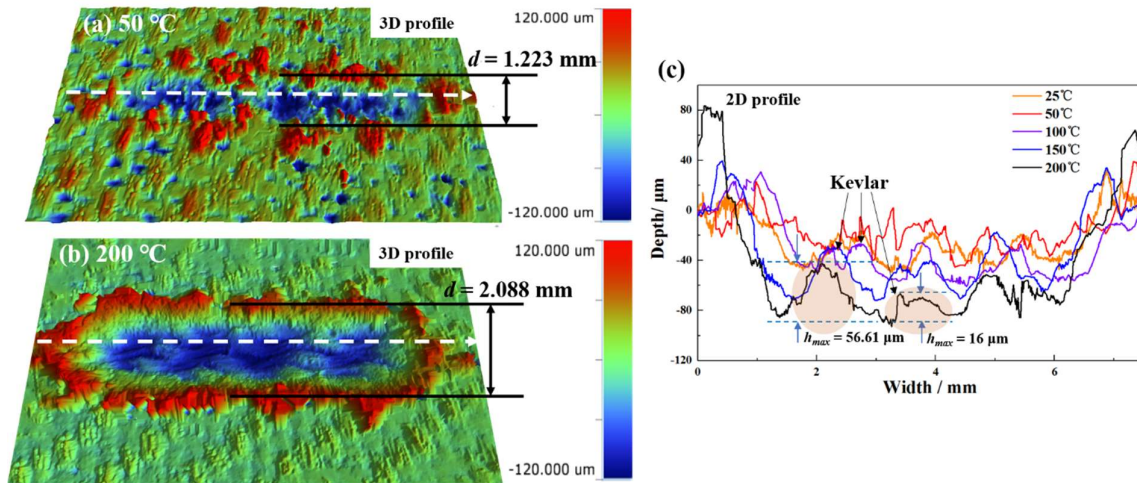
Fig. 11 shows the partial 3D-OM results of the PTFE/Kevlar wear scar at different temperatures (after 10,000 cycles). Corresponding to the wear data in Fig. 5, the fabric material wears only slightly at 50 °C. When the temperature increases from 50 °C to 200 °C, both width

and depth of the wear scars increase. At a temperature of 200 °C, the maximum width of the wear scar is 2.088 mm, and the height of the Kevlar peak is up to 56.61 μm. However, a low peak of 16 μm height in the center of the wear scar is observed, implying that the Kevlar material has undergone severe wear and breakage under this condition (Fig. 11b).

Fig. 11. 3D-OM results of worn PTFE/Kevlar fabric at different temperatures (10,000 cycles): (a) 3D profile at temperature of 50 °C; (b) 3D profile at temperature of 200 °C; (c) 2D profile as a function of temperature.

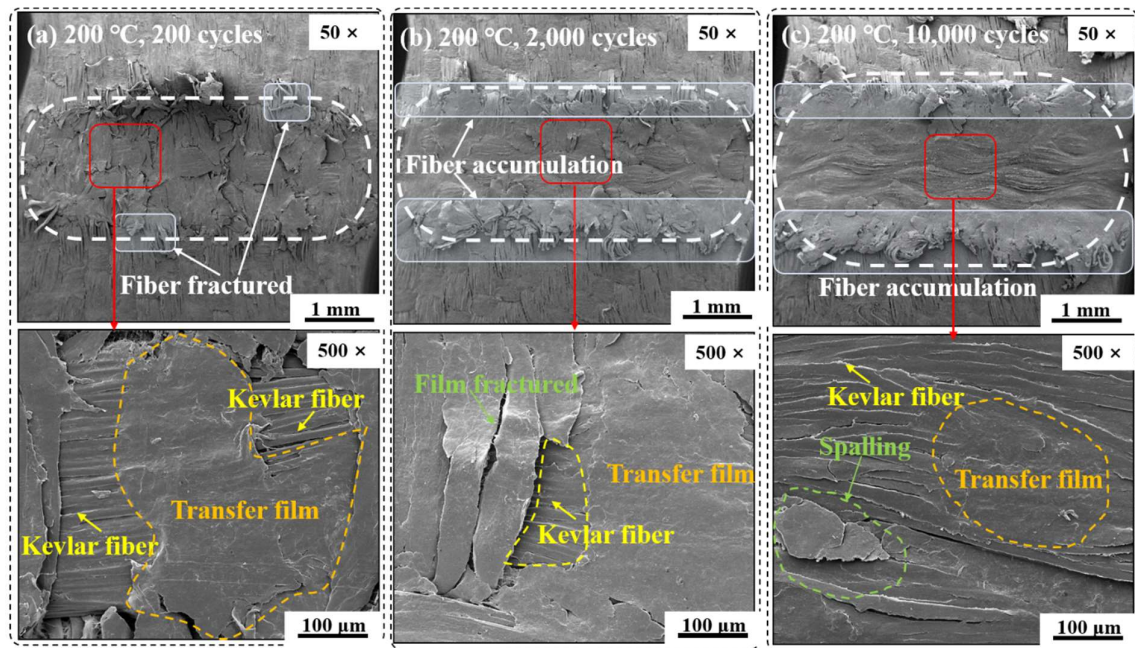
When the ambient temperature reaches 200 °C, severe damage rapidly occurs on the PTFE/Kevlar fabric. A large amount of fiber breakage and formation of transfer film are observed only running after 200 cycles (Fig. 14a). Under the combined action of cyclic loads and thermal effect, the transfer film is rapidly detached from the surface of the fabric material, as shown in Fig. 14b. When the test is carried out to 10,000 cycles, only a little PTFE transfer film remains in the middle of the wear scar, while a clear fiber structure could be observed behind the transfer film, which is the damaged Kevlar fiber (Fig. 14c).

Fig. 14. SEM images of worn surface of PTFE/Kevlar fabric at temperature of 200 °C: (a) 200 cycles; (b) 2,000 cycles; (c) 10,000 cycles.

The above SEM analysis indicates that a desired high temperature can effectively promote the adhesion of PTFE material to the contact surface, enhance the self-lubricating effect, and produce adhesive wear (Fig. 12). However, as the temperature increases, the PTFE transfer film accelerates consumption and peels off from the surface under the combined action of mechanical and thermal effects, causing the Kevlar fiber to lose the protection of the self-lubricating PTFE material and become exposed. Finally, the exposed Kevlar fiber suffers severe fatigue damage (Figs. 13-14).

As the temperature further increases to 200 °C (Fig. 15d), the C element in the wear scar becomes strong again, and appears "wave-like" as similar as the Kevlar. Whereas, the distribution of F in the middle of the wear scar is further weakened. It is suggested that at high temperature, as the fabric wears rapidly, the PTFE is continuously flattened and squeezed to edges of the wear scar, exposing the Kevlar fiber, which is consistent with the result in Fig. 14.

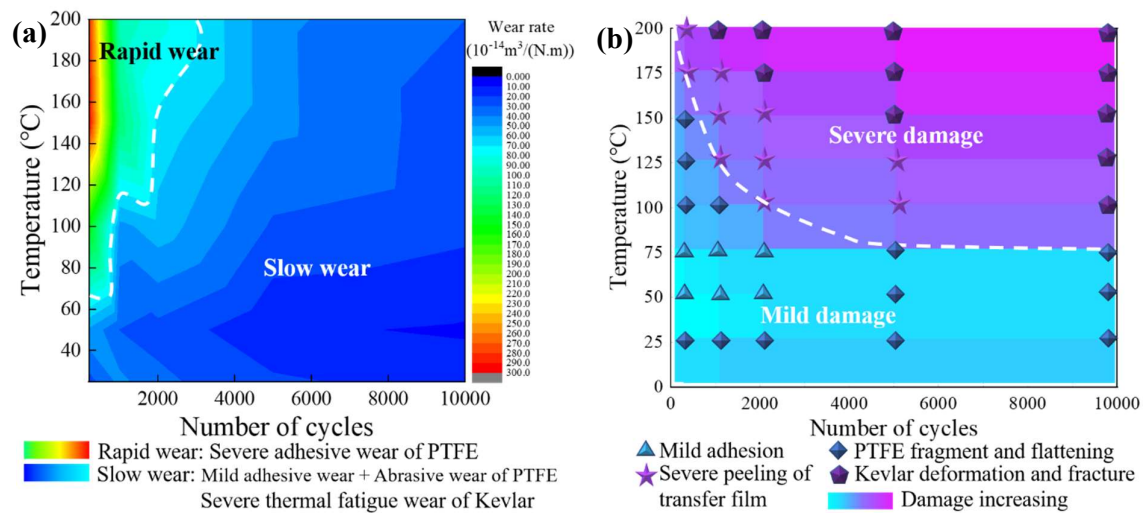
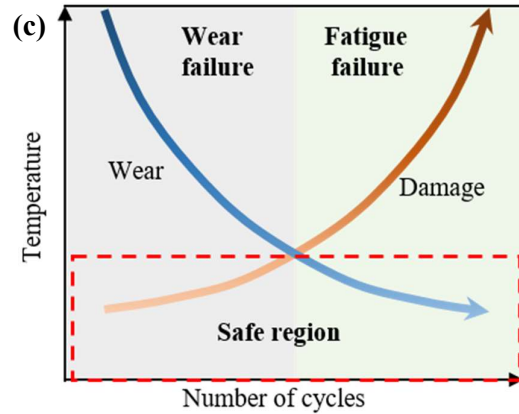
From the analysis above, there is a transition of wear mechanism and damage behaviors with the increasing temperatures and testing cycles. As it is known, the wear map, which was widely applied in the prediction and numerical simulation, is an effective way to distinguish the wear regimes and transition processes [31][35], as well as to understand the influence of various test conditions on the contact surfaces in the space-time framework of wear. In the present study, the transition maps of wear and damage behaviors in terms of reciprocating cycle and ambient temperature were concluded by examining the successive changes in the wear loss and surface damage of the PTFE/Kevlar fabric, as shown in Fig. 18.

Fig. 18. Wear and damage transition map of PTFE/Kevlar fabric: (a) wear map; (b) damage map; (c) the interaction of wear and fatigue damage.

Considering the wear rate in Fig. 5, two regimes, rapid wear (the wear rate $\geq 100 \times 10^{-14} \text{m}^3/(\text{N.m})$) and slow wear (the wear rate $< 100 \times 10^{-14} \text{m}^3/(\text{N.m})$), are identified in the wear map (Fig. 18a). Among them, the rapid wear regime is dominated by severe adhesive wear mechanism of the softer PTFE, while the slow wear regime includes mild adhesive wear and slight abrasive wear of PTFE, as well as the thermal fatigue wear of the harder Kevlar at high temperatures.

Subsequently, the damage map in Fig. 18b can be divided into two regimes based on the severity of the surface damage of PTFE/Kevlar fabric: mild damage and severe damage. Specifically, the damage behaviors in the mild damage regime include the slight adhesion at temperatures of 50~75 °C and slight PTFE fragment at room temperature, whereas severe surface damage behaviors, such as severe peeling of PTFE transfer film, exposure, deformation and fatigue fracture of Kevlar induced by thermal-mechanical load at high temperatures of above 100 °C, can be usually observed in the severe damage regime.

Fig. 18c presents the relationship between wear loss and surface damage. A mechanism of competition and restriction between wear and damage can be concluded [36]. The failure plot
