# Influence of Testing Temperature on the Mechanical Performance of Brazed Conventionally and Additively Manufactured 316L Stainless Steel Joints

In this work, brazed joints between samples of 316L stainless steel (316LSS) are formed using the Ag155 brazing filler metal. As an additional aspect of the investigation, the joints combine stainless steel formed by conventional processing and by additive manufacture (AM). These samples are then tested to determine their shear response with temperature, employing a bespoke test design comprising a set of three cylindrical samples held together with two brazed joints. Multiple samples are tested at 20 and 500 °C and single samples at intermediate temperatures. A shear strength above 200 MPa is retained up until 200 °C, and, despite significant differences in steel microstructure, the conventional or AM processing of the 316LSS does not affect joint failure. At higher temperatures, there is a progressive decrease in both the failure strength and the ductility of the joint. The reasons for the behavior are traced to changes, potentially associated with a transformed layer in the steel near to the joint, in the operating failure mechanism a

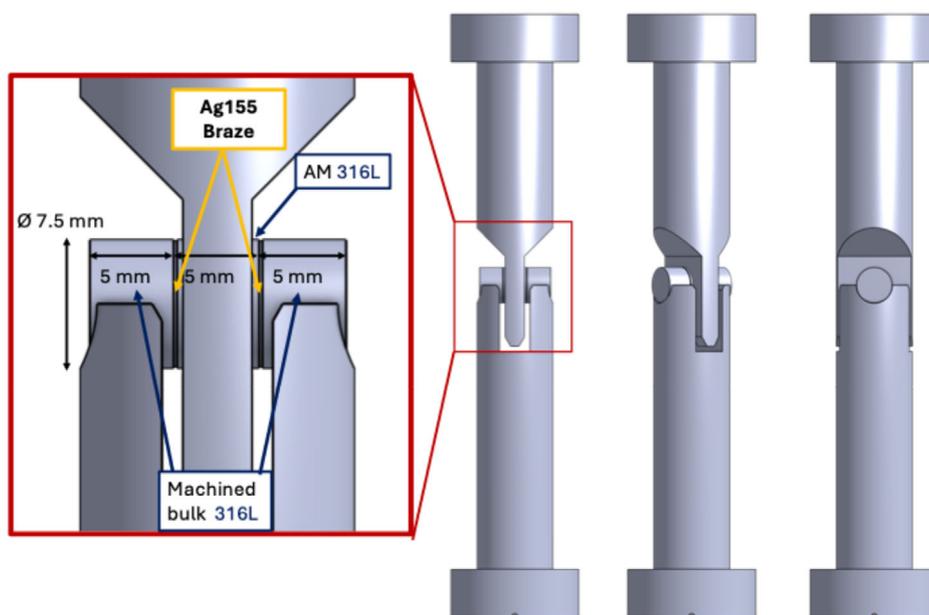
**Figure 1.** A schematic diagram of the configuration of the samples and testing rig. In testing, the edge cylinders are supported in semicylindrical grooves, while another machined shape applies pressure to the central cylinder, setting up shear stress across the joints.

The sample and testing rig are shown schematically in **Figure 1**. The present test method offered some advantages over other techniques that were often used for the assessment of the shear strength of brazed joints. Lapped shear samples were often the basis for industry standard tests, but these required relatively large amounts of material, both in terms of the filler needed to create the joint and also in terms of the amount of base material to be joined. These requirements could be problematic during early stages of material development, when the quantities of material accessible might be low. Another test that was used in this situation was the cylinder-on-plate test introduced by Matsu et al.<sup>[15]</sup> While the volume of material required is lower, this sample is asymmetrical and does not generate pure shear at the interface. The design used here offers some advantages over these methods; however, it is not perfect either, given the presence of edge effects,<sup>[16]</sup> which are neglected here. Also, there are aspects that need care in experimentation; for example, it is important that in brazing, the cylinders be kept parallel and well aligned unless final machining of the cylinder shown in Figure 1 is to be conducted after joining.

To close with a few remarks concerning the test procedure adopted here, the present geometry of shear test specimen, shown in Figure 1, was effective for these joints and could be suitable for assessing the properties of other kinds of brazed or soldered joints. As demonstrated, the design is compatible with testing at elevated temperatures and is suitable for use with developmental materials (fillers or substrates) given the small sample sizes involved. Unlike some other existing tests used for these purposes, the design offers the advantages of a symmetrical loading condition and a closer analogue to simple shear at the joint, along with the ability to obtain, from a single sample, both the fracture surfaces and an intact joint at a point just prior to failure, by means of which internal damage processes can be documented.

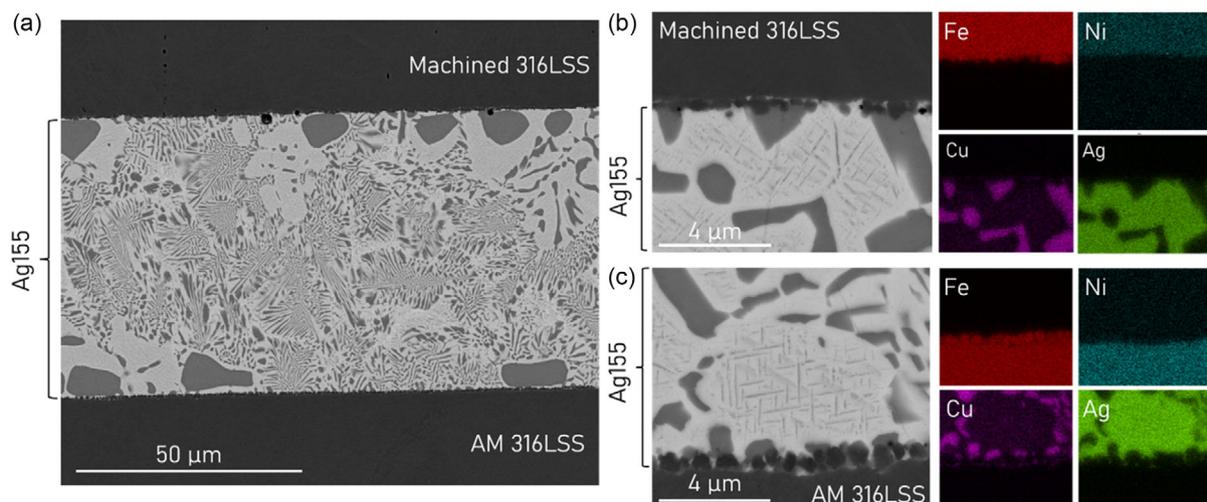
**Figure 2.** a) SEM image of the Ag155 joint cross section (taken from near the middle of the joint depicted in Figure 1, in samples that had not been loaded) with AM 316LSS at the top and machined 316LSS at the bottom, higher magnification SEM images and corresponding EDS maps of Fe, Ni, Cu, and Ag of the interface between Ag155 and b) machined 316LSS and c) AM 316LSS.

SEM images of the joint cross section in samples that were not loaded are shown in Figure 2. The microstructure of the joint braze alloy region is composed of larger Cu-based regions (medium grey) and a eutectic phase that combines an Ag-based solid solution (light grey) and a Cu-based solid solution, as highlighted by the EDS maps. This is consistent with literature examples of similar Ag–Cu-based brazing systems.<sup>[6,17]</sup> There is little interaction between the 316LSS and Ag155, but a layer of fine grains is present at the interface of the filler metal with both the AM and machined 316LSS that forms during brazing.

EDS maps show that the average composition of the layer (dark grey) does not feature Cu or Ag, but is rich in Fe, so it must be steel-based and originate from the stainless steel. Interestingly, the fine grains are depleted in Ni.

Macroscopic images of the fracture surface on the AM side of the joint are shown in **Figure 5** for each test temperature. The fact that the samples failed in shear is likely to have caused mutual rubbing of fracture surfaces and obscured features of the fracture surface, such as signs showing the crack path or initiation site; however, these fractographs provide evidence of a change in mechanism with elevated temperature. At temperatures up to 200 °C, there is some filler material present at the surface (i.e., the failure has not happened along the interface between filler and AM 316LSS), and evidence of macroscale ductility can be observed in the filler, with directional plastic deformation visible across the surface. At higher temperatures, the failure tends to occur between the filler and one or other of the 316SS sides of the joint, and evidence of brittle fracture is found, where the interface appears featureless (other than the observation of occasional defects, such as millimeter-scale porosity, the presence of which is typical in brazed joints; this arises during processing). SEM images of the ductile region of the filler metal at the fracture surface are shown in **Figure 6a,b**. The ductile behavior of the filler is evidenced in each micrograph by the presence of microvoid coalescence. Up to 200 °C, there is evidence of shear tearing, consistent with increasing ductility with rising temperature. For 20 °C (and also, slightly less visibly, at 200 °C), the separation between dimples observed is consistent with the microstructural features of the braze alloy, where a Cu-rich phase and eutectic regions, both roughly 20 μm wide, are present within an Ag-rich matrix, as shown in Figure 2.

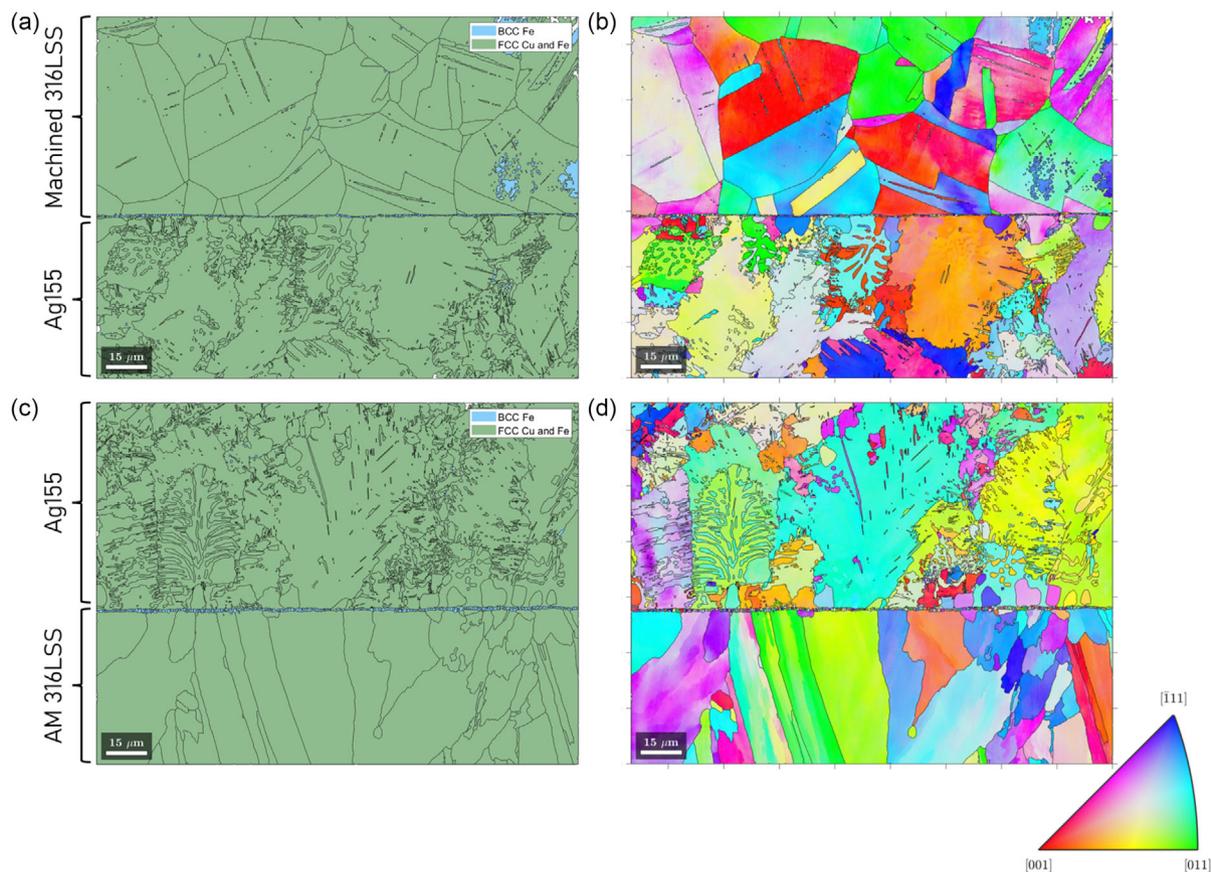
**Figure 3.** EBSD a,c) phase and b,d) inverse pole figure (IPF) maps for the interface region between (a,b) Ag155 and machined 316LSS and (c,d) Ag155 and AM 316LSS.

An examination of the interfacial region via EBSD in **Figure 3** reveals that the fine grains are formed of a body-centered cubic (BCC) Fe phase. BCC-Fe is also observed at a small volume fraction in the machined 316LSS, which can indeed contain residual ferrite.<sup>[18]</sup> Usually, 316LSS and the Ag155 filler metal have face-centered cubic (FCC) crystal structures. The difference in the grain structure of the stainless steel with processing route is visible, with the AM material having elongated columnar grains, while grains in the conventionally processed 316LSS are equiaxed and slightly twinned. There is no clear orientation relationship between the BCC-Fe grains and the base material or the filler metal. A similar BCC-Fe interfacial layer has been shown to form during the brazing, using a CuGeNi braze alloy, of austenitic stainless steels by Livera,<sup>[14]</sup> who further also noted a suppression of the BCC-Fe phase formation in AM 316LSS.

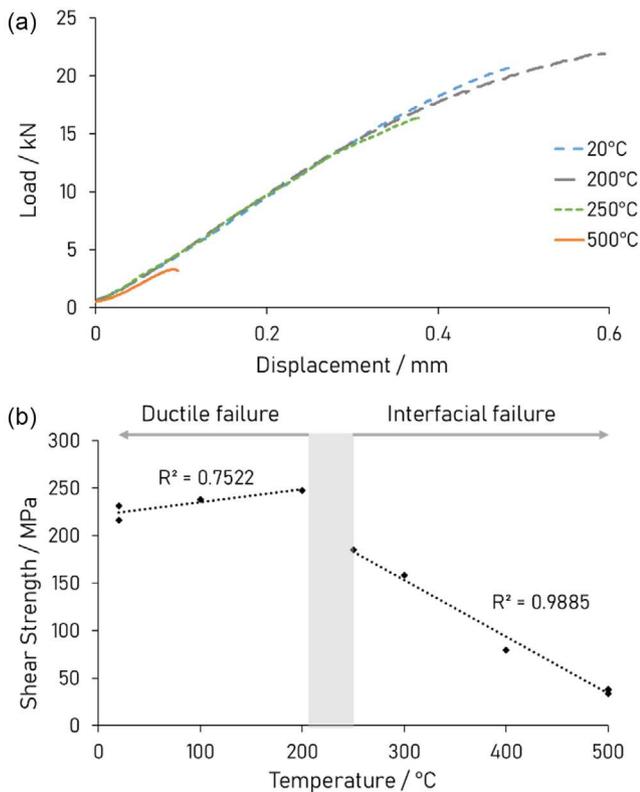
**Figure 4.** a) Force applied versus displacement for various temperatures tested and b) individual data points for shear strength at failure versus temperature for all samples tested.

**Figure 4** shows the relationship between the force applied and displacement recorded at several temperatures. As seen, the slope of the curves for all the datasets is the same, regardless of temperature, suggesting that there is little plastic deformation

or internal damage in the braze alloy prior to failure, and that the measured displacement is initially dominated by the overall load strain compliance. Up to 200 °C, the shear failure strength remains relatively unchanged, noting that apart from the tests at room and 500 °C, repeat samples were not tested, and while the trends in the results appear relatively clear, it is possible that specific features of the joints made, such as defects, have affected the results. It must also be noted that the failure strength, rather than the yield stress, was used in the analysis as the equipment was not fitted with an extensometer to accurately identify the strain within the braze of each sample. Therefore, the margin of error in the estimation of a yield stress was deemed too large for it to be of use.

At 200 °C, the increased ductility, seen in Figure 4a, results in the elongation of the dimples along the shearing direction on the braze side of the fracture surface, Figure 6b. At 500 °C, however, there is no sign of ductility visible along the fracture surface, shown by a featureless surface in Figure 6c. The SEM image in Figure 6c shows that the microstructure of the filler metal, with the darker spots rich in Cu and the lighter matrix rich in Ag, has essentially not been deformed during mechanical testing at 500 °C. On the other side of the fractured joint (Figure 6f), there is no evidence of the presence of the filler metal. This agrees with the macroscopic images in Figure 5, which show brittle interfacial failure above 200 °C. As fracture happens in the same region as the BCC phase occurs, it can be questioned if there is a correspondence between the two, and this can be investigated with examination of the joint cross sections.

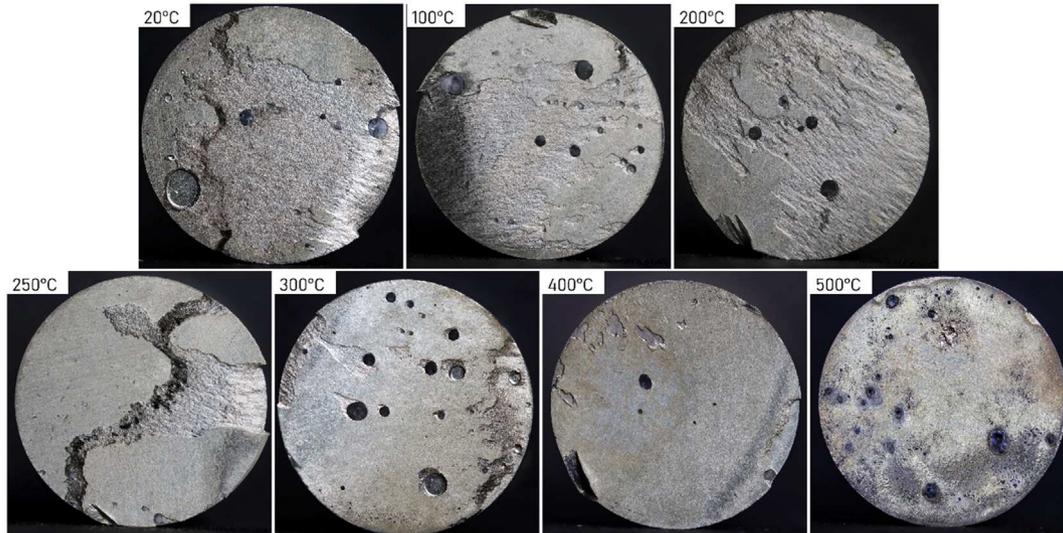
**Figure 5.** Photographs of the fractured surfaces taken of the AM 316LSS side of the joint after failure for all temperatures measured. All images show the full 7.5 mm diameter of the specimen. Black circular regions are pores that formed during the furnace brazing process and are typical for such joints. While such defects are candidates for the sites of crack initiation, due to the way the surfaces move past each other during testing, detailed analysis of the crack path and identification of crack initiation sites is not possible.

At 250 °C and above, the fractured surface displays macroscopically a more varied failure mode, with a decreasing proportion of ductile failure surface as the test temperature increases, as seen in Figure 5. At 250 °C, failure occurs at the interfaces between the filler metal and the 316LSS surfaces, with the fracture transitioning between the AM 316LSS/Ag155 filler interface on the left and the machined 316LSS/Ag155 filler interface on the right of the image in Figure 5. From 300 °C to 500 °C, Figure 5 shows that the joint fractography has few features beside the pores that formed during the furnace brazing process within the filler metal. The flat surfaces represent brittle interfacial failure, which occurs between the machined (for joints tested at 300 °C and above) 316LSS and the Ag155 filler metal. Overall, the fractured surfaces show a clear change in failure mechanism, from ductile up to 200 °C, to a brittle interfacial failure at higher temperatures. This in turn correlates with the distinct drop in strength that is seen past 200 °C in the mechanical testing data (Figure 4b). Data suggest a linear trend, although being based on single samples at each temperature apart from 500 °C, the trend must be

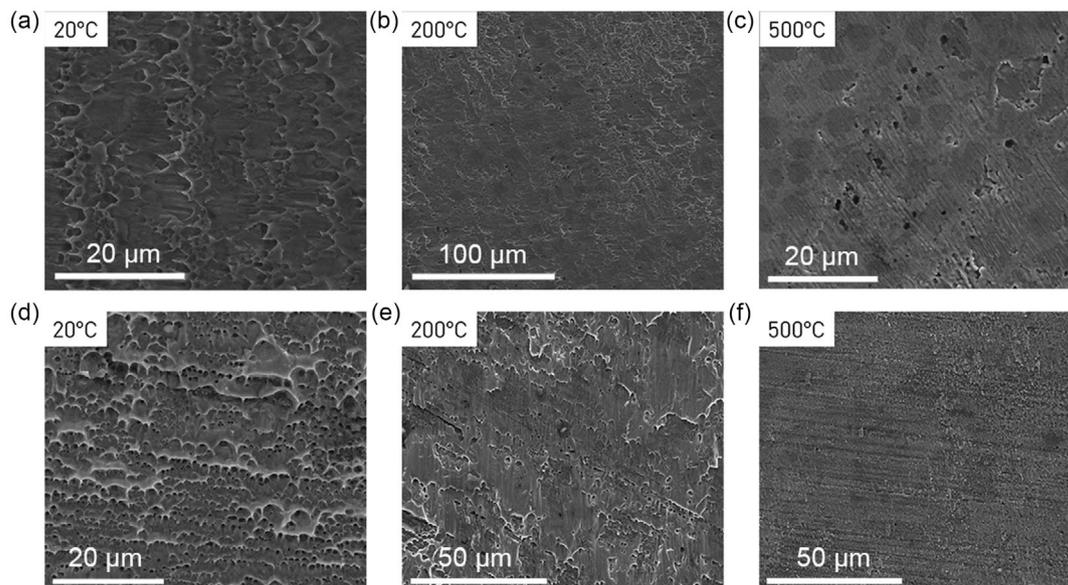
**Figure 6.** SEM images of the post-failure surfaces at various temperatures. Fracture normally occurs close to the interface between the brazing filler metal and one or other of the stainless steel cylinders, and images have been selected to show different sides of these fracture surfaces; the Ag155 side of the fracture surface at a) 20 °C, b) 200 °C, c) 500 °C, and the 316LSS side of a fracture surface (with all examples taken from the machined side of the joint for consistency; this side was the most common, but not exclusive, location for the failure to take place) at d) 20 °C, e) 200 °C, and f) 500 °C.

Variations in the failure mechanism as the temperature increases from 20 to 500 °C are further documented in the SEM micrographs in Figure 6a–f, which focus on the failure surfaces that are seen when fracture occurs at the interface between

the machined 316LSS and the filler metal. At 20 °C, the fractured surfaces appear ductile on both sides of the joint, with evidence of plastic deformation present along the failure surfaces of both the filler and the 316LSS side of the joint. Some degree of alignment of microvoids parallel to the polished grooves of the base material is found in Figure 6a; likely this is a consequence of the contrast in flow stress between the braze and stainless steel. Localization of ductile deformation at this scale is also induced by the two-phase microstructure of the Ag155 filler, consisting of an Ag-rich phase and a phase containing a larger proportion of Cu,<sup>[1]</sup> with the more highly pure Ag-rich phase likely to be the more ductile.

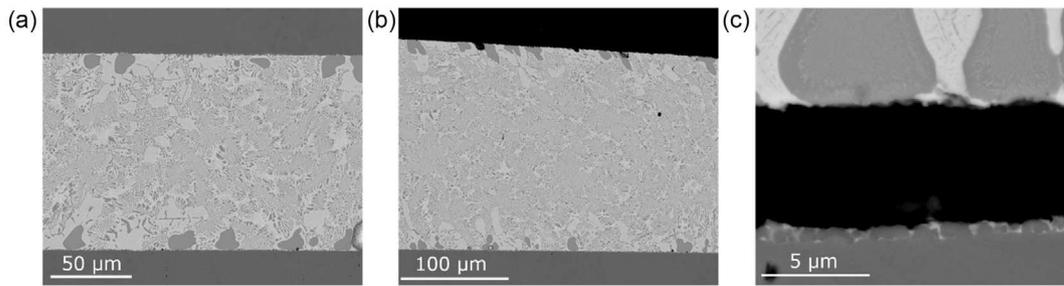
**Figure 7.** SEM images of the post-test Ag155 region on a) 20 °C near-failed joint compared with b) 20 °C failed joint, still attached to the AM 316LSS, and c) 500 °C near-failed joint which was still attached out of plane.

presence of any build-up of internal damage prior to separation; such intact joints are used later in this work to produce images in Figure 7a,c. To resolve the shear strength from the measured failure load, a value for the joint area is needed. In this work, samples were verified after manufacture to ensure that filler metal was visible along the complete circumference of each joint, signaling that the braze has flowed through the entire joint gap. Note that this does not imply that the joint is entirely filled: Some joint porosity is common in brazing and was observed here (as shown on the fracture surfaces in Figure 5, discussed later). To compute the apparent shear strength of the braze, the maximum total force applied was divided by the total area of both joints. This gives the average shear stress that was applied on either of the two joints at the moment the weaker joint failed. Doing so neglects the influence of edge effects and that of any large-scale pores within the braze (which reduce the effective braze surface area). Braze failure shear stress values reported here are, thus, lower-bound estimates of the local strength of a fully brazed joint and will tend to be lower than the average that might be assessed by other means using a smaller joint area. It is also noted that during testing, joint failure did not consistently occur on the same side of the specimen, indicating that failure is not related to any misalignment in the testing rig.

As previously mentioned, on the unbroken side, there is also an equivalent joint which has nominally experienced identical loading, but for which unloading has occurred before failure. These joints were also examined in cross section to see what can be learned about the failure processes, with example SEM micrographs shown in Figure 7. Figure 7a,b shows samples tested at 20 °C and compares cross sections through the full joint (showing the filler in the centre, and the 316LSS at the top and bottom) on the side where the joint remained intact in Figure 7a and the side where the joint was fully separated in testing in Figure 7b. The microstructure within the filler does not seem to be affected by the deformation. This suggests that the plastic deformation seen in the 20 °C fracture surface images is confined to the failure region and is not distributed into the depth. It is visible from comparison of Figure 7a,b that at 20 °C, the crack has followed a path situated

at, or near, the interface between the filler and the substrate. The fact that the joint on the side that did not fail at this temperature showed no signs of partial damage suggests that the failure process started at a particular weak flaw on the failed side of that sample.
