WEAR AND FATIGUE OF RAILWAY TRACK CAUSED BY CONTAMINATION, SANDING AND SURFACE DAMAGE

R.S. Dwyer-Joyce, R. Lewis, N. Gao and D.G. Grieve

The University of Sheffield, Department of Mechanical Engineering,
Mappin Street, Sheffield, S1 3JD
UK

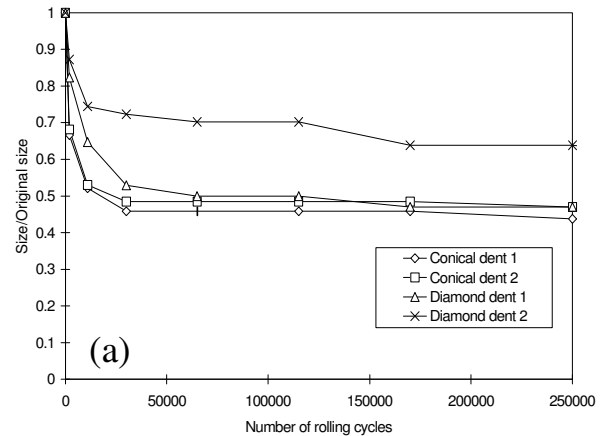
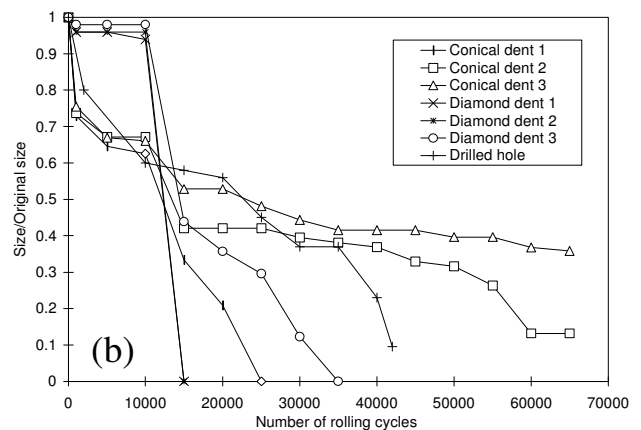
figure 3 The change in size of the indentations during (a) oil, and (b) water lubricated tests

Figure 2 shows a series of photographs from a single oil lubricated test captured at different stages during the test. The initial dent was generated using a Rockwell indenter and is rapidly reduced in size during the first few cycles. This process occurs by plastic flow of the dent side walls. Over the whole test, the weight loss is negligible so there is little effect of dent removal by a surface wear process. The Rockwell indentation leaves some dent shoulders on the rail surface. These shoulders and the side walls of the indentation collapse under contact loading. The dent then shakes down to a stable shape and little further deformation occurs (see figure 3a).

If water is used as the lubricant a different process takes place (see *figure 4*). Again the dent is deformed, but this time deformation continues throughout the test until the dent is completely closed (see *figure 3b*).
