## **SHAKING TABLE TESTS ON RC RETROFITTED FRAME WITH FRP**

This paper describes the experimental work undertaken on FRP seismic strengthening of a RC structure as part of the “Ecoleader” European program. Shaking table tests were performed on a one-bay, 2 storey, full-scale spatial RC-frame (4 m x 4 m, 6.6 m high, 30 t mass) at CEA Saclay on the AZALEE shaking table. Two further papers in this conference will describe the analytical work relating to the tests. The main objective of the program was to assess different strengthening strategies and techniques on a seismically under-designed R/C frame structure, in order to develop simple and rational techniques for use in FRP-strengthening of R/C structural elements (i.e., beams, columns and joints) and quantify their effectiveness through design equations. The original frame was shaken until severe damage was achieved and a sway mechanism was developed. It was subsequently strengthened with Carbon FRP aiming to change the collapse mechanism. The strengthening procedure proved to be amazingly successful and the frame resisted shaking up to the limits possible by the capacity of the shaking table.

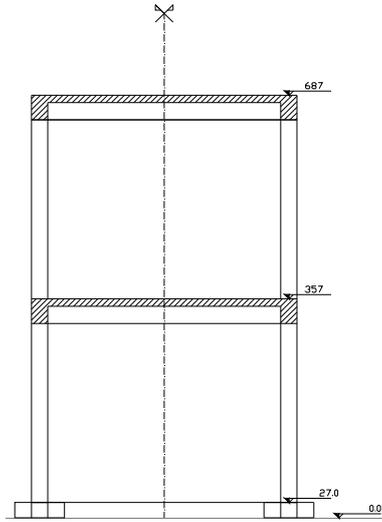
**Figure 1: Side view of the specimen**

- 2 square slabs : 0.12 m thickness and 4.26 m wide,
- 4 beams per slab: 0.40 m x 0.26 m section.

The total weight of the structure was about 20 tons. For the tests, an additional mass of 9 tons (4.5 tons per slab) was added. Figures 1 and 2 present the geometry of the specimen.

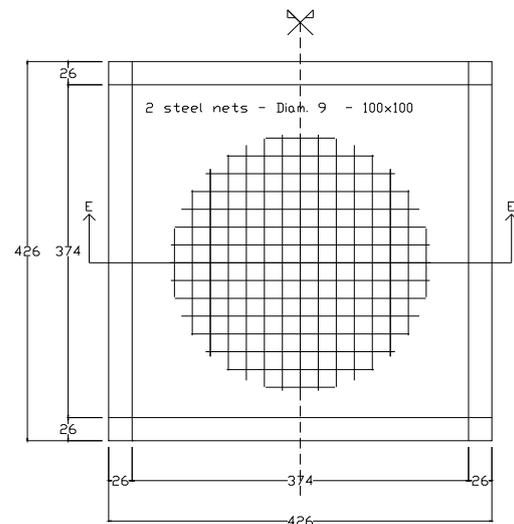
**Figure 2: Plan view of slab**

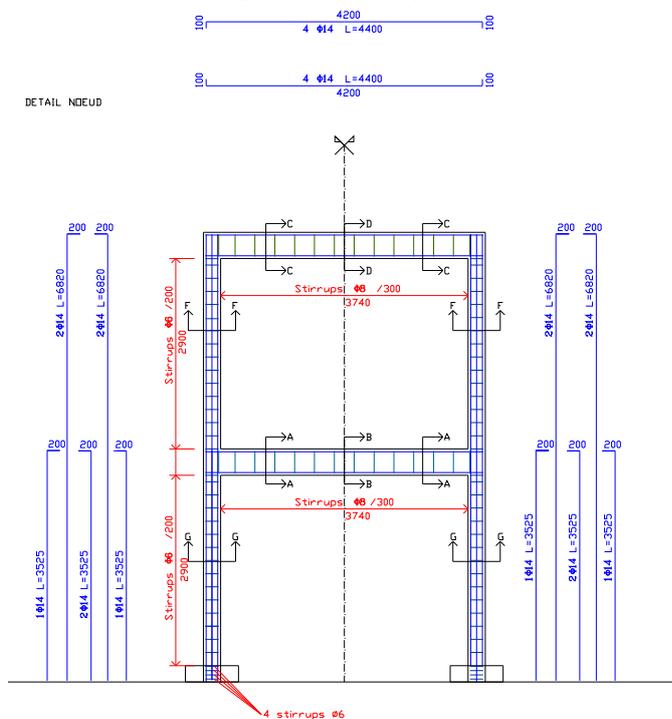
**Figure 3: Steel reinforcement of beams and columns**

- columns:
  - 3 $\phi$ 14 + 2 $\phi$ 14 + 3 $\phi$ 14 for the 1st floor,
  - 2 $\phi$ 14 + 2 $\phi$ 14 for the 2nd floor,
- beams:
  - 4 $\phi$ 14 top and bottom

The transverse reinforcement (stirrups) of beams and columns consisted of 6 mm and 8 mm diameter steel bars, respectively. The slab reinforcement consisted of steel mesh top and bottom ( $\phi$ 9 mm – 100 x 100 mm). The concrete cover was 30 mm. Figure 3 shows a sketch of the steel reinforcement of the frame, whilst figure 4 illustrates the anchorage details of the joints.

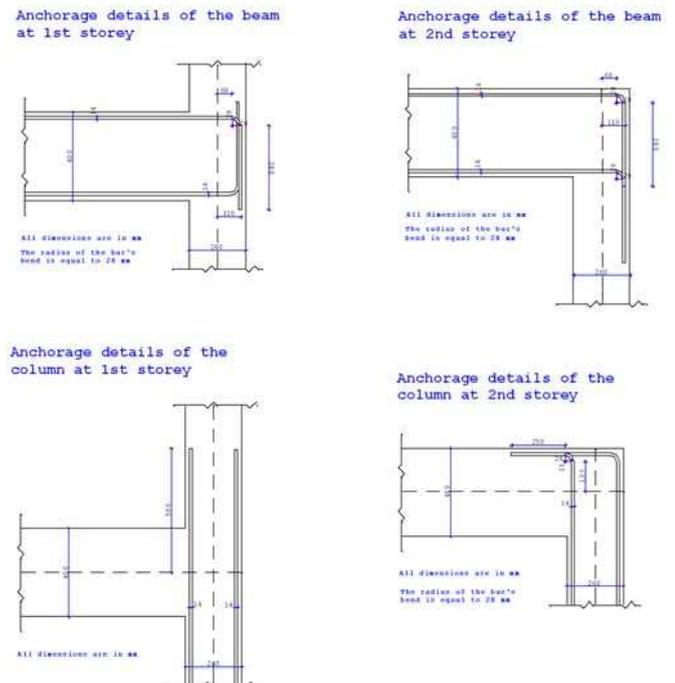
**Figure 4: Anchorage details of nodes**

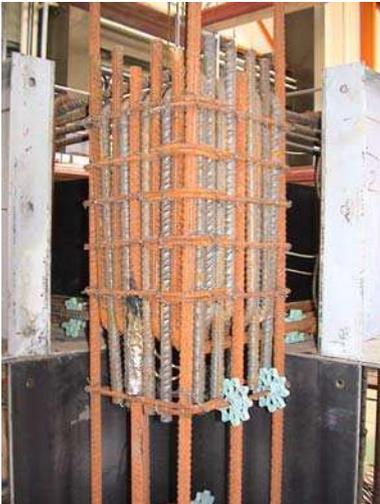
**Figure 5: Reinforcement of a 1<sup>st</sup> level node**

Figure 5 shows a view of the reinforcement typical of a joint in the 1<sup>st</sup> level. All longitudinal reinforcement bars were continuous without any lap splices. The specimen was cast at the CEA laboratory using steel formwork, specially designed and manufactured for the specific project (concrete compressive strength: 20 MPa). This formwork permitted the casting of one floor of the specimen (4 columns, 4 beams and 1 slab) each time. The specimen was cast in 2 phases. Figure 6 shows a view of the frame after casting.

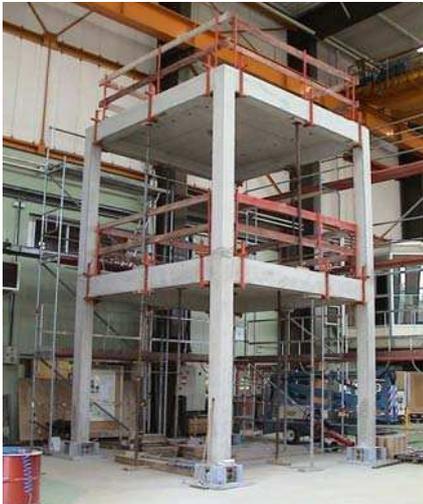
**Figure 6: Frame after casting**

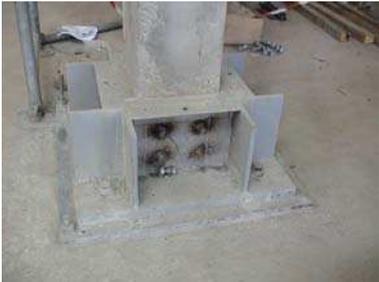
The frame was anchored on the AZALEE shaking table through a specially manufactured steel box at the base of each column (Figure 7). The vertical bars of the columns were welded on the base plate of the box aiming at fully fixed support conditions. Eight horizontal steel bars, four in each direction, were bolted on the sides of the steel box to increase its rigidity.

**Figure 7: Steel foundation box**

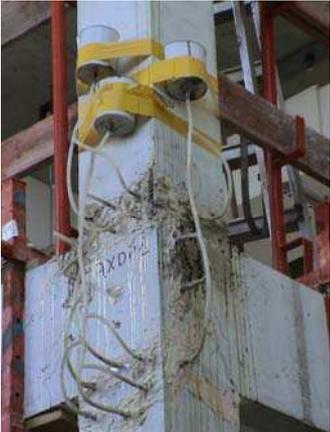
**Figure 8: Injection of resin into crack**

The strengthening design was undertaken in collaboration between Ecoleleader researchers and an industrial partner (Freyssinet – France). The industrial partner applied the strengthening after the last seismic test (0.4g) on the bare frame. Before applying the FRP, resin was injected into the main cracks of the joints (Figure 8). After injection and polymerization of the resin, surfaces were prepared and FRP was applied (Figure 9). The top (60 cm) and bottom (90cm) of each column were confined with one layer of CFRP. Joints were enhanced in flexure and shear using one layer of CFRP. Beams were not strengthened at all, following the main idea of transferring the plastic hinges into the beams. The Carbon FRP characteristics (according to the industrial partner) were the following:

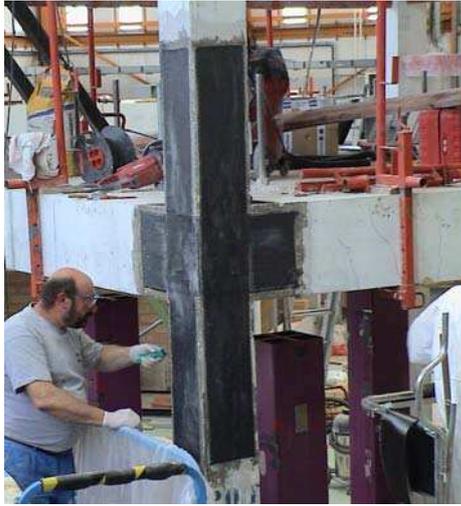
**Figure 9: FRP retrofitting**

Young modulus: 105 GPa, guaranteed stress in tension: 1700 MPa, Design tensile strength: 913 MPa, layer thickness: 0.48 mm and anchorage length 20 cm.

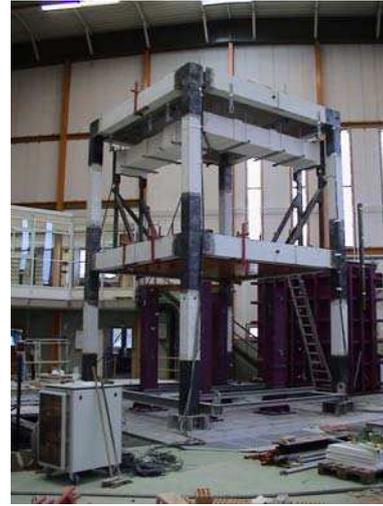
**Figure 10: Retrofitted frame on AZALEE shaking table**

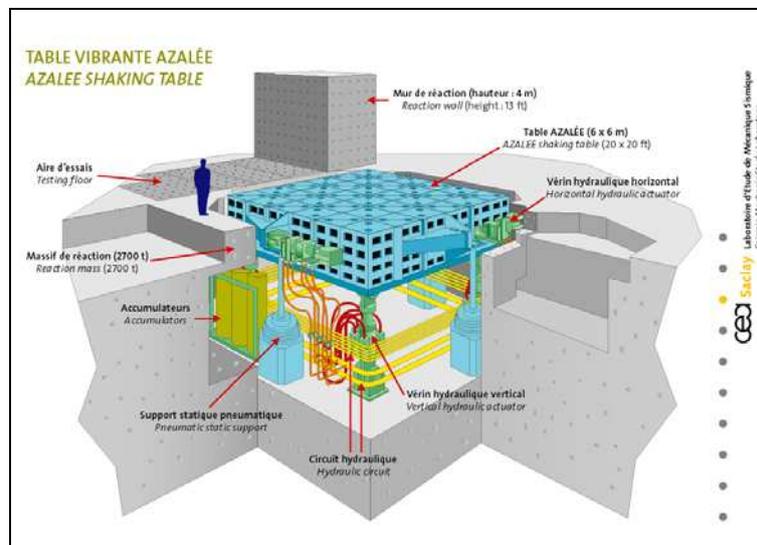
**Figure 11: AZALEE shaking table**

Tests were performed on the 6 DOF AZALEE shaking table of the “Seismic Mechanic Study” laboratory of CEA Saclay (France) (Figure 11). The maximum payload is 100 tons. The square base plate is 6 m wide. Eight hydraulic jacks (4 for horizontal and 4 for vertical excitations) are connected to the plate. Each jack has a maximum force of 1000 KN. Four static pneumatic supports are placed under the plate to support the weight of the table and the specimen. The maximum displacement range is 250 mm for the two horizontal axes and 200 mm for the vertical axis.

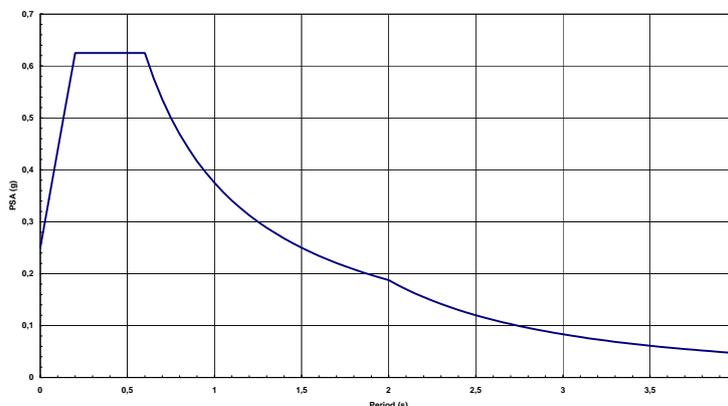
**Figure 12: Reference spectrum**

The reference spectrum was derived from Eurocode 8, corresponding to soil C (Figure 12). An artificial seismic signal of duration 20 seconds was calculated from this spectrum.

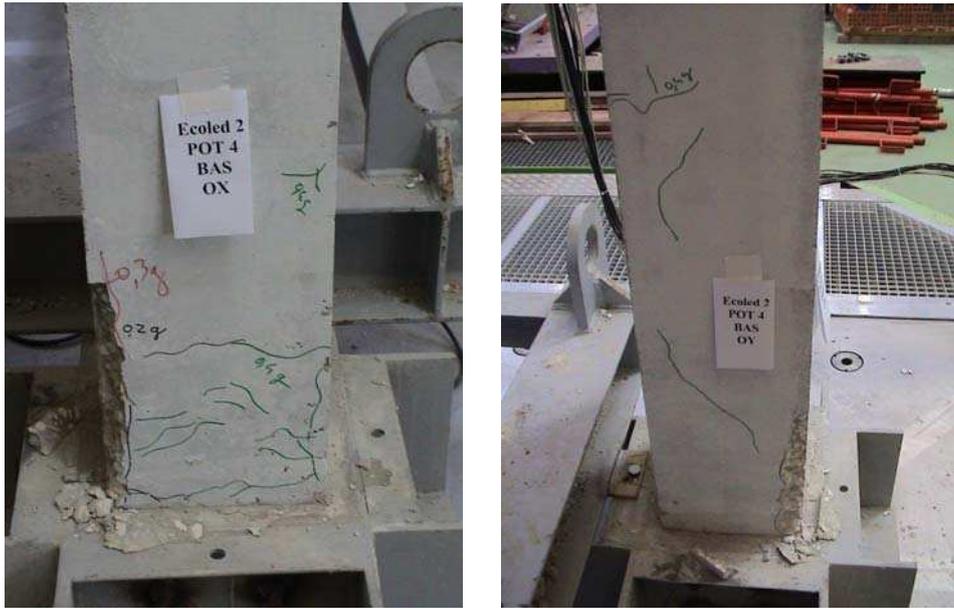
**Figure 13: Views of the cracks and the bottom of the columns of the mockup after the first series of tests without strengthening**

No damage was observed after the first two seismic tests. First visible cracks appeared during the 0.2 g seismic test on the joints of the 1<sup>st</sup> level (diagonal shear cracks) and under the joints of the 2<sup>nd</sup> level (horizontal cracks). Some new horizontal cracks appeared over the joints of the 1<sup>st</sup> level, on the columns and at the base of column 4 during the 0.3g seismic test. Finally, during the last seismic test (0.4 g), new cracks appeared on column 1 between the base and the 1<sup>st</sup> slab. At the base of column 4, spalling of concrete was observed. Figures 13 to 15 show views of cracks after this first series of seismic tests.

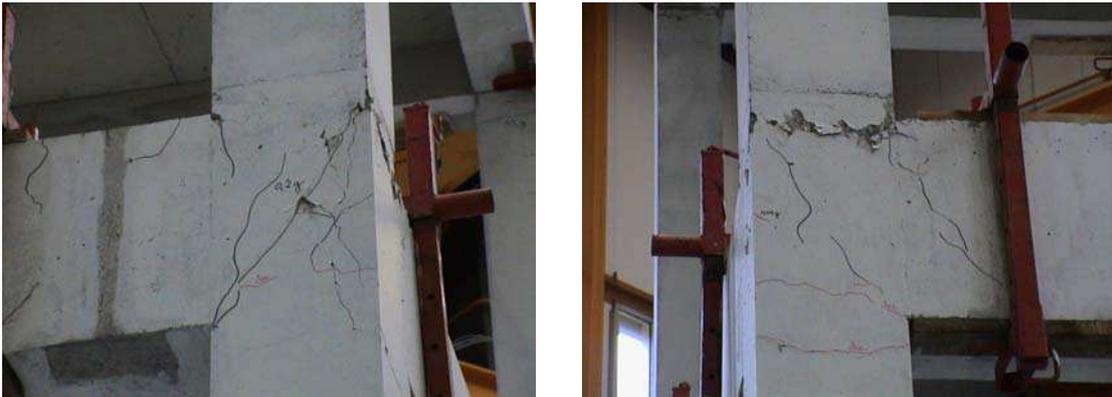
**Figure 14: Views of the cracks and the first slab level of the mockup after the first series of tests without strengthening**

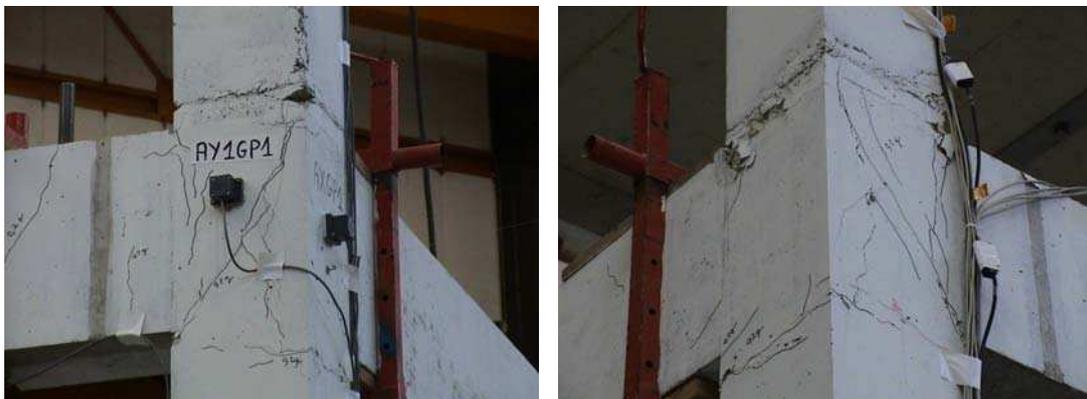
**Figure 15: Views of the cracks at the first slab level of the mockup after the first series of tests without strengthening**

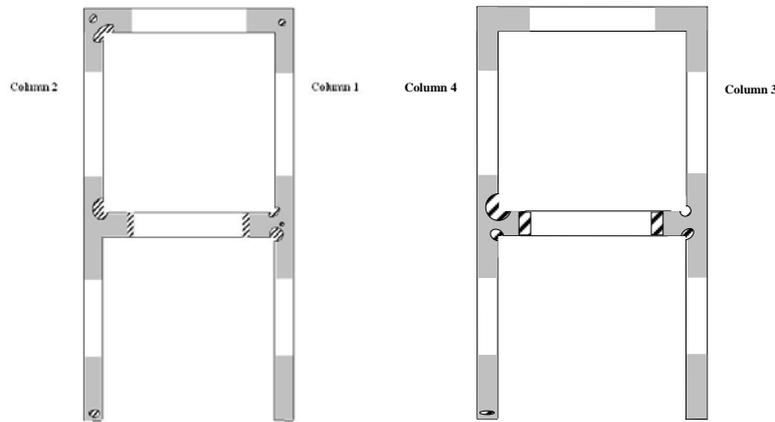
**Figure 16: Debonded areas of FRP after 0,5 g seismic test – (Front-back elevations)**

No damage appeared after the first seismic test at PGA 0.05g. Some FRP debonding was detected by manual tapping of the FRP at the base of the columns of the first floor after the test with PGA 0.2g. No further damage was detected until the end of the test with PGA 0.4g. After the test with PGA 0.5g, new cracks appeared on the beams and on the columns. The FRP sheets provided in the joints appeared to have debonded partially from the beams, as shown in figures 16 and 17. From this and other evidence from the strain gages readings, it was concluded that the plastic hinges were moved away from the columns and into the beams.

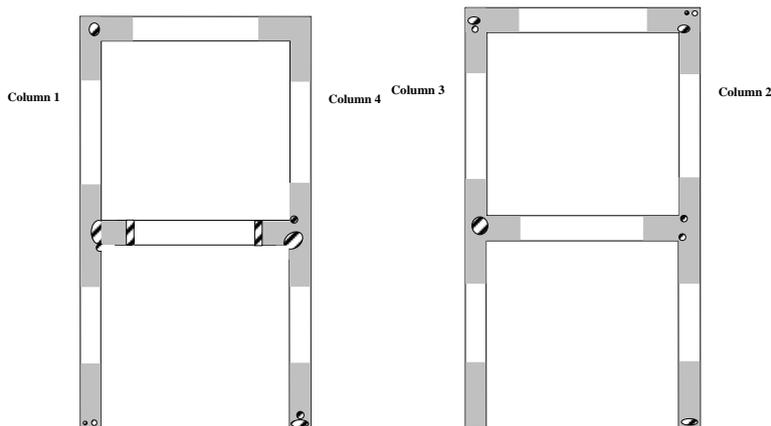
**Figure 17: Debonded areas of FRP after 0,5 g seismic test – (Side elevations)**

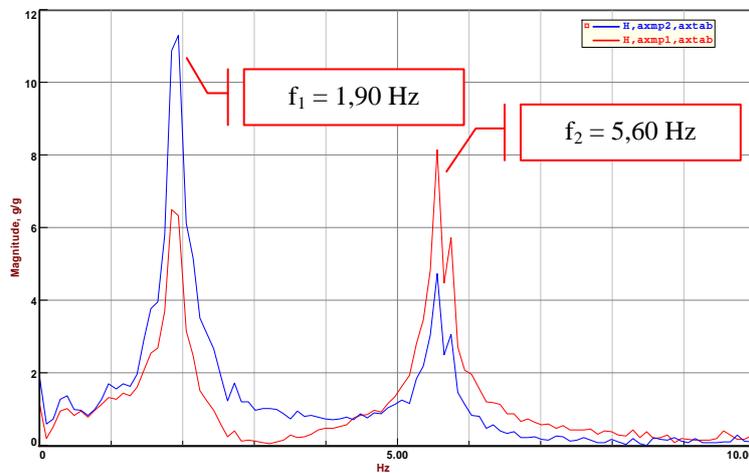
**Figure 18: Natural frequency measurements –Bare frame before seismic tests**

Table 2 shows the values of the first two natural frequencies of the bare frame measured before and after each seismic test. It is obvious that the 1<sup>st</sup> natural frequency of the specimen decreases as the acceleration increases due to the building's stiffness deterioration. It should be noted that the first frequency after the first serious motion of 0.1g decreased by 30%. This degradation in stiffness is associated with the cracking of the concrete sections. After the last test with a GPA of 0.4g, the frame was damaged substantially and a sway mechanism was achieved.

Figure 18 below, shows the results of the frequency measurements.
