This is a repository copy of *Seismic strengthening of masonry-infilled RC frames with TRM: Experimental study*.

Koutas, L. [orcid.org/0000-0002-7259-6910](http://orcid.org/0000-0002-7259-6910), Bousias, S.N. and Triantafillou, T.C. (2014) Seismic strengthening of masonry-infilled RC frames with TRM: Experimental study. *Journal of Composites for Construction*, 19 (2). 04014048. ISSN 1090-0268

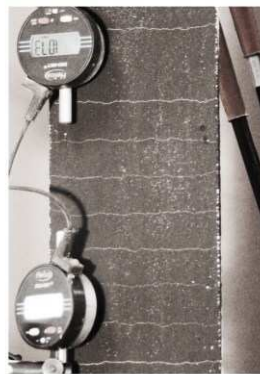
- Fig. 5 Tensile testing of TRM coupons: (a) coupons geometry; (b) test set-up; and (c) typical crack pattern (all dimensions in mm).
- Fig. 6 Strengthening scheme – Application steps: (a) bare frame; (b) shear strengthening of 1<sup>st</sup> and 2<sup>nd</sup> storey columns at shear-critical regions; (c) infilling with masonry; (d) application of 1<sup>st</sup> TRM layer on the face of masonry infills, bottom part of the textile; (e) application of 1<sup>st</sup> TRM layer on the face of masonry infills, top part of the textile; (f) application of textile anchors and extra textile patches on the front and back side of the specimen, respectively; (g) application of 2<sup>nd</sup> TRM layer on the faces of 1<sup>st</sup> storey masonry infill, bottom part of the textile; (h) application of 2<sup>nd</sup> TRM layer on the faces of 1<sup>st</sup> storey masonry infill, top part of the textile; (i) wrapping of the overhanging textile parts around the column corner.
