This is a repository copy of The Impact of Cracks on Photovoltaic Power Performance.

Dhimish, Mahmoud, Holmes, Violeta, Mehrdadi, Bruce et al. (1 more author) (2017) The Impact of Cracks on Photovoltaic Power Performance. Journal of Science: Advanced Materials and Devices. pp. 199-209.

The Impact of Cracks on Photovoltaic Power 1 Performance 2

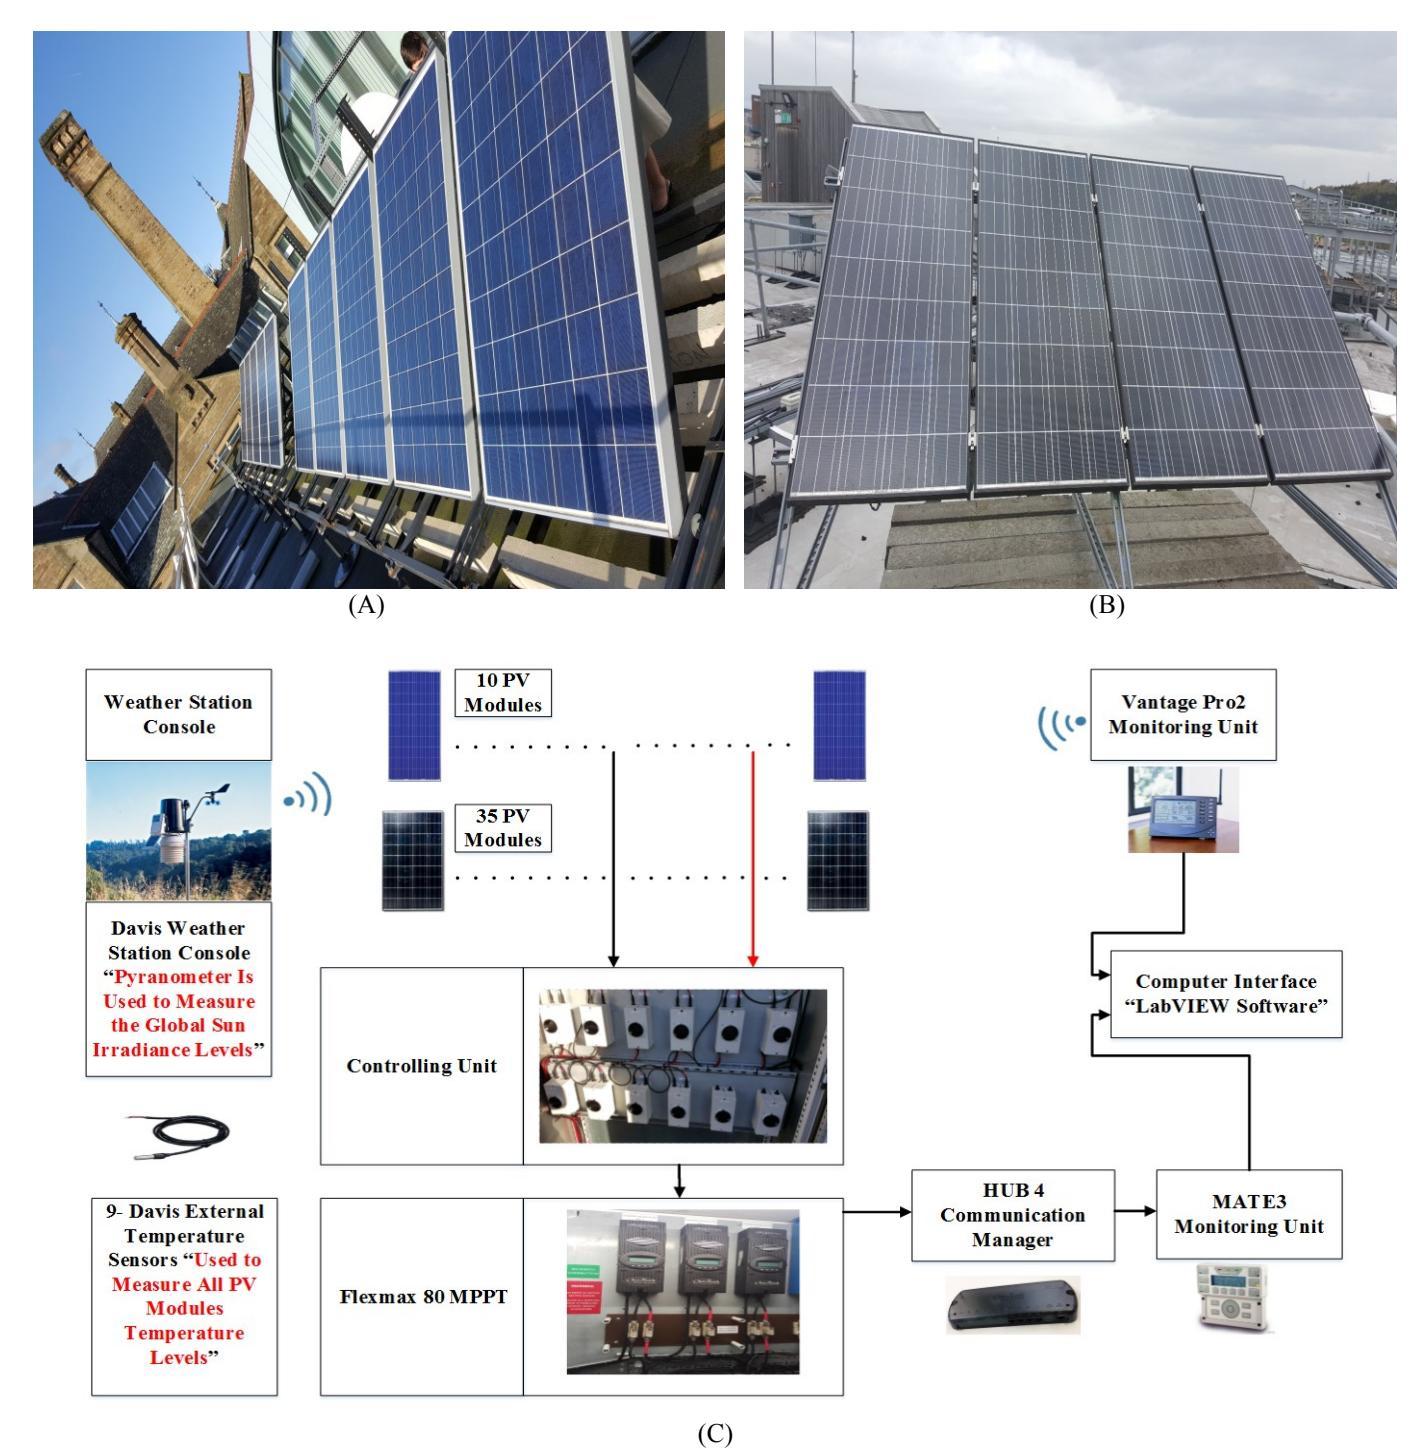
In this work, we used a statistical study of broken cells showing different crack types. Several test measurements are carried out on two different PV plants at the University of Huddersfield, United Kingdom. The first system consists of 10 polycrystalline PV modules with an optimum power 220Wp. However, the second system consists of 35 polycrystalline with 130Wp each. Both systems are shown in Fig. 1.

- As presented in Fig. 1(A) and Fig 1(B), there are two examined PV systems with total amount of PV modules equal to 45. To establish the connection for each PV module separately, a controlling unit is designed to allow the user to connect any PV module to a FLEXmax 80 MPPT. In order to facilitate a real-time monitoring for each PV module, therefore, Vantage Pro monitoring unit is used to receive the Global solar irradiance measured by Davis weather station which includes pyranometer. Hub 4 communication manager is used to facilitate acquisition of modules
- 75 temperature using Davis external temperature sensor, and the electrical data for each photovoltaic

Fig. 1(C) shows the data acquisition system. Furthermore, Table I illustrates both electrical

Fig. 1. (A) 10 PV Modules (SMT 6 (60) P) with 220W Output Peak Power; (B) 35 PV Modules (KC130 GHT-2) with 130W Output Peak Power; (C) Monitoring the Examined PV System Using LabVIEW Software

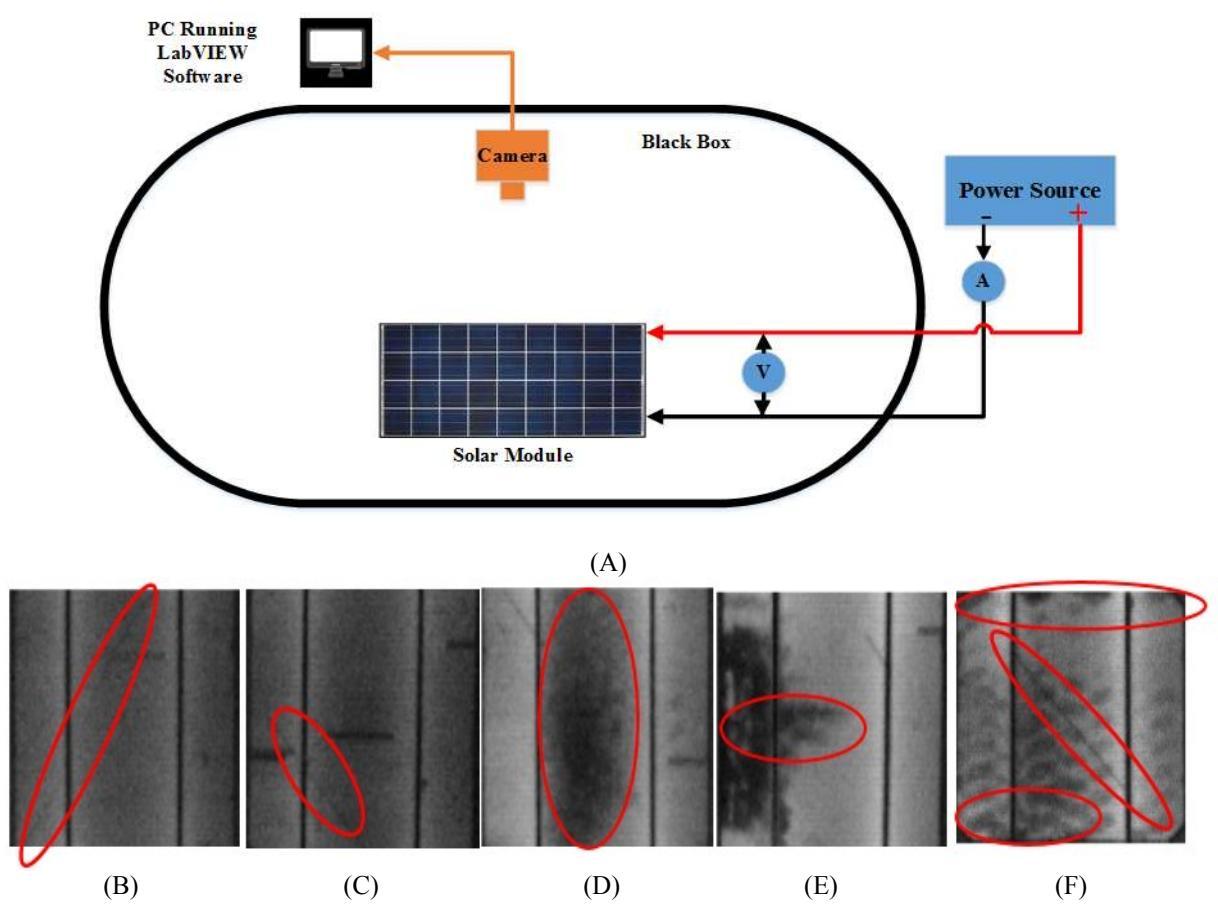
82 The electroluminescence system developed is presented in Fig. 2(A). The system is comprised of 83 a light-tight black-box where housed inside is a digital camera and a sample holder. The digital 84 camera is equipped with a standard F-mount 18-55 mm lens. To allow for detection in the near 85 infrared, the IR filter was removed and replaced with a full spectrum window of equal optical path length. In our setup a Nikon D40 was used, but in principle any digital camera with similar grade 86 CCD or CMOS sensor and where the IR filter can be removed would serve the purpose. The bias 87 88 was applied and the resultant current and the voltage are measured by a voltage and current sensors which are wirelessly connected to the personal computer (PC). The purpose of the PC is to get the 89 electroluminescence image of the solar module and predicting the theoretical output power 90 performance of the PV module. 91

In order to determine the cracks location, type and size; reflex camera has been used for imaging possible cracks in each PV module. As explained previously in the introduction, EL imaging technique is used worldwide and it has been demonstrated by many researchers [14-16]. Broken cells are sorted according to the type of crack, Fig. 2 shows all examined crack types which are classified as the following:

- 104 A. Diagonal crack $(+45^0)$
- 105 B. Diagonal crack (-45^0)
- 106 C. Parallel to busbars crack
- 107 D. Perpendicular to busbars crack
- 108 E. Multiple directions crack

Fig. 2. El Experimental Setup and Examined Crack Types. (A) Electroluminescence experimental setup; (B) Diagonal Crack (+45⁰); (C) Diagonal Crack (-45⁰); (D) Parallel to Busbars Crack; (E) Perpendicular to Busbars Crack; (F) Multiple Directions Crack

171 Diagonal cracks can be classified into two different categories: $+45^{\circ}$ and -45° as shown in Fig. 2(A)

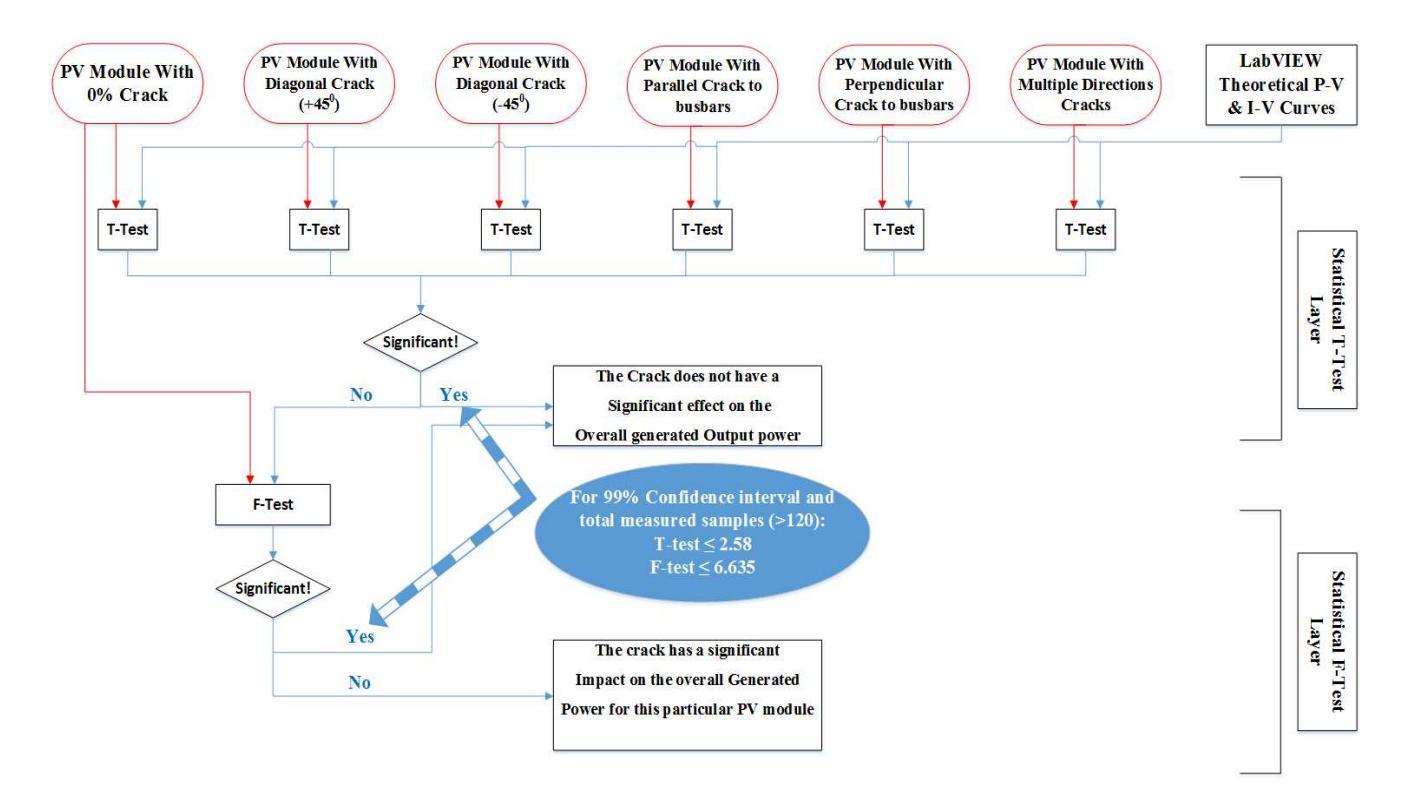
Fig. 3. Statistical Approach Used to Identify Whether the Crack Type has a Significant Impact on the Output Power Performance of a Photovoltaic Module

According to the statistical approach explained previously in Fig. 3, T-test and F-test methods are significant based on a threshold values. Therefore, we have divided all crack-types into two main

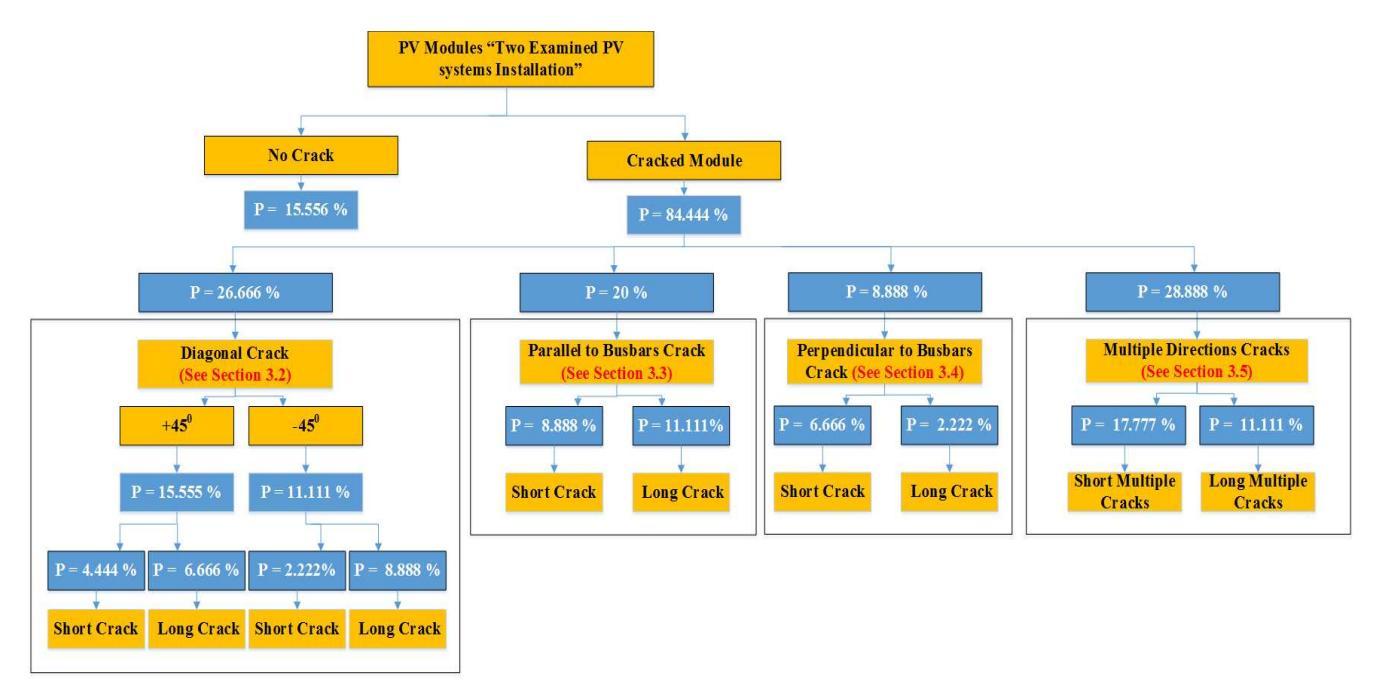
As described previously, the statistic micro cracks location, type and size was established by taking EL images of 45 PV modules. The EL images are taken with a reflex camera [23]. From the captured pictures, the number of cracked cells in each module is counted as shown in Fig. 4.

Broken cells are sorted according to the type of crack they show and the classification already presented in Fig. 2. The probability for a cell to be cracked and the crack-type distribution are presented in Fig. 4. Only 15.556% of the total PV modules have no cracks. However, 84.444% of the PV modules contains at least one type of the crack: diagonal (26.666%), parallel to busbars (20%), perpendicular to busbars (8.888%) or multiple directions crack (28.888%).

Fig. 4. Crack Types Probability Distribution among Both Examined PV Systems (45 PV Modules)

The observed modules have 38 PV modules with various crack-types. The probability of occurrence for each crack type can be seen in Fig. 4. Before considering the statistical approach, it is hypothetically true to say that 84.4% has a significant impact on the output power performance. However, the statistical approach has confirmed that this is incorrect, because only 60% has a significant impact on the output power performance for all examined PV modules.

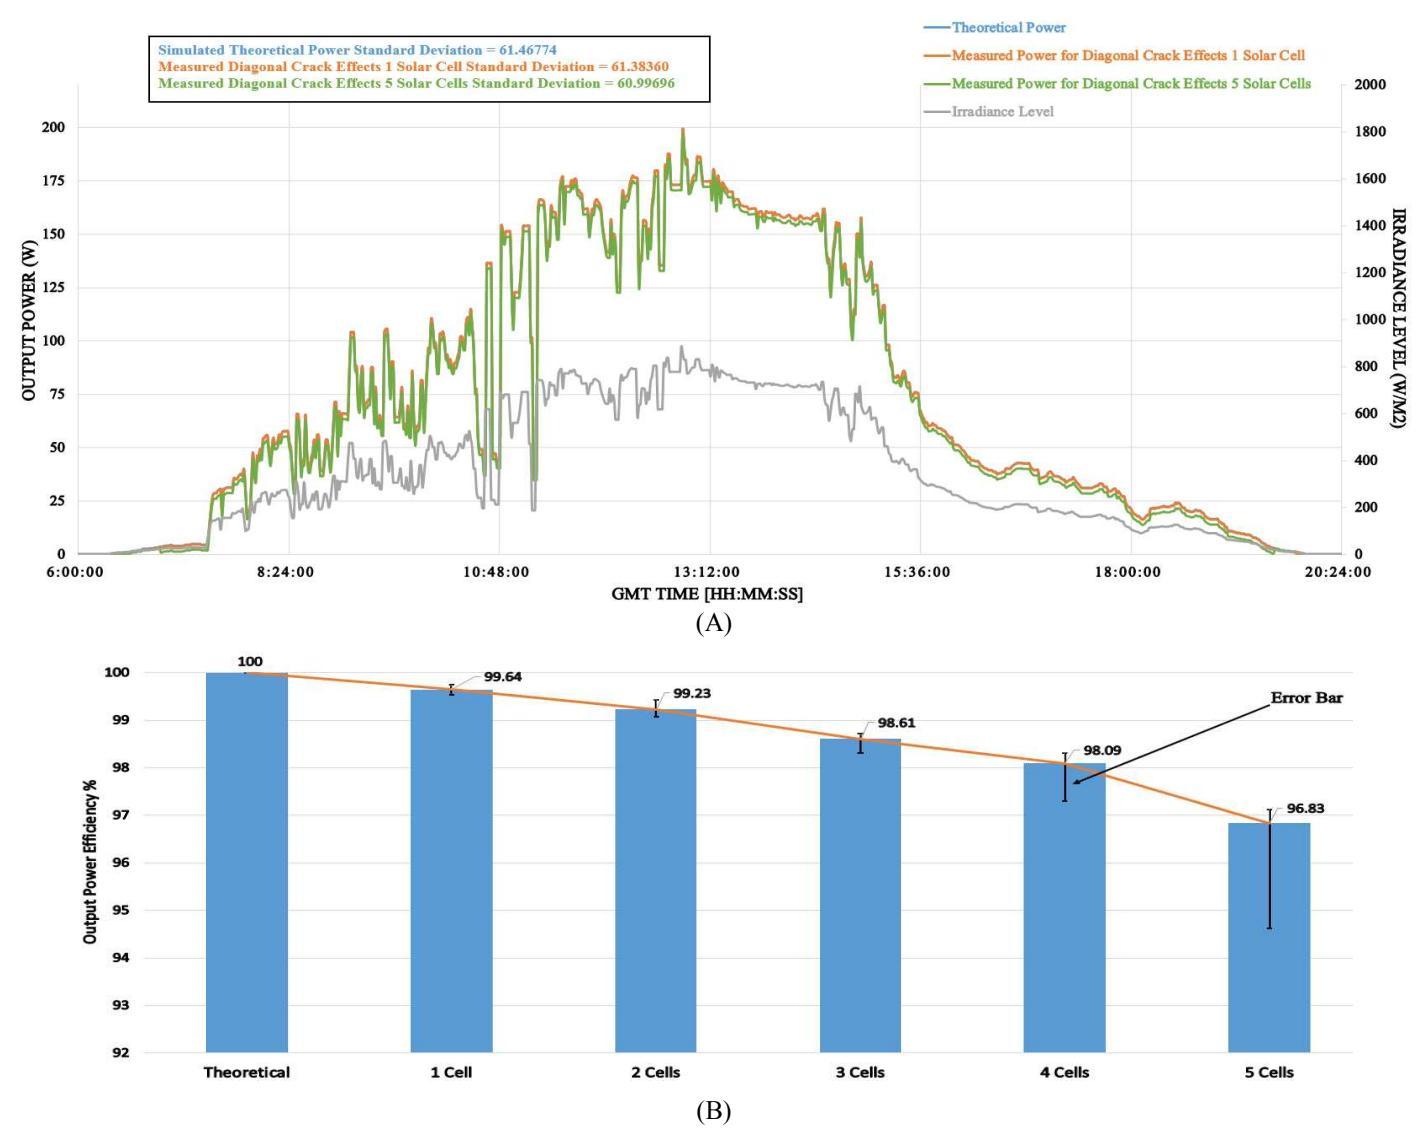
184 A real-time long-term measured data for a full day is carried out to estimate the output power performance for a diagonal crack which effects 1 and 5 solar cells are presented in Fig. 5(A). The 185 theoretical simulated output power which is calculated using LabVIEW software has a standard 186 deviation equals to 61.46 which is very close to the standard deviation for a diagonal crack which 187 effects 1 solar cell (SD=61.38). However, a diagonal crack effects 5 solar cells has a huge reduction 188 in the output power performance of the PV module where the standard deviation is equal to 60.99. 189 Finally, the measured output power of the PV module matches the theoretical output power, 190 therefore, the theoretical power in Fig. 5(A) cannot be seen, this results is also occurring in Fig. 191 6(A), Fig. 7(A) and Fig. 8(A). 192

193 Fig. 5(B) describes the output power efficiency for the examined diagonal cracks effects 1, 2, 3, 4

and 5 solar cells. Between 0.35 - 0.44% reduction of power estimated for a diagonal crack effects

195 1 solar cell. However, the estimated reduction of power for a diagonal crack effects 5 solar cells is

Fig. 5. (A) Real-Time Long-Term Measured Data for a Diagonal Crack Effects 1 and 5 Solar Cells; (B) Output Power Efficiency for a Diagonal Cracks Which Effects 1, 2, 3, 4 and 5 PV Solar Cells

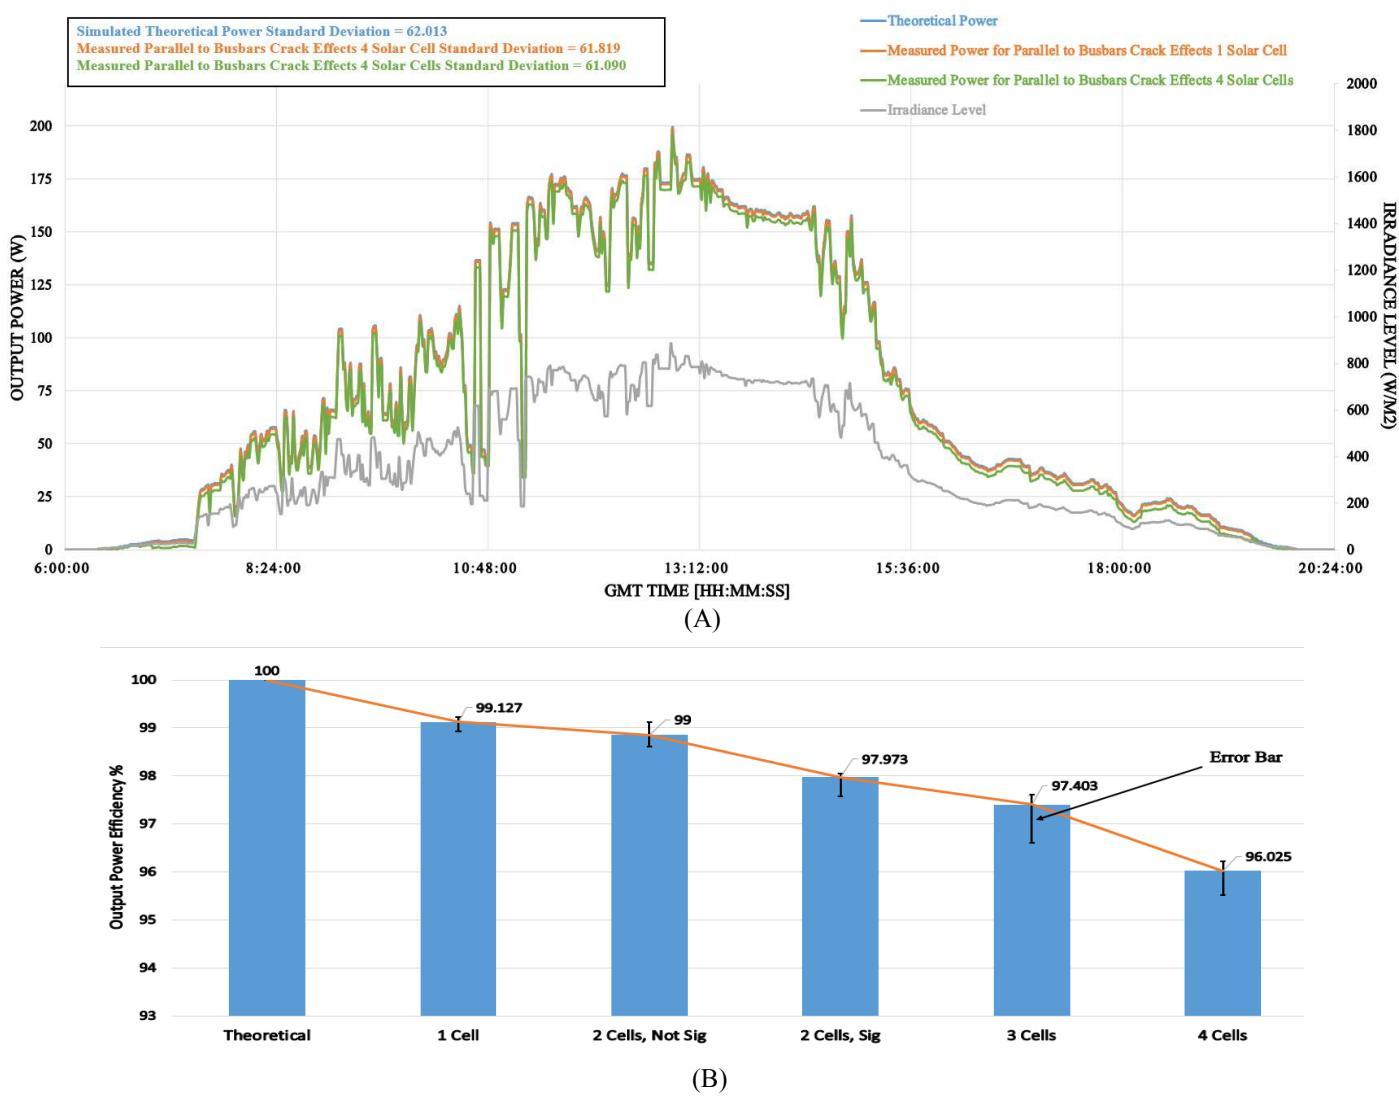
- Fig. 6(A) presents real-time measured data for a parallel to busbars crack effects 1 and 4 solar
- cells. The standard deviation for the theoretical simulated power is 62.01 which is very close to
- the standard deviation for a parallel to busbars crack effects 1 solar cell (61.8). However, parallel
- to busbars crack effects 5 solar cells has a huge reduction in the output power performance of the
- PV module while the standard deviation is equal to 61.09.
- Fig. 6(B) describes the output power efficiency for the examined parallel to busbars cracks effects
- 216 1, 2, 3 and 4 solar cells. The reduction of power estimated for a parallel to busbars crack effects 1
- solar cell is between 0.75% 0.97%. However, the estimated reduction of power for a parallel to
- busbars crack effects 3 and 4 solar cells is between 2.39% 3.0% and 3.67% 4.55% respectively.

Fig. 6. (A) Real-Time Long-Term Measured Data for a Parallel to Busbars Crack Which Effects 1 and 4 Solar Cells; (B) Output Power Efficiency for Parallel to Busbars Crack Which Effects 1, 2, 3 and 4 PV Solar Cells

259 Similarly, Fig 10(B) describes the surface shape of a parallel to busbars crack which effects 3 solar 260 cells. The degradation of the power in the affected solar cells is between 2.5 and 2 Watt. The overall power efficiency of the PV module is equal to 97.41% which is very similar to the value
(97.4%) described earlier in Fig. 6(B).

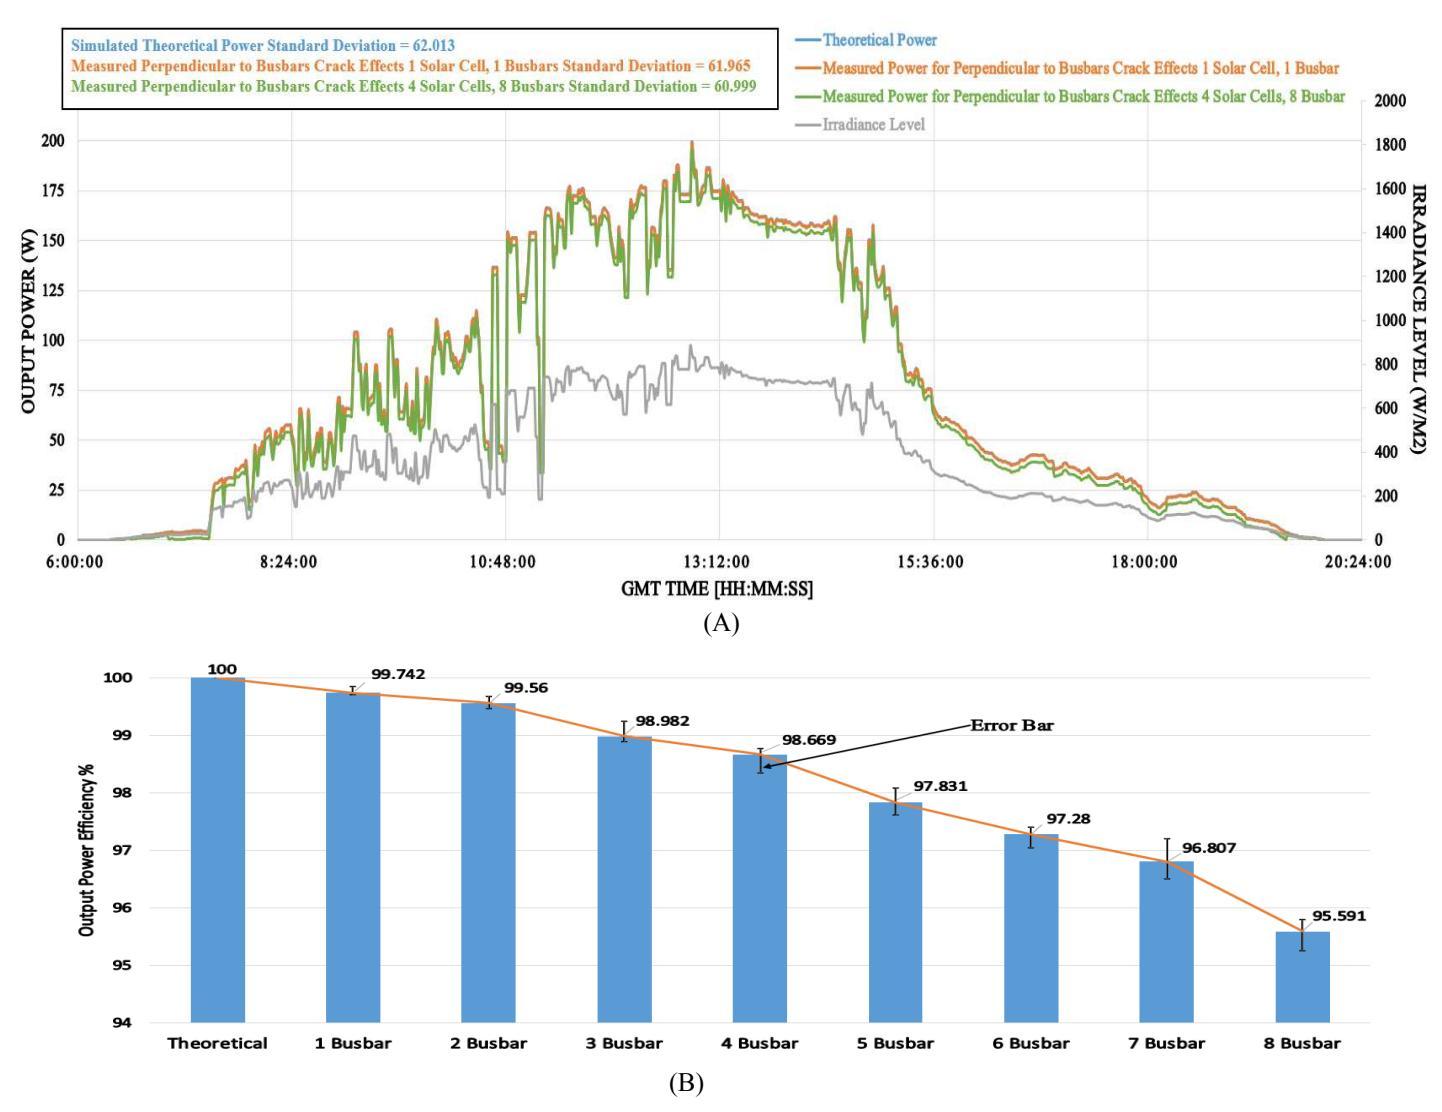
results for a perpendicular to busbars cracks effects 1 and 4 solar cells can be seen in Fig. 7 (A),

the difference between the theoretical standard deviation and a perpendicular to busbars cracks

Fig. 7. (A) Real-Time Long-Term Measured Data for a Perpendicular to Busbars Crack Effects 1 and 4 Solar Cells; (B) Output Power Efficiency for a Perpendicular to Busbars Crack Which Effects 1, 2, 3 and 4 (1-8 busbars) PV Solar Cells

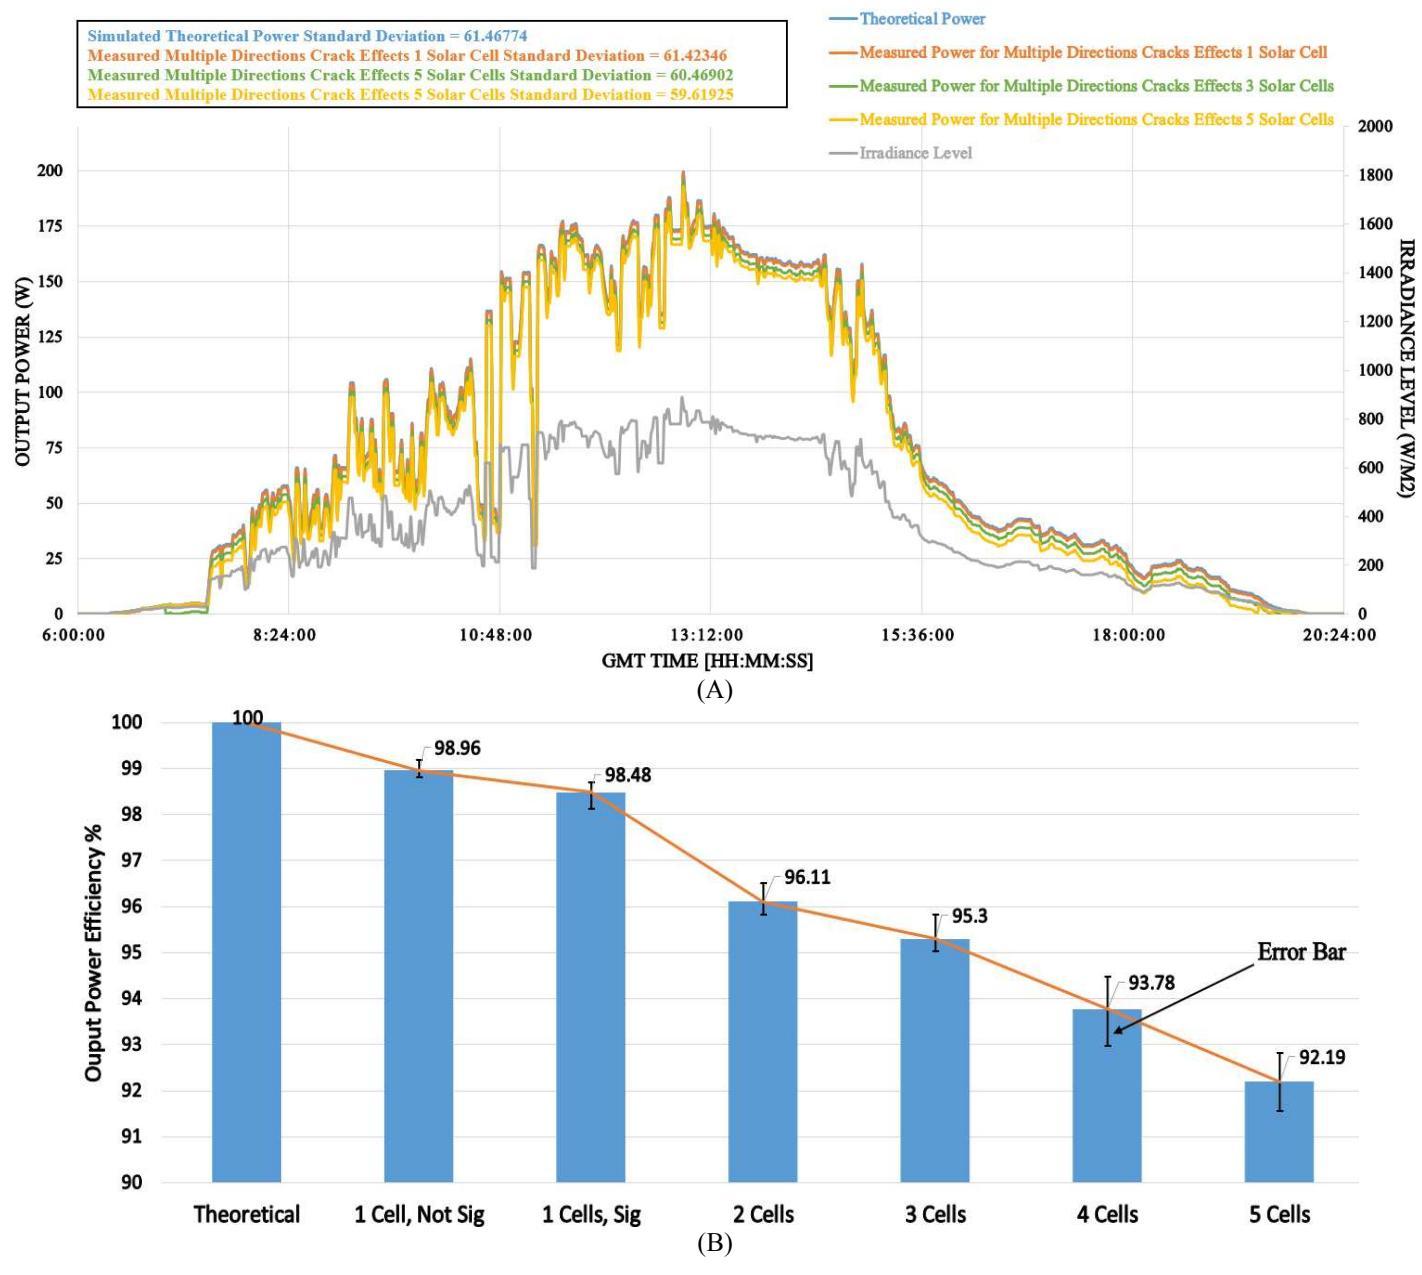
Multiple directions cracks have the highest degradation in the PV measured output power. Three different measured data are presented in Fig. 8(A). As illustrated in Fig. 8(B), multiple directions crack effects 5 solar cells reduce the power efficiency of the PV module up to 8.42%. However, the average reduction in the power for a multiple directions crack effects 1 solar cell with an approximate broken area less than 46.2 mm² is equal to 1.04%.

Fig. 8. (A) Real-Time Long-Term Measured Data for a Multiple Directions Crack Effects on 1, 3 and 5 Solar Cells; (B) Output Power Efficiency for a Multiple Directions Crack Which Effects 1,2,3,4 and 5 PV Solar Cells

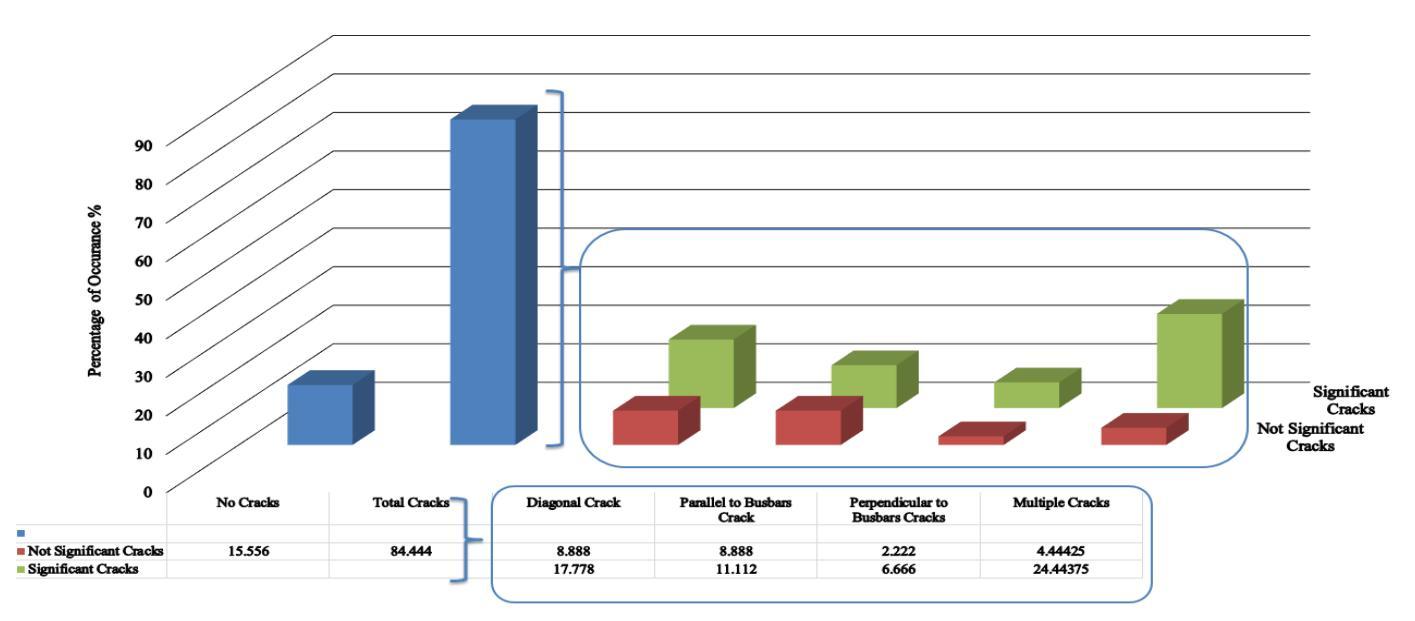
Fig. 19. Percentage of Cracks in the Examined PV modules, overall significant Cracks equals to 60% out of 84.444%

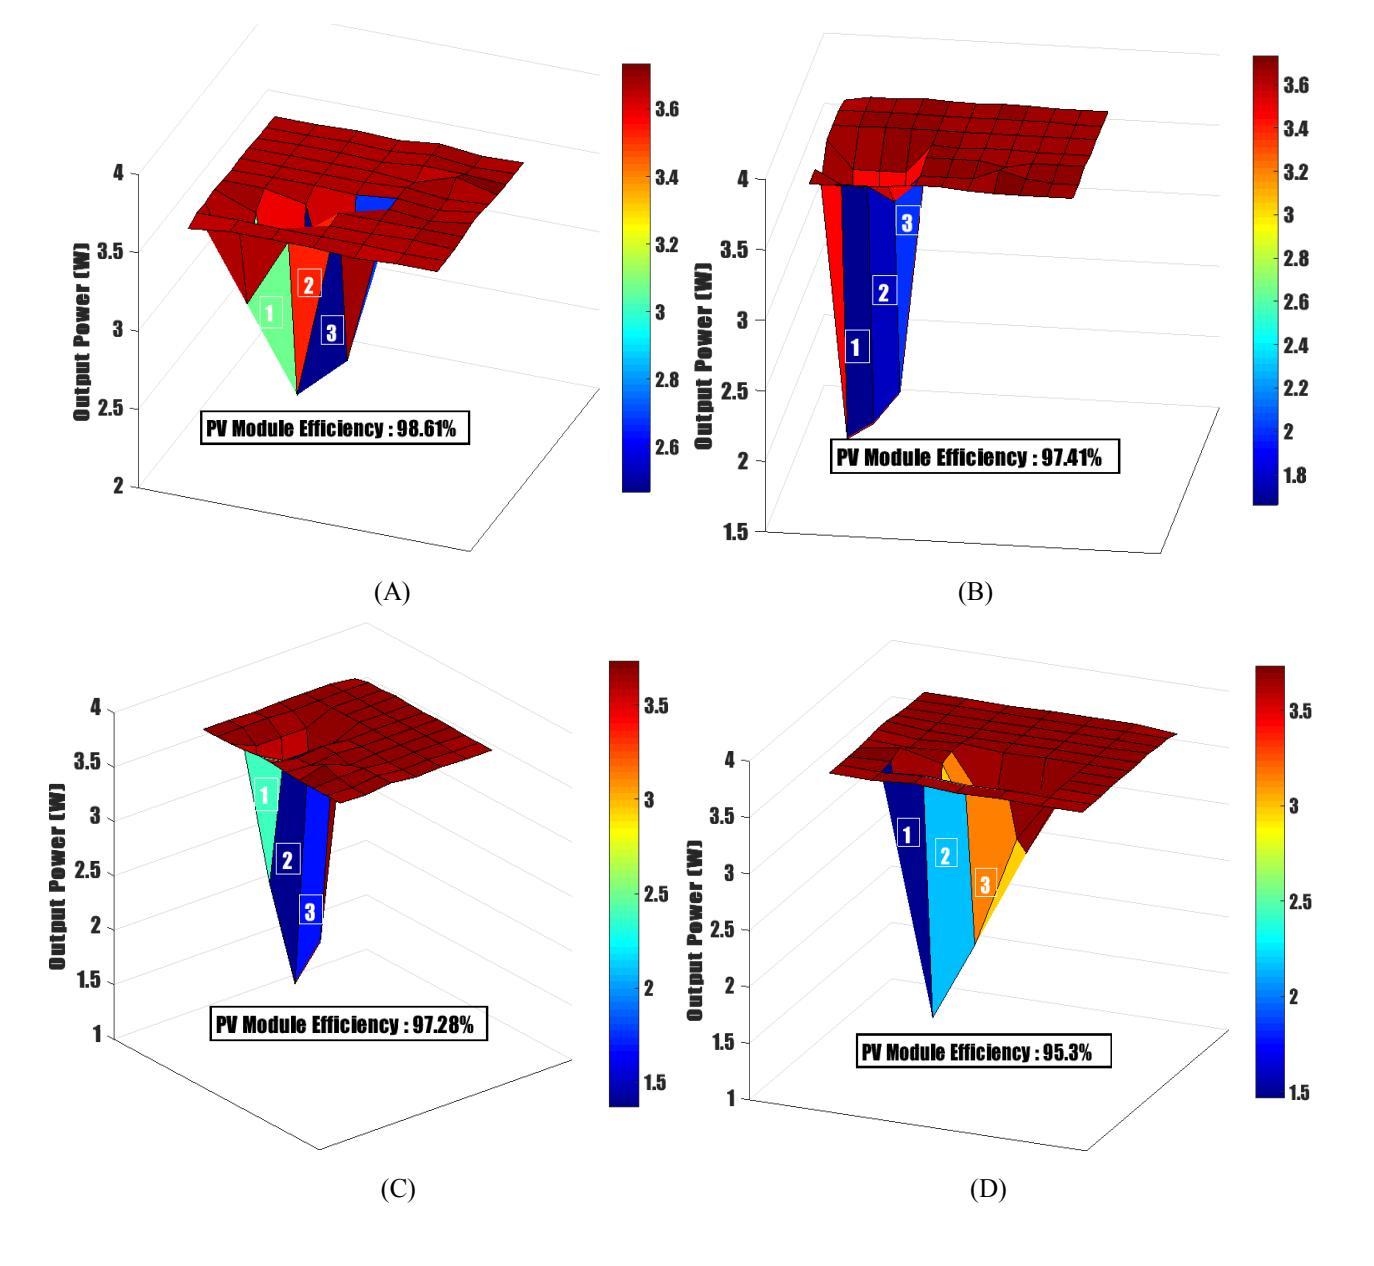
For better understanding how some cracks effects the surface of the PV modules, we have created a MATLAB code which can simulate the measured data of a cracked PV module in order to evaluate the surface shape for a particular crack-type using Surf(x, y, z) MATLAB function [24].

Fig. 10(A) shows a diagonal crack $(+45^0)$ effects 3 solar cells. It is clear that the surface of three different solar cells are damaged (Noted as 1, 2 and 3). The degradation of the power for the solar

263 The surface shape for a perpendicular to busbars crack effects 3 solar cells, 6 Busbars is illustrated

in Fig. 10(C). However, Fig. 10(D) shows a cracked surface for a PV module that is affected by a

265 multiple directions crack on 3 different solar cells. Moreover, a perpendicular crack effects a solar

cell with 2 busbars has an estimated degradation of power equals to 1.5 Watt. Overall efficiency

- of the cracked surfaces is equal to 97.28% for a perpendicular to busbars crack which effects 3
- solar cells (6 busbars), and 95.3% for a multiple directions crack which effects 3 solar cells.

Fig. 10. (A) Surface Shape for a Diagonal (+45⁰) Crack Effects 3 Solar Cells; (B) Surface Shape for a Parallel to Busbars Crack Effects 3 Solar Cells (C) Surface Shape for a Perpendicular to Busbars Crack Effects 3 Solar Cells, 6 Busbars; (D) Surface Shape for a Multiple Directions Crack Effects 3 Solar Cells
