Power loss and hotspot analysis for photovoltaic modules affected by potential induced degradation

Mahmoud Dhimish ^{[b] ⊠} and Andy M. Tyrrell¹

npj Materials Degradation (2022)6:11; https://doi.org/10.1038/s41529-022-00221-9

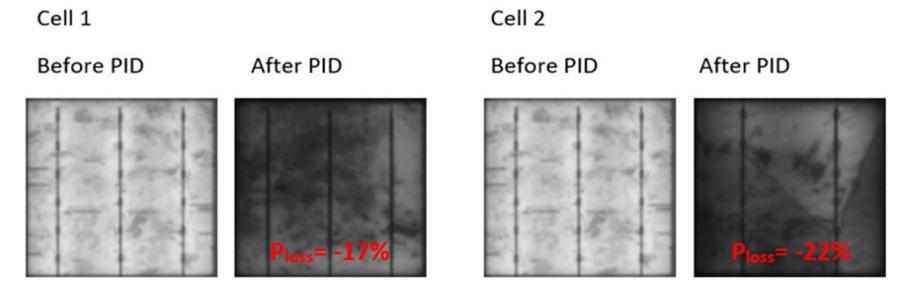
Fig. 1 EL images were taken before and after the PID test. The EL images are captured using Brightspot EL imaging setup, and the power loss (P_{loss}) was estimated under the standard test conditions.

To identify the consequence of PID on PV modules, electroluminescence (EL) imaging is usually performed^{19–21}. For example, in Fig. 1, the EL image is shown for two different solar cells before and after the PID experiment was performed. The darker exhibition of the cells under EL testing corresponds to less efficiency, with an estimated power loss of -17% and -22%, respectively. However, other researchers^{22,23} have suggested using photoluminescence (PL) imaging to consider the effects of PID on cells. PL imaging is more practical for inspecting large-scale PV modules. PL imaging cannot identify inactive areas in the cells, and the interconnection failure, whereas an EL imaging setup can identify both failure modes²⁴.

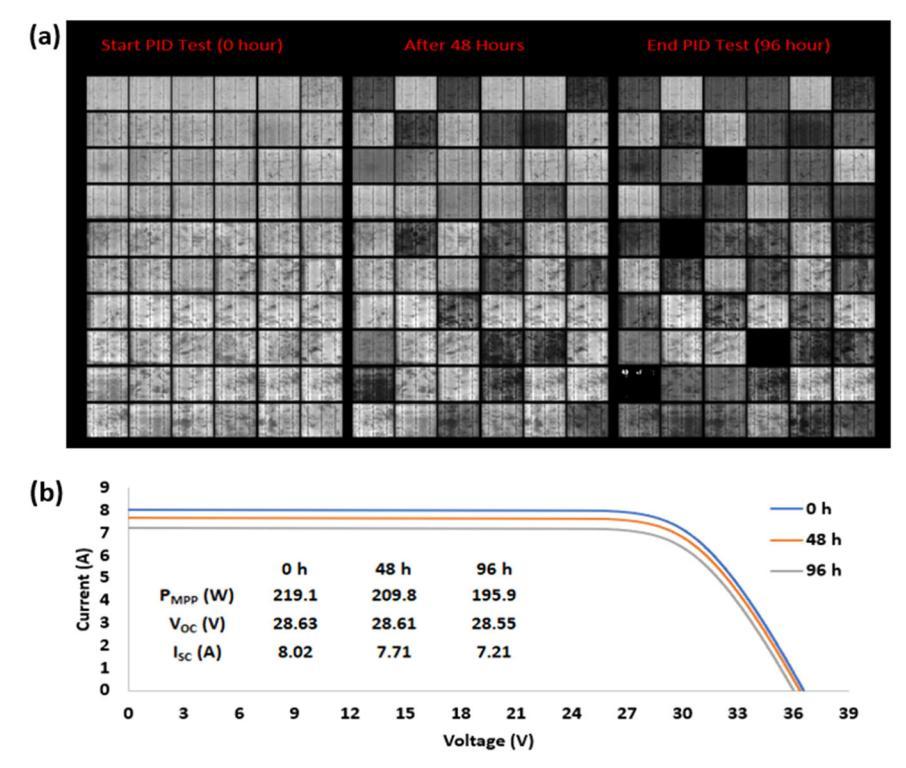
Fig. 2 Results of the PID test. a EL image of a PV module before and after the PID test is performed at 0, 48, and 96 h. b Measured I–V curves under the standard test conditions.

The PID tests were performed on the 28 tested PV modules. For example, Fig. 2a, shows the EL images of one of the examined PV modules at 0, 48, and 96 h. It is clear that the PID test develops a complete degradation mode for several cells, leading to a drop in the output power. Figure 2b shows the module's measured *I–V* curves; as time progresses, as can be seen from these graphs there is a significant drop in the output power. Using Eq. (1), the output power loss is equal to -10.58% after completing the PID testing. Consequently, there is a notable drop in the *I_{SC}* however, there is only a slight change in the *V_{QC}*.

The V_{OC} slightly decreases as the module temperature increases. Accordingly, there is an expected increase in the module temperature after performing the PID testing. However, this increase is insufficient to drop the V_{OC} drastically. In comparison, a more significant drop in the I_{SC} is distinguished because the short-circuit drops when several factors change, such as a decrease in the solar cell area (i.e., cracks development in the cell) and a reduction of the number of photons observed by the cells.

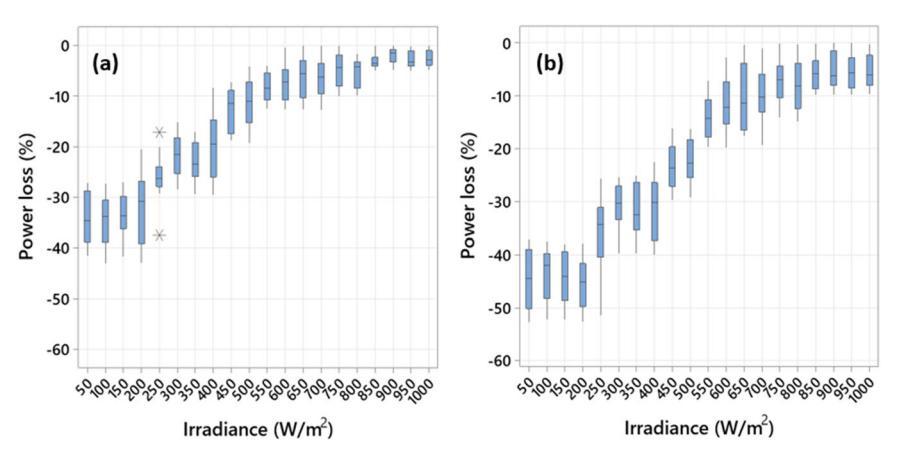
Fig. 3 Calculated power losses versus irradiance. a PID test at 48 h, b PID test at 96 h. The irradiance step change is 50 W/m² taken for the 24 tested PV modules, and the temperature is maintained at 25 °C. The error bars represent the average collected data of the 28 tested PV modules.

For all tested PV modules, the correlation between the measured power losses vs irradiance during the PID test at 48 and 96 h were measured (Fig. 3), the values at 0 h have not been considered as the power losses are minimal. The power losses at 50–200 W/m² is 2–4 times higher than at 1000 W/m². This effect is due to shunting, which increases while irradiance levels are decreasing. This result concurs with the scientific community, where the PID is closely associated with reducing shunt resistance^{29,30}. A marginal plot is a scatterplot that compares two different experiments using the data samples histogram. Accordingly, a marginal plot has been obtained and demonstrated in Fig. 4 using the measurements of the PID experiment at the initial state (0 h) and by the end of the experiment (96 h). The x-axis and y-axis represent the power losses of the examined PV module at 0 and 96 h, respectively.

The results confirm a significant power loss in the examined PV module after being subjected to the PID test for 96 h. For example, if a PV module has -8% power losses at the initial state of the PID test, the power losses would likely be in the range of $-30\% \sim -50\%$ after 96 h.

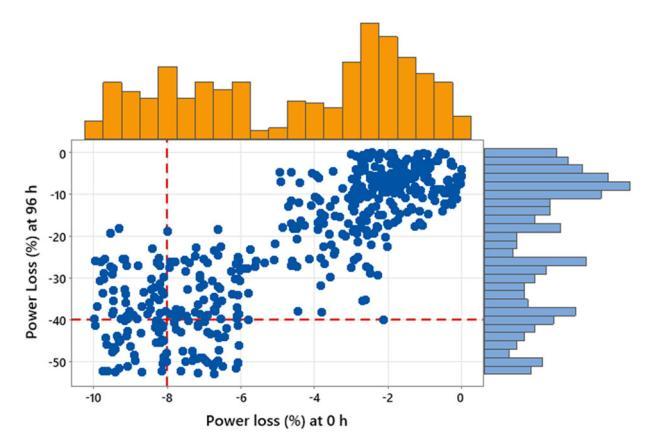
Fig. 4 Marginal plot of the samples taken during the PID test at 0 h and after 96 h. The histogram corresponds to the actual distribution of the data taken during both experiments, PID at 0 h and 96 h.

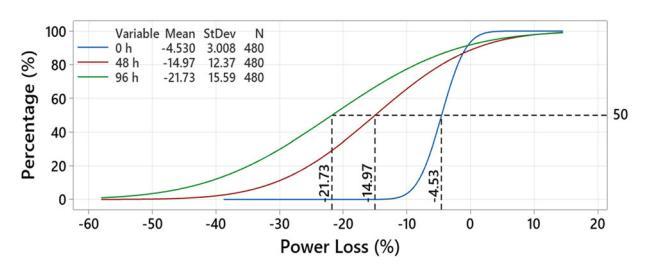
Fig. 5 Cumulative distribution function of all measured samples. The horizontal dashed line at 50% corresponds to the mid-range of the percentile.

This study has considered the cumulative density function (CDF) of all measured samples, as shown in Fig. 5. This plot gives an indication of the PID impact over time. The y-axis represents the percentage of the PV module performing a specific power loss. For example, after 48 and 96 h of PID testing, there is a 50% chance that the power loss of the PV module is -14.97% and -21.73%,

respectively. On the other hand, there is only -4.53% power loss before the PV module is affected by PID (at 0 h). It is worth noting here that 50% has been applied as it corresponds to the midrange of the percentile, which provides a more accurate prediction of the power losses.

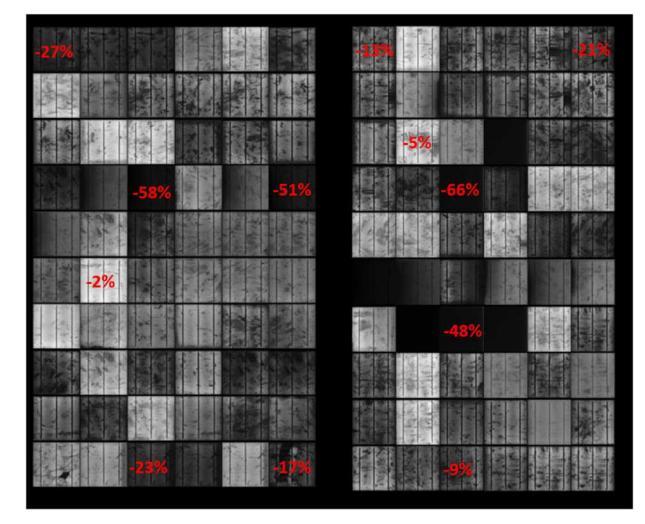
Fig. 6 EL images after PID are completed for two different PV modules. The power loss labelled in red was estimated under the standard test conditions.

The correlation between the EL images and the actual power losses of the solar cells is shown in Fig. 6. Both PV modules EL images were taken after the PID was completed, at 96 h. This feature is already available using the EL software. It uses the difference in the light/spectrum of non-PID versus the PID images; hence, the power losses can be estimated. The "blackout" EL images does not necessarily resemble -100% losses in the output power. This is because they have no illumination under the EL test; however, they still generate current. In contrast, it is relevant to reflect that few solar cells are unaffected after completing the PID test, and their output power losses remain below -5%. This suggests that these cells were influenced by lower shading rates, heat, humidity, or any form of cracks during their working life.

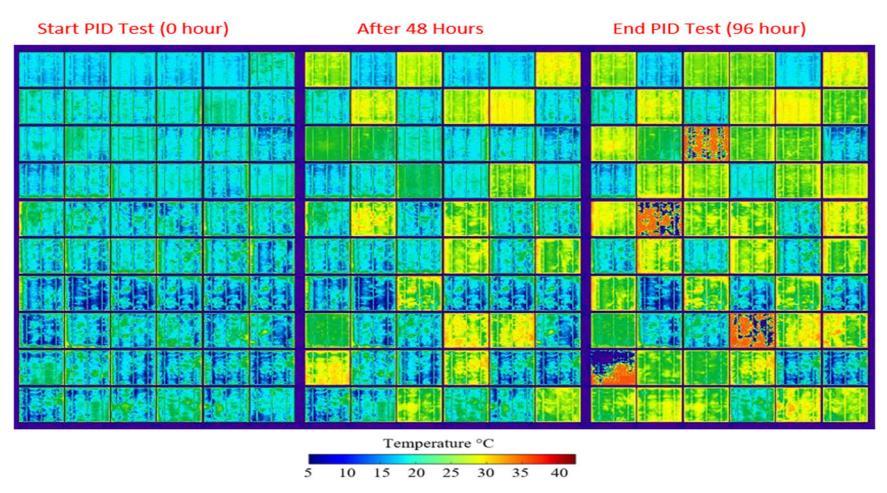
Fig. 7 Thermal images for one of the examined PV modules taken under standard test conditions. The EL image of this PV module is shown in Fig. 2.

The correlation between the PID and the increase in the temperature of the solar cell has also been investigated. Figure 7 shows that at the start of the PID test, 0 h, the surface temperature of the PV module is approximately 22 °C. After 48 h of PID testing, the PV modules develop nearly 20 hotspots with an increased temperature varying from 25 to 30 °C. At 96 h, the PID experiment has impacted the PV module with 30 hotspots, with four being affected by a significant increase in the temperature, 45 °C. The development of these hotspots will now affect the reliability and durability of the PV modules, making them less efficient and more difficult to operate than before the PID test.

Observing the evolution of the hotspots and considering the average surface temperature in the PV module, it can be observed that an increase in the PV module temperature after the PID test is likely to follow. It is also expected that multiple hotspots are being created in the module. The resultant hotspots in the module will impact the yield power, therefore, and as illustrated in Fig. 3, the power loss of the modules affected after the PID is completed can vary depending on the solar illumination, but, on average, there is -25% drop in the output power.

According to Fig. 7, some solar cells are affected by a significant increase in their temperature, up to 40 °C. This is because these cells are generating a much lower current compared with adjacent cells. Usually, this phenomenon occurs when the cells are being affected by cracks.

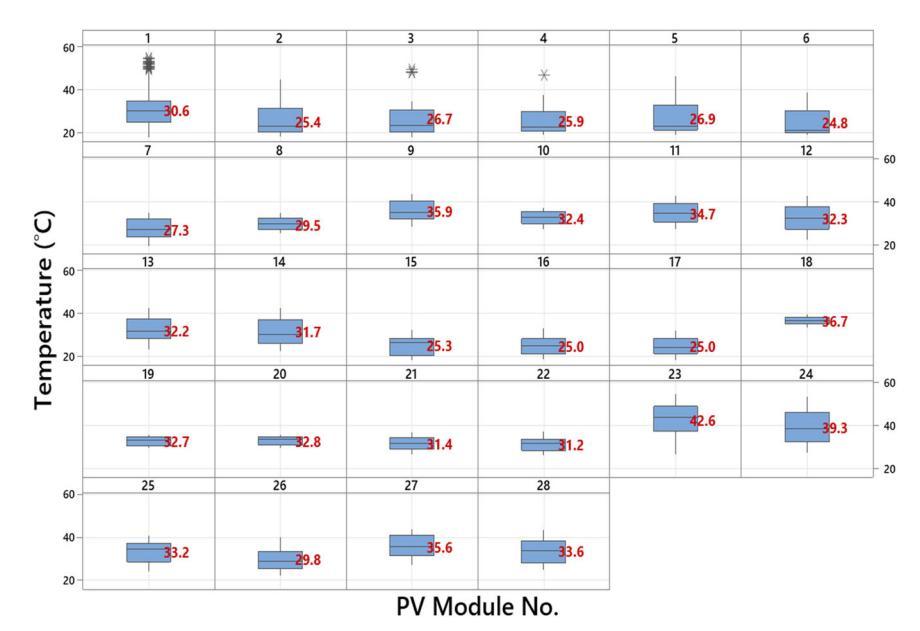
Fig. 8 Extracted PV modules temperature after PID test was performed. The error bars represent the collected data of the 28 tested PV modules after completing a single PID test (96 h).

Using FLIR software, the temperature data from all the PV modules after completing a single PID test (96 h) can be extracted; the temperature profile are presented in Fig. 8. The mean value of the PV modules temperature varies between 25 to 42 °C. Therefore, following the IEC61215 standard, if the average PV temperature is above 30 °C, it is assumed that the PV module fails the reliability test. In contrast, and according to the results

illustrated in Fig. 8, it can be recognized that 17 out of the 28 examined PV modules fail the reliability test. Therefore, these modules are likely to have severe degradation when exposed to environmental/outdoor conditions.

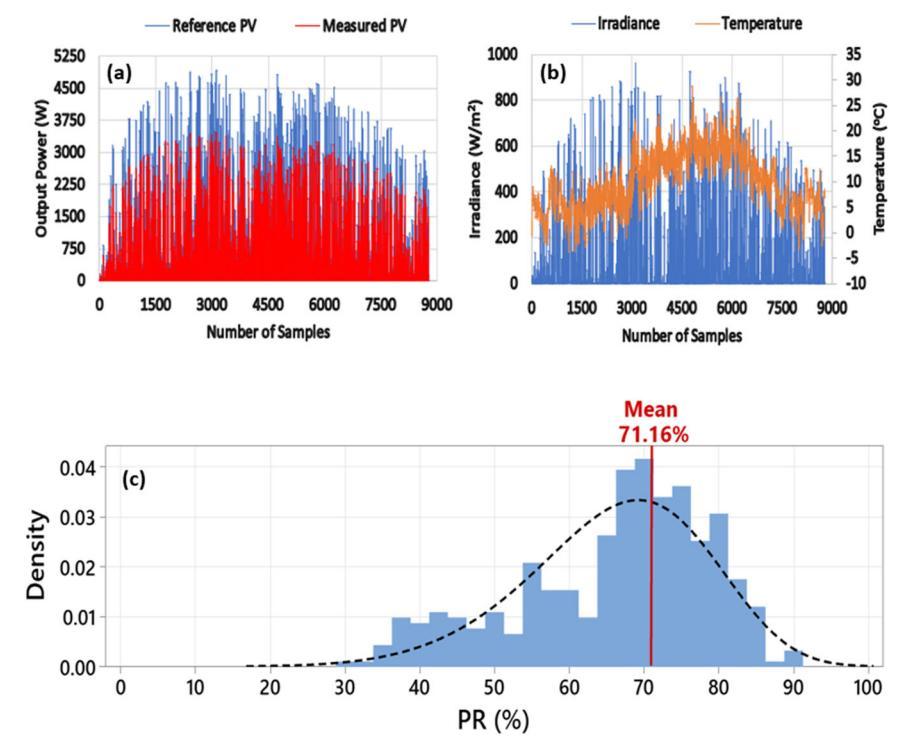
Fig. 10 Output measurements of the PV modules while operating in the field. a Measured PV output power (after PID test is completed) versus reference PV cell output power. b Solar irradiance and PV cell temperature. c PR ratio analysis.

The output measured power versus the reference PV cell power is shown in Fig. 10a. In addition, Fig. 10b, presents the actual irradiance and temperature of the PV system. The data has been collected over 12-months. The PR is then calculated using Eq. (2), and as shown in Fig. 10c, the mean PR ratio is found at 71.16%.

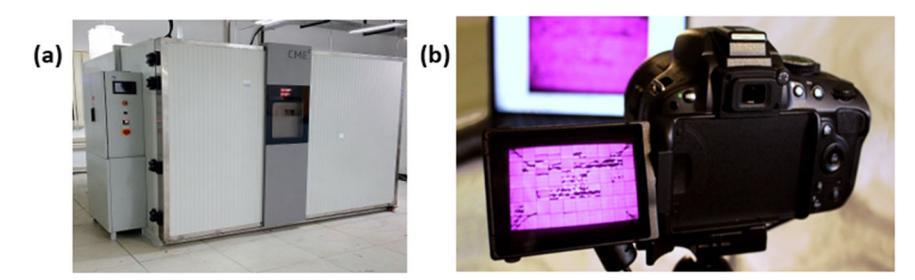
Fig. 11 PV testing equipment. a Damp heat test chamber. b EL imaging camera.

The modules were placed in a damp heat test chamber (Fig. 11a) at 85% relative humidity and 85 °C and biased with a voltage of -1000 V. For the accelerated PID test, aluminium foil was placed on the front surface of the samples and kept in place with a glass plate. The positive and negative module contacts were shorted and connected to the negative terminal of a high-voltage power source. The AI foil was connected to the positive terminal. Following the IEC62804 standard, the EL images and current-voltage (*I–V*) curves were measured at 0, 48, 96 h. The relative power loss due to PID is then calculated using Eq. (1).

The PVA-1500V3 PV analyzer kit was used to obtain the measurements for the *I*–*V* curves. This instrument can measure voltage up to 1500 V, and its *I*–*V* curve measurement precision is approximately $\pm 2\%$. The Brightspot automation EL imaging setup (Fig. 11b) was used to capture the EL images of the PV modules. The EL imaging setup was not corrected over time to avoid altering the resolution of the EL captured images, even when the EL signal of several degraded modules dropped significantly.

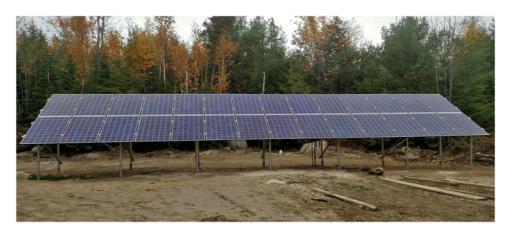
Fig. 12 Examined PV modules placed outdoor after the PID test is completed. The PV system consists of 28 modules distributed among two strings, each string comprising 14 modules.

After the PID tests were performed, the PV modules were placed outdoors to monitor their performance. The PV modules were randomly selected and combined in two strings, each string comprising 12 series-connected modules. On the monitoring side, an inverter (SMA Sunny Tripower 15000TL-30) was used to connect the PV installation to the power grid and act as data acquisition for the system. To estimate the PR ratio using Eq. (2), the reference solar cell to evaluate the P_{STC} is required, and Davis weather station to measure G_{pog} and T_{ref} .

After the PID test was completed, the examined PV modules were placed outdoor (Fig. 12) to analyse their performance ratio and whether any module would develop hotspots. The performance ratio was calculated over 12-months using Eq. (2), and for the thermal imaging inspection, a FLIR E54 thermal camera with thermal sensitivity of ± 0.1 °C was utilised.
