Li, H, Yang, D, Zhong, Z et al. (2 more authors) (2018) Experimental investigation on the micro damage evolution of chemical corroded limestone subjected to cyclic loads. *International Journal of Fatigue*, 113. pp. 23-32. ISSN 0142-1123

Experimental investigation on the micro damage evolution of chemical corroded limestone subjected to cyclic loads

Abstract

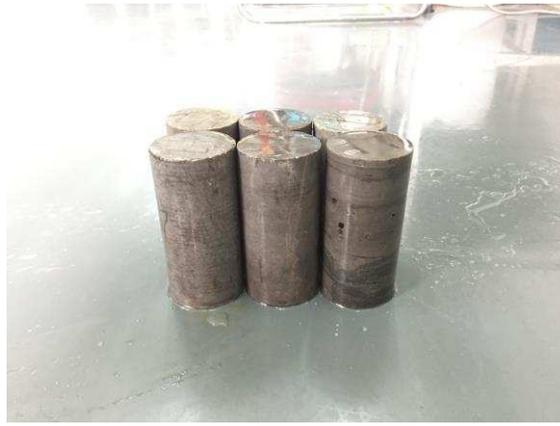
Figure.1. Limestone samples

The rock samples are limestone, taken from Jinyun Mountain Tunnel in Chongqing China. The Jinyun Mountain Tunnel has two tunnels, each with a length of 7.379 km and have a maximum depth of 220 m. Limestone, a common sedimentary rock in southwest China and is the main rock of Jinyun Mountain, is selected as the test samples in this experiment. All the samples are drilled from a single block without macroscopic cracks and machined and finely ground into cylindrical shapes with a length of 100 mm and a diameter of 50 mm, as shown in Figure 1. According to the X-ray diffraction (XRD) analysis it is found that the limestone samples are composed of 92% calcspar and quartz and 1% accessory minerals. A typical microstructure of the limestone is shown in Figure 2.

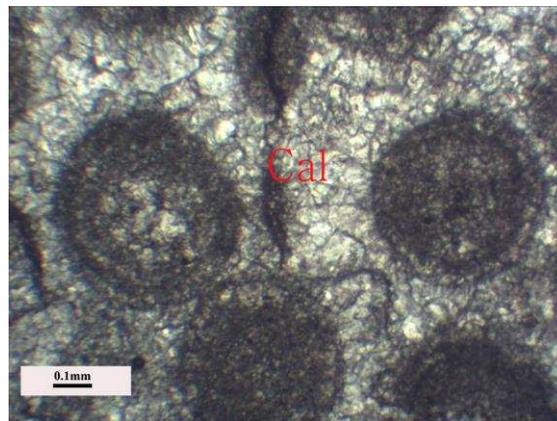
Figure.2. Microscope image of a limestone sample: Cal, calcspar.

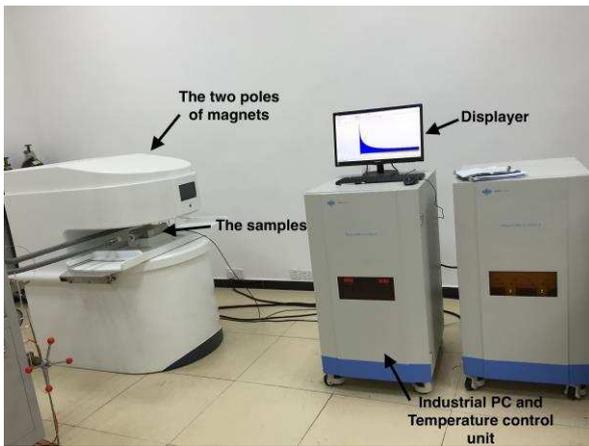
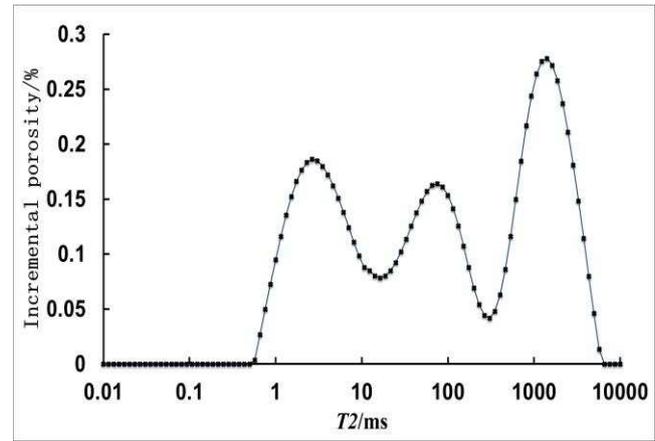
Figure.3. The NMR system and an example of its T_2 spectrum.

Figure.3 shows the NMR system, and a T_2 spectrum. The NMR system measures the signal intensity of hydrogen atoms, which depends on the number and size of pores inside the rock, in the fully-saturated rock and outputs transverse relaxation time distribution (T_2 spectrum), porosity and Magnetic Resonance Imaging (MRI), which can be used to investigate the pore size distribution and micro structure damage of the rock.

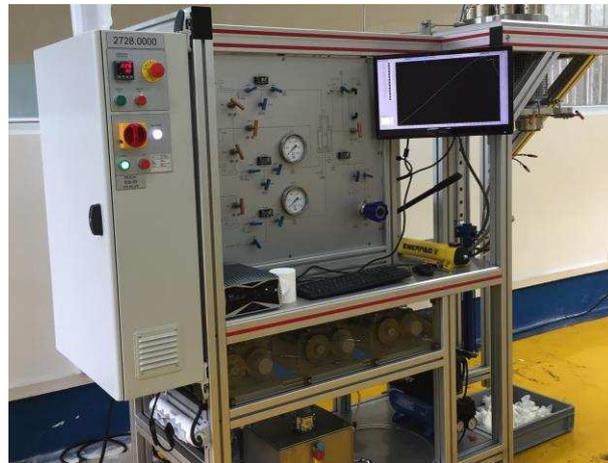
Figure.4. The Rock Testing System

All the mechanical tests are conducted using the Rock Testing System, as shown in Figure 4.

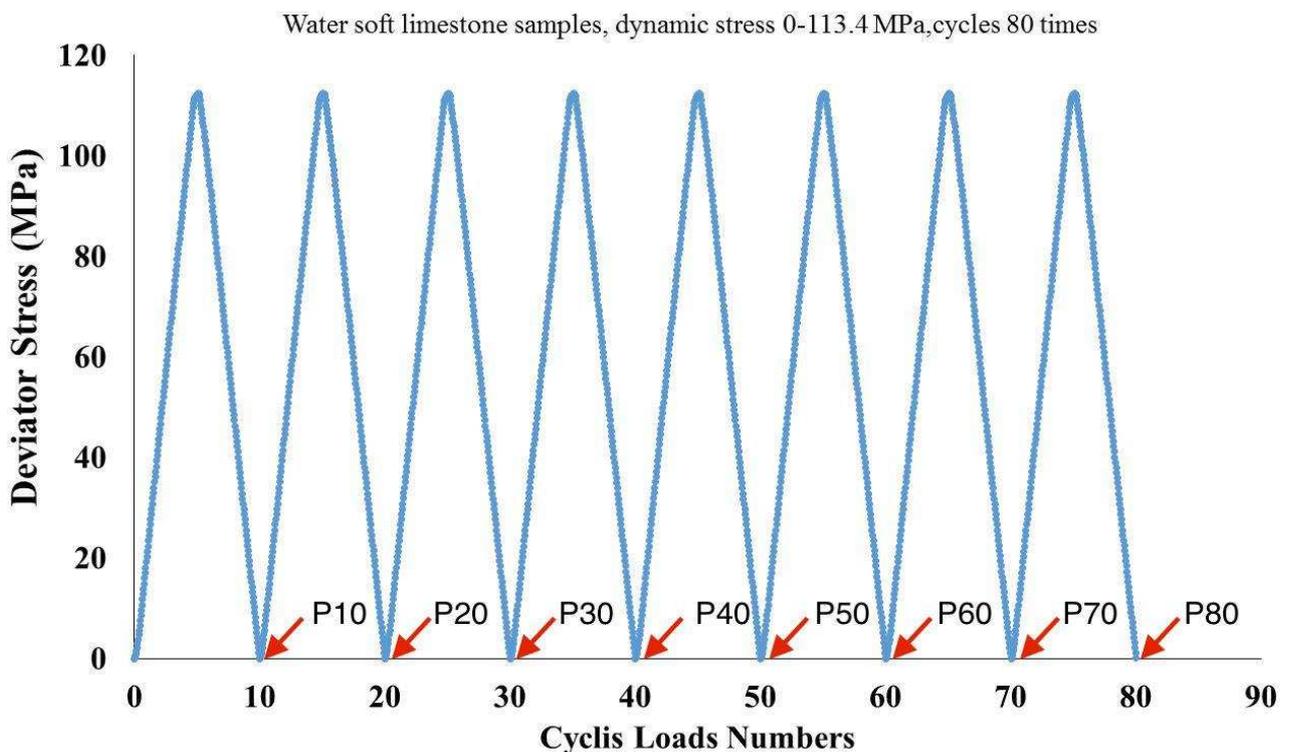
Fig .5. The load-time curves during the cyclic loading for the limestone samples

(4) Cyclic loading tests are conducted at the same loading levels but with different cycle numbers. Each cycle of uniaxial cyclic loading processes is as follows: the rock sample is loaded to 85% of its UCS with loading rate of 0.01 mm/min. When the maximum load is reached, the stress of each sample is then unloaded to zero with the same rates. Each test consists of 8 cyclic loading stages, with 10 loading cycles, 20 loading cycles, 30 loading cycles, 40 loading cycles, 50 loading cycles, 60 loading cycles, 70 loading cycles, 80 loading cycles, respectively. These 8 stages are conducted on the corresponding 8 samples in a group. Take Group A as an example: sample A-1 is suffered from 10 times cyclic loads, sample A-2 is suffered from 20 times cyclic loads.... sample A-8 is suffered from 80 times cyclic loads. The load-time curves during the cyclic loading for the water soft limestone samples is shown in Fig 5 as an example.

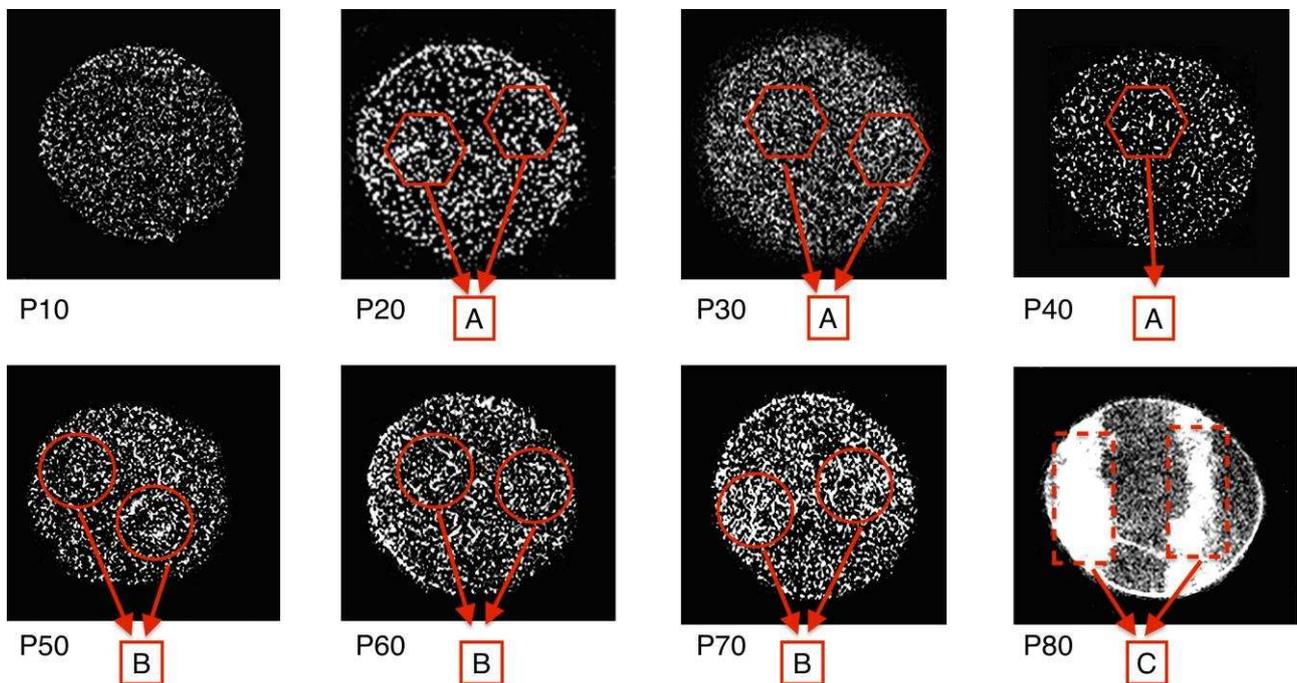
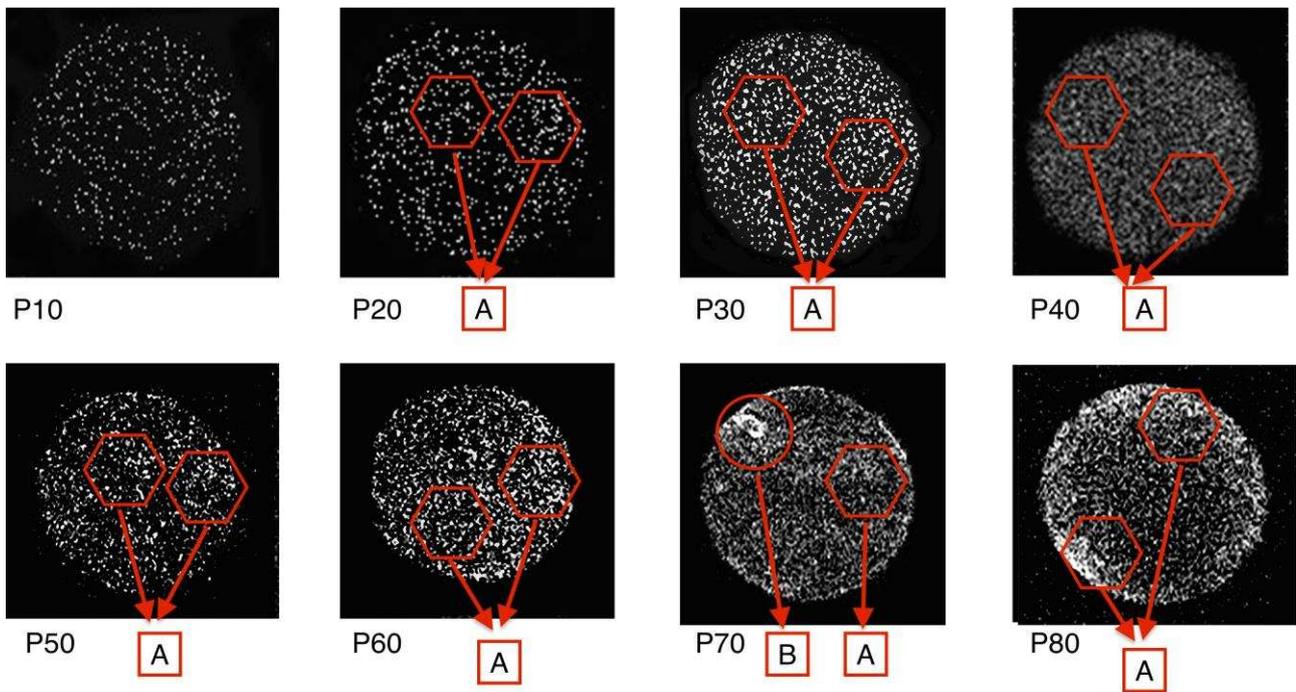
(a) Limestone samples immersed in pH3 solution

(b) Limestone samples immersed in distilled water

Fig .6. The NMR inner section images of the samples after cyclic loading. (‘A’ indicates smaller pores, ‘B’ indicates connection of pores into cracks and ‘C’ indicates the macro rupture.)

The bright areas in the images correspond to pores inside the limestone samples. An increase of the brightness and the number of white points indicates an increase of the porosity. It can be seen from Fig.6 that image brightness of the limestone samples increase as the increase of number of load cycles. While, the image of the water softened sample suffered 40 times of cyclic loads is blur and darker than other images in this group, this is due to the heterogeneous distribution of the porosity inside the rock. A quite significant increase of porosity occurs between the 10 times and 80 times of load cycles, where the brightness of the images increases sharply. And there are macro cracks emerged in the samples corroded by pH3 solution after 80 loading cycles, as shown in Fig 6 (a). In general, the brightness and the number of white points in the images of the chemical corroded samples is higher than that in distilled water, which confirms the micro damage of limestone in the chemical solutions develop faster than in distilled water.

Combined with NMR test results, Fig 6 and Fig 7, it can be found that: (1) When the loading cycle is low (taking samples corroded by pH3 solution as an example), around 20 cycles, the damage evolution curve is obviously convex. Then the micro damage rise steadily with the increasing loading cycles. After 60 loading cycles, the damage evolution curve becomes concave. The inflection point in the micro damage-loading cycles curve is plotted (see Fig. 10).

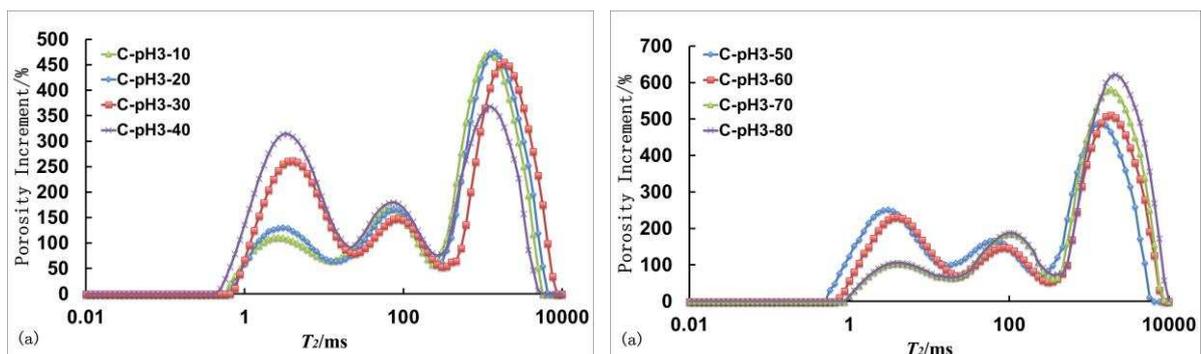
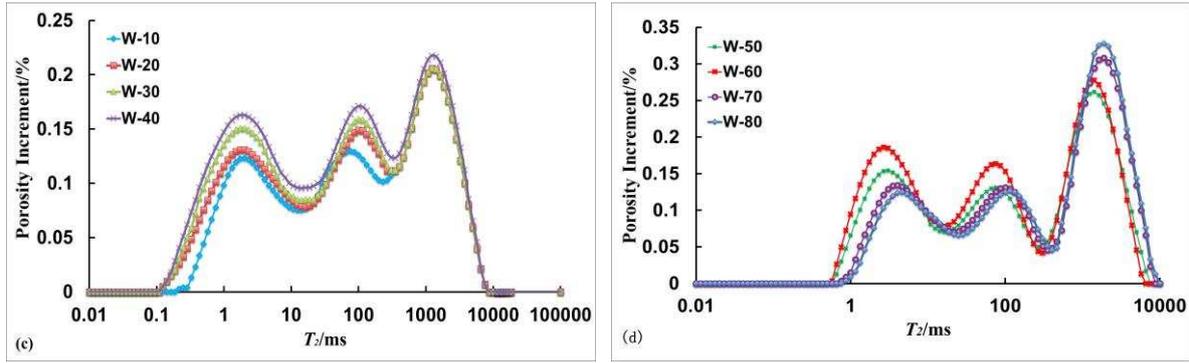
(a) Chemical corroded samples (PH=3)

(b) Water soft samples

Fig.7. T_2 distributions of samples under cyclic loading conditions (Left: 10-40 cycles; Right: 50-80 cycles).

A few observations can be made from the test results: (1) after cyclic loading, the area under the T_2 spectrum curves of the limestone samples have largely changed, indicating significant changes of microstructure of the limestone samples. (2) From Fig. 6 and Fig. 7, of the evolution of damage in the limestone samples (taking samples corroded by pH3 solution as an example) subjected to cyclic loads show three distinctive stages: micro crack emergence stage, micro damage development stage and damage acceleration stage. In the micro crack emergence stage, there is a slight increase of the first peak of the T_2 spectrum curve, which means there are newly emerged small pores inside the limestone samples. After 30 to 60 cycles, the limestone sample enters into the micro damage development stage, where the first and the second peaks of the T_2 spectrum curve increase greatly, which indicates the significant increase of porosity due to the emergency of new pores as well as the convergence of existing pores. This is then followed by the damage acceleration stage which leads to rupture. In this stage, the first and second peak decrease, while the third peak increases significantly, indicating the initiation of new micro cracks is constrained, and the internal cracks of the specimen are gradually converged and interconnected to form a shear band to cause the failure. (3) Compared to water soft ones, the chemical corroded limestone samples are more sensitive to the cyclic loading: the T_2 spectrum area and peak point growth of the samples corroded by pH3 solution are more faster

and obvious than the water corroded ones, that indicates the porosity and micro cracking increase of the chemical corroded samples are faster than that in distilled water.

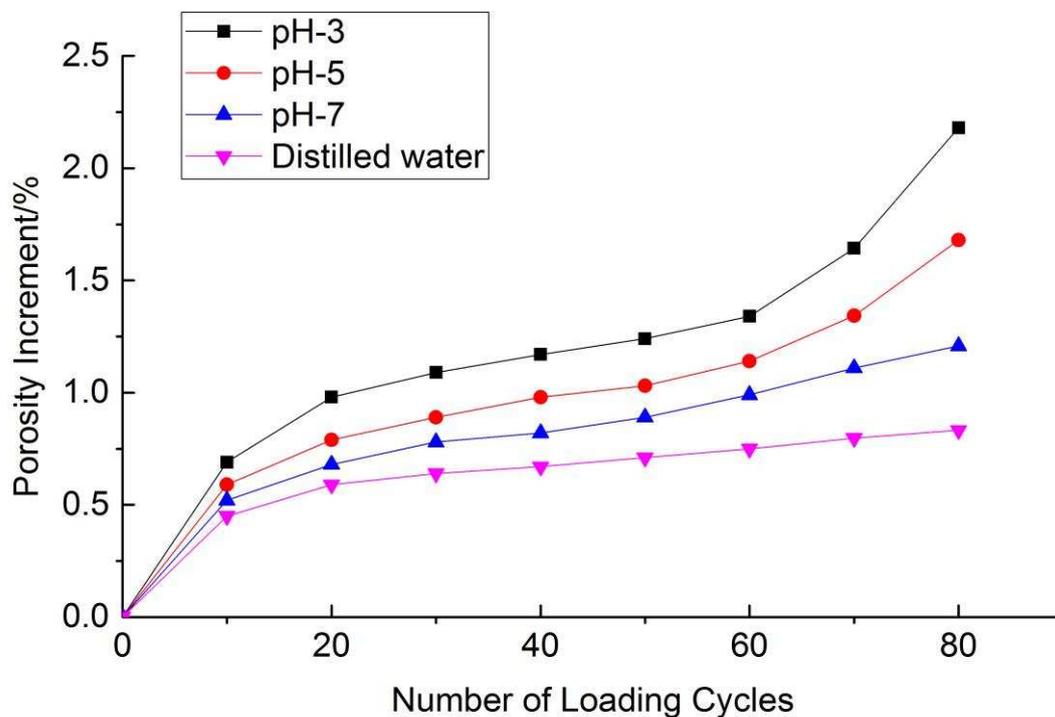
Fig. 8 Porosity increment rate vs number of loading cycles

The porosity of corroded samples obtained by NMR is shown in Table 1, and the porosity increment-loading cycles curve is shown in Fig. 8.

It can be found that the porosity of the limestone samples increase with the increasing loading cycles, which means the micro damage of the samples increase continuously. The porosity increment of limestone samples corroded by pH3 solution are always greater than that in other pH values solution, and develop faster than other group of samples. Due to the chemical ions exchange between the solution and the rock [23], there is a slight increase of porosity of the samples corroded by pH7 solution, and the porosity growth is higher than that in distilled water, which porosity increment is smallest among all the sample groups.

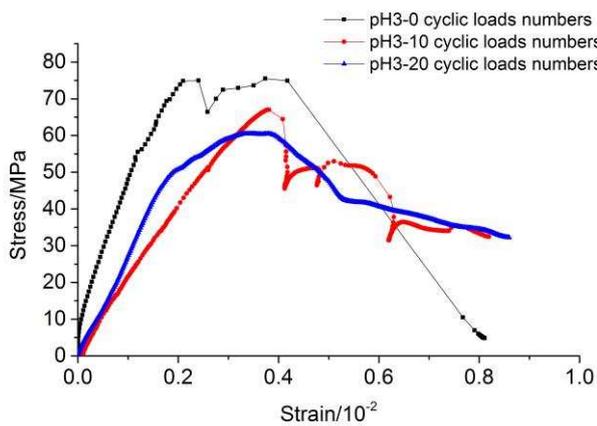
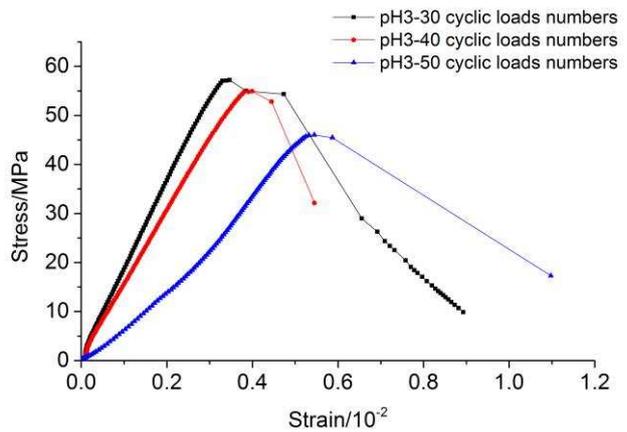
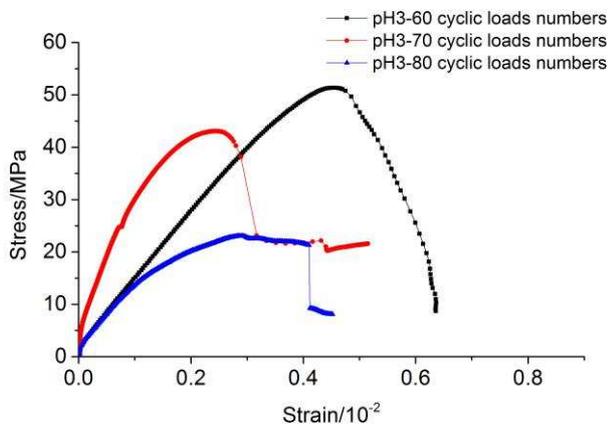
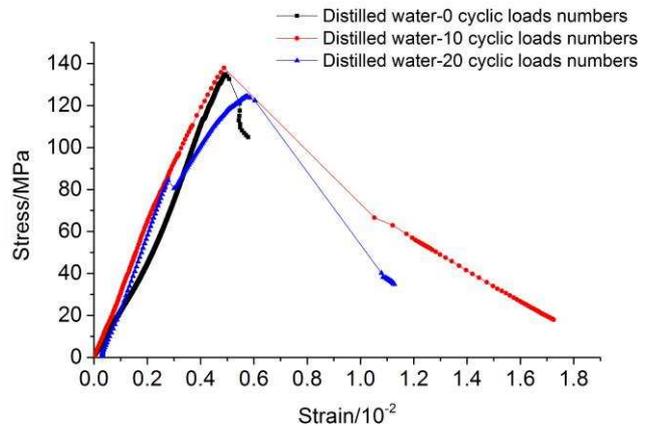
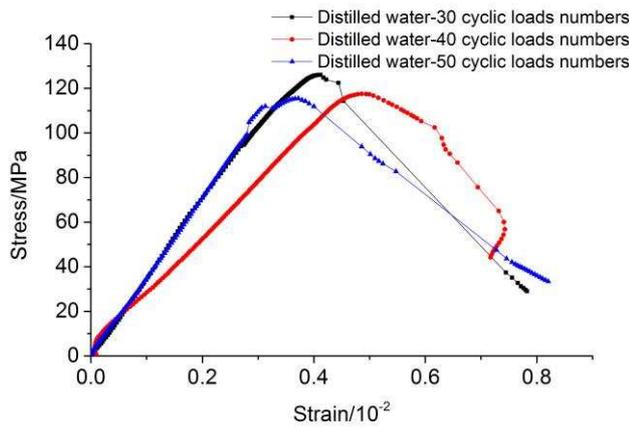
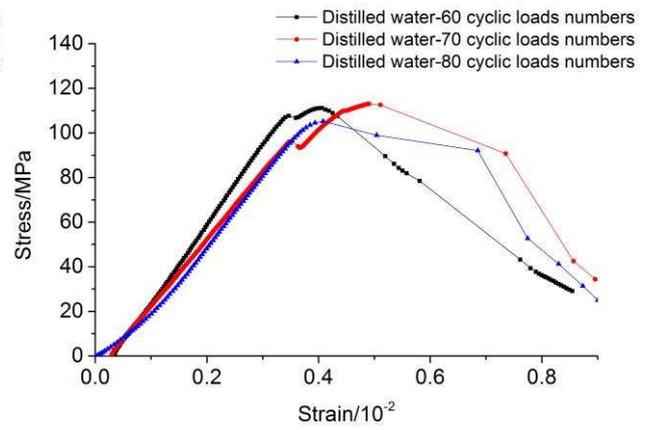
Fig. 9 Stress–strain curves of limestone samples under compression.

After cyclic loading, the chemical corroded and the water soft samples are tested by Rock 600-50 test system under compression until completely ruptured. The peak strength of the corroded samples after treated with different numbers of cyclic loads is shown in Table 3. The stress–strain curves of limestone samples after different loading cycles are shown in Fig 9 (a), (b) and (c). Attention is focused on samples corroded by pH3 solution, because there is more significant degradation of mechanical properties occurring in this sample group. The stress–strain curves of the water soft sample are plotted in Fig 9 (d), (e) and (f) for comparisons.

The observation from Fig.9, Fig.10, Table 3 and Table 4 is that: (1) SDP increases with the increasing micro damage rate, until it is approximately more than 4.5% at which point rock should be broken. (2) The chemical solutions have an impact on microstructure of limestone as well as the mechanical properties, and the cyclic fatigue affects the mechanical properties more seriously for the chemical corroded samples: with the same number of loading cycles, the peak strength of the chemical corroded samples is degraded much more significantly than that of the water soft ones.

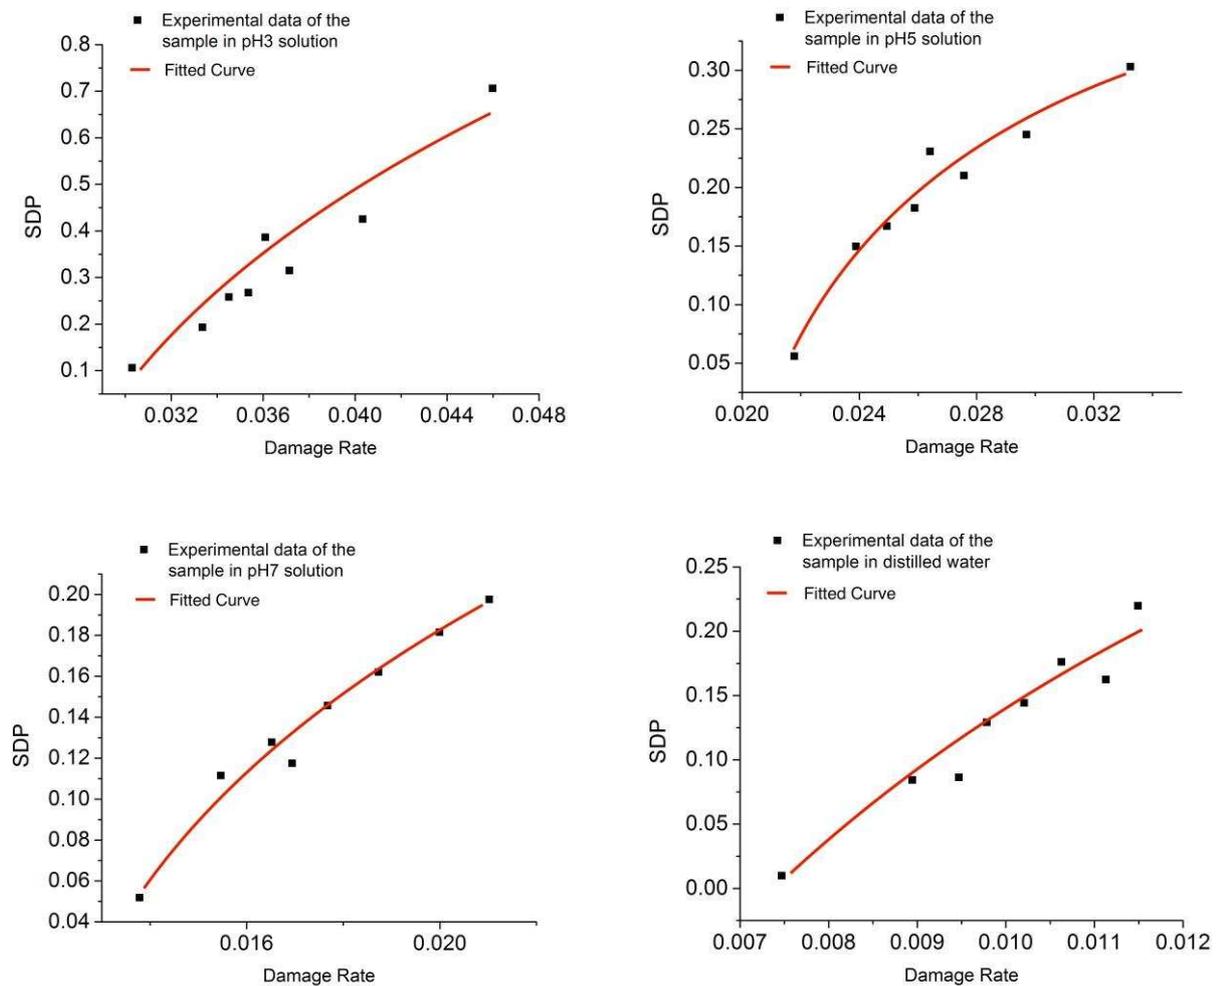
Fig.10 Strength degradation vs damage rate.

Fig.10 shows the relationship between micro damage and SDP of limestone samples after cyclic loading, and the corresponding micro damage rates is calculated and shown in Table 4.

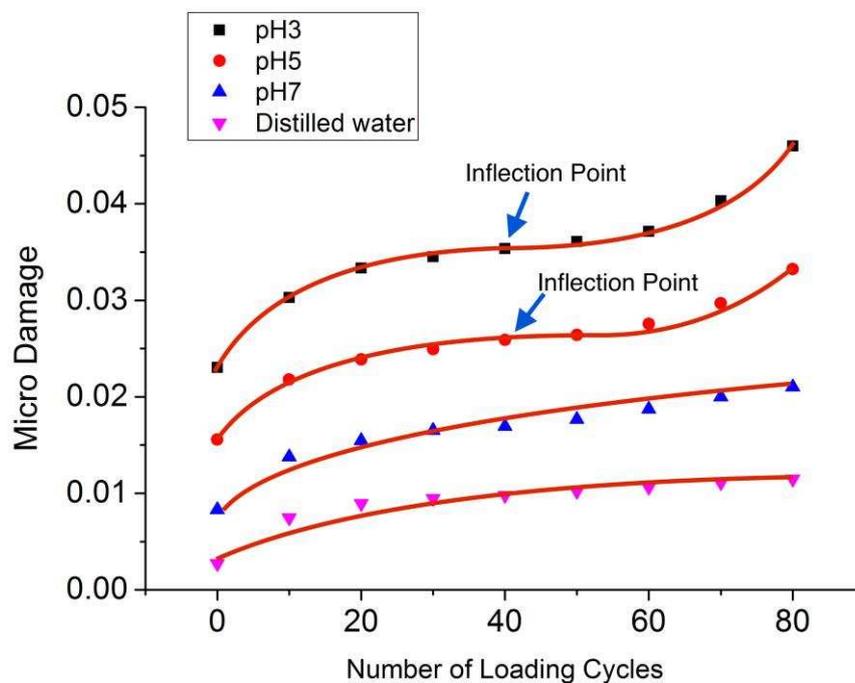
Fig. 11 Micro damage vs number of loading cycles

The damage rate evolution law of all the samples is shown in Fig 11. As it is talked in Chapter 3.1, there are three damage evolution stages of the corroded sample treated with cyclic loads: micro crack emergence stage, micro damage development stage and damage acceleration stage. These stages are also plotted in Fig 11.

(2) The inflection point in the micro damage-loading cycles curve is a turning point of the micro damage evolution process: before this point, the main change of the T_2 spectrum curves takes place in the first and second peaks, which indicates the micro damage of limestone in this stage is caused by sharp increase in number and size of micro cracks. While after this point, the third peak of the T_2 spectrum curve increases rapidly, which indicates the micro cracks increasing is restrained, the micro damage of limestone is caused by micro crack connection.

(3) The inflection point in the damage curve of the chemical corroded sample often emerge in lower loading cycles compared to others, so that the ultimate loading cycles (until the sample rupture) of the chemical corroded samples, is shorter than water soft ones. This is because after chemical erosion, the rock structure of limestone samples becomes softer, that accelerates the convergence of the micro crack as well as the rupture stage, and makes the damage evolution process become faster.
