Sanusi, S.H. and Fletcher, D. [orcid.org/0000-0002-1562-4655](https://orcid.org/0000-0002-1562-4655) (2017) The effect of white etching layer patches on a larger rail defect. In: MATEC Web of Conferences. 8th International Conference on Mechanical and Manufacturing Engineering 2017 (ICME'17), 22-23 Jul 2017, Langkawi, Malaysia. .

# The effect of white etching layer patches on a larger rail defect

*Shahmir Hayyan Sanusi*<sup>1,\*</sup>, and *David Fletcher*<sup>2</sup>

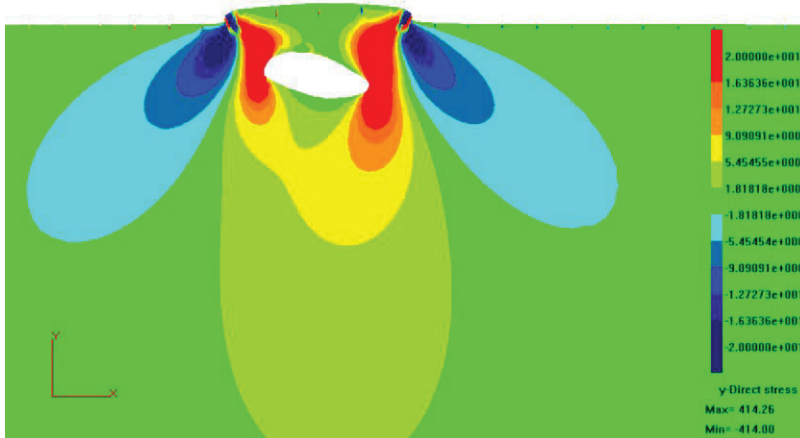
**Fig. 10.** Deform vertical stress plot for the case where thin expansion layer is present above the defect (case 2). Mechanical load (contact) and crack were absent. The deformation plot scale factor was set to 100 for clarity. Units in MPa.

The expansion of the metallurgical transform layer lying above the defect will introduce an opening stress region below its whole length until a certain depth as shown in Figure 10. It can be seen that the region of the maximum opening stress occurred at the side of the defect where crack initiation point is located. For the shortest crack (0.5 mm), the whole length of the crack is situated at the region where maximum opening stress occurred (e.g. y-direction direct stress). As the crack lengthens, the crack tip had exceeded these maximum stress regions where only some part of the crack length is affected by the opening stress and this will result in a very minor reduction in the KI value as the crack lengthens.
