Goodall, R. orcid.org/0000-0003-0720-9694, Hernandez-Nava, E., Jenkins, S.N.M. et al. (5 more authors) (2019) The effects of defects and damage in the mechanical behavior of Ti6Al4V lattices. *Frontiers in Materials*, 6. 117. ISSN 2296-8016

The Effects of Defects and Damage in the Mechanical Behavior of Ti6Al4V Lattices

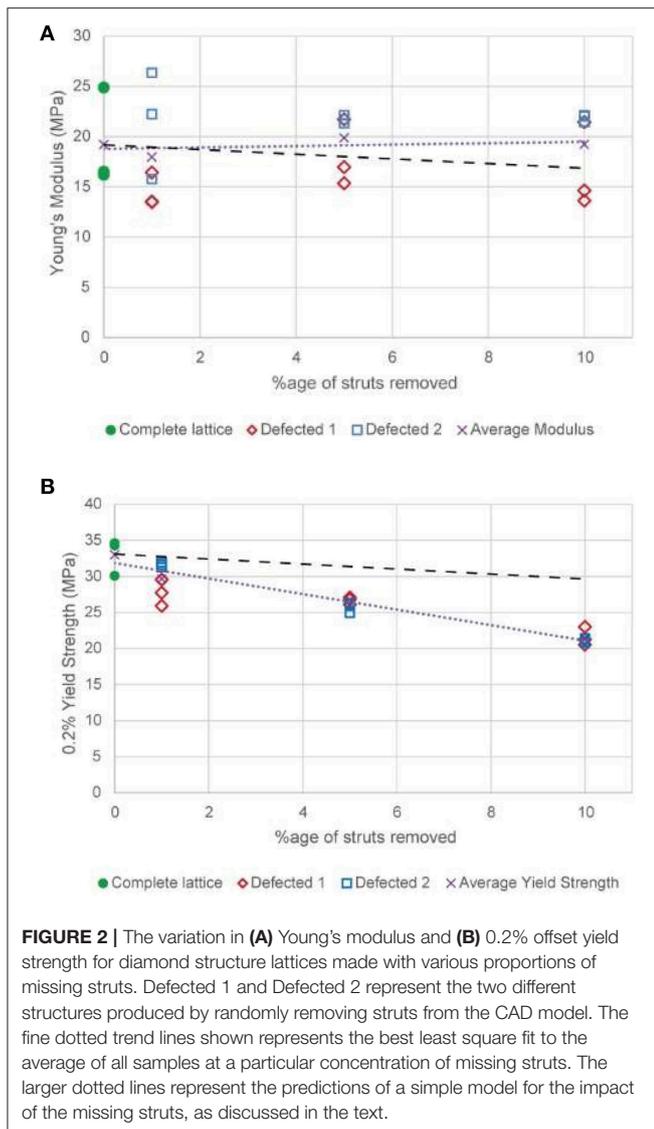
From **Figure 2A** it can be seen that the effect of the removal of struts, even up to a relatively high level, does not apparently have a consistent effect on the Young's modulus. The trend line for these data is almost horizontal, and there is significant scatter in the data. This indicates that there are factors other than the overall number of missing struts that have a significant effect on the Young's modulus, at least up to the maximum (and relatively elevated compared to the likely occurrence in processing) level of defects explored. The identity of one of these factors is suggested by the observation that the two different random structures formed have a significant, and roughly consistent, difference between their modulus values at all levels of defects. This indicates that for elastic behavior the location of struts removed may be especially significant, with the removal of struts from key areas (which could exist due to irregular strut shape at the microscale and non-uniform load distribution arising from the previously-removed struts) affecting the behavior much more

On the other hand, the plastic deformation results show a clear trend for decreasing strength when an increasing number of struts is removed (see **Figure 2B**), and the scatter between the different structures, and within repeat tests on the same structure, is much less. This in turn suggests that removing struts has a much greater effect on plastic behavior. The same, simplistic argument can be applied as was used to understand the elastic properties. This indicates that, under an equal stress model, the penalty for defects should be the same, i.e. that the yield stress of defected material should be $(1-f)\sigma_y$, where f is the fraction of defects and σ_y is the yield strength of the lattice in the undefected condition. A line of this slope is also plotted on **Figure 2B**.

This allows the penalty of different defect concentrations to be estimated, and a line of slope $-E$ is plotted on **Figure 2A**, starting at the mean value of the complete lattice modulus, to show this effect. This line shows that there would be expected to be a negative trend, which is not clearly seen in the data, however, over the range examined, the magnitude of this trend is actually rather small, and is within both the experimental error range and the range of results produced from the different, random structures. Therefore, the results obtained are consistent with a penalty to the elastic properties of defects of the range predicted.

In the case of strength, it is clearly seen that the penalty for defects in the material is higher than predicted, with the slope being closer to $-3\sigma_y$ than $-\sigma_y$. The reason for this departure is that the mechanics of deformation are more complex than for the simple model in the case of permanent deformation. It is known (e.g., Gibson and Ashby, 1997) that missing cell walls or struts in porous materials can also affect the mode of deformation, with the tendency for defects to contribute to the nucleation and propagation of deformation bands in ordered structures (Silva and Gibson, 1997). Finite element analysis could be one way of

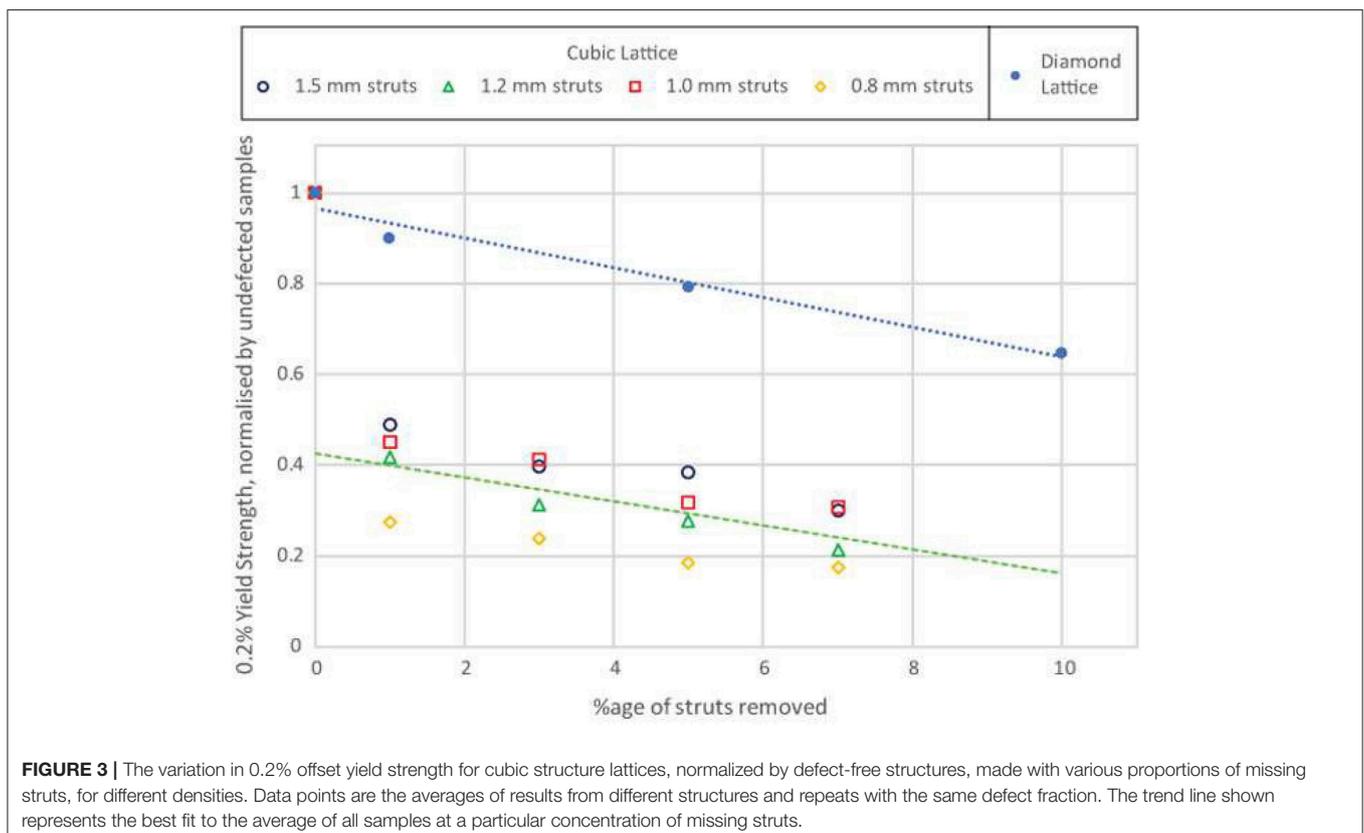
Lattice samples based on a simple cubic lattice, with defects incorporated have also been produced, and, unlike the diamond lattices, have been created at various densities. Testing of these samples gave the results in **Figure 3**, showing the variation in the offset yield strength with inclusion of artificial defects. Data points plotted are the averages for different defect structures and repeats. As the lattices evidently show very different strength with density variations, the data are normalized here to the offset yield strength of the artificial defect-free lattice of the corresponding density. These data show several things in relation to the defect tolerance of lattices. Firstly, taking the cubic samples of different density collectively, the trend in behavior seems the same in each, indicating that it is the nature of the structure, rather than the amount of porosity or metal, which influences the behavior with regard to defects of this type.

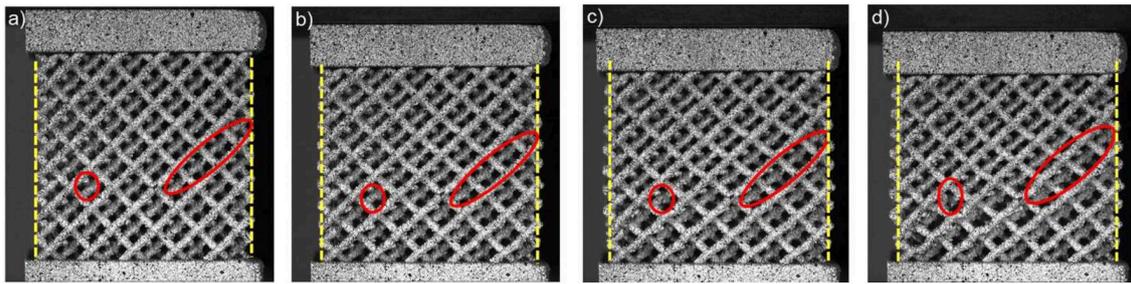
FIGURE 4 | Deformation and damage development in compression **(a)** undeformed structure, **(b)** initial buckling mode that shows barrelling effect (vertical lines added to aid observation), **(c)** damage initiation at the highlighted nodal position, **(d)** final fracture at the nodes. The video from which these stills were taken is available online.

Deformation and damage development in samples subjected to compressive loading is shown in **Figure 4** (also available as a video online). It has been found that the solid block (which is connected to the struts at the surface nodes) restricts the deformation of the samples at the interface nodal positions. This forces the material to experience a barrelling deformation up to the maximum applied load, where damage initiates. The implemented restriction prevents failure from initiating at the upper or lower contact points, and ensures failure occurs within the body of the structure. Otherwise, the mode of failure and the failure path appear to be comparable to samples tested without the solid block. Damage starts by

crack initiation at the nodal position, highlighted in red in **Figure 4**; however, no sign of catastrophic failure was observed at the struts. Similar deformation patterns were observed in the samples subjected to unequal compression experiments (where the loading is a combination of compression and indentation) wherein the compressive stress was followed by local shear deformation within the structure (**Figure 5**). Several deformation mechanisms, including tensile, compression and shear, were activated in the latter experimental setup, as the samples passed beyond the uniform compressive state. Although tensile and compressive deformation fields were observed in different parts of the samples, the failure occurred at the nodal positions located inside the localized shear zone.

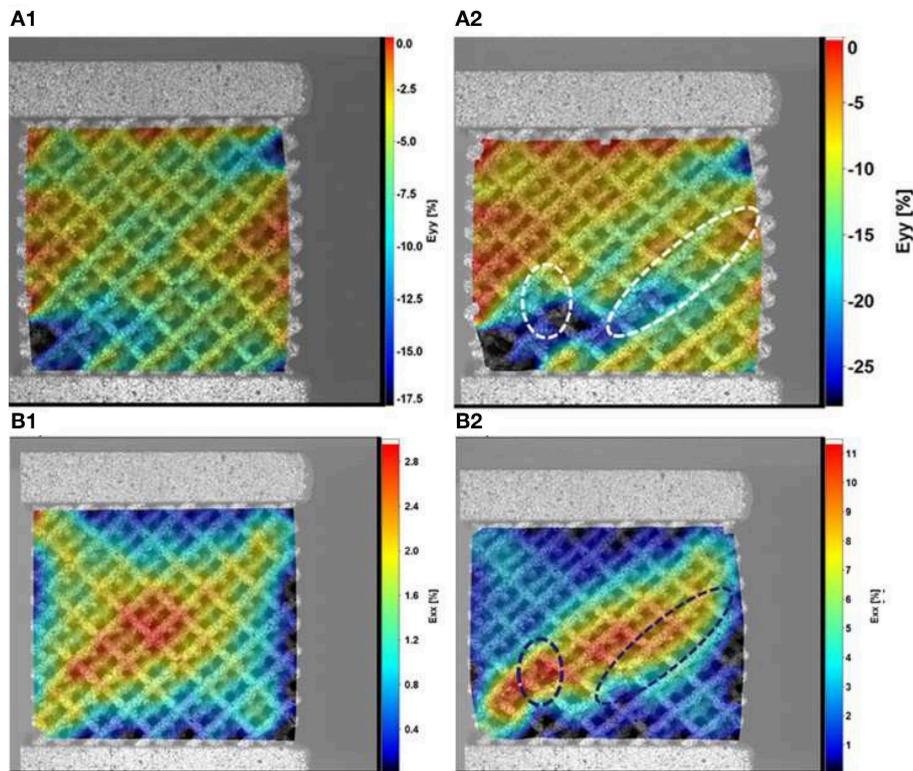
FIGURE 5 | Local strain distribution in y (**A1,A2**) and x (**B1,B2**) directions, relative to the test, for samples under compression, (**A1,B1**) at the maximum compressive force and (**A2,B2**) at the point of final fracture. The load was applied in the same direction as the build, y direction in the figure (vertical).

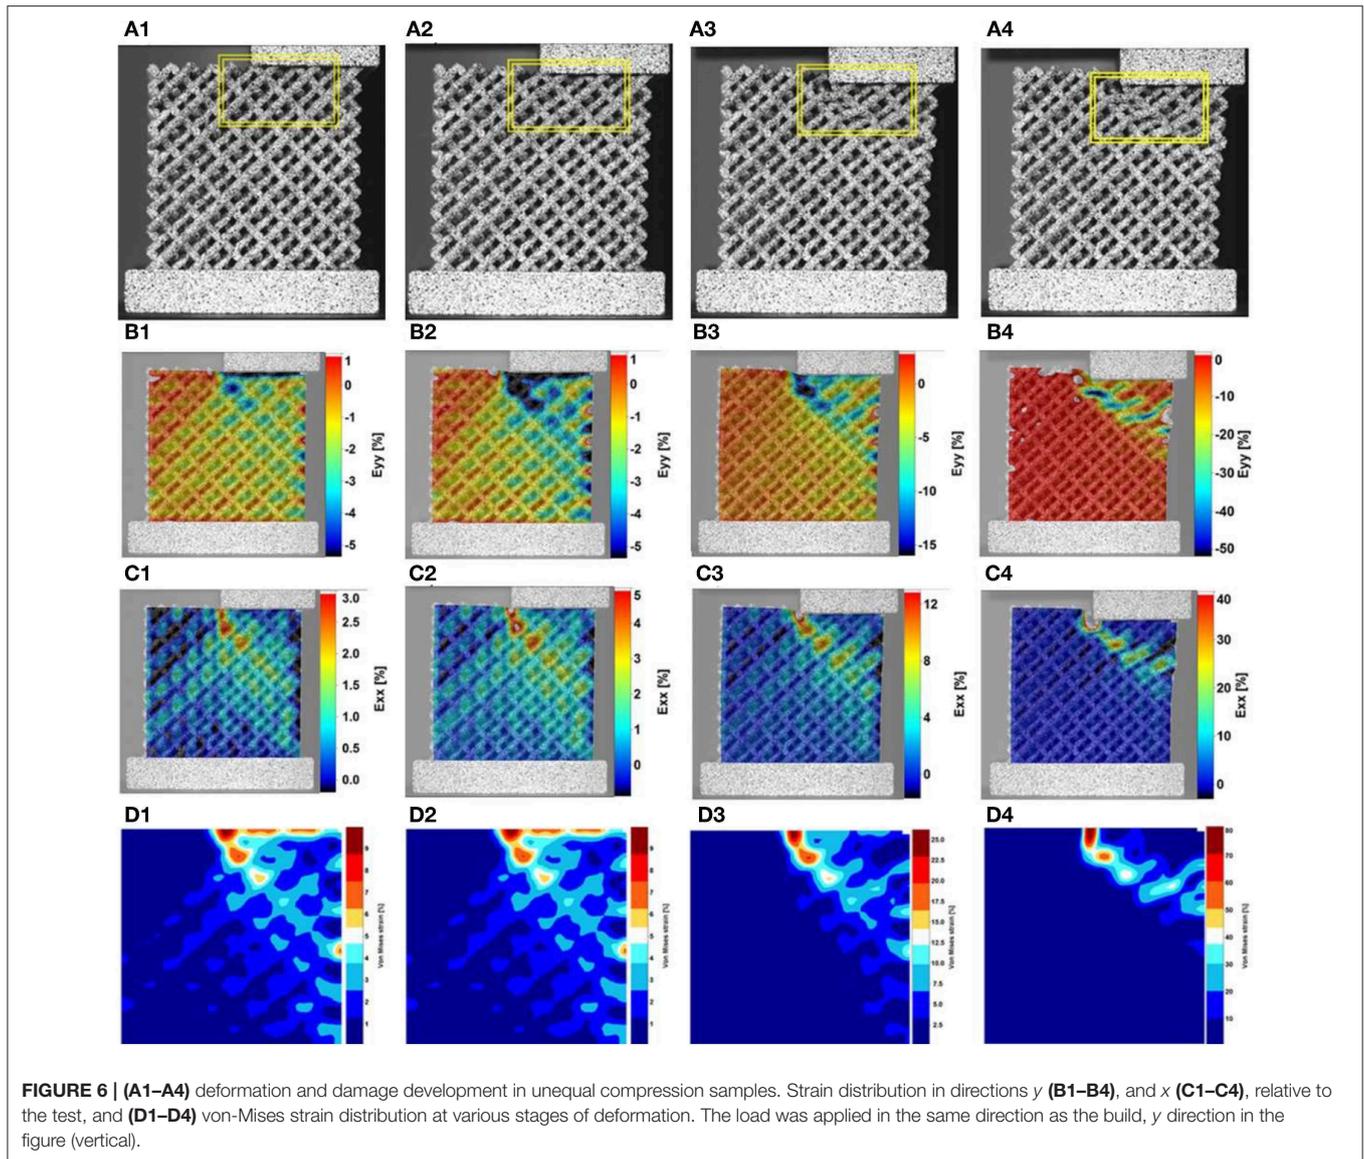
The strain distributions in **Figure 6** show that the applied forces were transferred to the structure with the maximum equivalent strains measured at nodal positions in contact

with solid blocks (Figure 6C1). This is followed by further deformation localization in the regions directly below the upper block. Figures 6A3,4 indicate that struts are bending toward the end of the experiment, leading to higher strain values in x and y directions (in plane directions in the test) at the nodes. According to the strain distributions, failure occurs at about 45° with respect to the loading direction. This shows that the sample does not undergo failure under compressive stress directly (i.e., the failure does not initiate directly under the loaded plate), rather it is a mixed-mode failure, initiated at the interface between the half

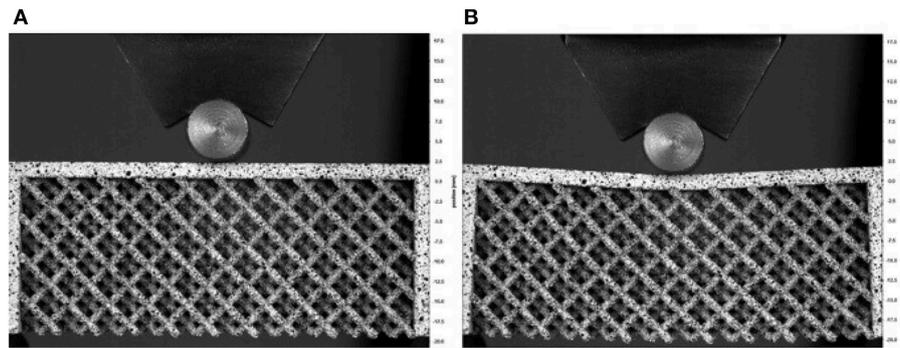
FIGURE 7 | Bending test sample (A) at early stages of the experiment and (B) just before the final failure.

Figure 7 shows the test setup for the bending experiments before and after failure. This setup is critically important, as the lattice structure is subjected to a tensile stress field (which is difficult to engineer in samples of lattices that can be tested without risk of interface failure) and damage is observed to start from the lower set of cells where maximum tensile stress is expected. A very limited amount of plastic deformation was

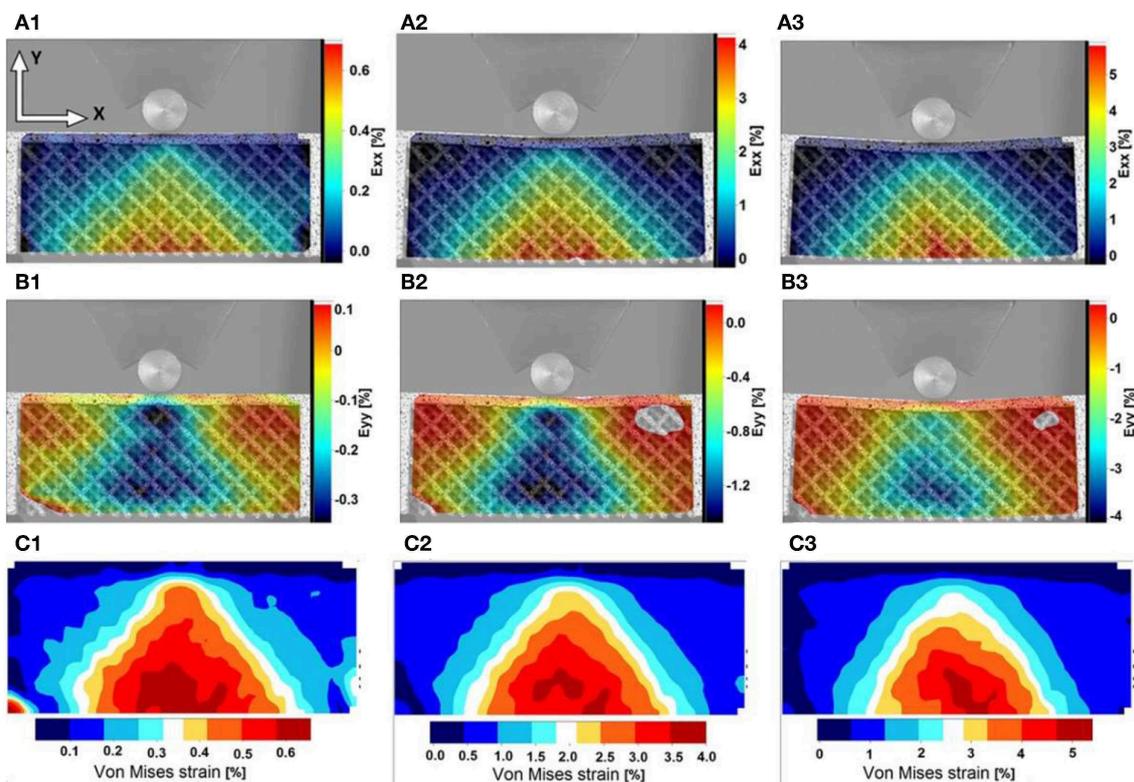
FIGURE 8 | Distribution of (A1–A3) axial strain E_{xx} , (B1–B3) axial E_{yy} and (C1–C3) von-Mises equivalent strain during the bending experiment showing the maximum local strain of about 5% at the onset of crack initiation and propagation within the structure.

Strain distribution within the lattice structure during the bending experiment is shown in **Figure 8** for three different times during the loading cycle which correspond to the start of the test, middle of the test and just before the failure of the sample. According to the results, the in-plane longitudinal strain (E_{xx} , **Figures 8A1–3**), representative of uni-axial stress at the tensile side of the sample, increases from the start of loading and reaches a maximum value of 5% (measured by DIC) just before fracture. The results show the strain is localized directly below the contact point with the roller where the maximum tensile stress occurs. Additionally, the distribution of the E_{yy} strain component indicates that the lattice structure is absorbing the applied deformation as the strain concentration point is shifted toward the center of the structure, away from the stress free boundaries. This may indicate that the internal layers of the structure are taking more compressive deformation compared to the free surfaces at the boundaries.

The distribution of equivalent von-Mises strain for the bending samples is shown in **Figures 8C1–3**. The equivalent strain is throughout localized at the outer layer of the structure and reaches a critical value of 5% just before failure. This value is almost identical to the E_{xx} strain; tensile deformation is considered to be the dominant mode of deformation. Therefore, the investigated lattice structures show very different mechanical behavior dependent on the nature of the applied external load, with higher resistance to failure in compression, where a total deformation of about 10% is reached, compared with tension, where the total deformation is about 5%. These measured values could be used to develop a strain-based failure criterion for more complex loading scenarios, as well as in predicting the damage tolerance of structures made from such lattices.

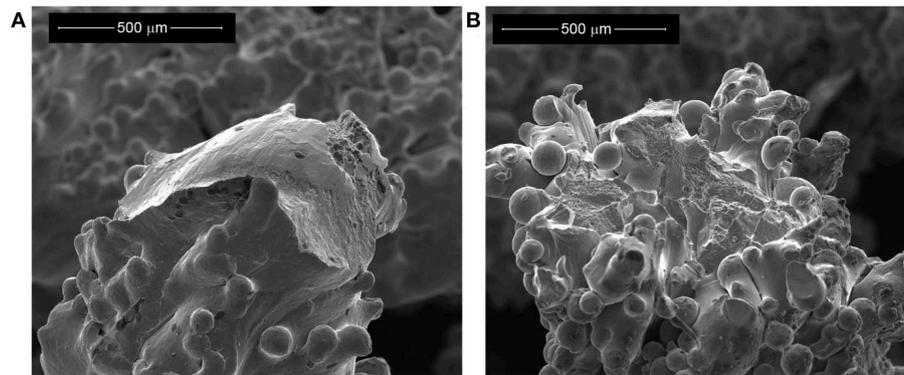
FIGURE 9 | Scanning Electron Microscope images of the post-test failure surfaces in samples deformed by compression **(A)**, and in tension **(B)**, the latter using the bending beam sample approach.

The presence of the different modes of deformation observed is confirmed, and their effects demonstrated, by examination of the fracture surfaces in the samples (**Figure 9**). Looking across many broken struts, failure is most frequently observed to occur at the nodes where struts interconnect, where, if the

The failure point is typically where a strut meets a node (the root of the strut), and not through the node itself, as this is the site of stress concentration, in a similar way to any macrostructure. Observation of the broken surfaces (such as those in **Figure 9**) shows limited local plastic deformation under both tensile and compressive loading, with cracking sometimes observed in regions of the strut away from the failure point, though this is difficult to identify consistently and with high confidence, due to the surface roughness. This effect means that struts fail before buckling, which would be theoretically predicted to be the failure mode for many lattice structures (Fan et al., 2009). The high degree of surface roughness is evident (as typically observed in EBM struts in the absence of post-processing treatment (Lhuissier et al., 2016)). A significant contribution to this roughness comes from a large number of spherical features of around 50 μm in size, almost certainly particles of the original powder, which were not fully molten and have been incorporated into the strut surface.
