Liskiewicz, T., Rybiak, R., Fouvry, S. and Wendler, B. (2006) *Fretting wear of Ti(CxNy) PVD coatings under variable environmental conditions*. Proceedings of the Institution of Mechanical Engineers Part J: Journal of Engineering Tribology, 220 (3). pp. 125-134. <http://dx.doi.org/10.1243/13506501JET139>

Fretting wear of Ti(C_xN_y) PVD coatings under variable environmental conditions

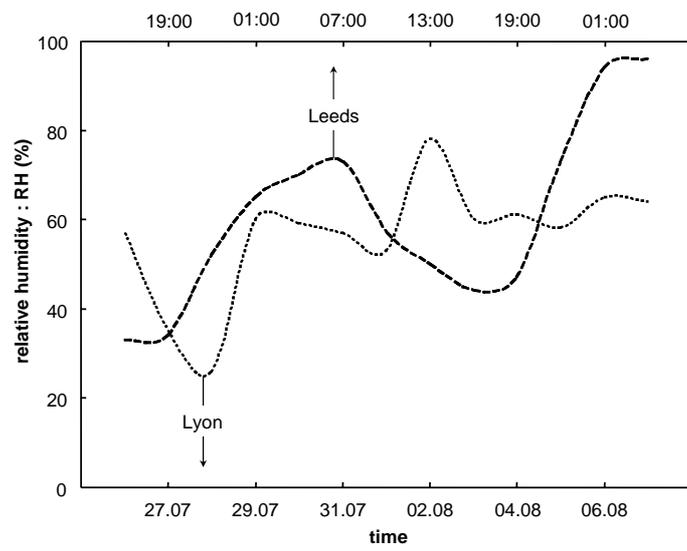
Fig. 1. Evolution of air relative humidity as a function of time for two locations: Leeds (between 26.07.2005 16:00 GMT and 28.07.2005 04:00 GMT); Lyon (between 26.07.2005 and 07.08.2005) [14].

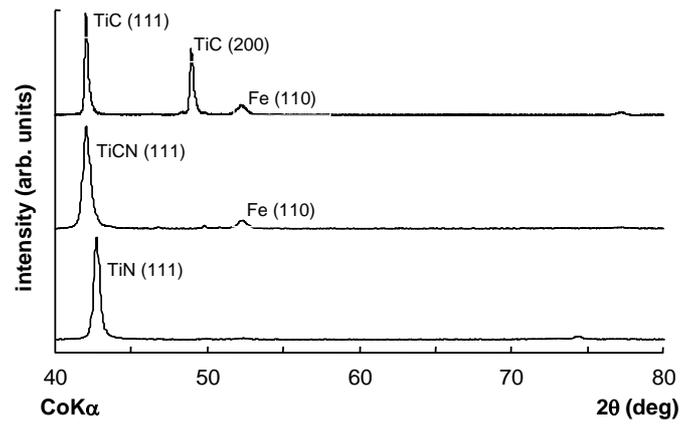
Fig. 2. X-ray diffraction patterns of the three coatings under investigation deposited onto the quenched and tempered Vanadis23 HSS steel substrate.

X-Ray diffraction spectra of the hard coatings is shown in Fig 2. Monochromatic $\text{CoK}\alpha$ radiation and conventional Bragg's geometry (θ - 2θ) have been used during registration of the spectra. Due to this geometry the intensity of a diffraction peak (hkl) is related (among others) to the number of planes with suitable distance d_{hkl} and orientation parallel to the surface of the sample. One can see from Figure 2 that in case of the TiN and TiCN coatings only one diffraction peak from (111) planes has been registered and also that the angular position of the TiCN (111) peak is more near to that of the TiC (111) peak than to the respective peak of the TiN phase. This can be interpreted as a result of different concentration of carbon and nitrogen atoms in the TiCN phase: the concentration of the former is greater than that of the latter. Taking into account a rather considerable thickness of these two coatings ($4\mu\text{m}$ in case of TiN and $2.5\mu\text{m}$ in that of TiCN) as well as the fact that according to the respective powder diffraction data [29] the relative intensities of the first three peaks should amount 72:100:45 and 59:100:46 for TiN and $\text{TiC}_{0.7}\text{C}_{0.3}$ phases respectively, it is evident that the orientation of crystallographic planes in these two coatings is not fortuitous. Similar preferred orientation of (111) planes is reported in the bibliography of the arc-deposited TiN coatings [30] and can be related to greater thermodynamic stability of the first nuclei of the growing coating in the case when the most dense packed (111) planes of these nuclei are parallel to "mirror"-finished flat

substrate's surface [31]. In case of the third coating there are two peaks (111) and (200) registered in the X-ray spectrum of the TiC phase (the intensity of the 220 one is equal to 0) and their relative integrated intensities are 100 and 48, respectively. Taking into account that the thickness of this coating (1.6 μm) is much less than that of the the TiN and TiCN coatings, it is necessary to take this limited thickness into consideration in order to compare the relative intensities of the diffraction peaks. According to the formulas given in [32], it has been calculated (on the base of: coating thickness, mass absorption coefficient of the wavelength λ of the X-ray $\text{CoK}\alpha$ radiation by the TiC phase, the mass density of the latter and the experimental values of the diffraction angles 21.03 deg and 24.47 deg for the given wavelength λ on the (111) and (200) planes of the TiC coating, respectively) that the corrected integrated intensities of these two peaks of the TiC coating are 100 and 51,5. These two values are contradictory to the ones expected for the relative intensities of these two peaks from the ICDD diffraction standard (card No. 32-1383) for the powder specimen of the TiC phase, which are 80 and 100, respectively. These contradiction can be withdrawn once again at the assumption that there exists a strong prevalence of (111) planes at least in comparison with (200) and (220) ones with similar orientation parallel toward the substrate's surface in this TiC coating deposited by the indirect method [28]. Some micro-peaks observed on the diffraction profile of the TiCN coating come from carbides in the substrate material. The appearance of the (110) Fe peak on the diffraction spectra of the TiC and TiCN phases in Fig. 2 is due to the substrate material and gives a proof of smaller thickness of these two coatings in comparison with that of the TiN coating.

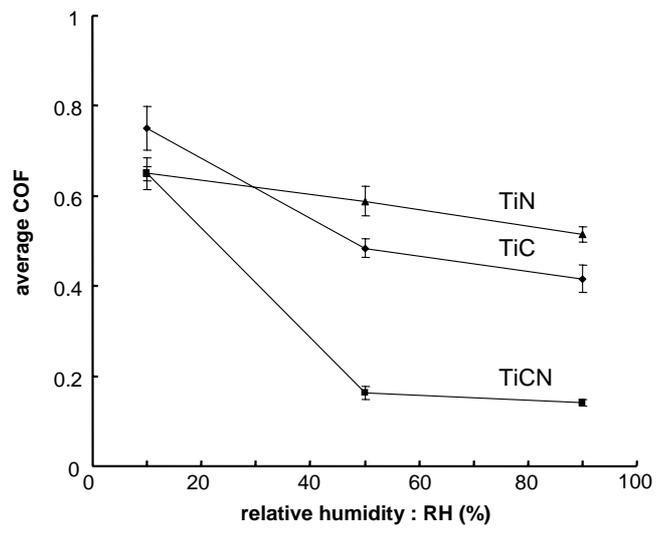
Fig. 3. Average COF value of the hard coatings under investigation as a function of RH.

Fig. 3 presents an average value of the COF for hard coatings under investigation as a function of three RH values. A running-in period has been observed for all coatings after which the friction forces stabilized and the value of COF has been calculated by deriving the average value between 3000 and 10000 fretting cycles. The error bars represent the difference between maximum and minimum value of COF recorded during this period. For each coating under investigation the value of the COF is decreasing with increase of the RH. One should note however the significant decrease of the COF value for TiC and TiCN coatings between the RH values 10% and 50% as different from very slowly decreasing COF value in the same RH interval for the TiN coating. The greatest change of the COF value has been noticed for the TiCN coating: from 0.65 at RH=10% to less than 0.2 at RH=50%.

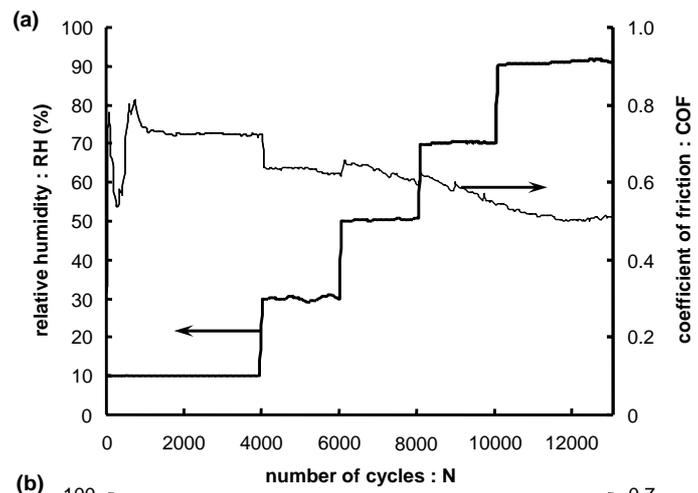
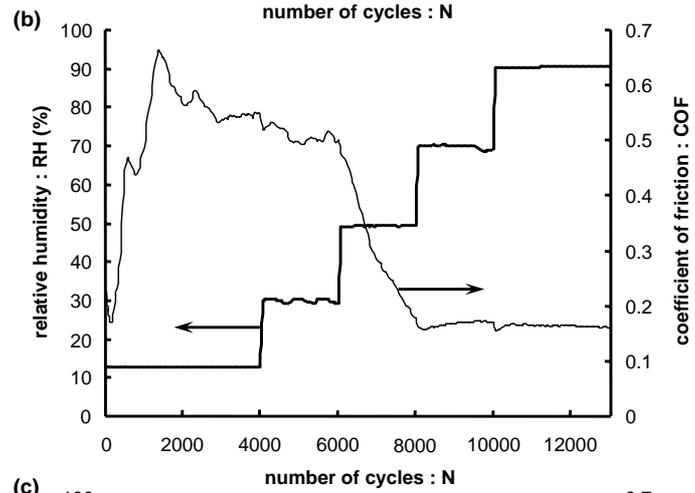
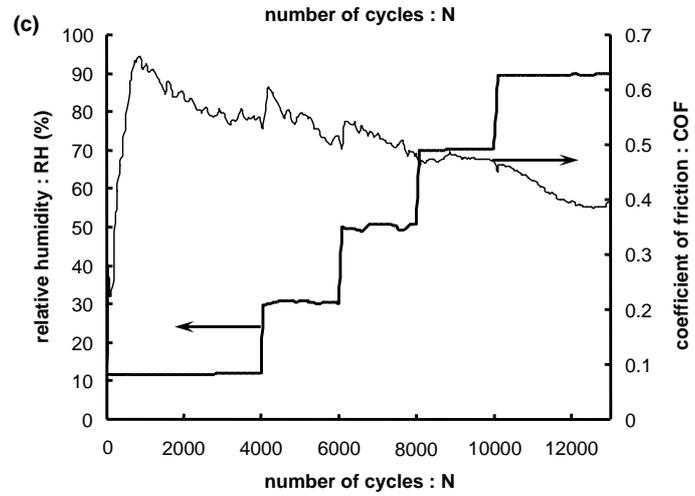
Fig. 4. Evolution of friction coefficient as a function of variable relative humidity and the number of fretting cycles for (a) TiC, (b) TiCN and (c) TiN coatings.

In order to refer to the real environmental conditions, where components can be subjected to significant humidity variations within a short time, we have designed the unique fretting experiment, where during a single fretting test RH was increased stepwise from 10% to 90% as shown in Fig. 4. During each humidity increase the fretting test was suspended for a time

interval as short as possible – usually less than 5 minutes – in order to adjust a new RH value in a closed chamber. These short detention intervals seem to be responsible for the characteristic discontinuities in COF evolution, which can be easily observed e.g. for TiC coating at 30% RH. These variations deform the overall COF evolution and suggest that rather continuous change of the RH during the fretting test should be applied. Nevertheless, this kind of test provides a very promising procedure for evaluation of the dynamic response of the system to variable environmental conditions. For TiC and TiN coatings the coefficient of friction is decreasing rather evenly whereas a sudden drop is observed for TiCN coating during the fretting interval at 50% RH. A critical value of coefficient of friction can be defined ($\text{COF}_{\text{cr}} \approx 0.5$), which separates the low and high friction regimes. One can see from Fig. 4 that the COF tends steeply to a value lower than the critical one immediately after switching the RH level from 30% to 50%, which suggests that the critical RH level has a value between 30% and 50% RH. Determination of an exact value of the relative humidity (RH_{cr}) requires additional detailed fretting tests in this critical range of the relative humidity.

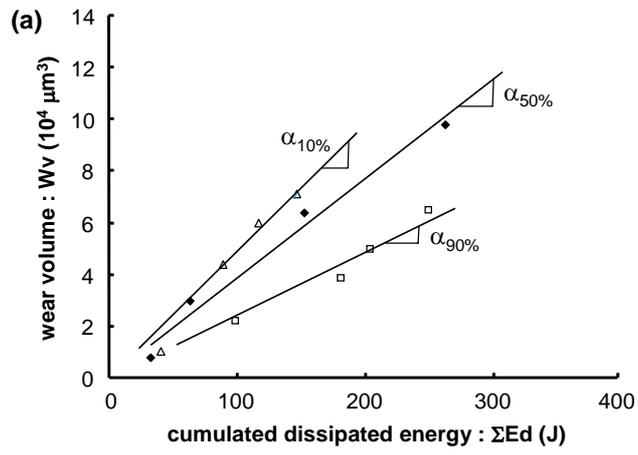
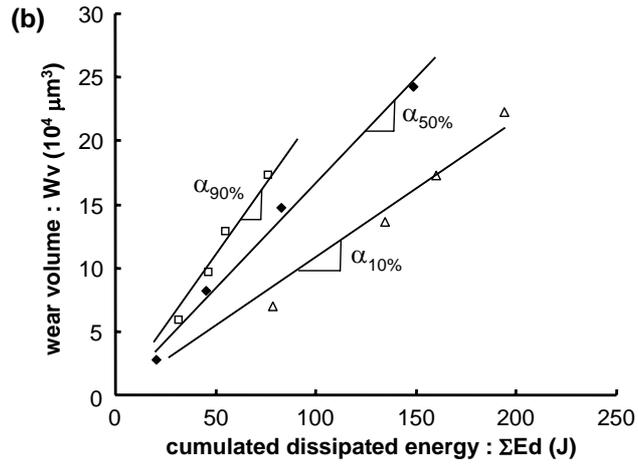
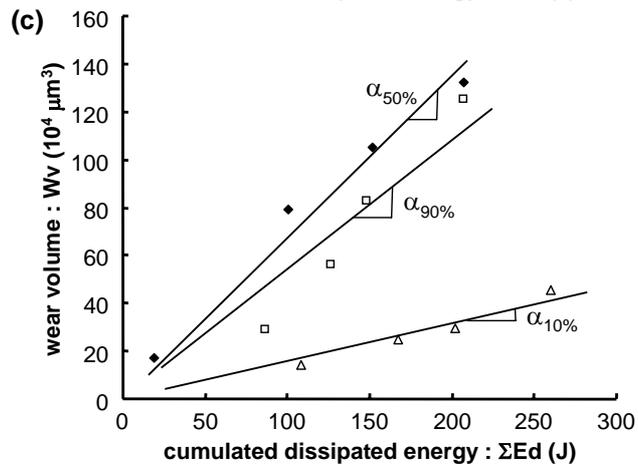
Fig 5. Evolution of the wear volume as a function of cumulated dissipated energy for (a) TiC, (b) TiCN and (c) TiN coating.

The energy wear coefficient allows to synthesise wear resistance of a friction couple combining the sliding distance, the normal force and the friction coefficient influences. However, it is shown to strongly depends on the relative humidity as illustrated in Fig. 5. Linear approximations passing through the origin have been considered to fit the different experimental wear kinetics. The corresponding energy wear coefficients (α) as well the associated regression coefficients (R^2) have been compiled in Table 2. Except for one condition (TiN / RH=90%) the regression coefficients are systematically superior to 0.9. It basically confirms the stability of the given energy wear approach to capture the wear kinetic for a given relative humidity. Independently of the applied relative humidity it can be outlined that the best wear resistance (i.e. the smallest energy wear coefficient) is observed for the TiC, then the TiCN and finally the TiN coating.

The differences in terms of wear energy rates which are illustrated in Fig. 5 are very interesting regarding the stability of the energy wear approach. The approach includes the friction coefficient through its formulation and for a given stable wear regime, relation of the wear volume and cumulated dissipated energy should be expressed by a single, unique energy wear coefficient. This fretting wear behaviour has been observed under significantly lower normal load of 1N for a TiN coating tested against alumina ball at different relative humidities [27]. The very different wear regimes observed in this study suggest that humidity not only interacts on the friction behaviour but also on the corresponding wear mechanism. Energy wear approach is stable only for constant RH conditions and can not be directly extrapolated for variable RH conditions, as it doesn't take into account different tribochemical response of a system.

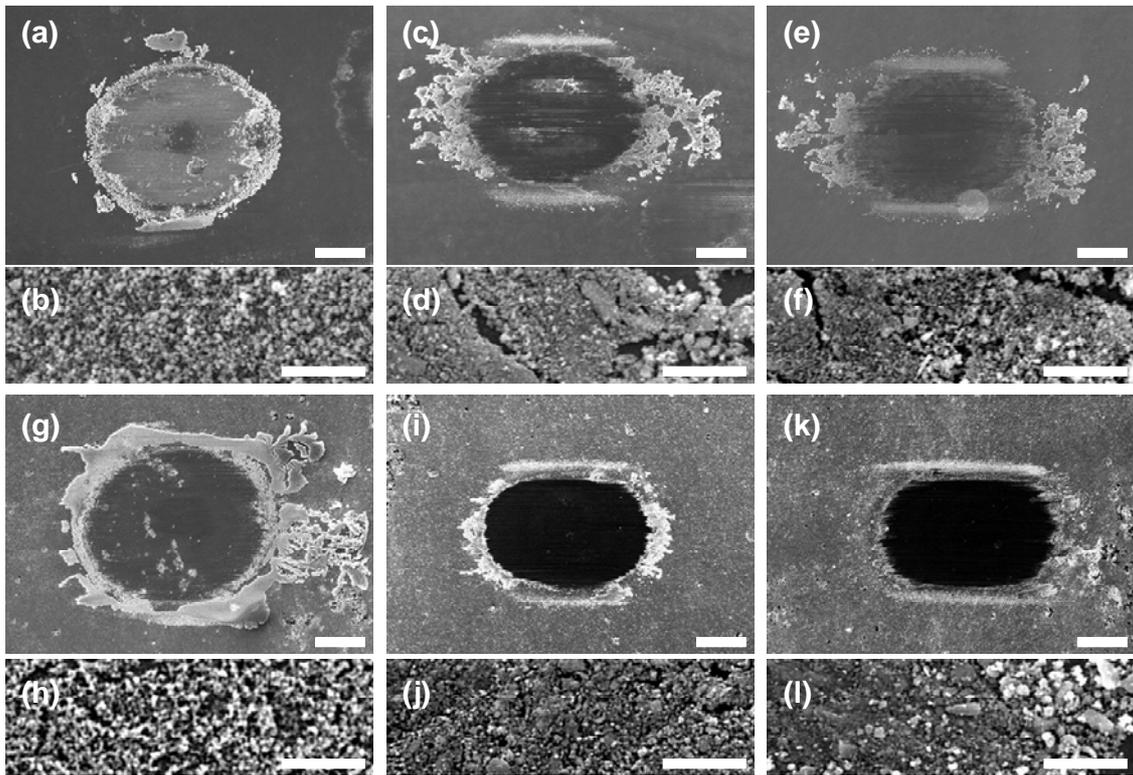
Fig. 6. SEM images of wear scars and debris created during fretting wear; (a,b) TiC at 10%RH; (c,d) TiC at 50%RH; (e,f) TiC at 90%RH; (g,h) TiCN at 10%RH; (i,j) TiCN at 50%RH; (k,l) TiCN at 90%RH. Scale bare length = 200 μm (for the Figs. a, c, e, g, i, k); scale bare length = 10 μm (for the Figs. b, d, f, h, j, l).

An interesting evolution of wear particles distribution has been established in the present work (Fig. 6). Similar amount of debris has been observed for all the three values of the RH in case of TiC coating, while in case of TiCN and TiN coatings the quantity of debris is lower for higher values of the RH.

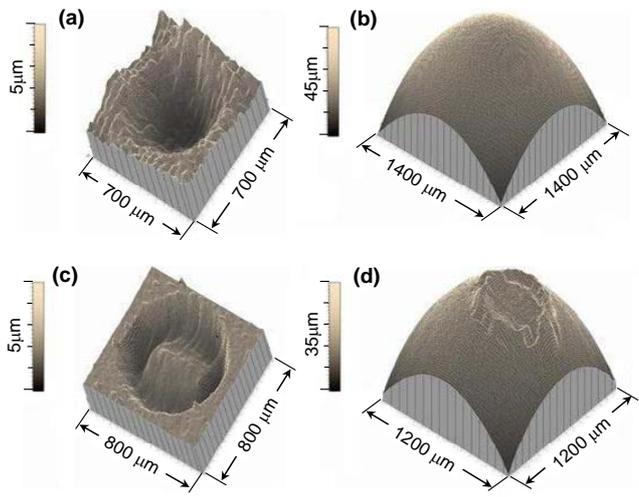
Fig. 7. Surface morphology of coated specimens and alumina counterbody after fretting test:

(a) TiC coating; (b) alumina ball; (c) TiN coating; (d) alumina ball with TiN debris.

The 3D surface morphology analysis of wear scars as well as of the alumina ball surface allowed to establish that the missing wear particles in case of TiCN and TiN coatings are transferred onto the ball surface. With increasing number of fretting cycles an annular spatial structure is being formed on the surface of the counterbody (Fig. 7d). In contrast to this finding similar transfer of the debris is not observed in case of the TiC coating (Fig. 7b).

To estimate the volume of the TiN coating transferred onto the surface of the alumina ball, a separation procedure has been carried out using Surfscan® software. For the 15000 of fretting cycles this volume was equal to $1.011 \cdot 10^6 \mu\text{m}^3$. If we compare it with the wear volume of the scar ($1.859 \cdot 10^6 \mu\text{m}^3$), the ratio of the material transfer can be calculated as 0.54. Hence, it is clear that approximately half of the removed material is transformed in this case into the debris and ejected outside the contact area, while the second half is transferred onto the counterbody surface. However, it should be indicated that this calculation has been done for a given test duration and the ratio of the material transfer should be treated as a demonstrative value as it can evolve as a function of applied fretting cycles.

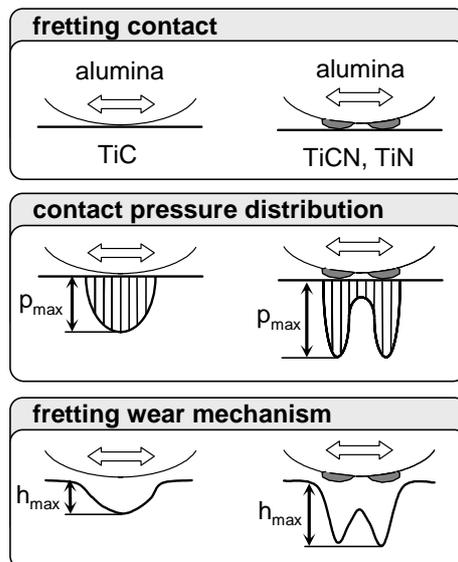
Fig. 8. Schematic representation of two different mechanisms of the fretting damage observed in the experiments.

The phenomenon of debris transfer has been observed in tribology of thin films [10], it is conducive to formation of a new counterface and as a result to evolution of loading conditions in the contact area. It has been observed, that the maximum wear depth of the TiCN and TiN coatings is situated at the border of the wear scar and a minimum at its centre (Fig. 7c). Therefore the longitudinal profile of the wear scar has a typical W-shape. It has been proved earlier [30] that this characteristic scar shape, obtained under gross slip condition, is related to a modification of the surface geometry by the generation and distribution of the third-body within the contact area. Evolution of the contact geometry leads to the shear and pressure fields modification. The maximum stress values are observed in the centre of the contact at the beginning of the test and are being translocated towards the borders of the contact during test duration. This type of damage is especially dangerous for thin films as for a relatively small wear volume a significant wear depth occurs and, at last, wear through the coating and reaching the substrate. The initial Hertzian radius for a studied contacts was around $180\mu\text{m}$, then the coating surface was subjected to progressive wear and the wear scar radius was increasing exponentially with a test duration. The schematic representation of the both damage mechanisms observed in the experiments is summarized in Fig. 8.
