Long, H., Al-Tubi, I.S. and Martineze, M.T.M. (2015) Analytical and Experimental Study of Gear Surface Micropitting due to Variable Loading. *Applied Mechanics and Materials*, 750 . 96 - 103. ISSN 1660-9336

Analytical and Experimental Study of Gear Surface Micropitting due to Variable Loading

H. Long^{*}, I.S. Al-Tubi, M. T. M. Martinze

Departmental of Mechanical Engineering, The University of Sheffield, Sheffield, United Kingdom

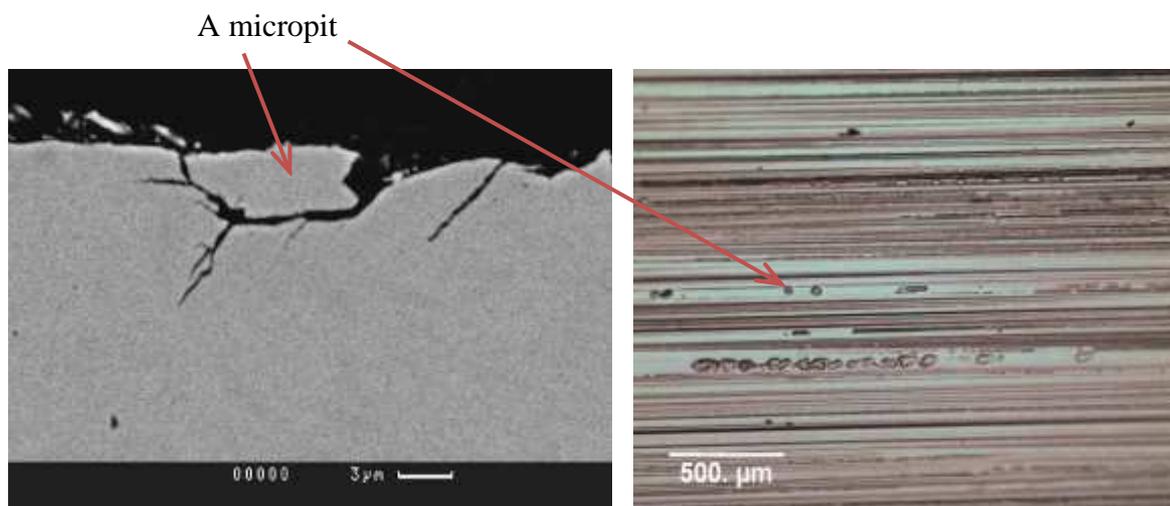
Fig. 1 Micropitting characteristics: depth and length of a micropit [6]

Micropitting is a Hertzian contact fatigue phenomenon and it is a form of localised material surface damage that occurs under rolling and sliding contact operating in elastohydrodynamic (EHL) or boundary lubrication regimes [5]. Micropitting failure is commonly observed in materials with high surface hardness and it is characterised by the removal of surface roughness asperities and the formation of cavities. Micropits initiate from small, surface or subsurface initial cracks; which are relatively small compared to the size of the contact zone, usually 5–10 μm long and 5–20 μm deep, as shown in Fig. 1 [6], and grow under repeated contact loading cycles [7]. The cracks grow in a shallow angle usually less than 30° with respect to the surface, at some point they curve back towards the surface, which in due course will cause the material to break and produced a fractured surface. Continuous loss of material produces a profile deviation for the gear tooth, if continued, it results in reduced gear tooth accuracy, increased loads and noise. If it cannot be restrained, it propagates into macropitting where pits are larger than 1 mm and have irregular shapes or other modes of gear tooth failures such as spalling and scuffing.

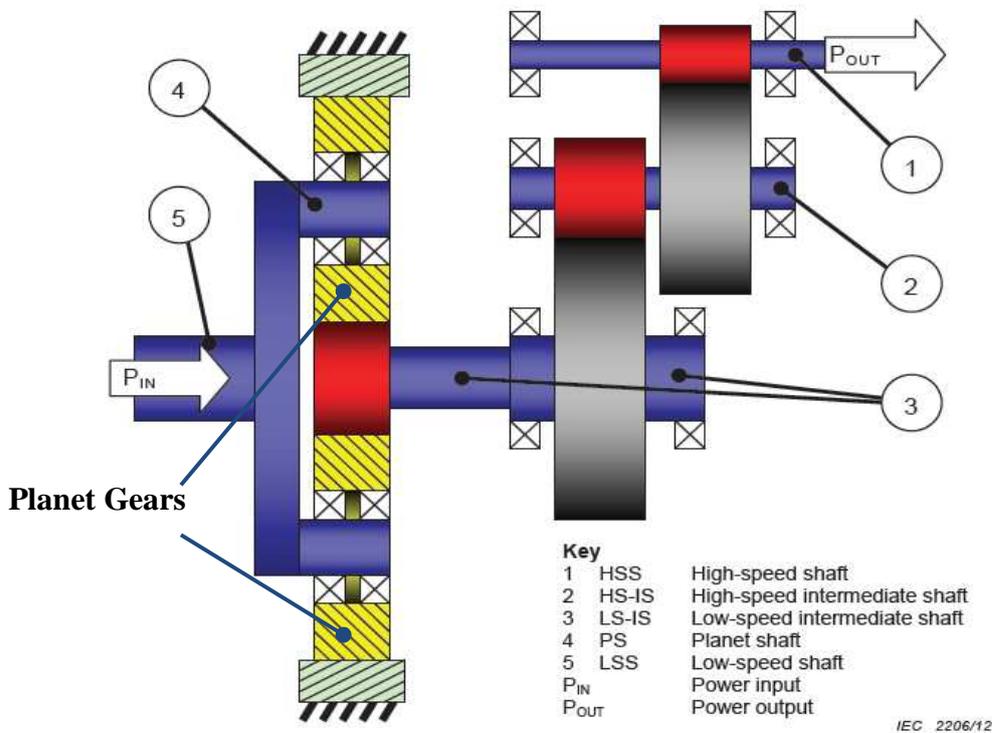
Fig.2 Three-stage wind turbine gearbox design with one planet stage [13]

This paper aims to investigate the effect of variable loading on gear tooth surface micropitting, for an application in planet gears of a wind turbine gearbox. The wind turbine is a megawatt scale machine and has a three-stage gearbox design with one planetary gear stage and two parallel gear stages [13], as shown in Fig. 2. Only planet gears of the low speed shaft (LSS) of the gearbox are studied in this paper because the LSS gears operate under heavy shaft torques and low rotational speeds which are the conditions prone to micropitting damage. During gear meshing, gear tooth surfaces experience rolling and sliding, in the same and opposite directions, as shown in Fig. 3, depending on the contacting tooth's relative velocities. The occurrence of sliding significantly changes the stress distribution in the surface and sub-surface of gear teeth. Sliding in opposite direction to rolling results in higher stresses because rolling is in one direction and sliding is in the other. At tooth tip and root regions (tooth addendum and dedendum) where the maximum sliding occurs, modified gear tooth profiles are commonly used to reduce contact stress level and to improve stress distribution.

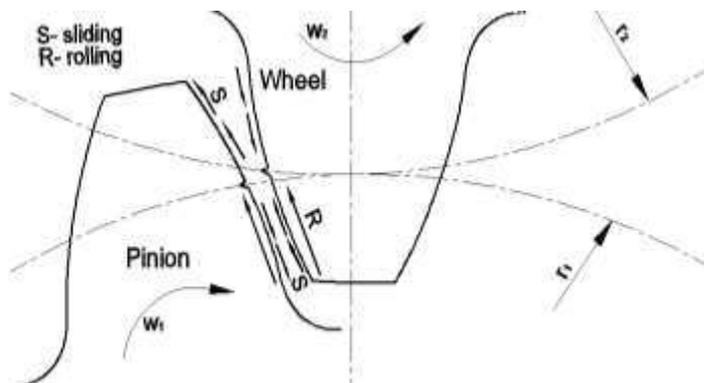
Fig.3 Gear tooth surface rolling and sliding

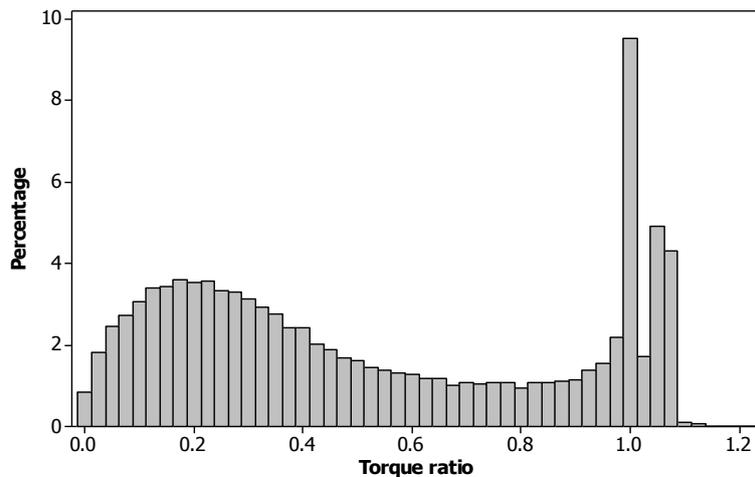
Fig. 4 Histogram of torque ratio of planet gear shaft

To consider wind turbine gearbox loading and speed variations, the SCADA (Supervisory Control and Data Acquisition) data of 10-minute average of generator power output and generator rotational speed for a period of 2.2 years recorded in an operating wind turbine, are analysed to derive the torque and speed variation ranges and corresponding numbers of occurrences. These analyses are presented as histograms of planet gear shaft torque and rotational speed variations, as show in Fig. 4 and Fig. 5 respectively. The values of planet gear shaft torque and rotational speed are nominalised as torque ratio and rotational speed ratio respectively. For example, the torque ratio is determined by dividing the torque values by the rated torque value of the planet gear shaft. Details of gear parameters, material properties, lubricant properties are given in Al-Tubi and Long (2012) [14]. As can be seen in Figs. 4 and 5, the gearboxes operate near the rated torque and rated rotational speed (the ratio equals to 1.0) for most of the time in operation, as expected. However, the torque ratio histogram in Fig. 4 shows the occurrences of torque values above the rated torque, indicating a probability of overloading. The highest torque ratio of over 1.18 is recorded from the 2.2 years of SCADA data analysed. As shown in Fig. 5, high numbers of occurrences of shaft rotational speed ratios are concentrated between 0.55 and 0.6 and at rated speed ratios. The high torque ratios occur when the power ratio is high and the speed ratio is below the rated rotational speed, indicating that the high torque ratios occur at the transient region between partial load and full load of the generator.

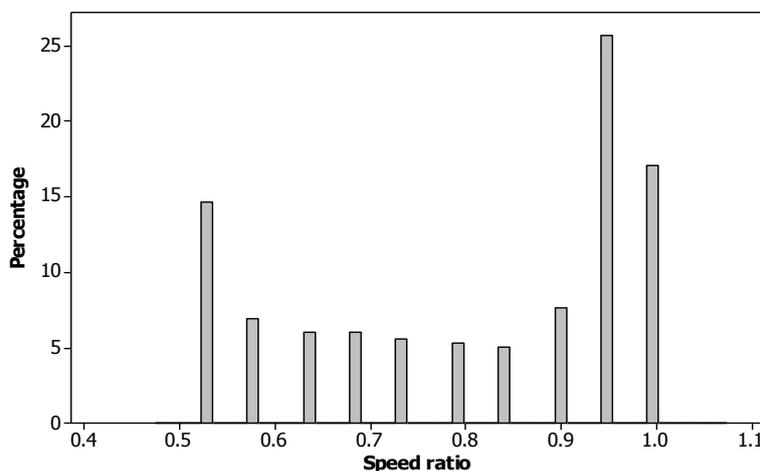
Fig. 5 Histogram of rotational speed ratio of planet shaft

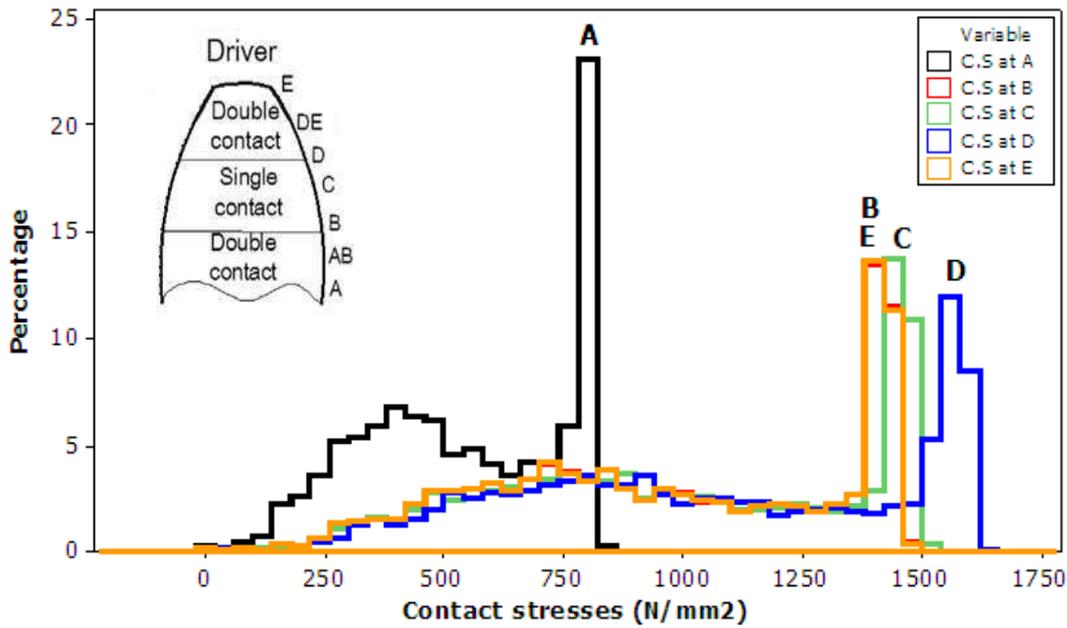
Fig. 6 Histograms of contact stress at 5 contact points on gear tooth flank

The local contact stress and specific lubricant film thickness at different contact point A, B, C, D and E of tooth flank along the line of action are calculated. The locations of these points, as shown as the insert image in Figs. 6 and 7, are selected based on the suggestion of ISO/TR 15144-1:2010 where the variations of the contact stress and specific lubricant film thickness during single and double tooth contact can be evaluated. The maximum sliding between gear teeth occurs in mesh-in, point A and mesh-out, point E because the difference of velocities of gear teeth is greatest in these regions.

As can be seen in Fig. 6, histograms show that the contact stress at point D varies considerably covering a wide range due to the variation of planet gear shaft torque. The contact stress at point D has a high probability of occurrence within a narrow range from 1530 to 1640 N/mm². The maximum contact stresses of the gear tooth surface occur at point D (at tooth dedendum), and the minimum values occur at point A (tooth addendum).

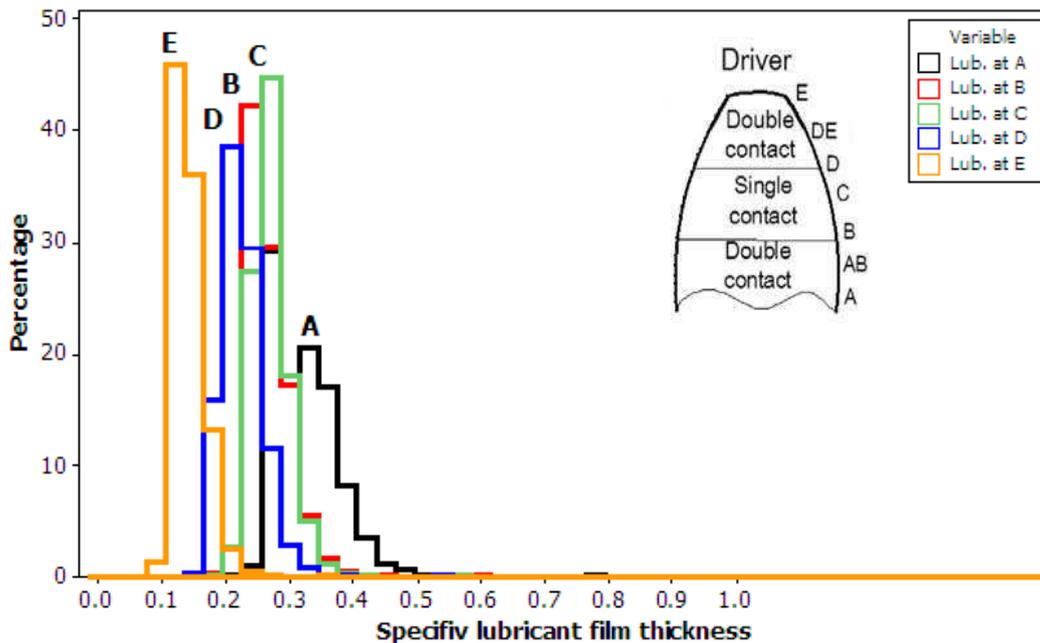
Fig.7 Histograms of specific lubricant film thickness at 5 contact points on gear tooth flank

The safety factor against gear micropitting may be defined as the ratio between the minimum specific lubricant film thicknesses and the permissible specific lubricant film thickness as given by Eq. 4. Currently there are no recommended values of the required minimum safety factor for wind turbine gearbox applications. However, according to Kissling (2012) [15] the range of micropitting safety factor, n , is defined by rating the risk at three levels: the high risk ($n < 1$), limited risk ($1 \leq n \leq 2$) and low risk ($n > 2$). Fig. 7 shows histograms of specific lubricant film thickness at the five contact points using the mean surface roughness value of 0.7 μ m as recommended by the international

standard [13]. It reveals that the specific lubricant film thickness is smaller than 1.0 at all contact points, while point E has lowest values at high percentage of occurrences, indicating a high risk of micropitting of the whole gear tooth surface. It is clear that the high level of gear shaft torque and its considerable variation range has contributed to the high level of contact stresses and its variations and these in turn reduce the specific lubricant film thickness, resulting in high risk of micropitting.

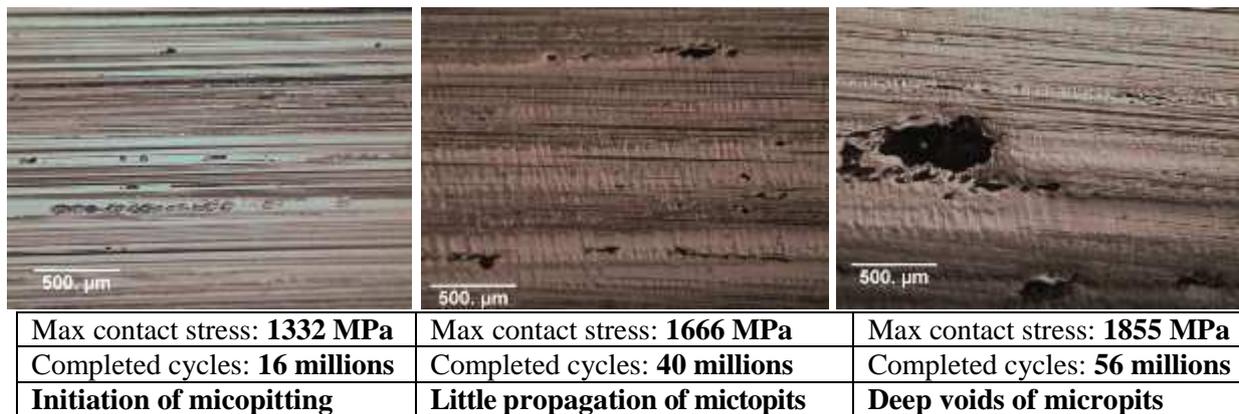
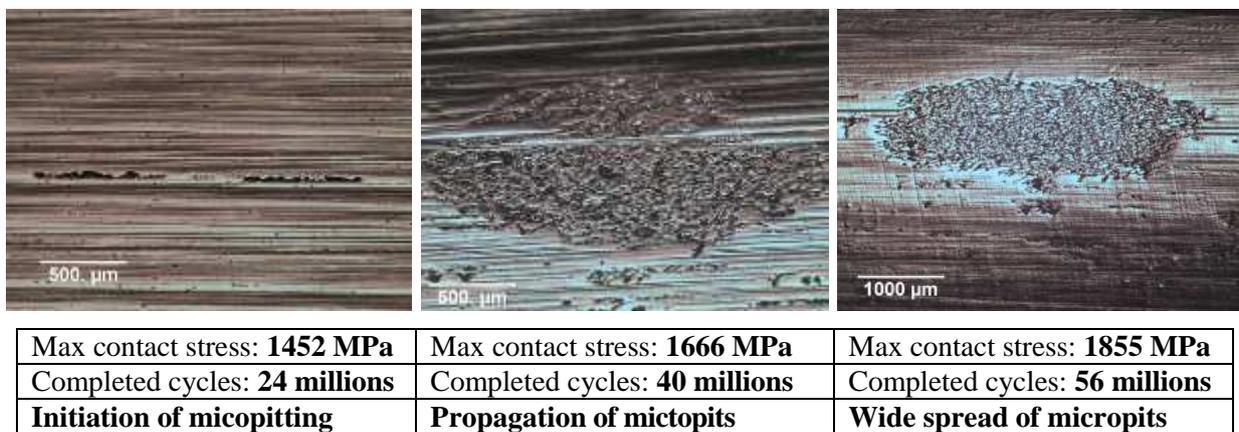
(a) Tested gear tooth dedendum

(b) Tested gear tooth addendum

Fig.8 Micropitting initiation and propagation under different contact stress levels and load cycles

surfaces are obtained by using replica samples of the surfaces and digital image analysis. Fig. 8 shows gear tooth surface micropitting in dedendum (tooth root region), Fig. 8a, and addendum (tooth tip region), Fig. 8b, after completing step-up contact stress levels and corresponding loading cycles as detailed in the figure. The micropitting initiates first at the dedendum at contact stress of 1332 MPa after 16 million cycles then it initiates at the addendum at a higher contact stress of 1452 MPa and load cycle of 24 million cycles. However the micropits on the addendum starts to spread over the tooth surface after the contact stress increases to 1666 MPa with 40 million cycles completed. At the end of test of 56 million cycles, the characteristics of micropits are different on gear tooth dedendum and addendum: the micropits are deeper on the dedendum but shallow micropits spread over the most surface on the addendum. This is because that the profile modification of gear teeth leaves the grinding cutting edges on gear tooth surfaces which may initiate micropitting. The experimental observation reveals that the micropitting can initiate at the dedendum and/or at the addendum.
